H. B. ROBINSON STEAM ELECTRIC PLANT, UNIT NO. 2
DOCKET NO. 50-261/RENEWED LICENSE NO. DPR-23

**H. B. ROBINSON STEAM ELECTRIC PLANT, UNIT NO. 2 - REQUEST FOR ADDITIONAL
INFORMATION REGARDING APPLICATION TO REVISE TECHNICAL SPECIFICATION
SURVEILLANCE REQUIREMENT FREQUENCIES TO SUPPORT 24-MONTH FUEL CYCLES**

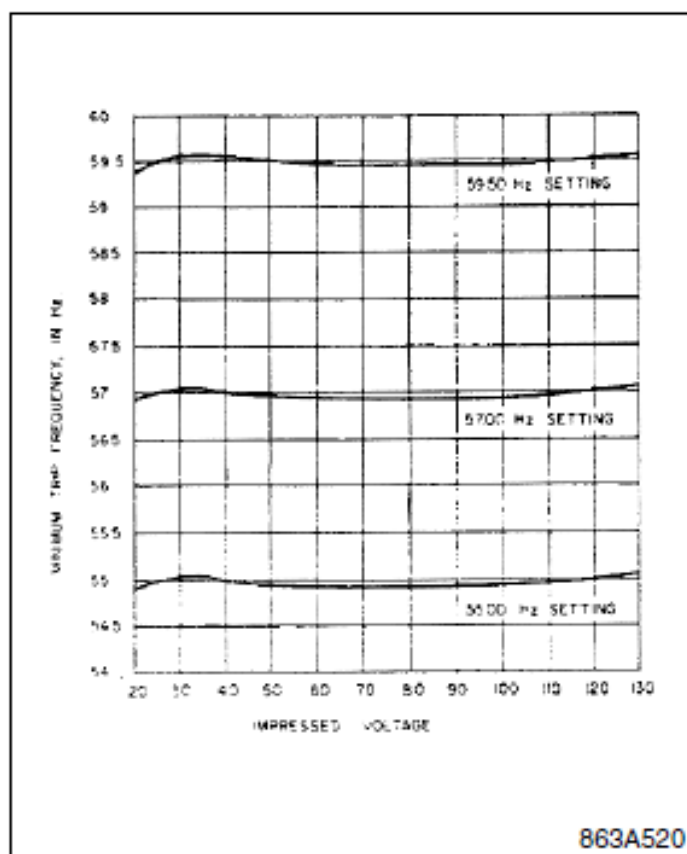
Figure 7: Typical Voltages vs. Minimum Frequency Curves 60 Hertz KF Underfrequency Relay

The RCP Underfrequency (UF) relays are Westinghouse type KF underfrequency relays. The calibration of these relays is based on Westinghouse Installation, Operation, and Maintenance Instructions I.L. 41-503F, effective May 1968. The voltage versus frequency setpoint response is relatively flat between 120VAC and 40VAC as shown below:

The vendor maintenance instructions include verification that the frequency trip setpoint is between 0.06Hz and 0.08Hz above the desired trip frequency when the applied voltage is reduced from 120VAC to 40VAC. This verification of frequency trip point over varying voltages (120VAC and 40VAC) is referred to in the discussion below as consistency of trip setpoint. RNP Calibration Procedure PIC-806, Westinghouse Type KF Underfrequency Relay, provides a desired trip setpoint of 58.20Hz for 120VAC applied voltage, with a tolerance of 58.00Hz to 58.40Hz. At the 40VAC applied voltage, the desired trip setpoint is 0.07Hz greater than the 120VAC frequency setpoint, and a tolerance of 0.060Hz to 0.080Hz above the 120VAC frequency setpoint.

RNP Technical Specifications Table 3.3.1-1, Item 12, provides a Nominal Trip Setpoint of 58.2Hz, and an Allowable Value of greater than or equal to 57.84Hz. The Allowable Value is applied for the evaluation of calibration as-found data to determine whether the instrument drift exceeded acceptable limits.

- 2007 (Work Order (WO) 00782776) – Relay 811/1 was found out-of-tolerance for consistency of trip setpoint between 120VAC and 40VAC. The AS-FOUND trip frequency for 120VAC was 58.15Hz, and for 40VAC was 58.27Hz. The AS-FOUND trip frequency at both voltages satisfies the Allowable Value of $\geq 57.84\text{Hz}$. The AS-FOUND values for 120VAC and 40VAC differed by 0.12Hz, exceeding the expected performance of 0.06Hz to 0.08Hz. The relay could not be adjusted to within the desired AS-LEFT tolerance. The event is conservatively identified as a failure because the component could not be adjusted within expected tolerance which could be indicative of age related degradation, and may not have been detected by means other than the calibration. A Technical Review of the out-of-tolerance condition was performed per RNP Procedure MMM-006, Calibration Program. The Technical Review of the out-of-tolerance condition determined that the relay would have operated within the setpoint range (above Technical Specifications (TS) Nominal Trip Setpoint (NTS)), allowing the system to perform its intended function. Since the relay could not be adjusted to within the more restrictive AS-LEFT tolerance, the Technical Review identified the proper action as replacement of the relay.

- 2008 (WO 01064106) – Relay 811/1 was found out-of-tolerance for consistency of trip setpoint between 120VAC and 40VAC. The AS FOUND trip frequency for 120VAC was 58.350Hz, and for 40VAC was 58.515Hz. The AS FOUND trip frequency at both voltages satisfies the Allowable Value of $\geq 57.84\text{Hz}$. The AS FOUND values for 120VAC and 40VAC differed by 0.165Hz, exceeding the expected performance of 0.06Hz to 0.08Hz. The Technical Review of the out-of-tolerance condition determined that the relay would have picked up sooner (Allowable Value satisfied) on a decreasing frequency condition, and identified the proper action as calibrating the relay to within tolerance. This event does not represent instrument drift that exceeded acceptable limits.

- 2013 (WO 02010241) – Relay 811/1 was found out-of-tolerance for consistency of trip setpoint between 120VAC and 40VAC. The AS FOUND trip frequency for 120VAC was 58.29Hz, and for 40VAC was 58.41Hz. The AS FOUND trip frequency at both voltages satisfies the Allowable Value of $\geq 57.84\text{Hz}$. The AS FOUND values for 120VAC and 40VAC differed by 0.12Hz, exceeding the expected performance of 0.06Hz to 0.08Hz. The relay would have picked up sooner (above TS NTS) on a decreasing frequency condition, and the proper action was calibrating the relay to within tolerance. This event does not represent instrument drift that exceeded acceptable limits.

- 2008 (WO 01064106) – Relay 811/2 was found out-of-tolerance for consistency of trip setpoint between 120VAC and 40VAC. The AS FOUND trip frequency for 120VAC was 58.170Hz, and for 40VAC was 58.260Hz. The AS FOUND trip frequency at both voltages satisfies the Allowable Value of $\geq 57.84\text{Hz}$. The AS FOUND values for 120VAC and 40VAC differed by 0.090Hz, exceeding the expected performance of 0.06Hz to 0.08Hz. The Technical Review of the out-of-tolerance condition determined that the relay would have picked up sooner (above TS NTS) on a decreasing frequency condition, and identified the proper action as calibrating the relay to within tolerance. This event does not represent instrument drift that exceeded acceptable limits.
