Report No.: SIR-94-080
Revision No.: 1
Project No.: CEOG-01Q
File No.: CEOG-01Q-401
March 1995

**Relaxation of Reactor Coolant Pump
Flywheel Inspection Requirements**

Structural Integrity Associates, Inc.

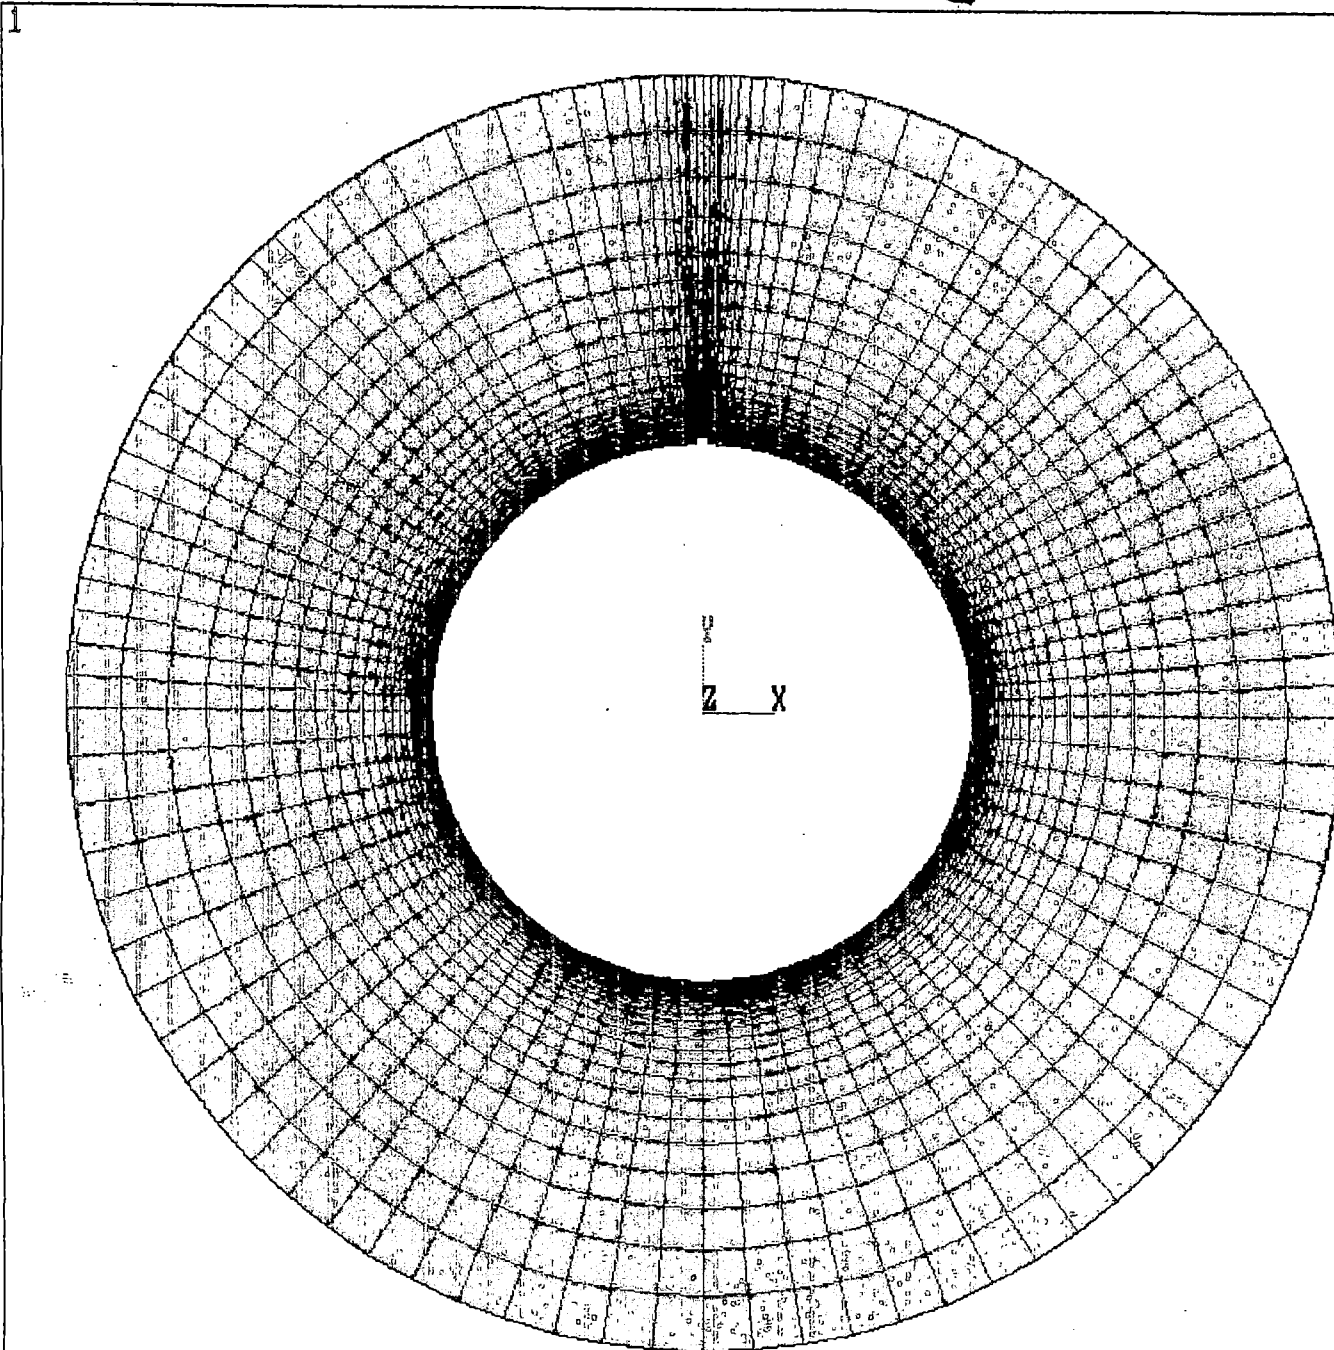
Figure 5-2. Finite Element Model for Large Bore Flywheel

CEOG Flywheel Evaluation, Large Bore Diameter

The ANSYS computer program [13] was used to develop the models. Each flywheel was modeled using the geometric and material information provided in Table 2-1. Two-dimensional isoparametric elements were used to develop a plane strain model for the flywheels. A plane strain model is justified for these analyses since the flywheels are relatively thick. The keyway for each of the flywheels was explicitly modeled in order to determine the stress concentration effect in this region, with adequate refinement of the finite element models in the keyway region in order to determine the peak stress. A typical finite element model for the large-bore flywheels is shown in Figure 5-2 while a typical smaller bore flywheel finite element model is shown in Figure 5-3. A total number of 2472 elements were used for the large diameter models, while 2944 elements were used for the smaller diameter models.

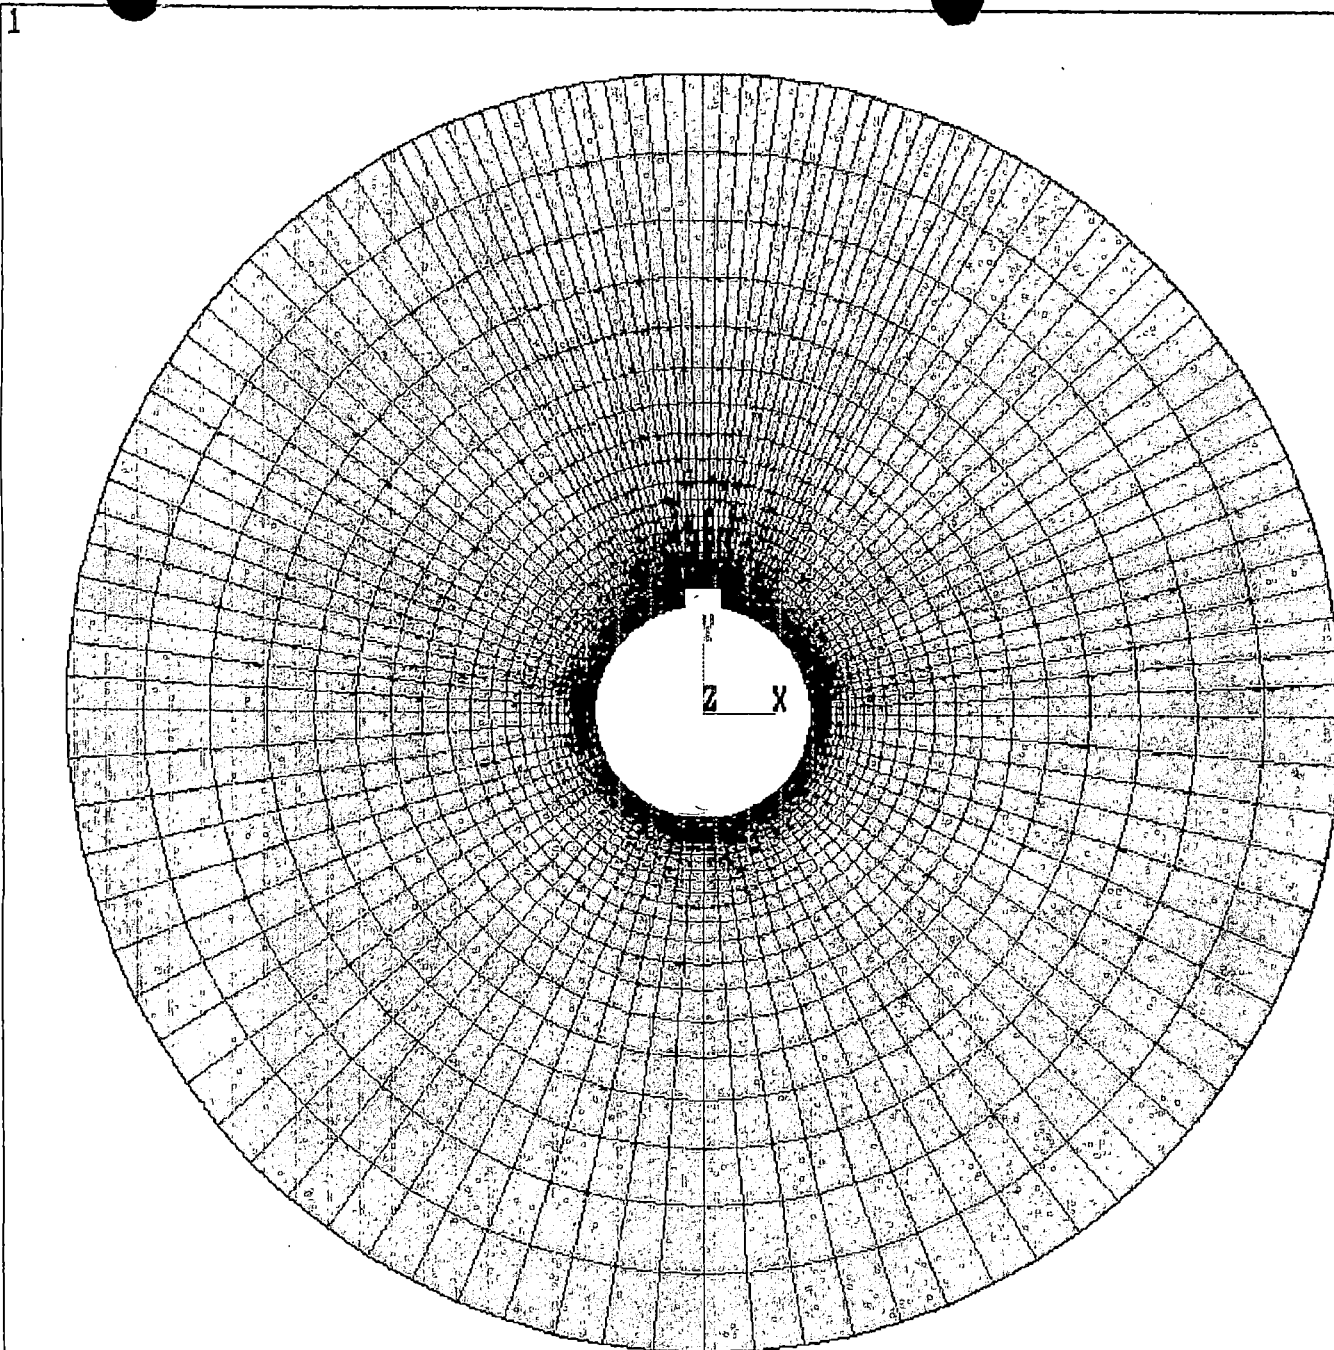
Figure 5-3. Finite Element Model for Small Bore Flywheel

CEOG Flywheel Evaluation, Small Bore Diameter

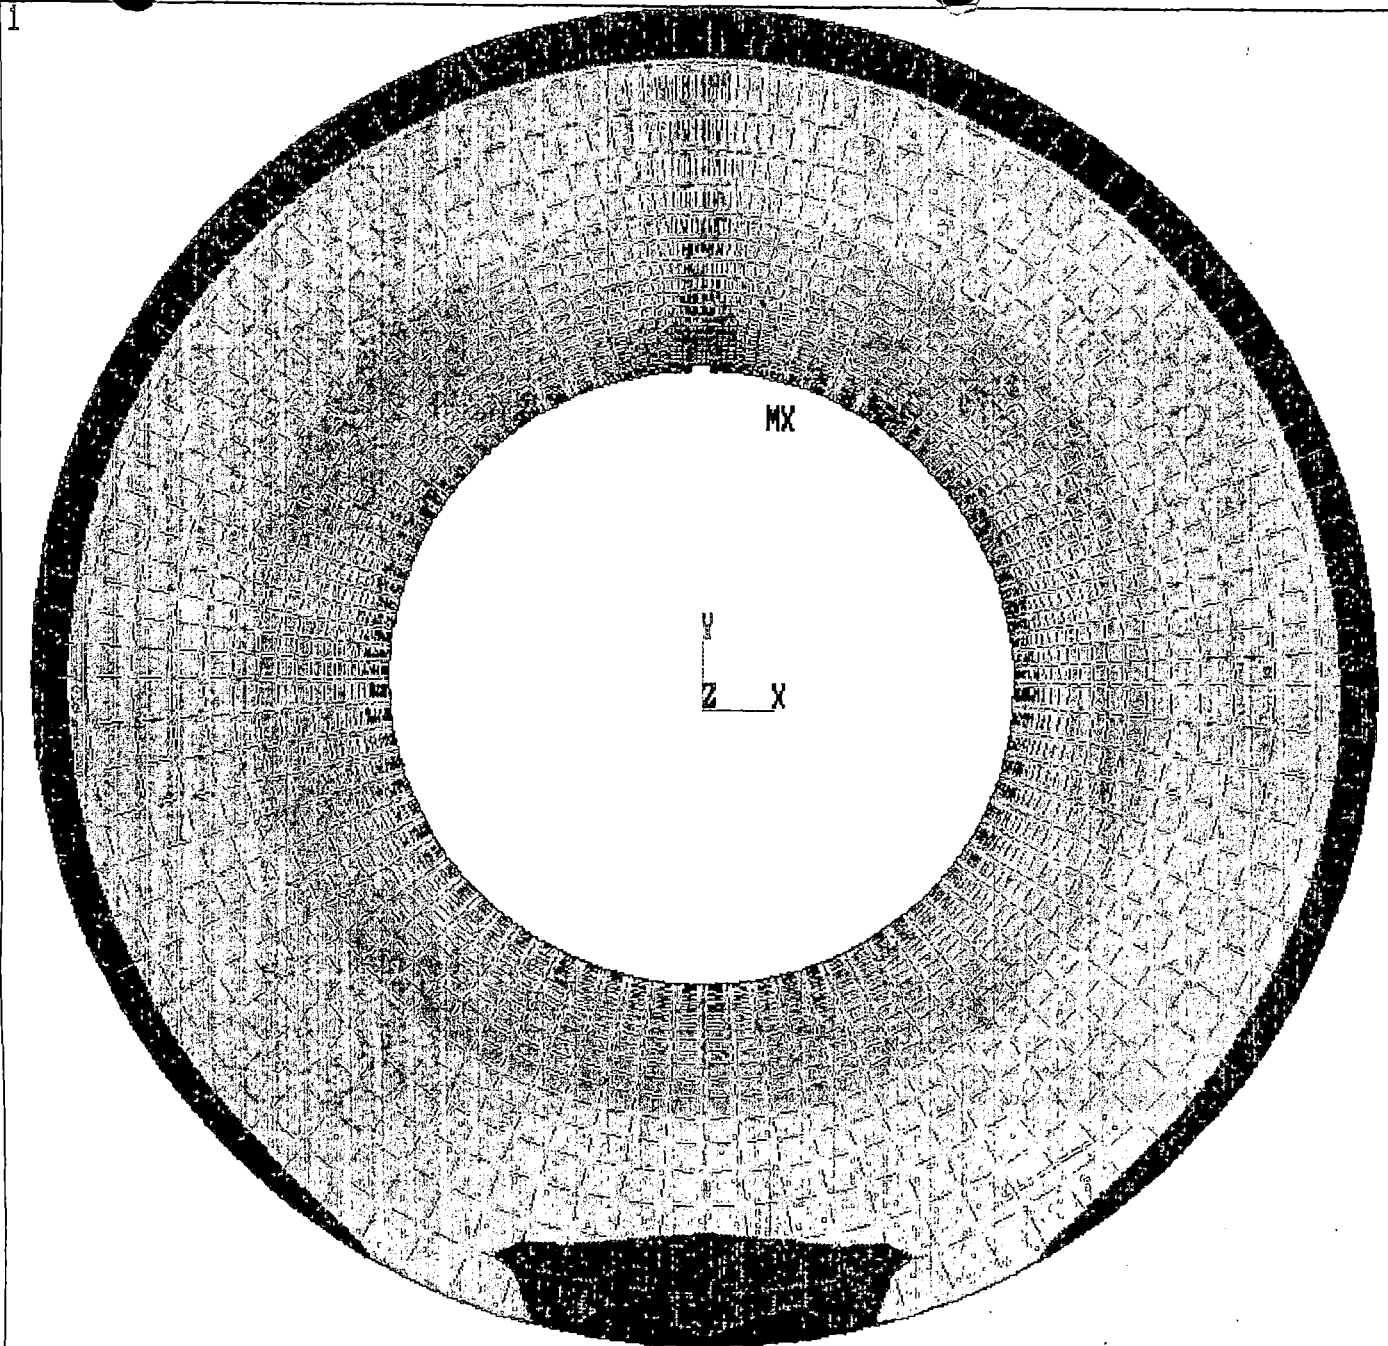
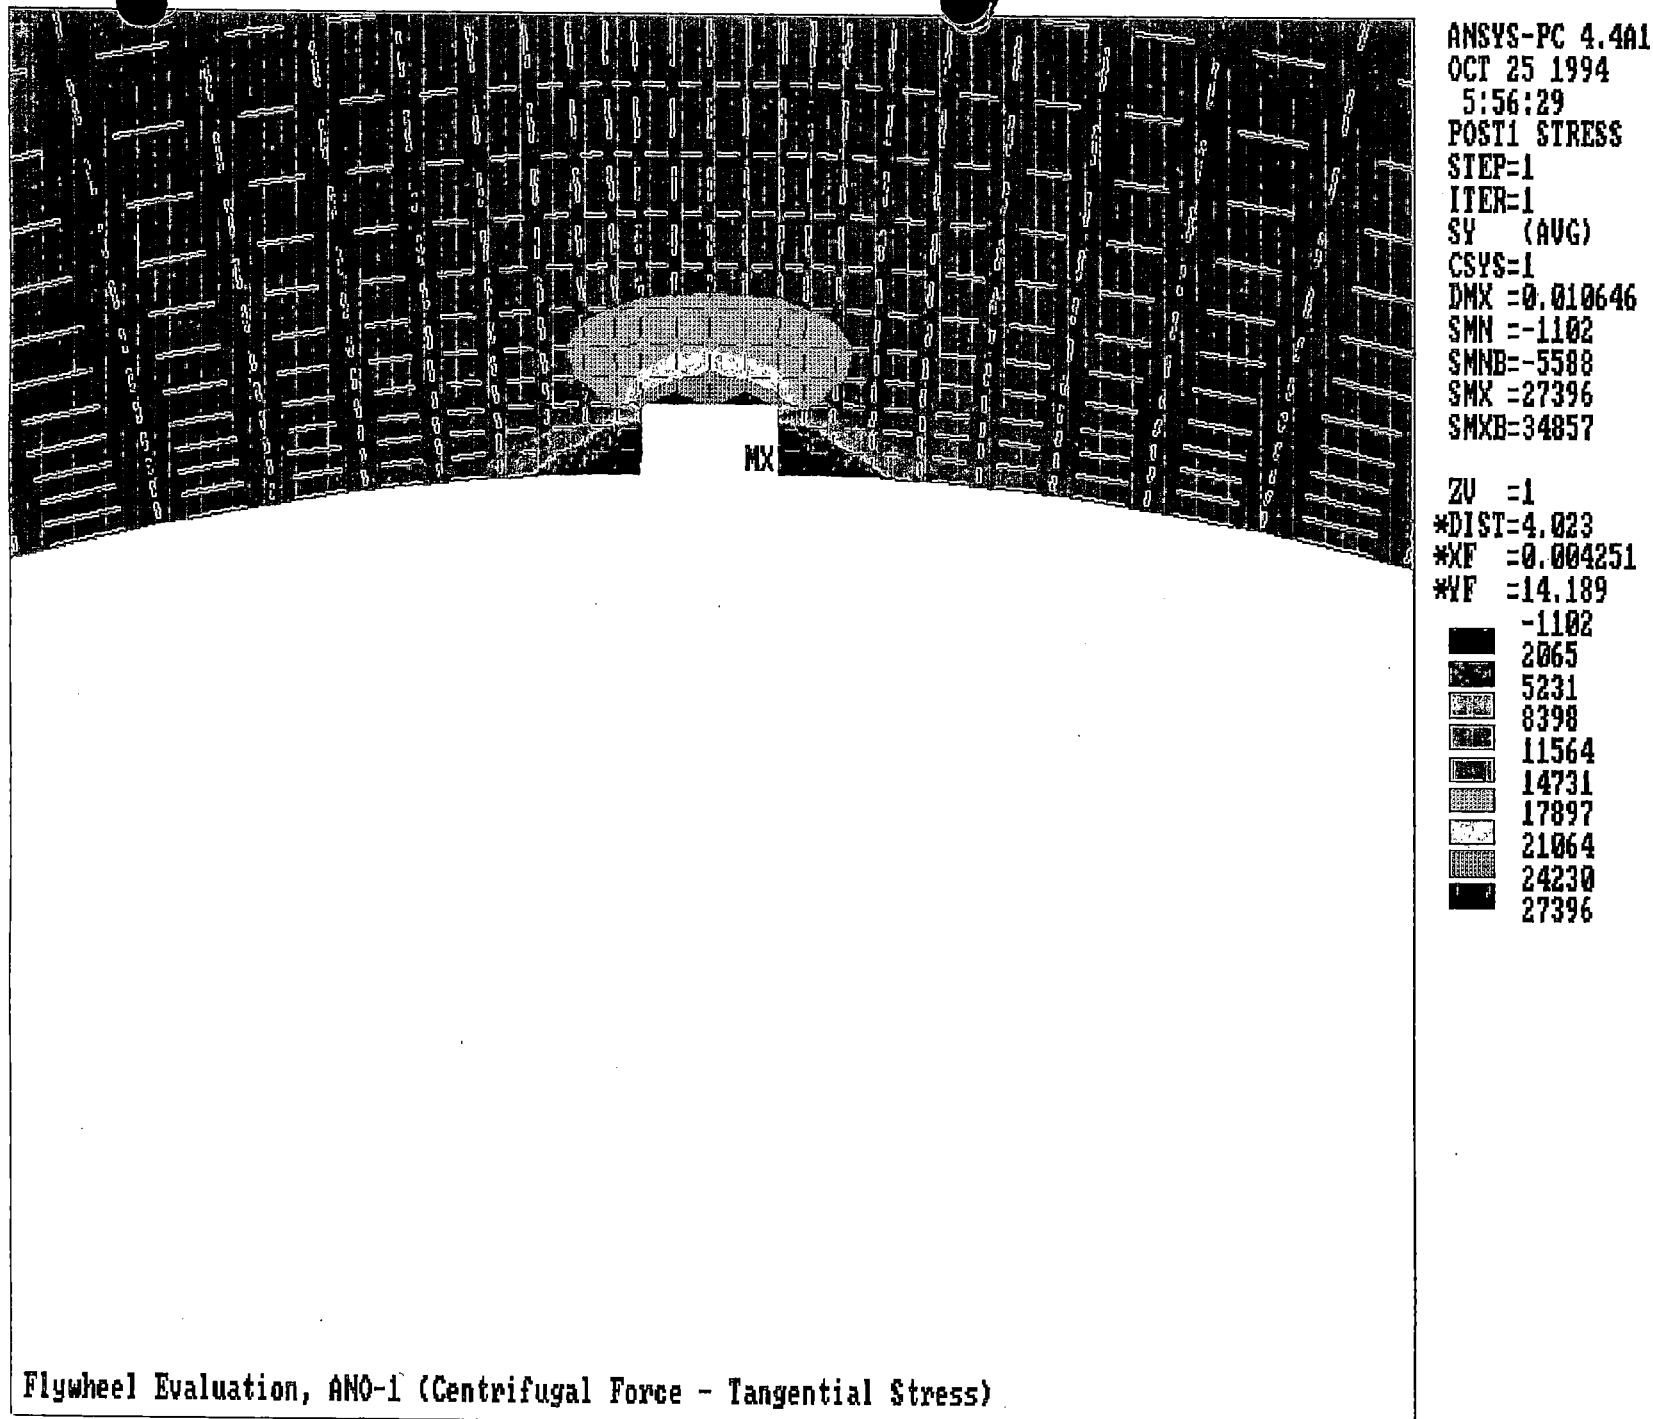
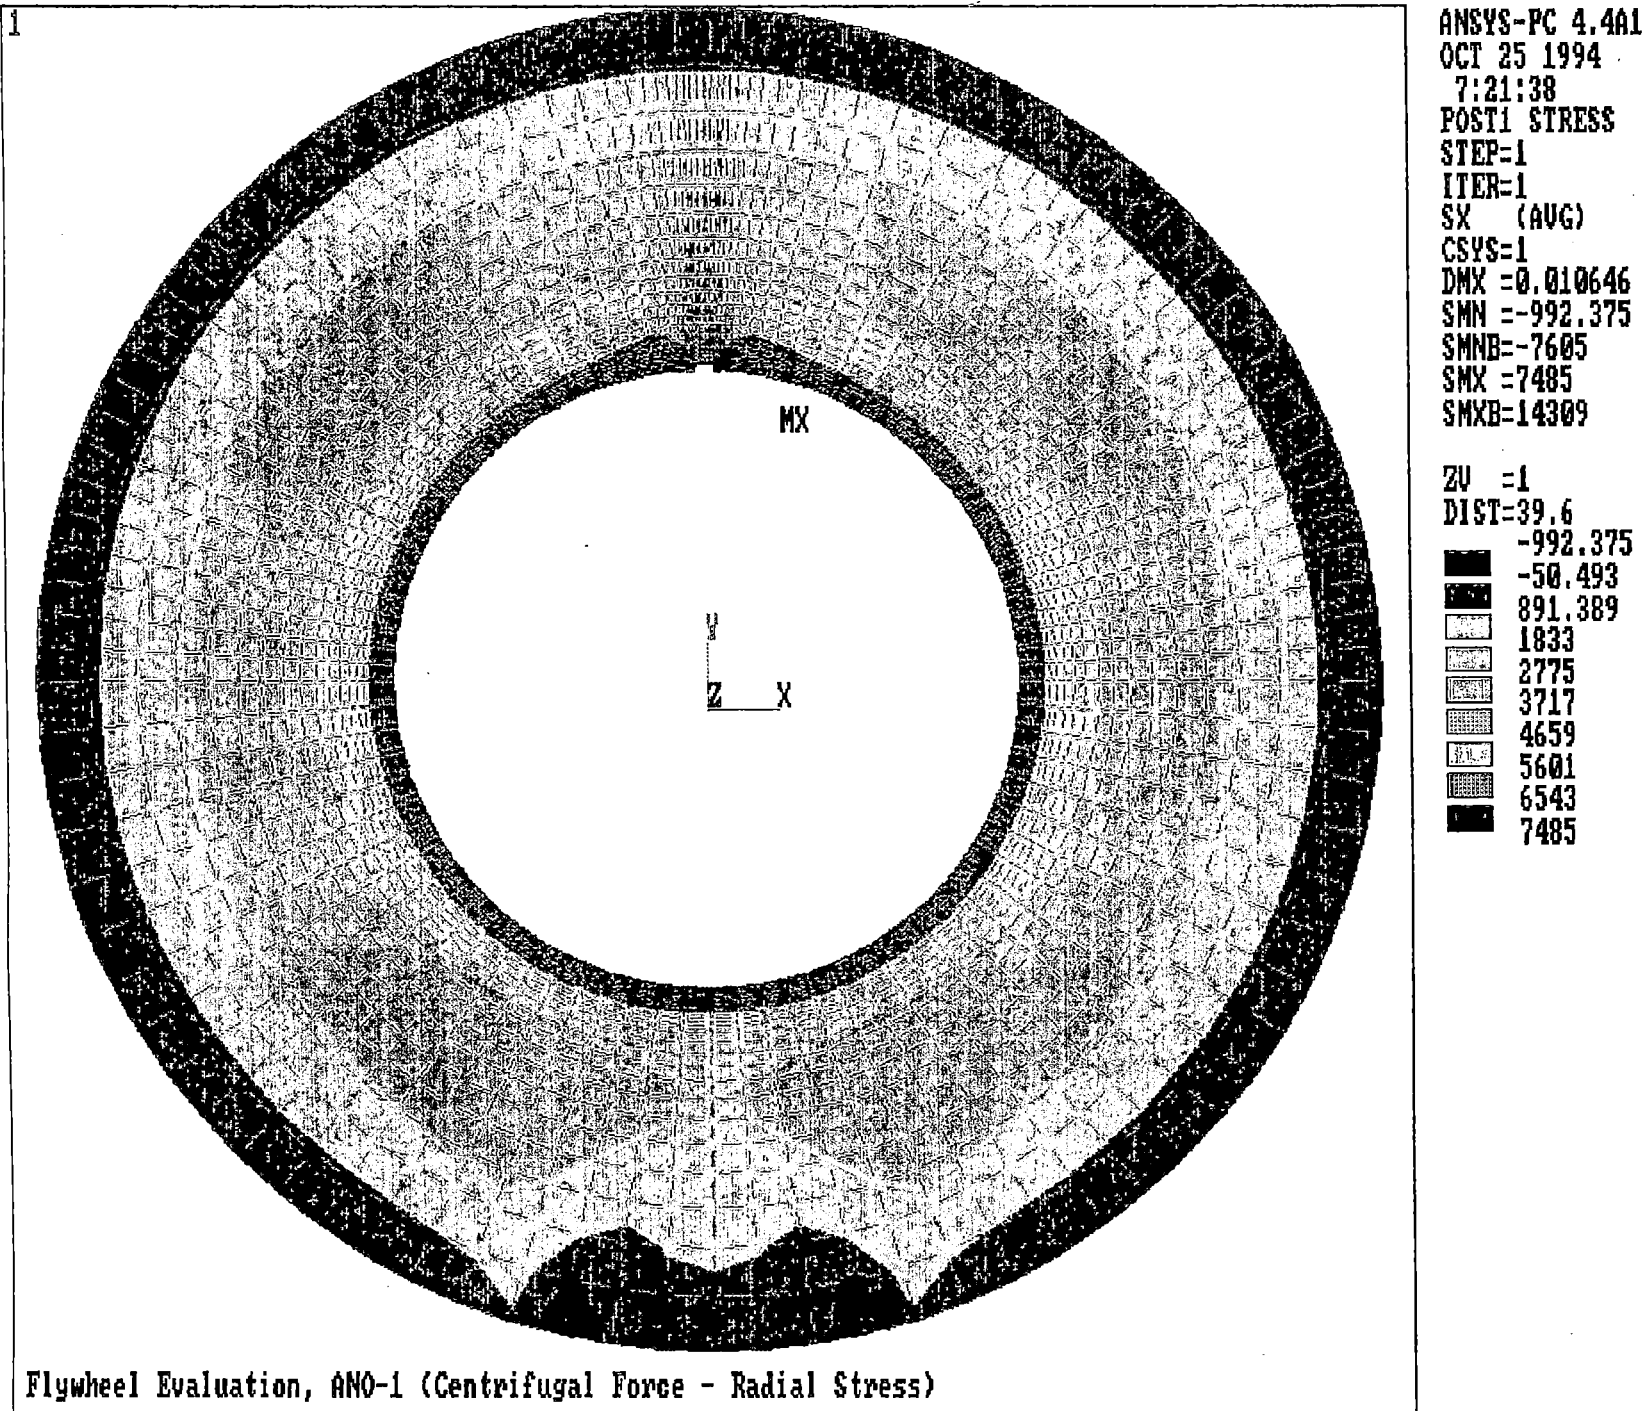
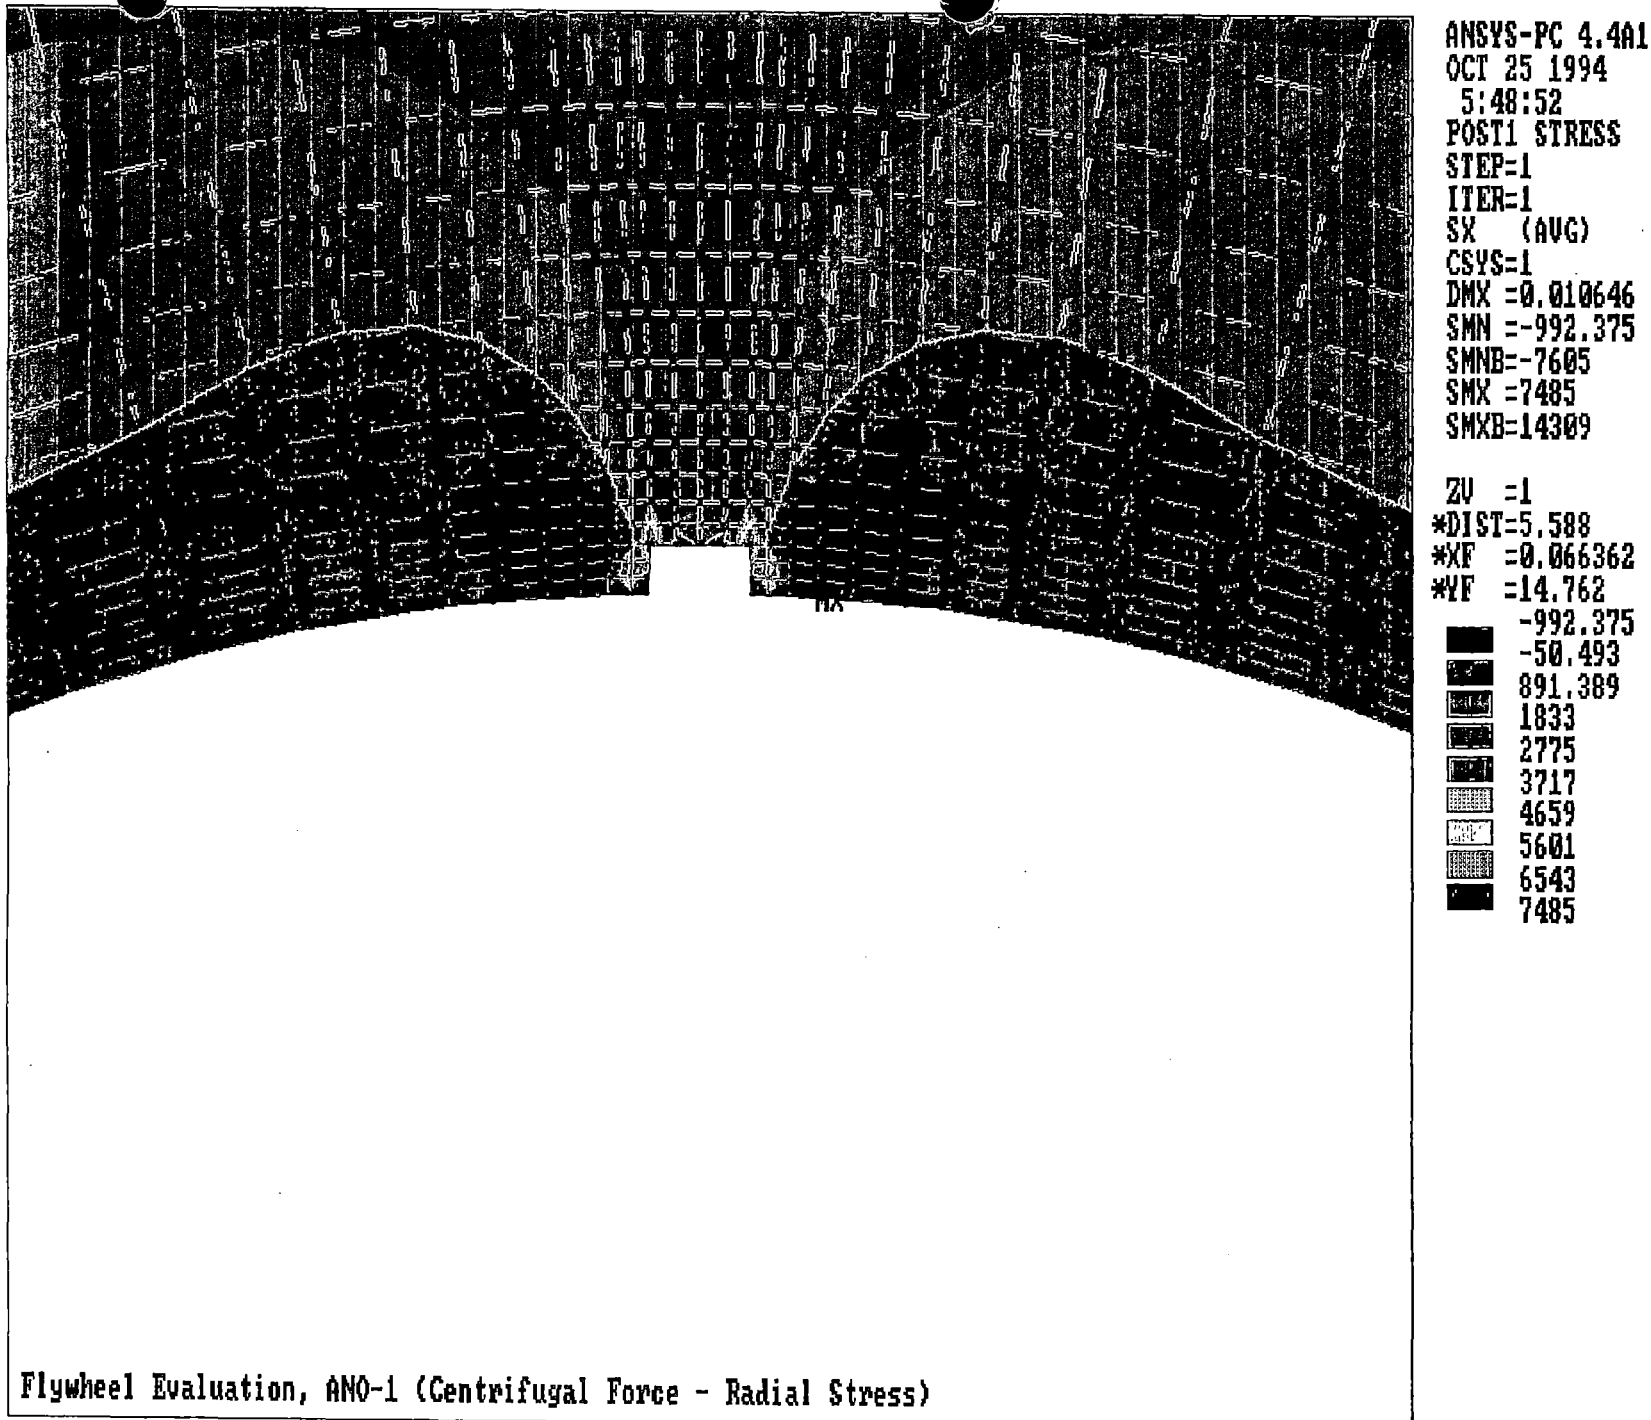
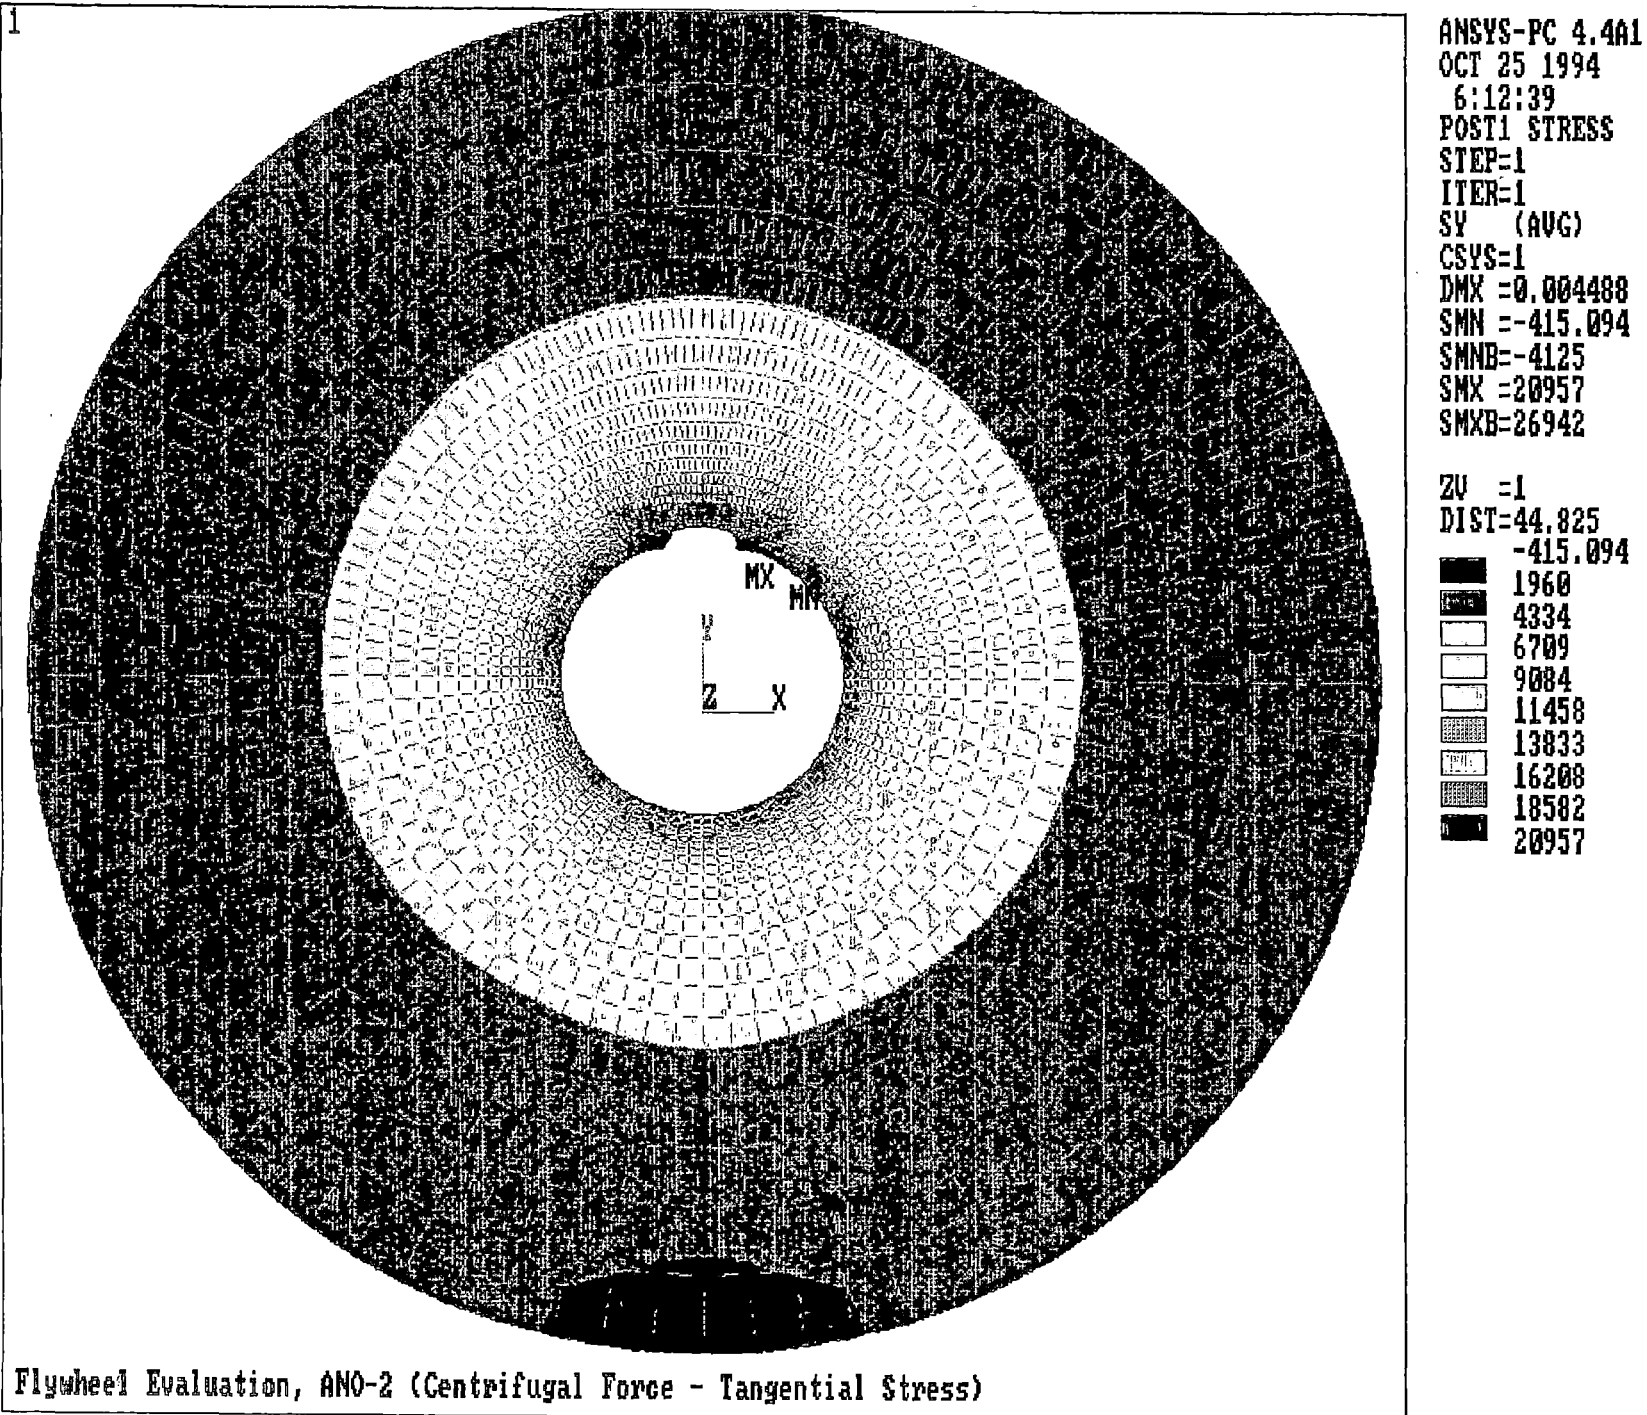
Flywheel Evaluation, ANO-1 (Centrifugal Force - Tangential Stress)

Figure 5-4. Overall Tangential Stress Distribution Due to Centrifugal Force (ANO-1)

Figure 5-5. Details of Tangential Stress Distribution in Keyway Region Due to Centrifugal Force (ANO-1)

Figure 5-6. Overall Radial Stress Distribution Due to Centrifugal Force (ANO-1)

Figure 5-7. Details of Radial Stress Distribution in Keyway Region Due to Centrifugal Force (ANO-1)

Figure 5-8. Overall Tangential Stress Distribution Due to Centrifugal Force (ANO-2)

Figures 5-4 through 5-27 present the tangential and radial stress distributions under centrifugal loading for all six flywheels considered in the evaluation. Four figures are presented for the flywheel of each plant. The first two figures for each plant depict the overall stress distribution and detailed keyway region stresses in the tangential direction. The third and fourth figures provide the overall stress distribution and detailed keyway stresses in the radial direction.
