Report No.: SIR-94-080
Revision No.: 1
Project No.: CEOG-01Q
File No.: CEOG-01Q-401
March 1995

**Relaxation of Reactor Coolant Pump
Flywheel Inspection Requirements**

Structural Integrity Associates, Inc.

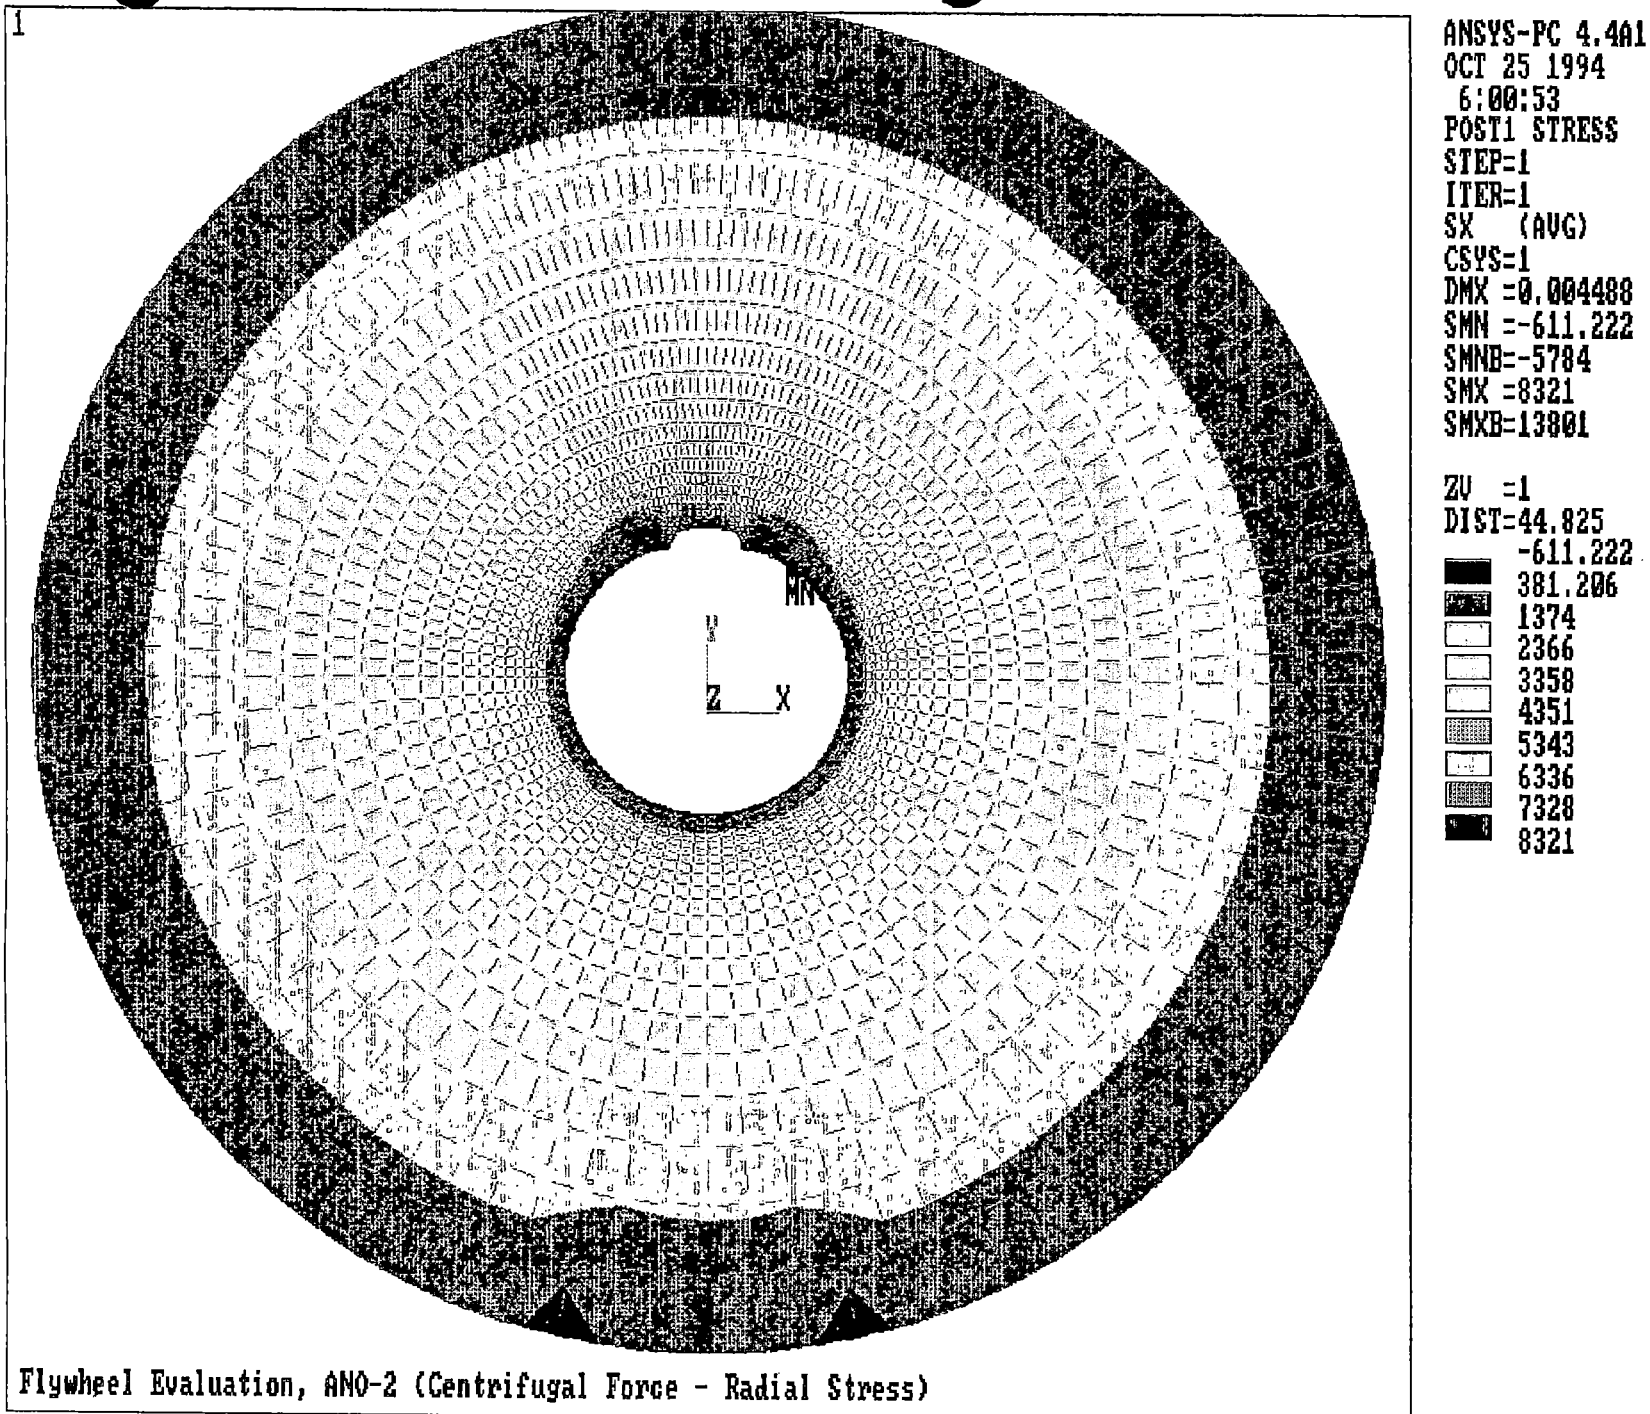
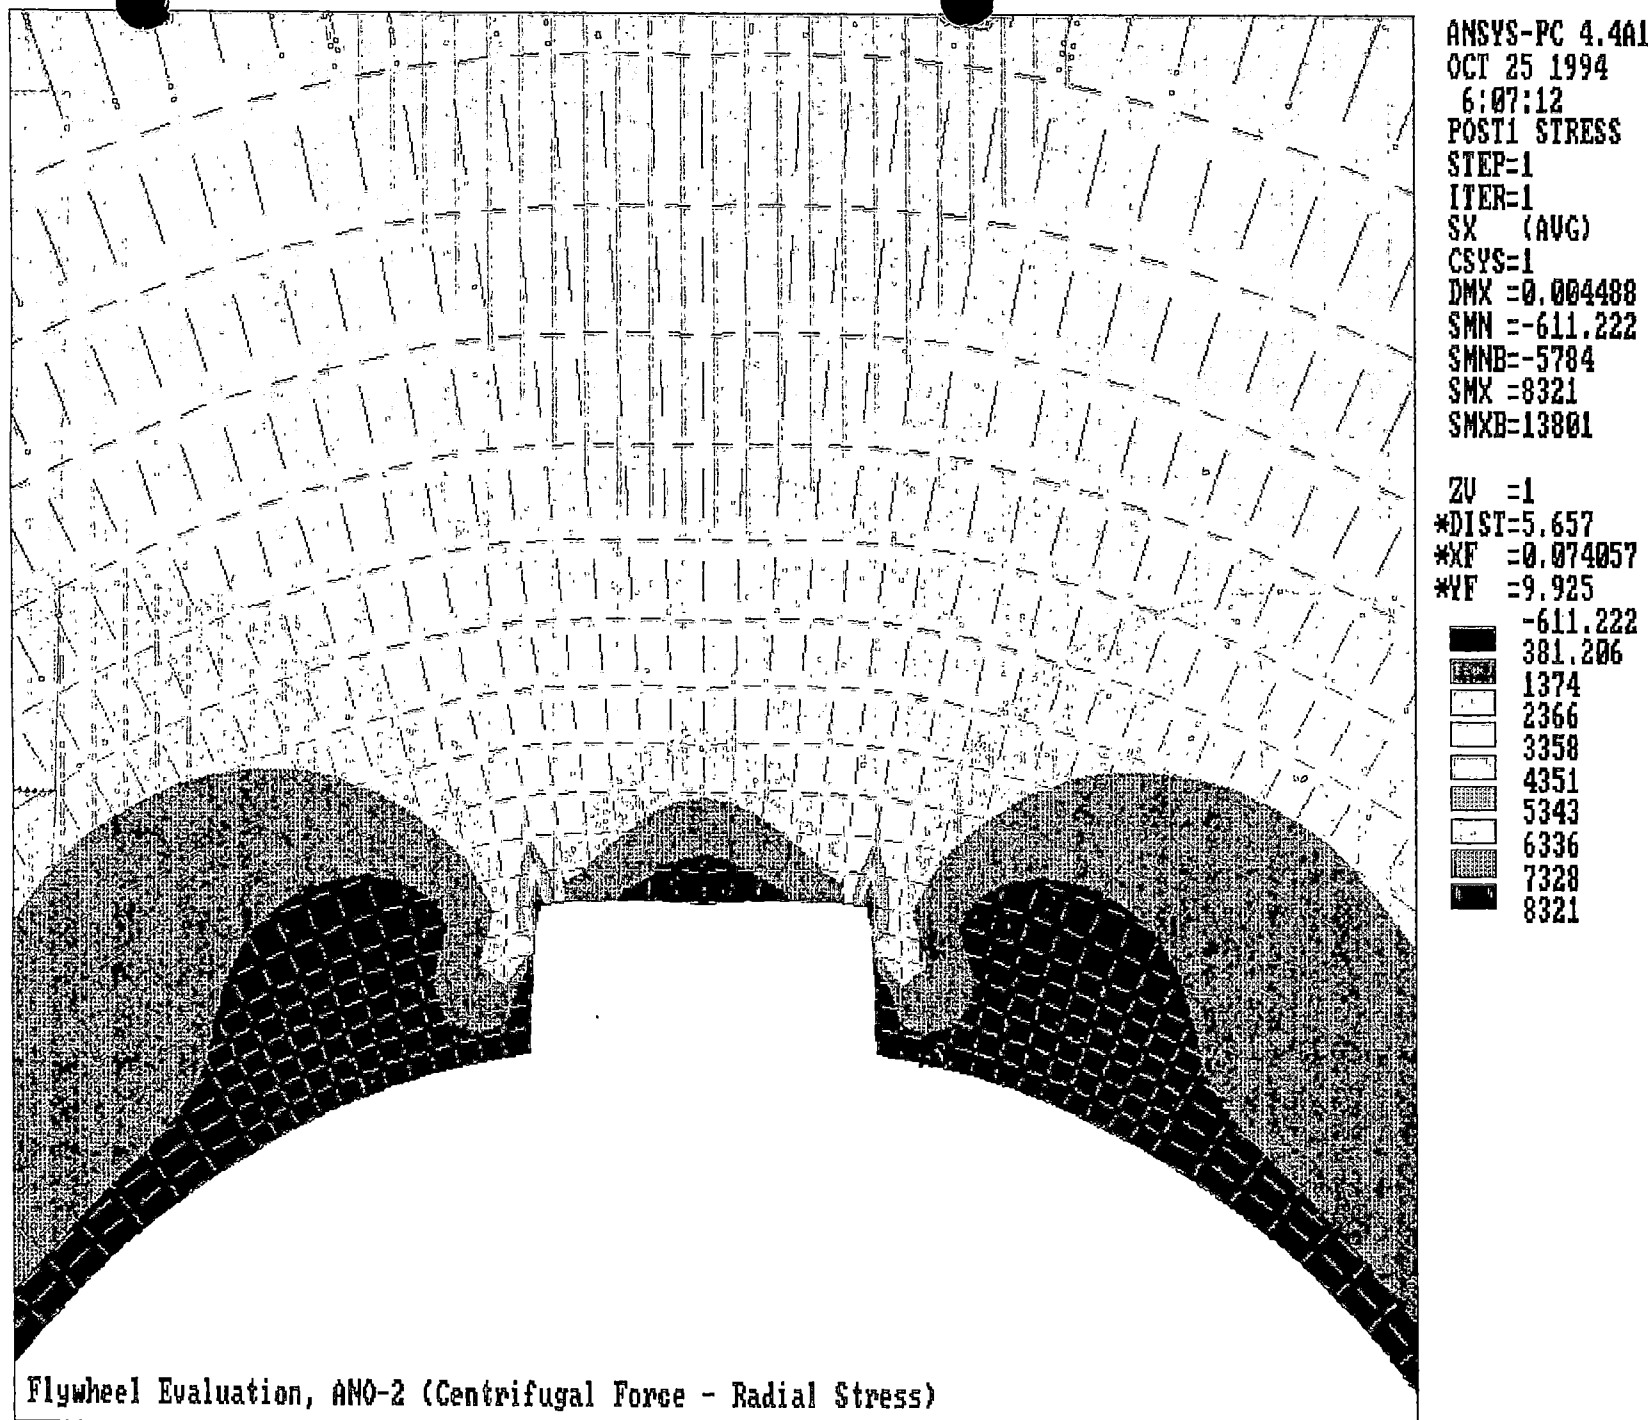
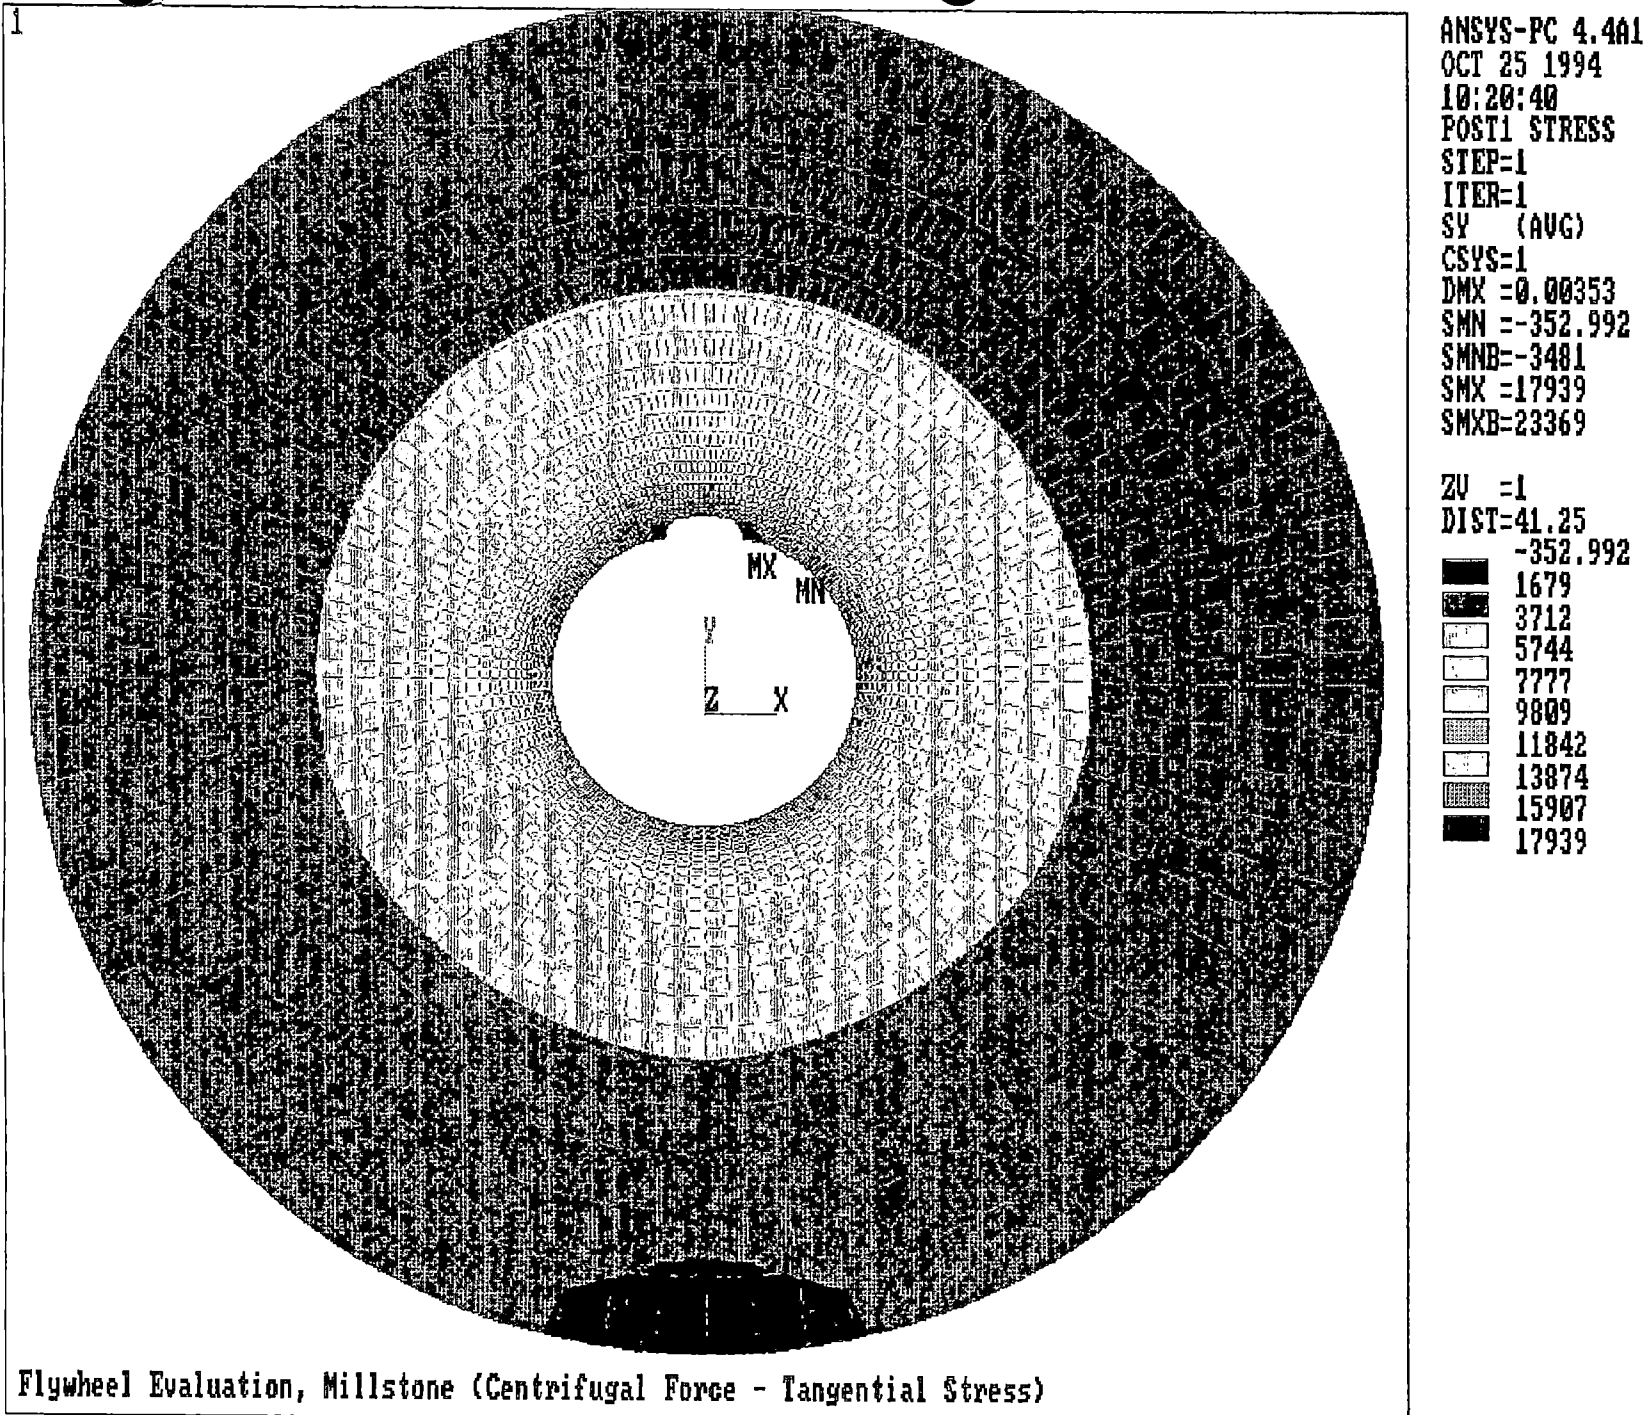
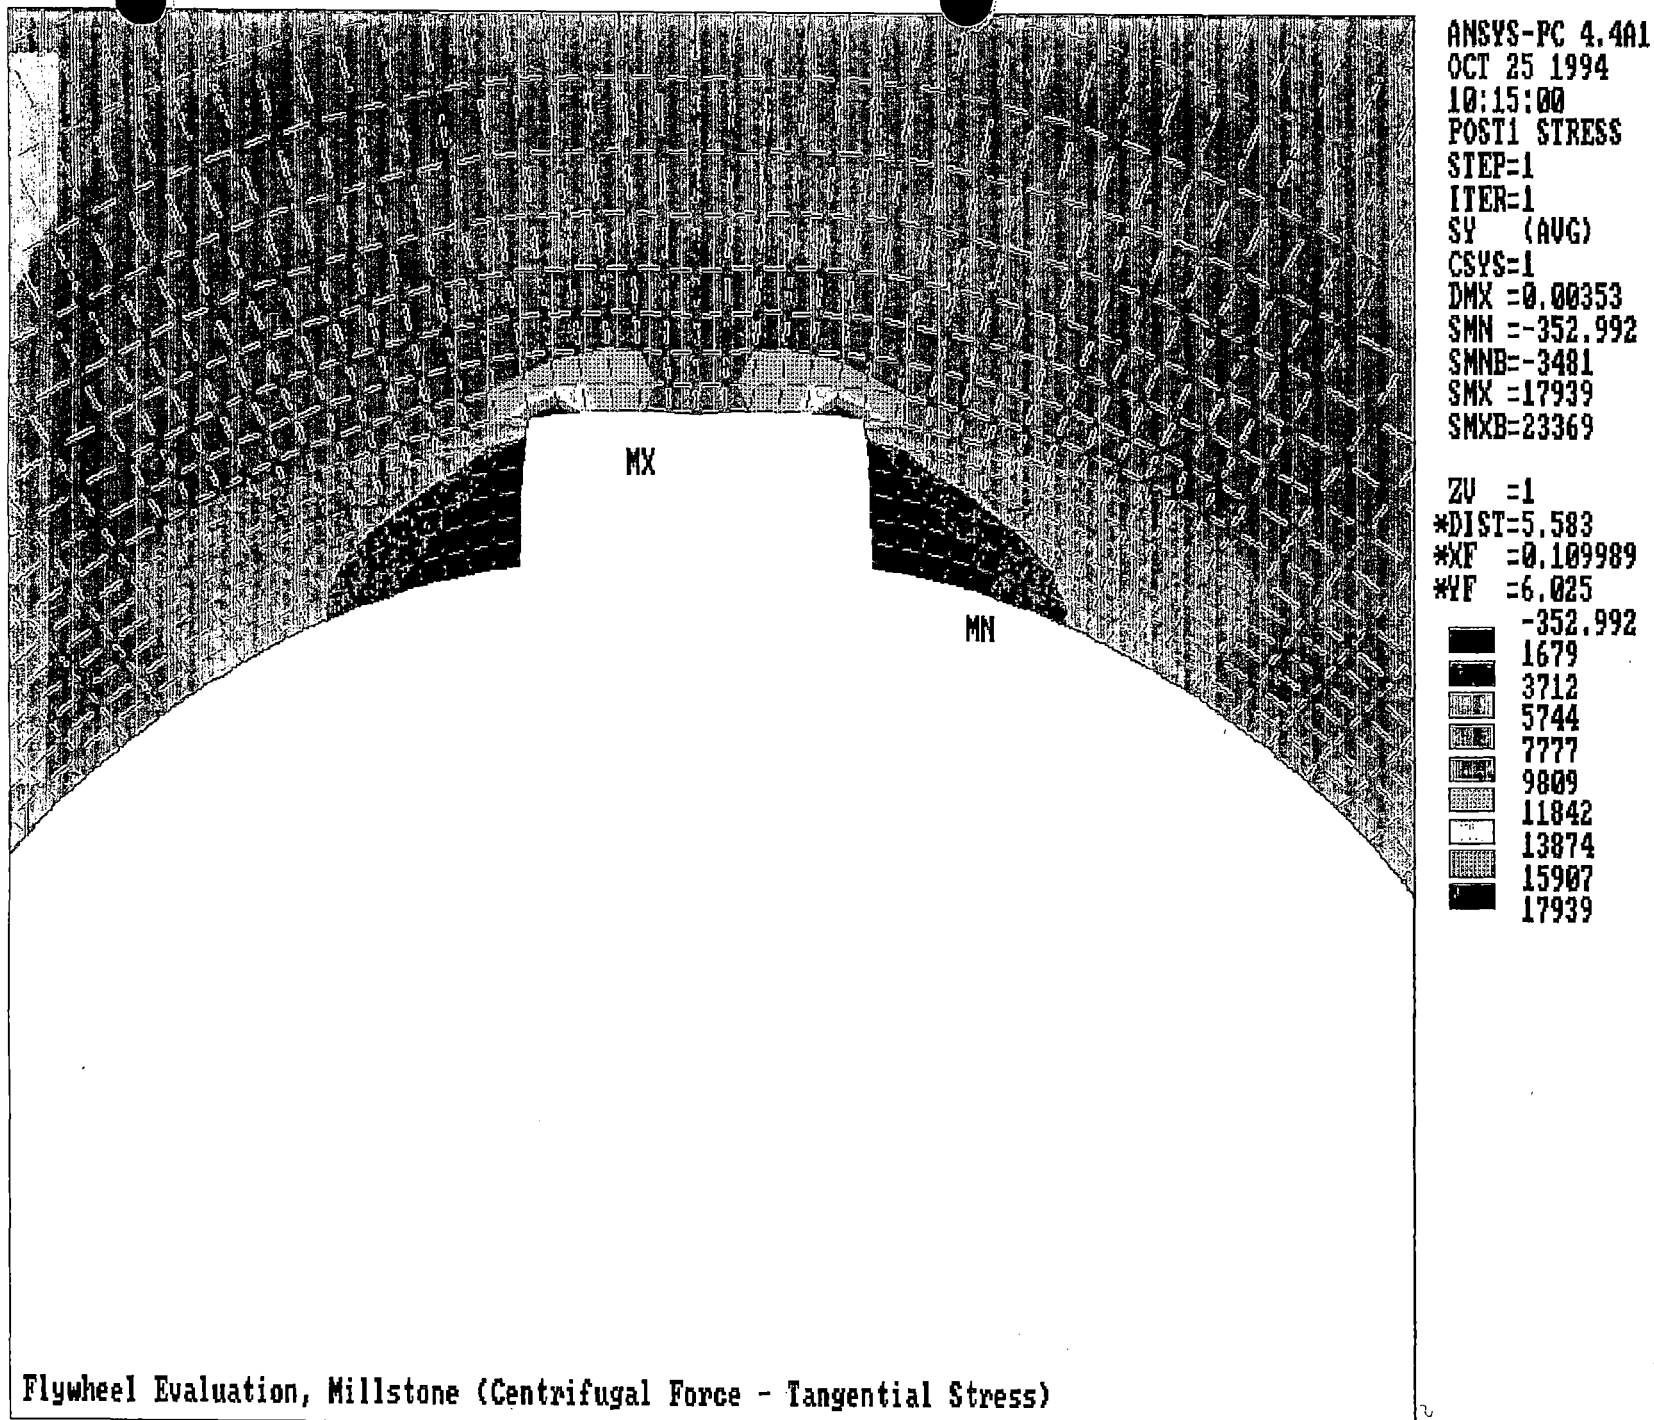
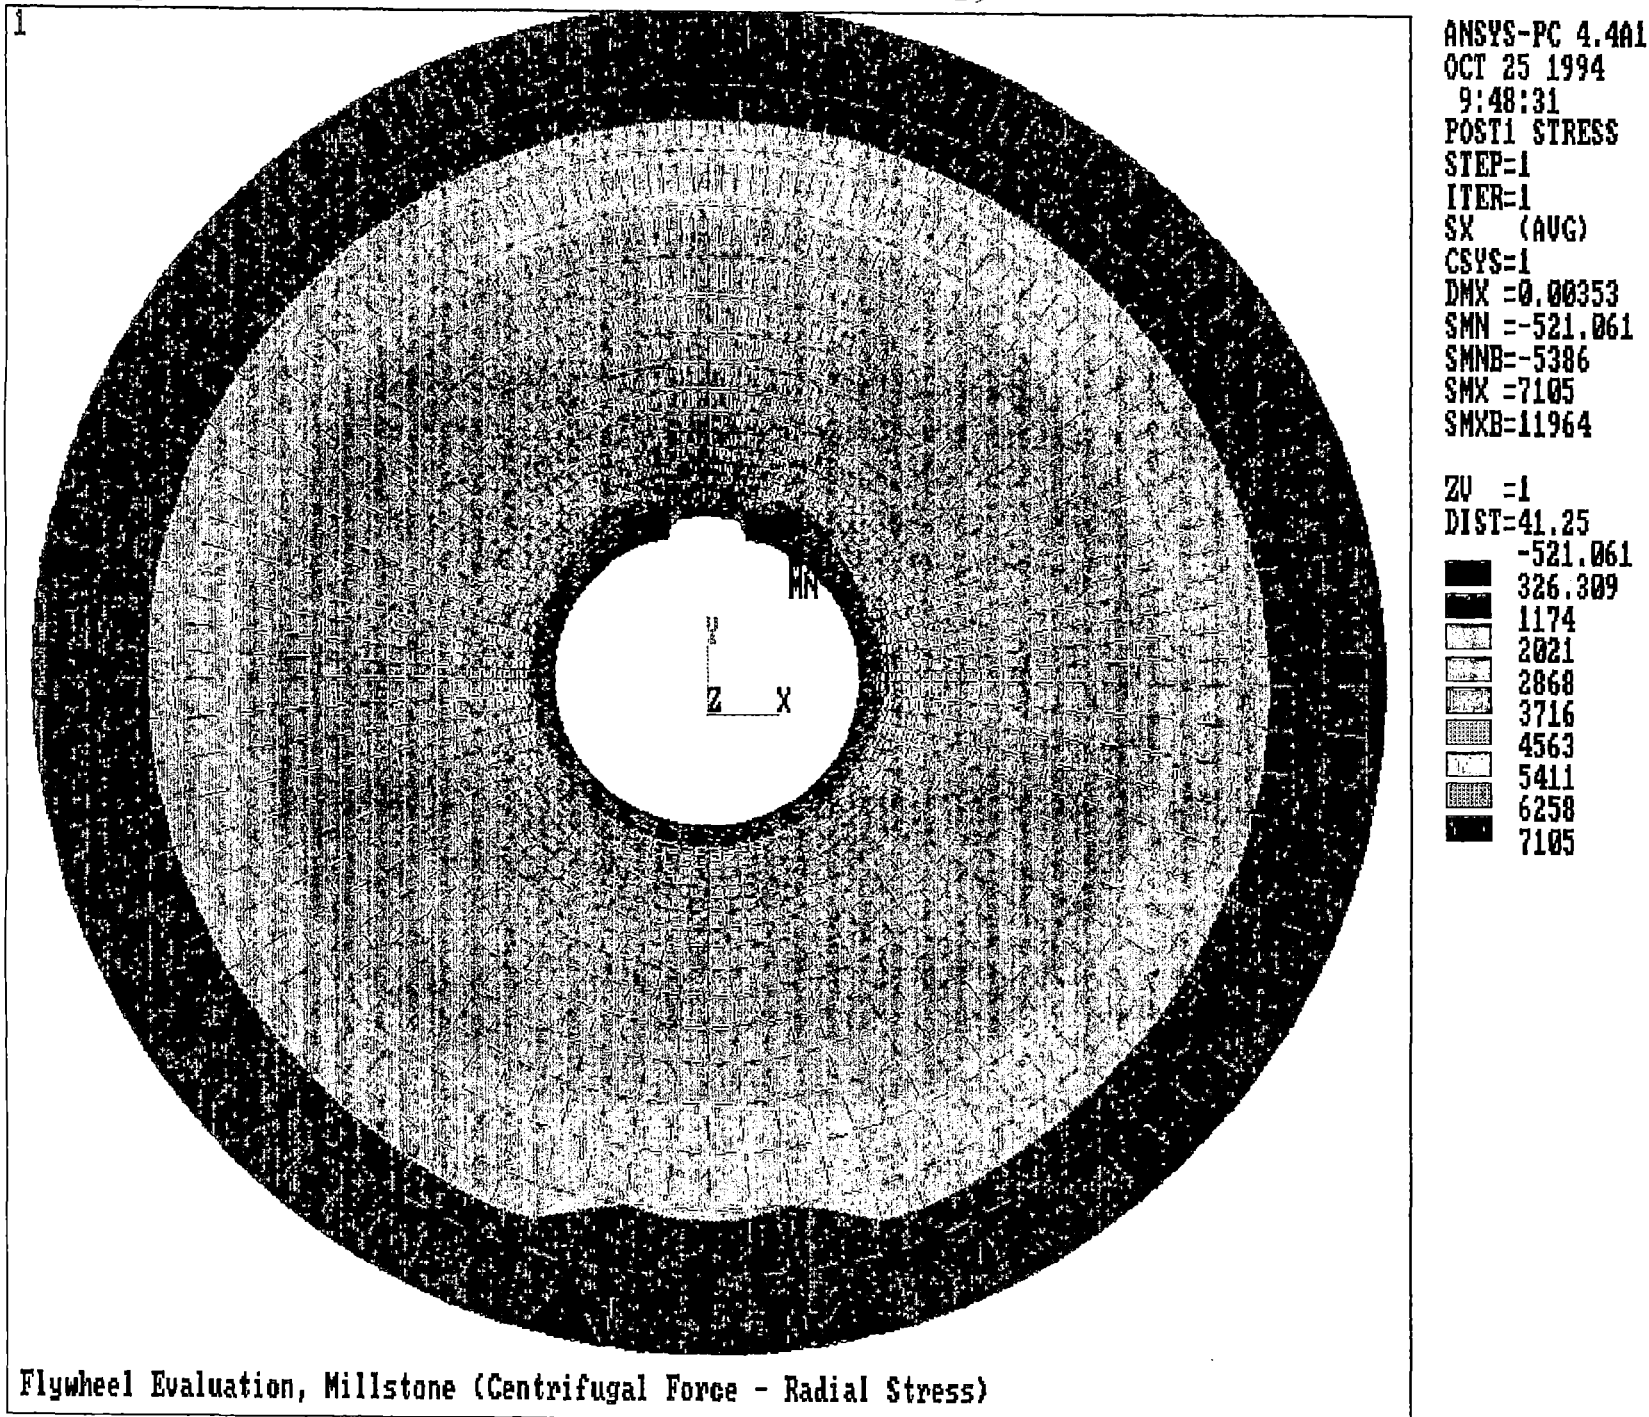
Figure 5-9. Details of Tangential Stress Distribution in Keyway Region Due to Centrifugal Force (ANO-2)

Figure 5-10. Overall Radial Stress Distribution Due to Centrifugal Force (ANO-2)

Figure 5-11. Details of Radial Stress Distribution in Keyway Region Due to Centrifugal Force (ANO-2)

Figure 5-12. Overall Tangential Stress Distribution Due to Centrifugal Force (Millstone-2)

Figure 5-13. Details of Tangential Stress Distribution in Keyway Region Due to Centrifugal Force (Millstone-2)

Figure 5-14. Overall Radial Stress Distribution Due to Centrifugal Force (Millstone-2)

Figures 5-4 through 5-27 present the tangential and radial stress distributions under centrifugal loading for all six flywheels considered in the evaluation. Four figures are presented for the flywheel of each plant. The first two figures for each plant depict the overall stress distribution and detailed keyway region stresses in the tangential direction. The third and fourth figures provide the overall stress distribution and detailed keyway stresses in the radial direction.

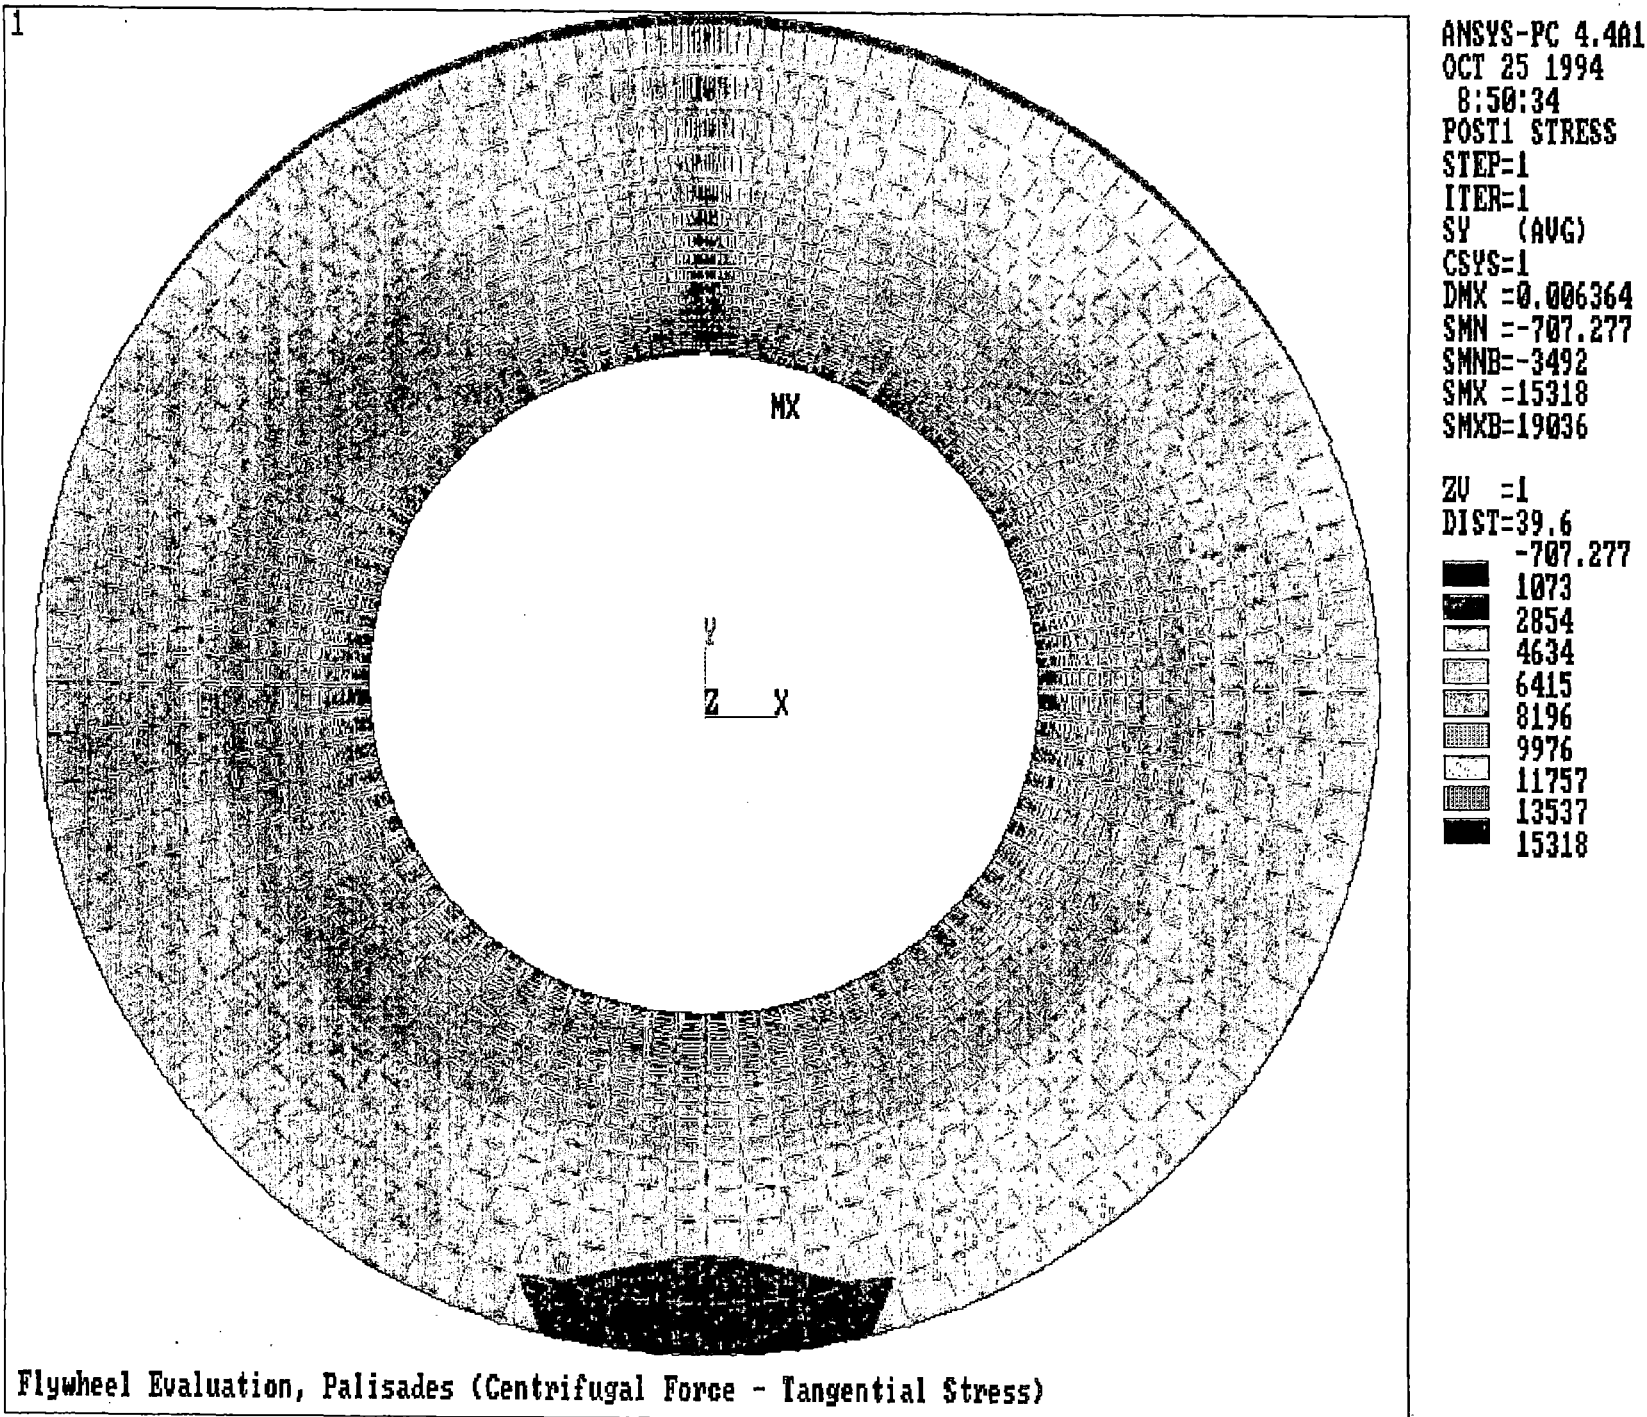
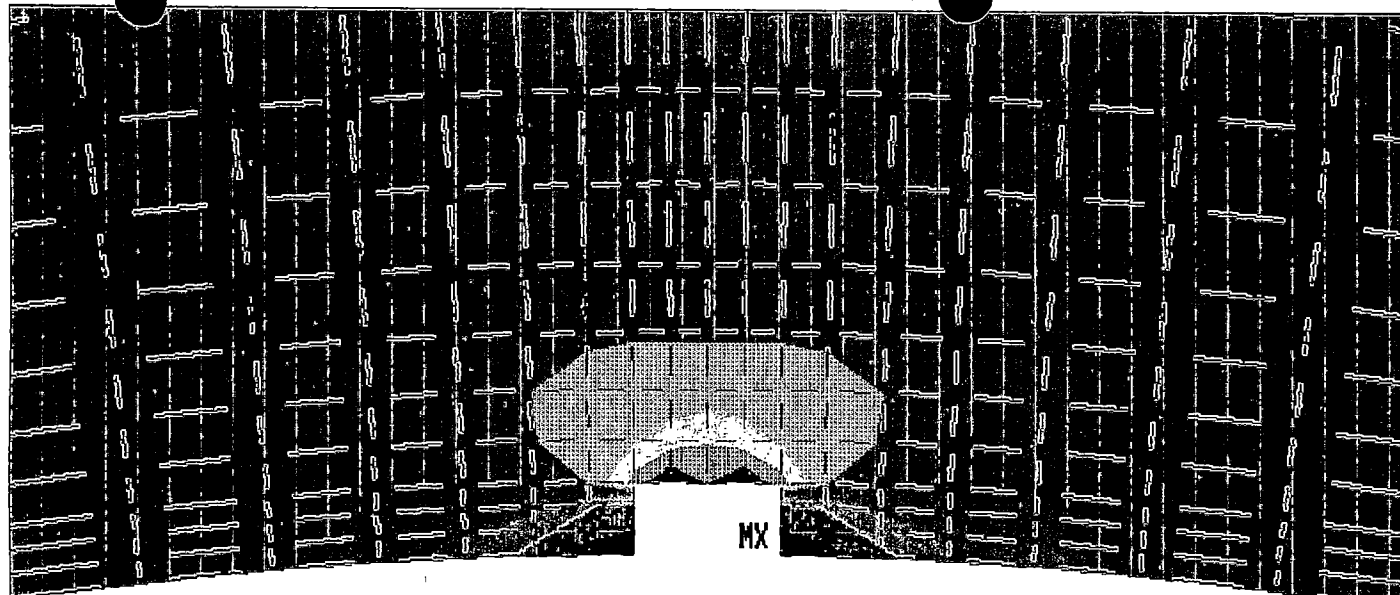
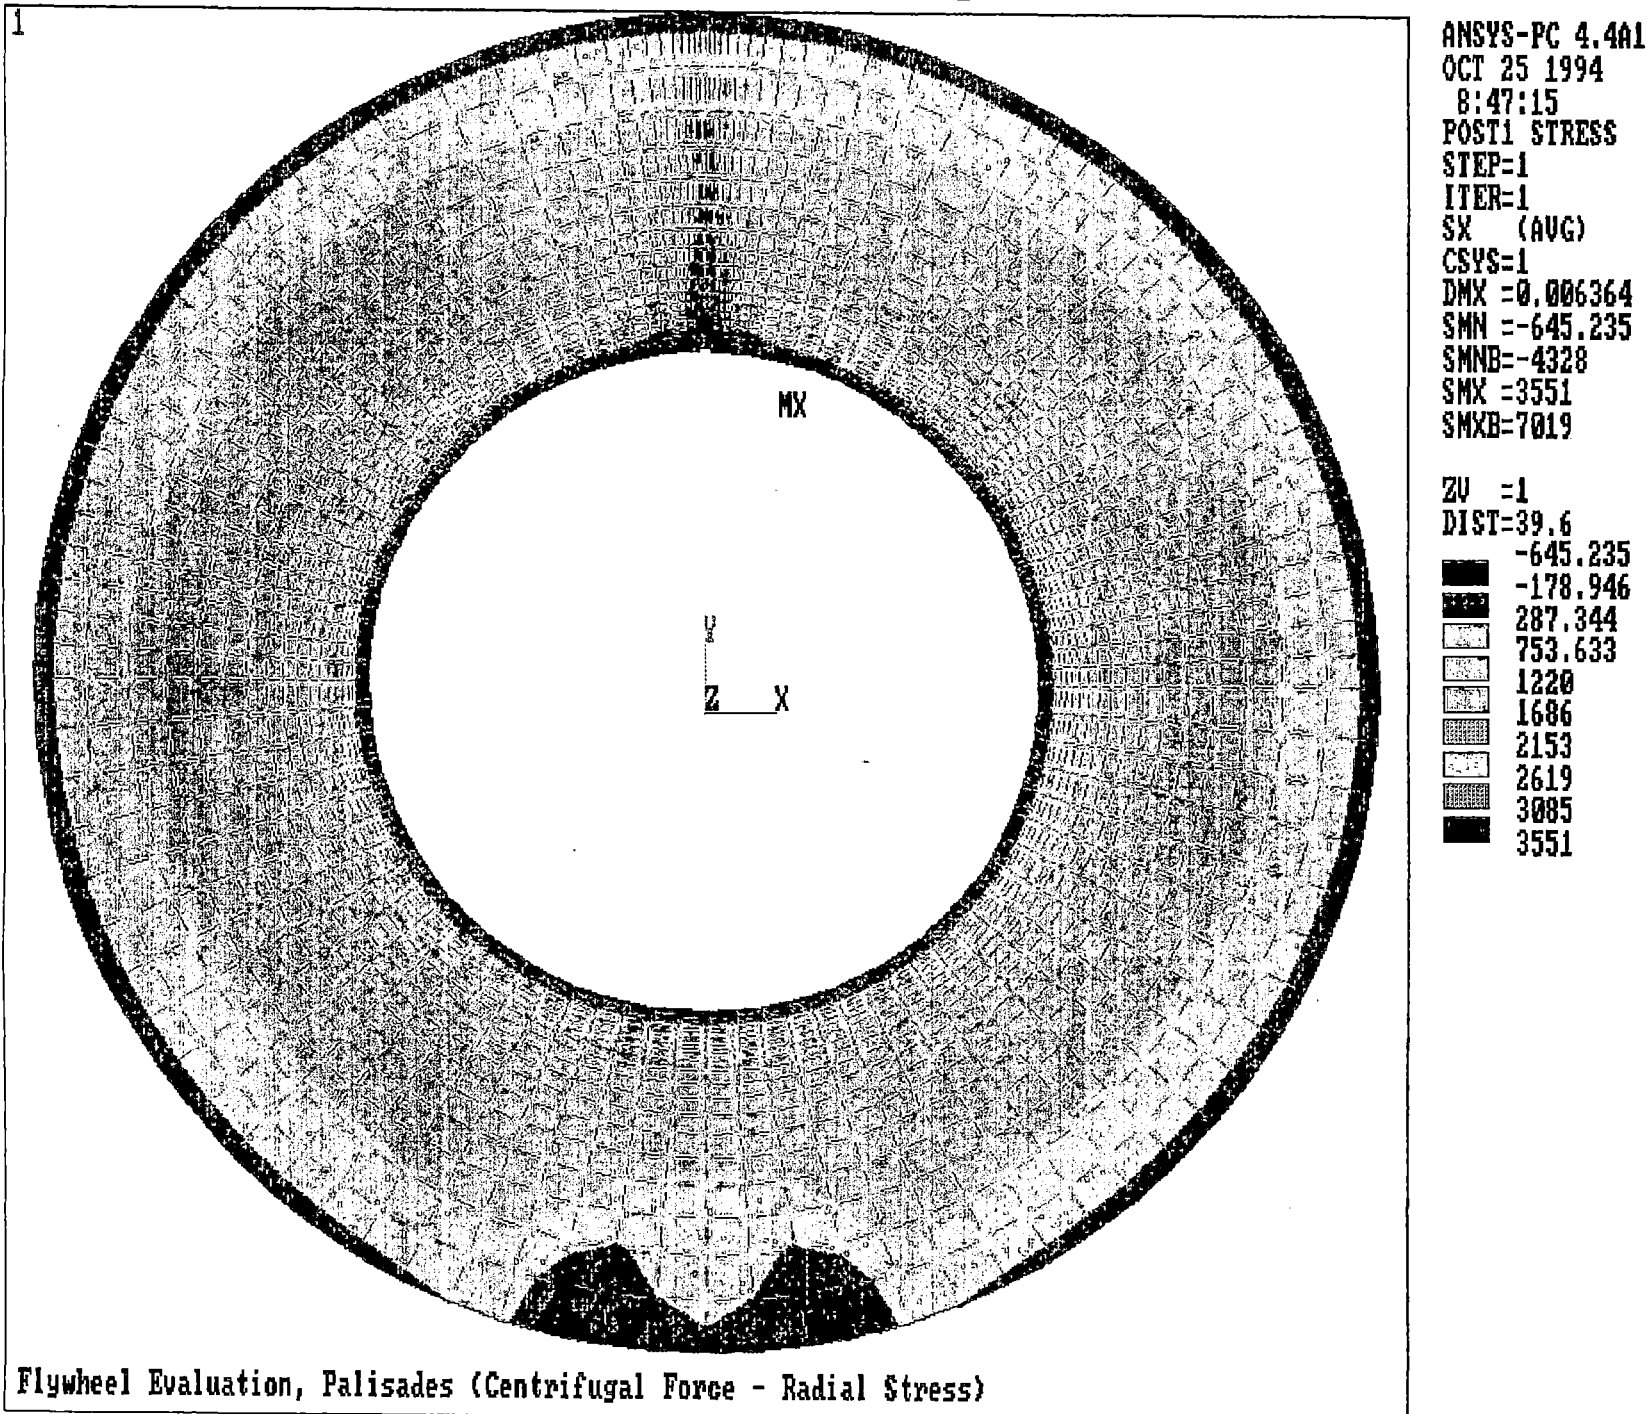
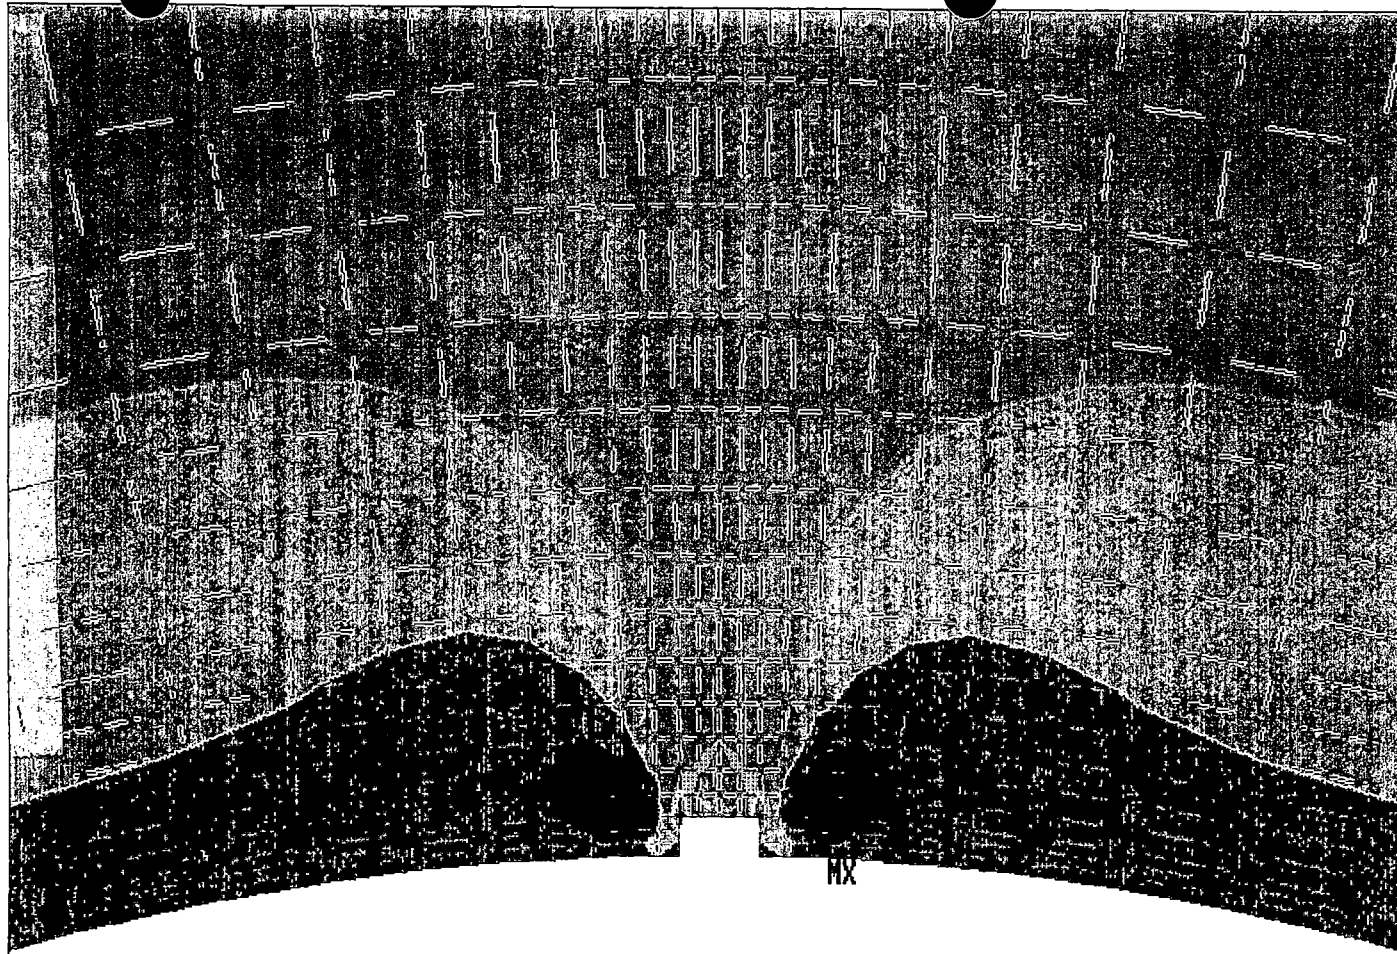
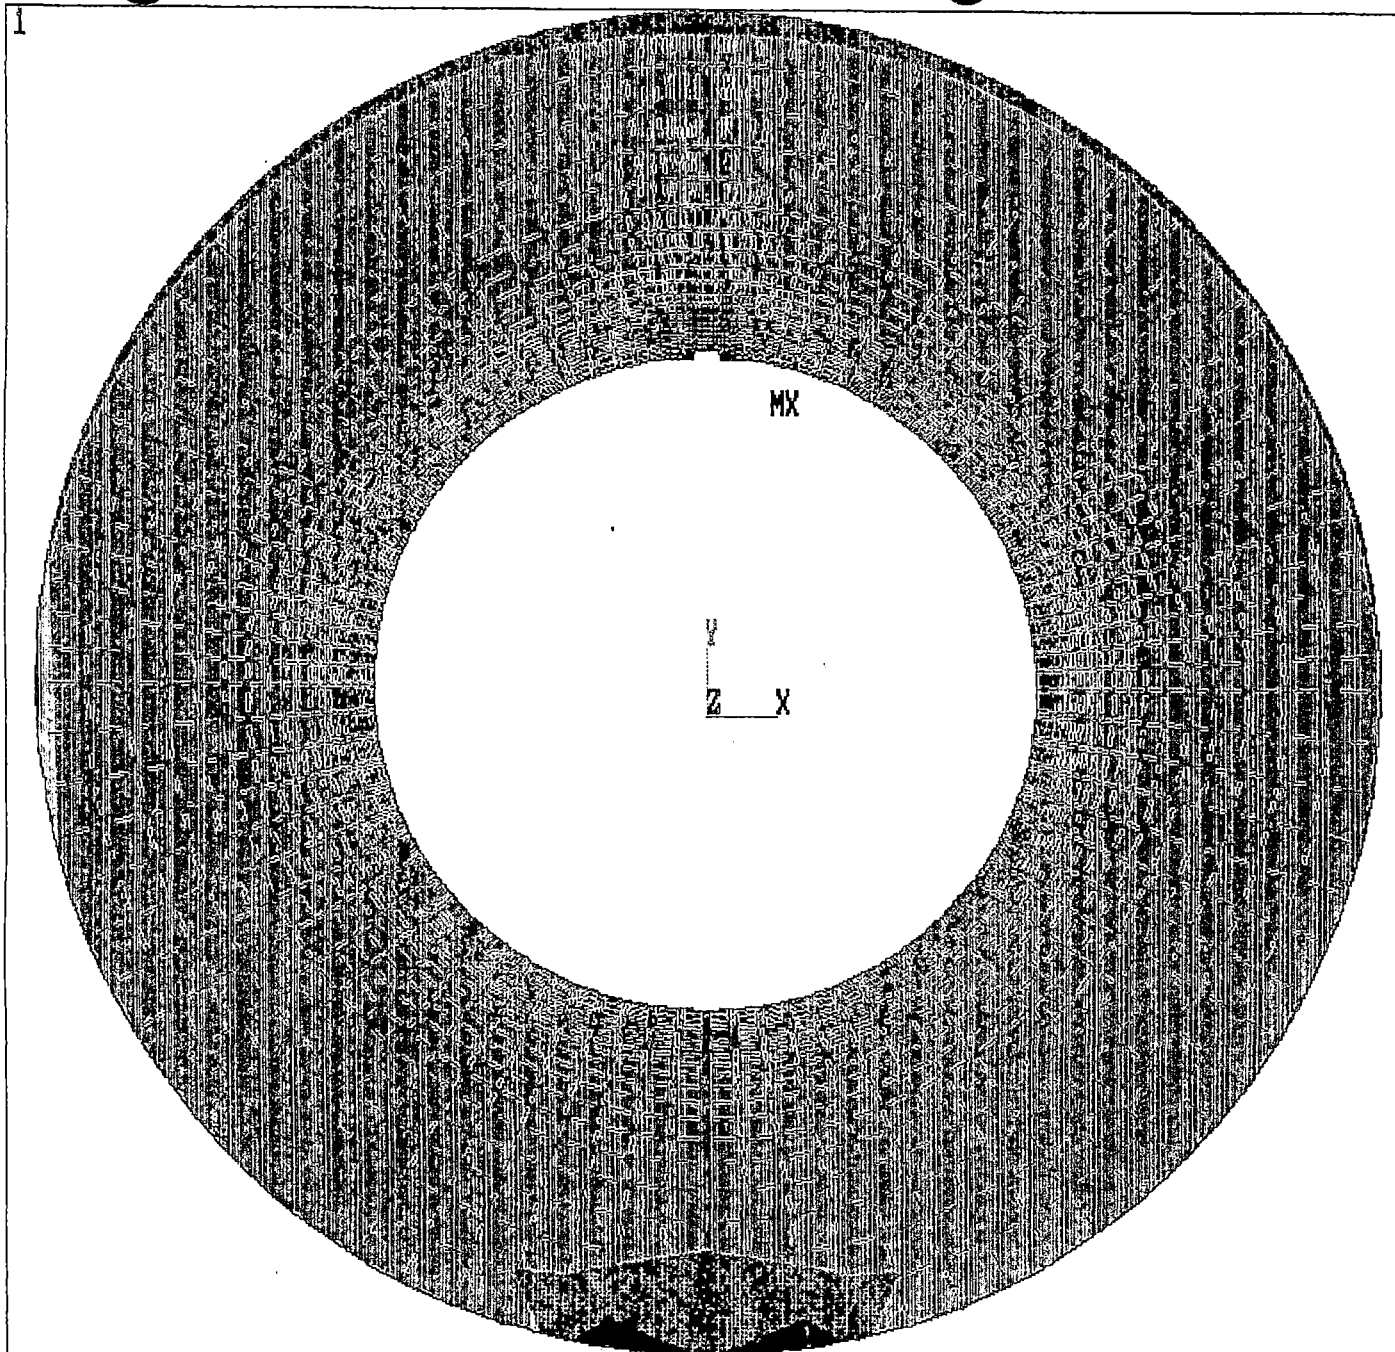
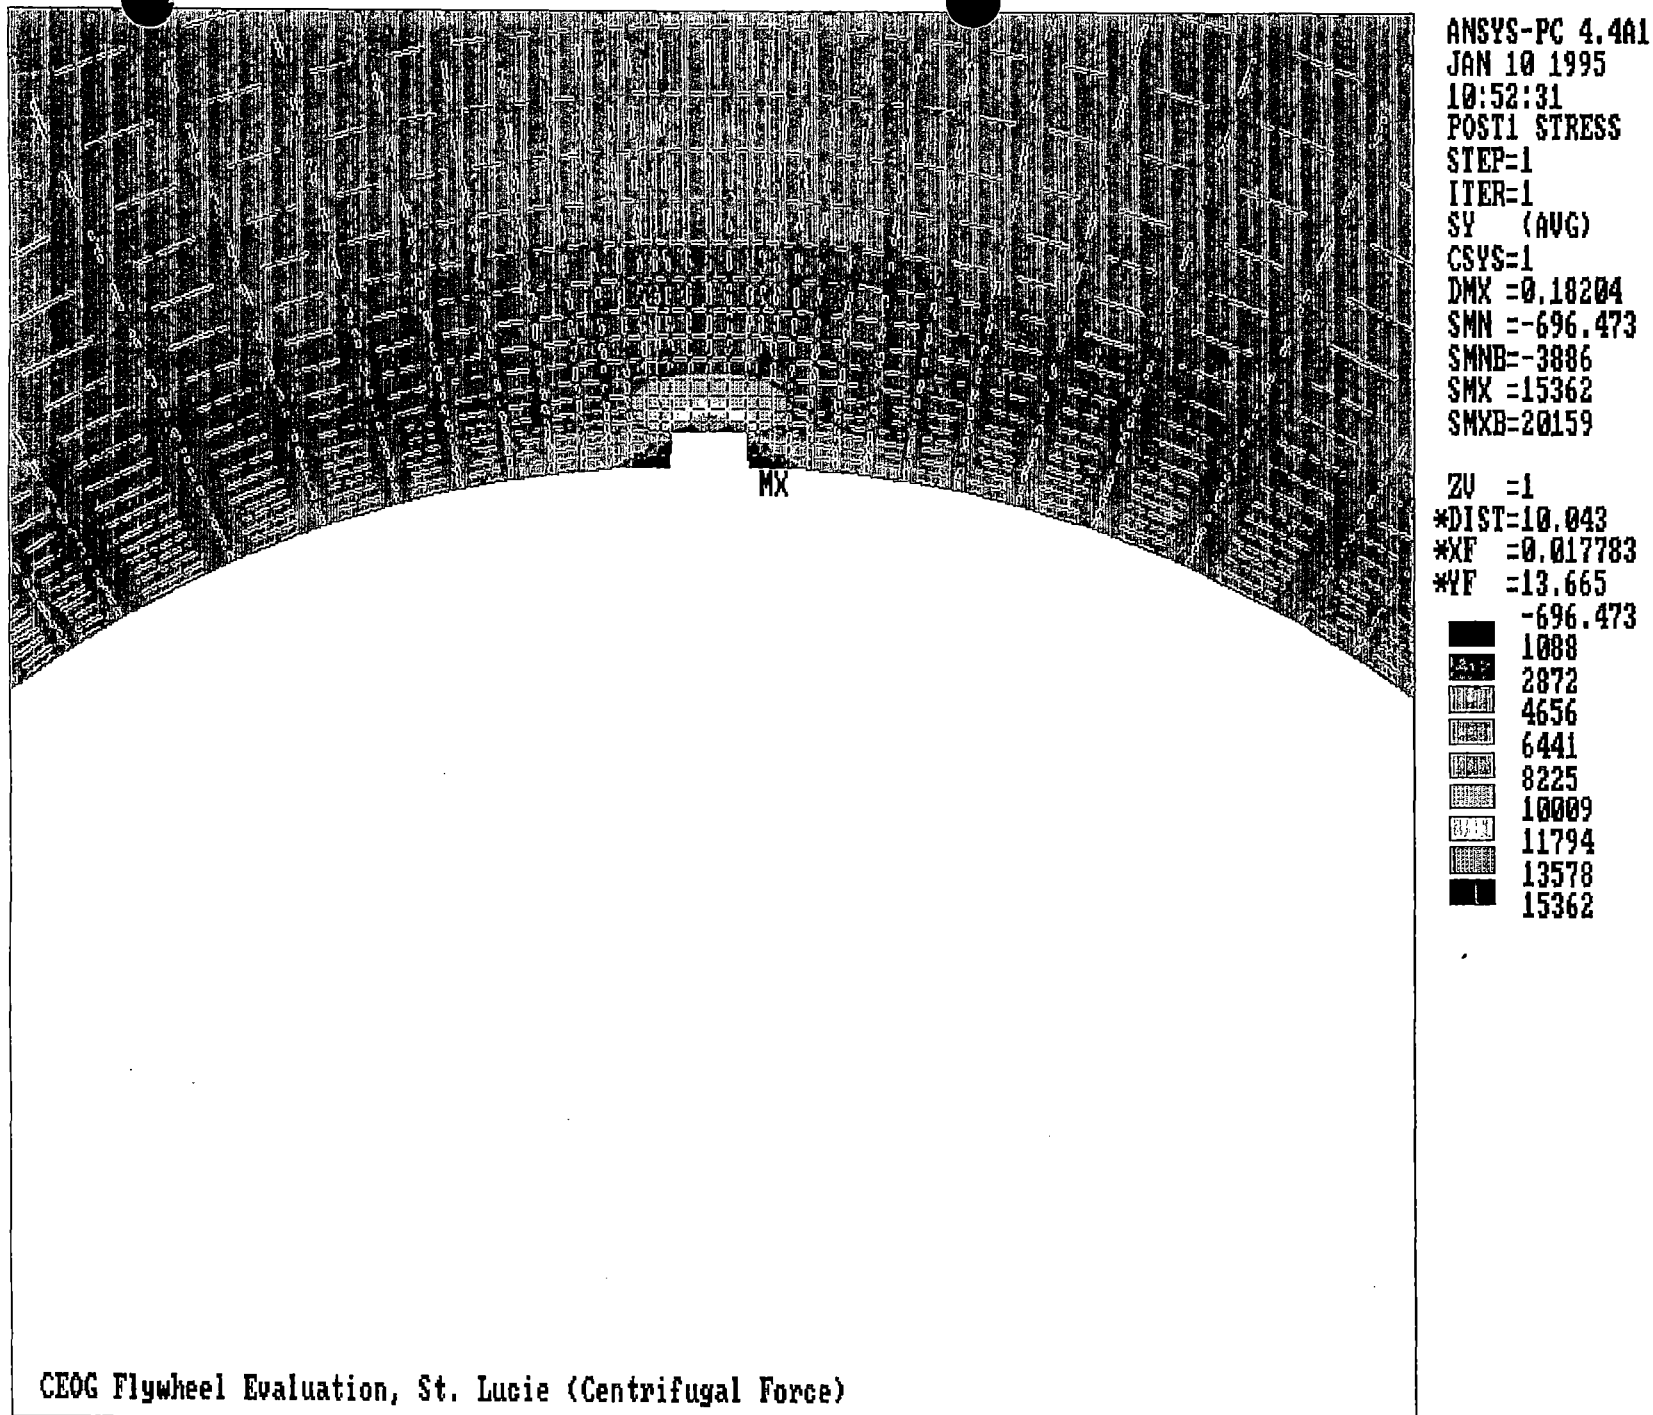
Figure 5-15. Details of Radial Stress Distribution in Keyway Region Due to Centrifugal Force (Millstone-2)

Figure 5-16. Overall Tangential Stress Distribution Due to Centrifugal Force (Palisades)

Figure 5-17. Details of Tangential Stress Distribution in Keyway Region Due to Centrifugal Force (Palisades)

Figure 5-18. Overall Radial Stress Distribution Due to Centrifugal Force (Palisades)

Figure 5-19. Details of Radial Stress Distribution in Keyway Region Due to Centrifugal Force (Palisades)

Figure 5-20. Overall Tangential Stress Distribution Due to Centrifugal Force (St. Lucie)
