Report No.: SIR-94-080
Revision No.: 1
Project No.: CEOG-01Q
File No.: CEOG-01Q-401
March 1995

**Relaxation of Reactor Coolant Pump
Flywheel Inspection Requirements**

Structural Integrity Associates, Inc.

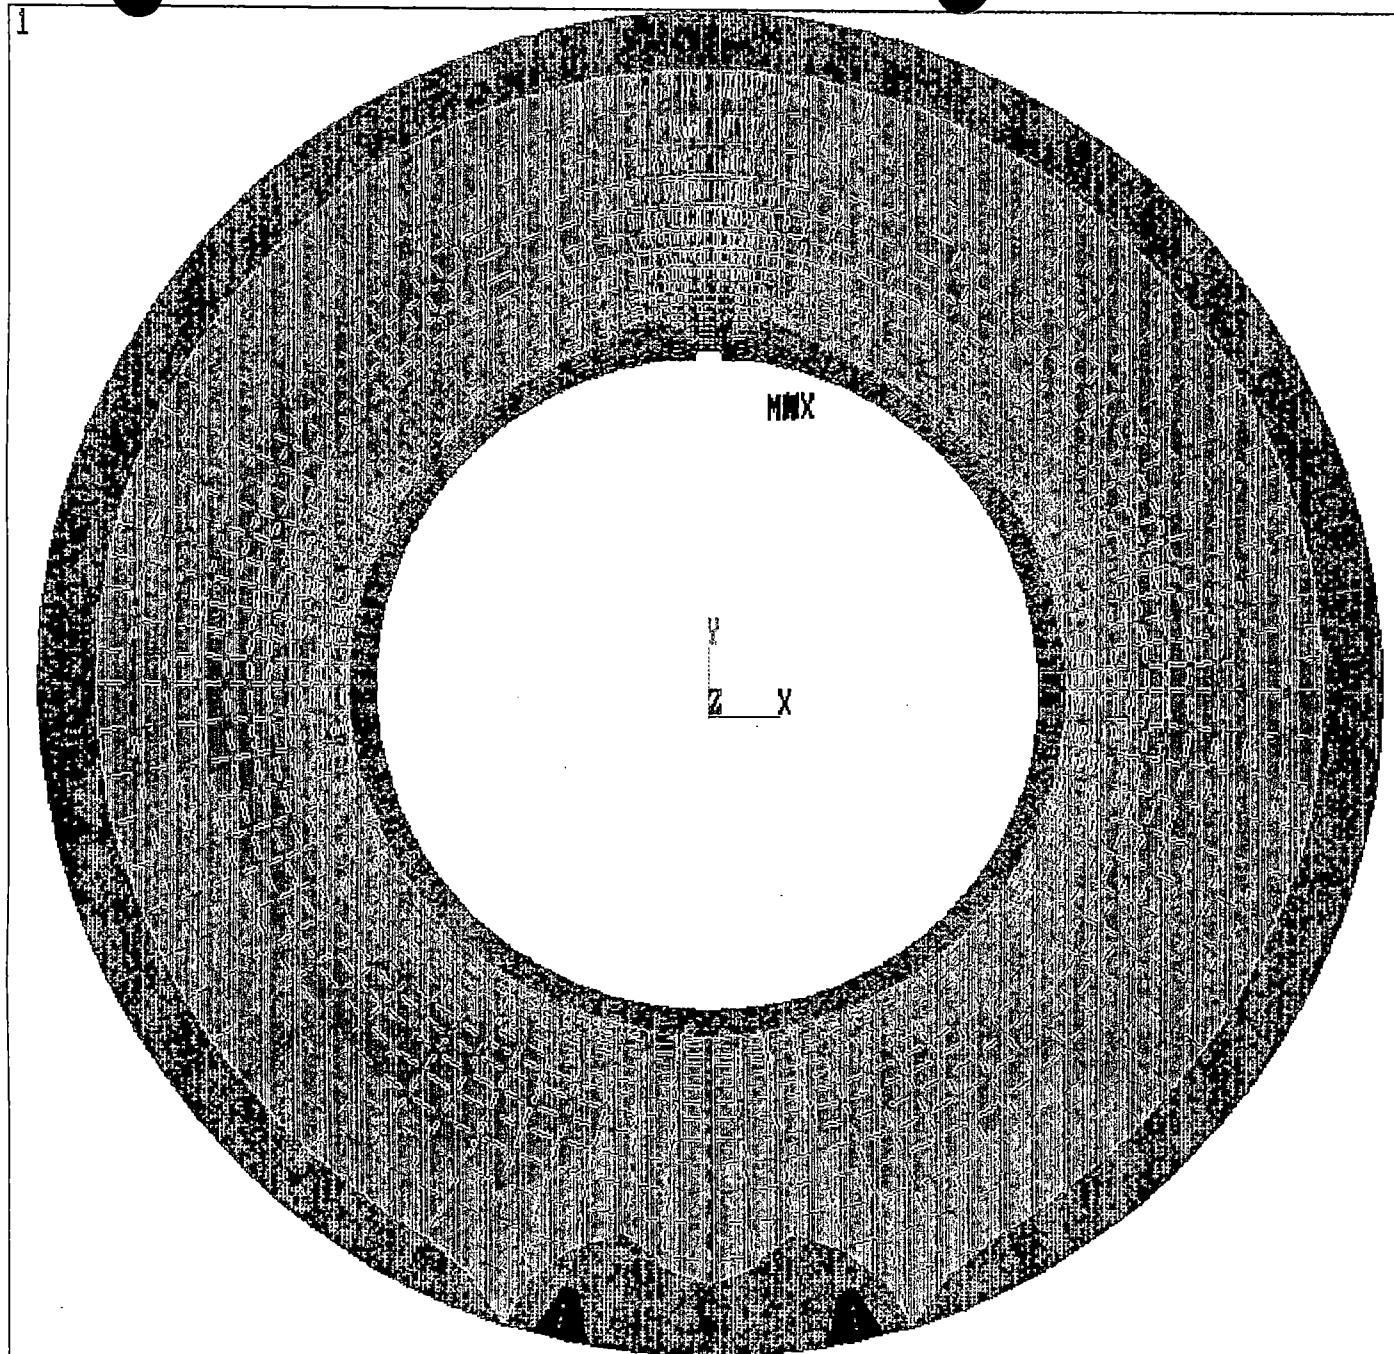
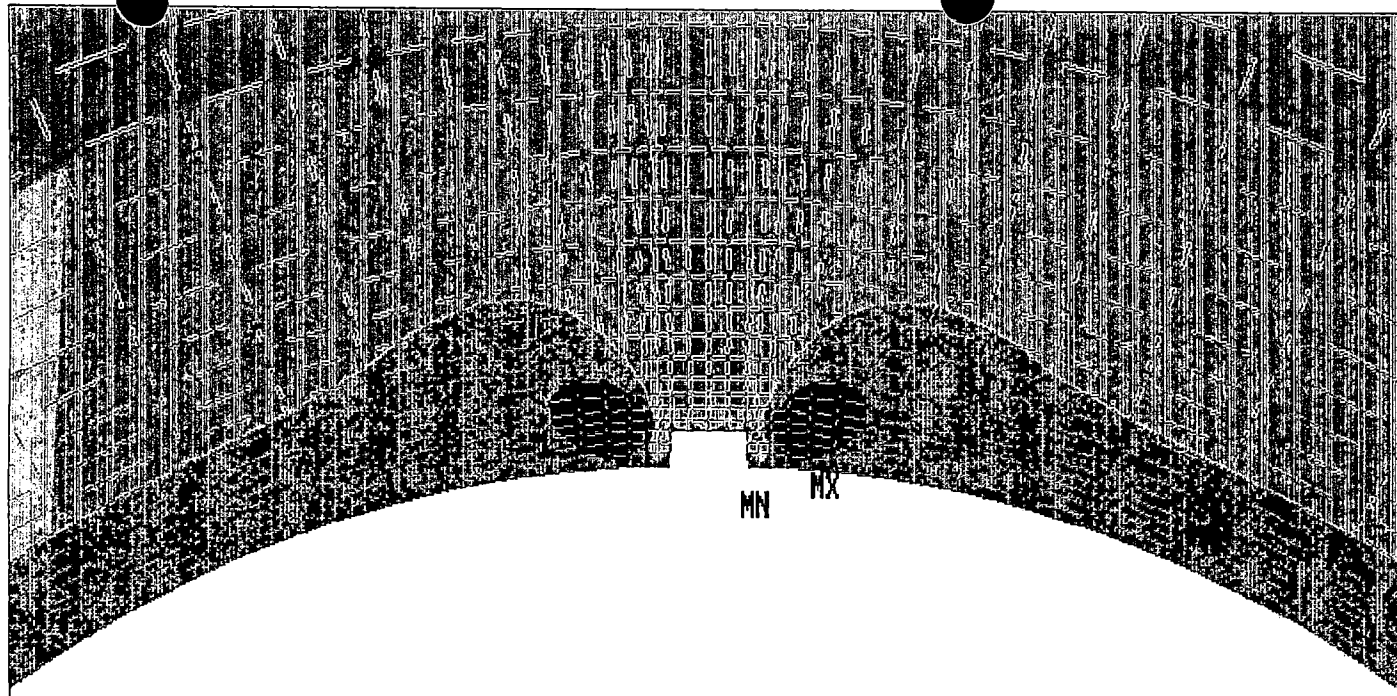
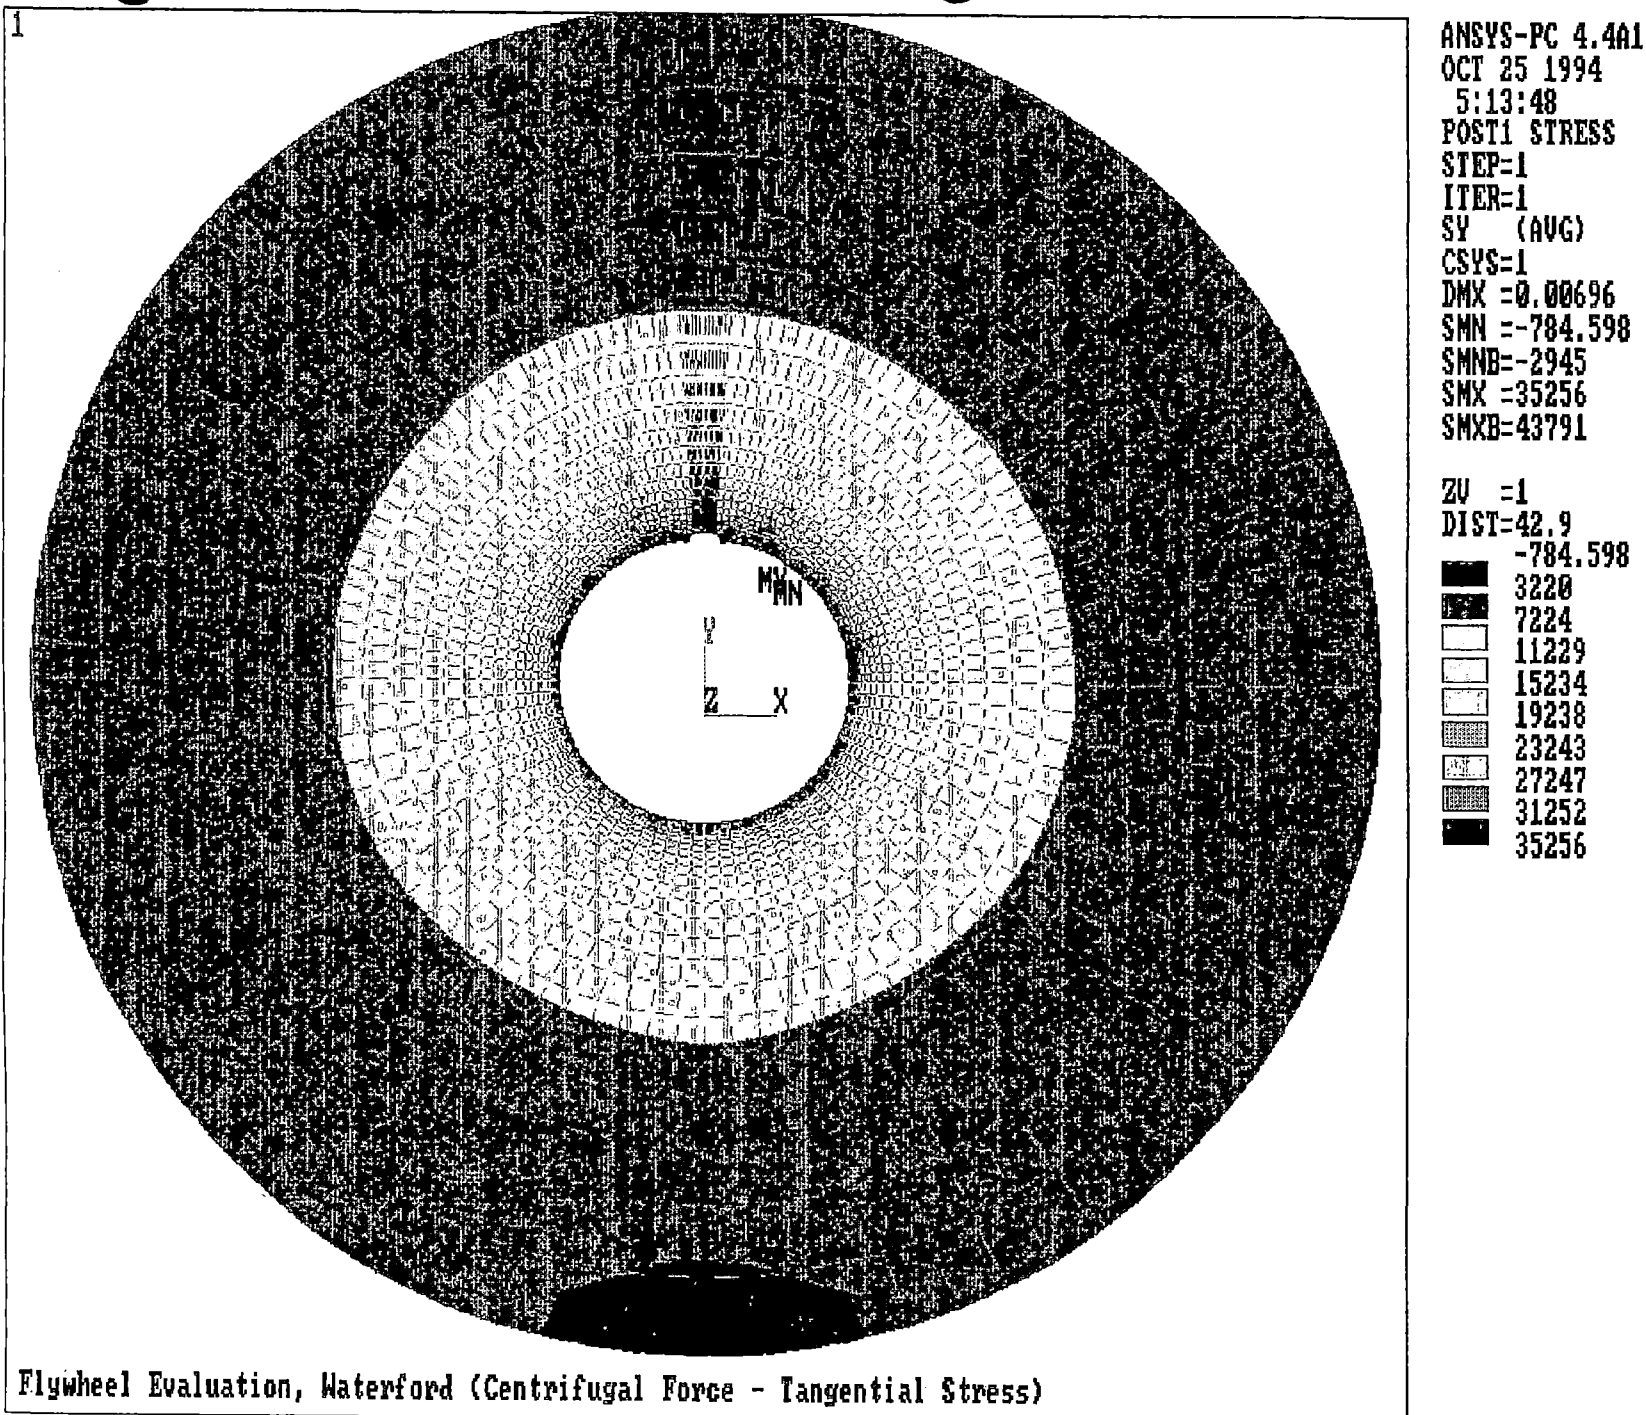
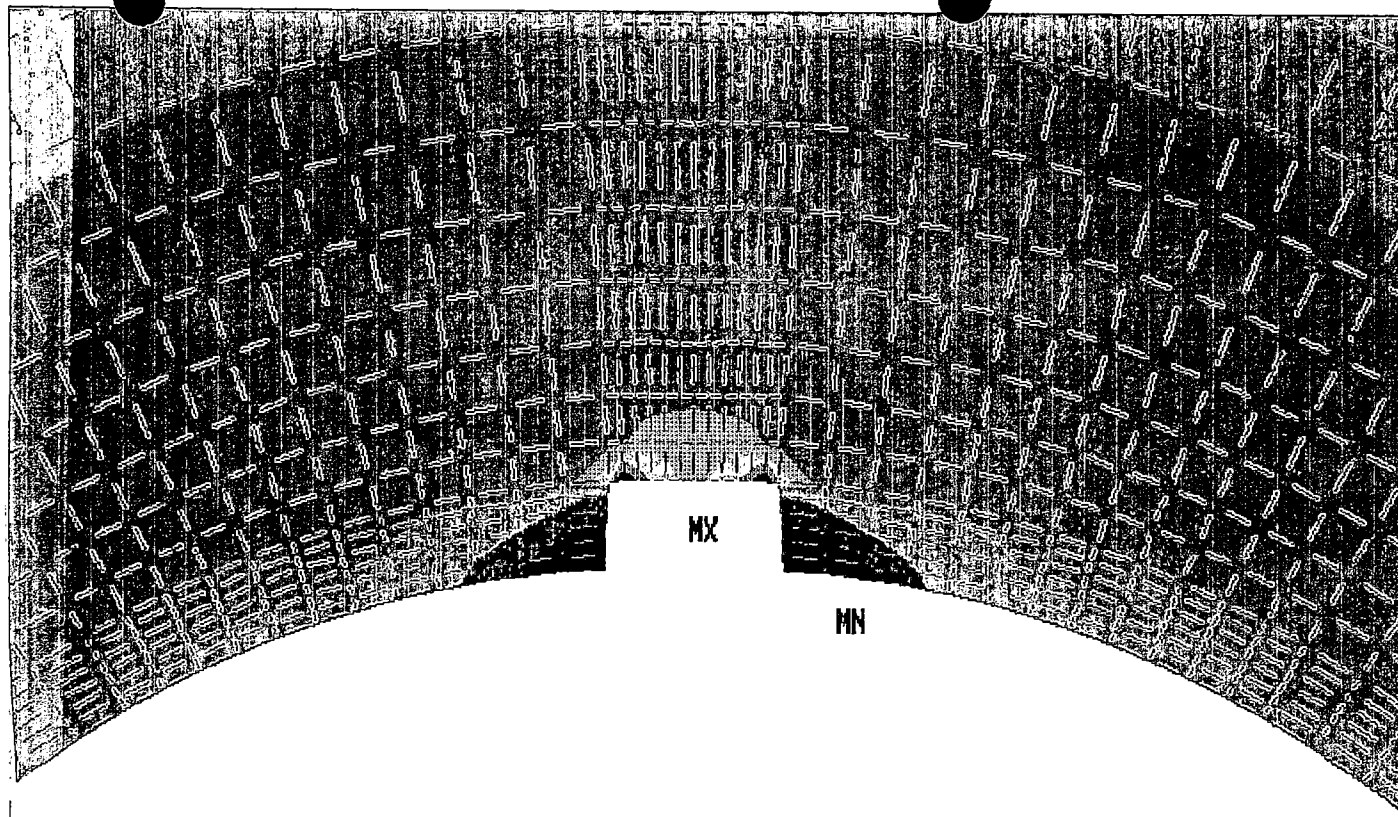
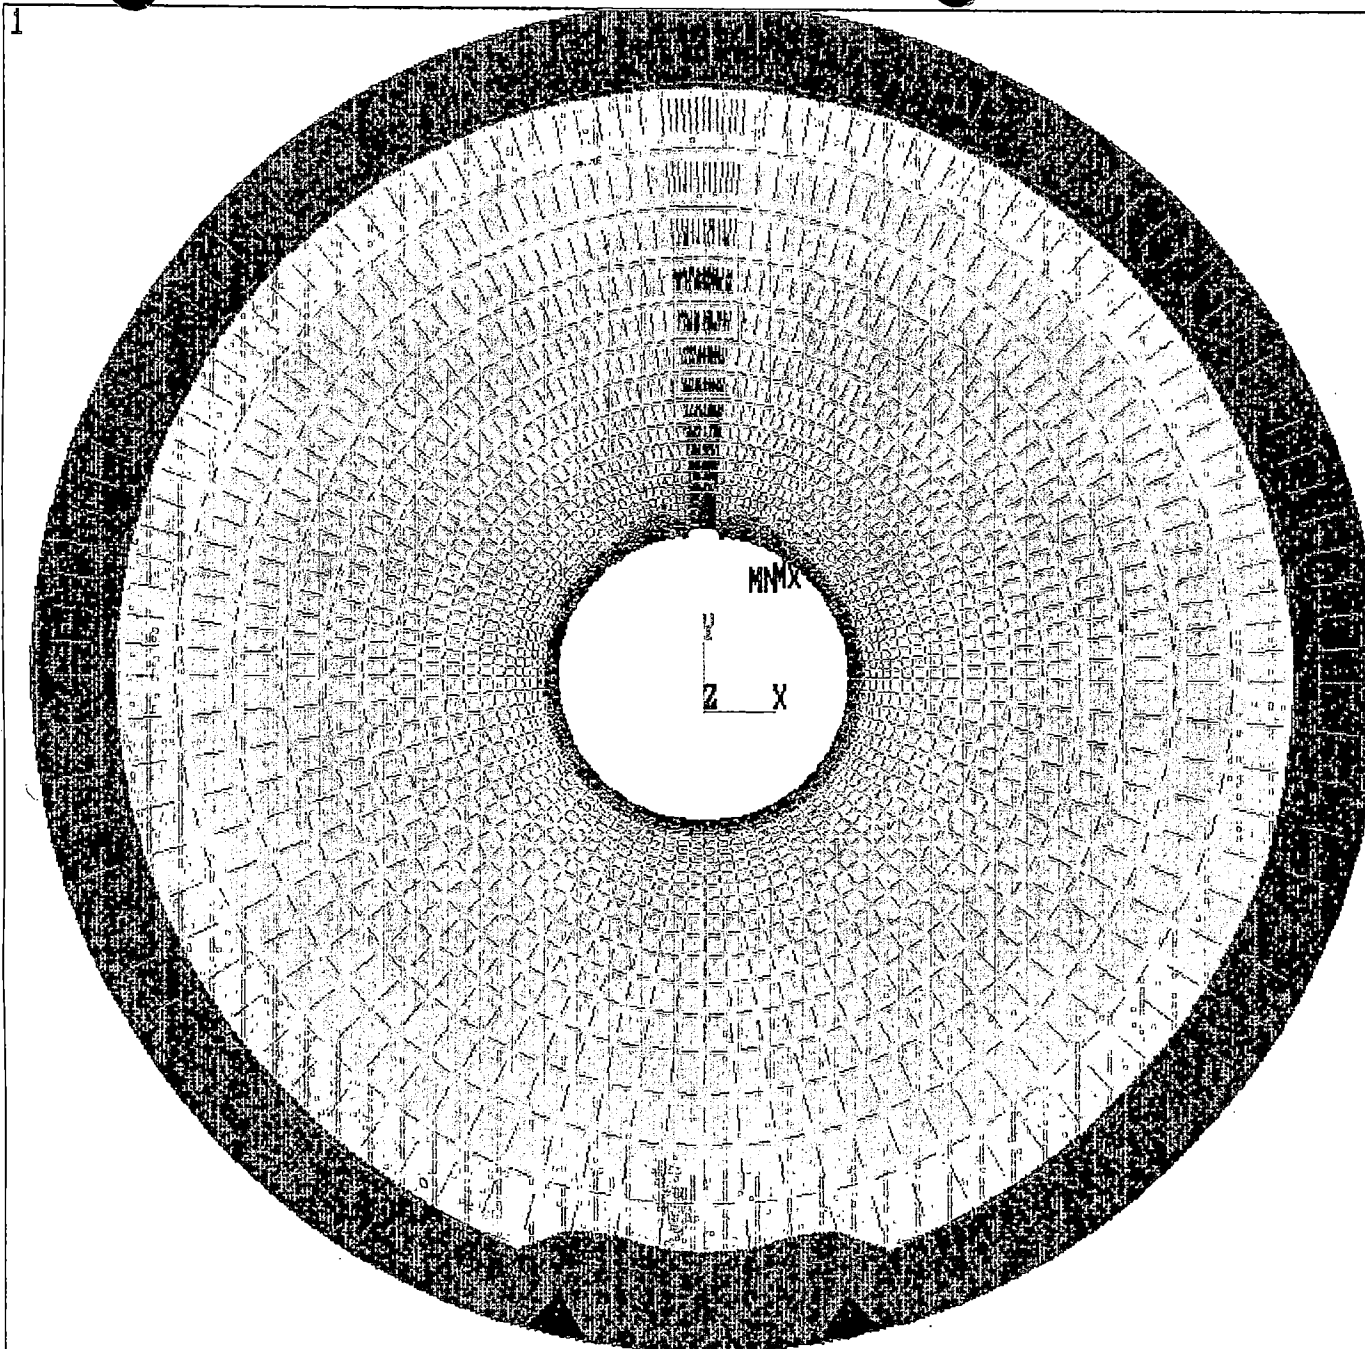
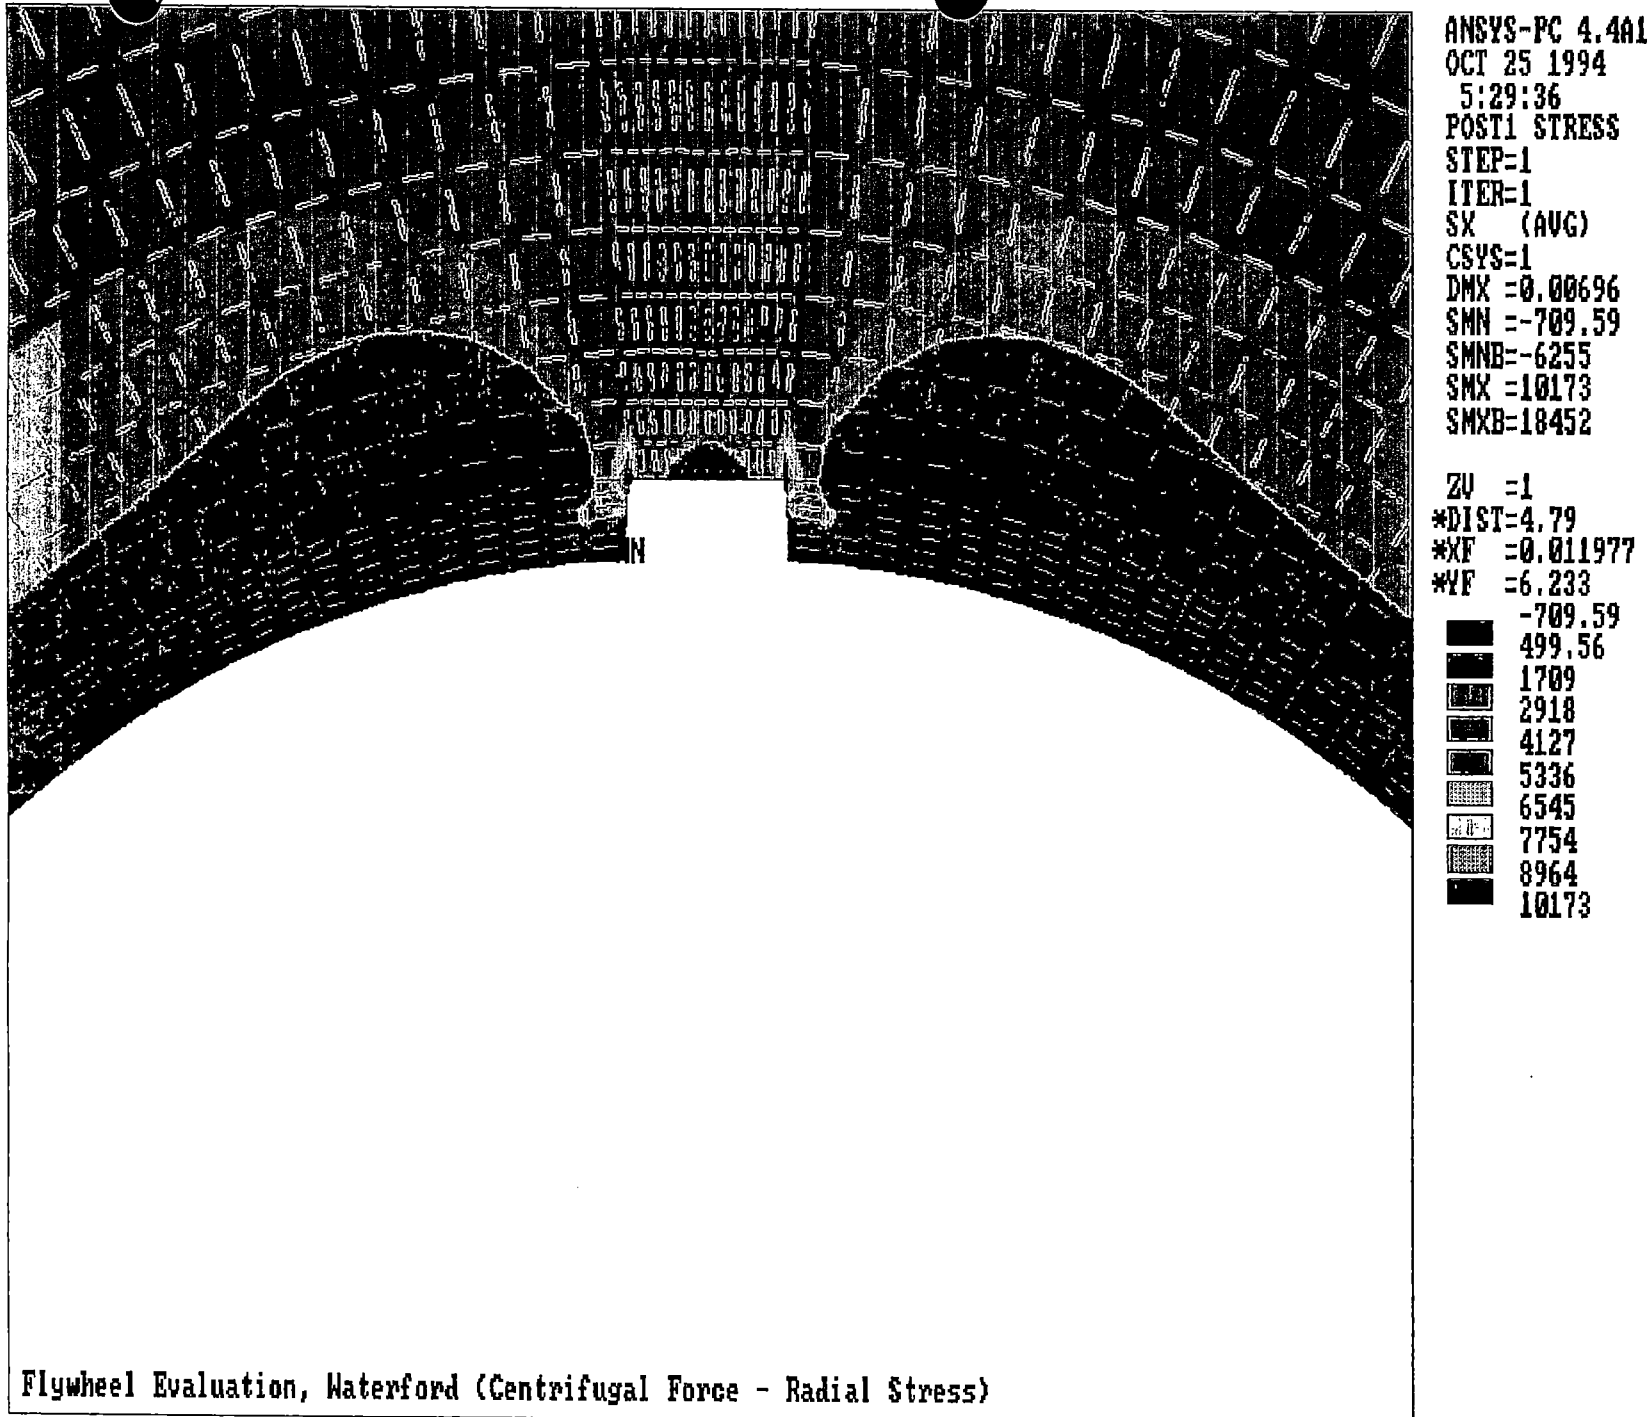
Figure 5-22. Overall Radial Stress Distribution Due to Centrifugal Force (St. Lucie)

Figure 5-23. Details of Radial Stress Distribution in Keyway Region Due to Centrifugal Force (St. Lucie)

Figure 5-24. Overall Tangential Stress Distribution Due to Centrifugal Force (Waterford-3)

Figure 5-25. Details of Tangential Stress Distribution in Keyway Region Due to Centrifugal Force (Waterford-3)

Figure 5-26. Overall Radial Stress Distribution Due to Centrifugal Force (Waterford-3)

Figure 5-27. Details of Radial Stress Distribution in Keyway Region Due to Centrifugal Force (Waterford-3)

Figures 5-4 through 5-27 present the tangential and radial stress distributions under centrifugal loading for all six flywheels considered in the evaluation. Four figures are presented for the flywheel of each plant. The first two figures for each plant depict the overall stress distribution and detailed keyway region stresses in the tangential direction. The third and fourth figures provide the overall stress distribution and detailed keyway stresses in the radial direction.

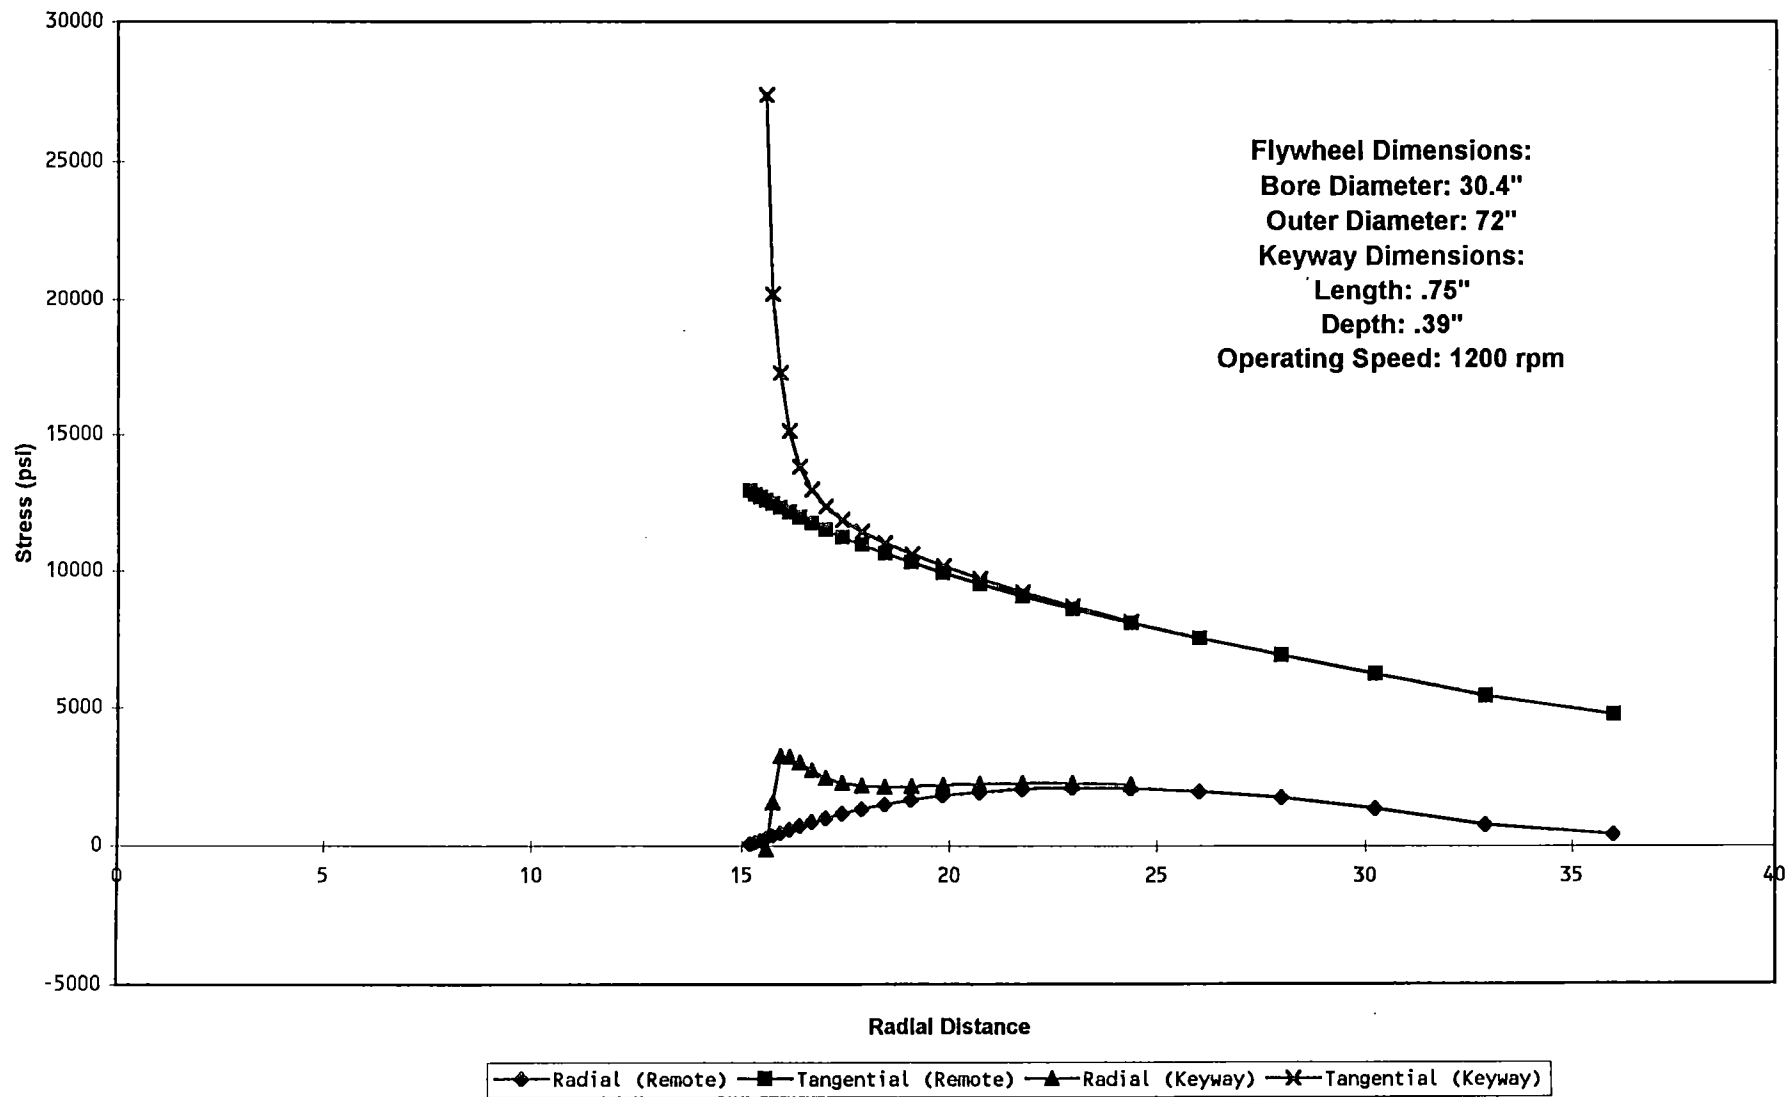
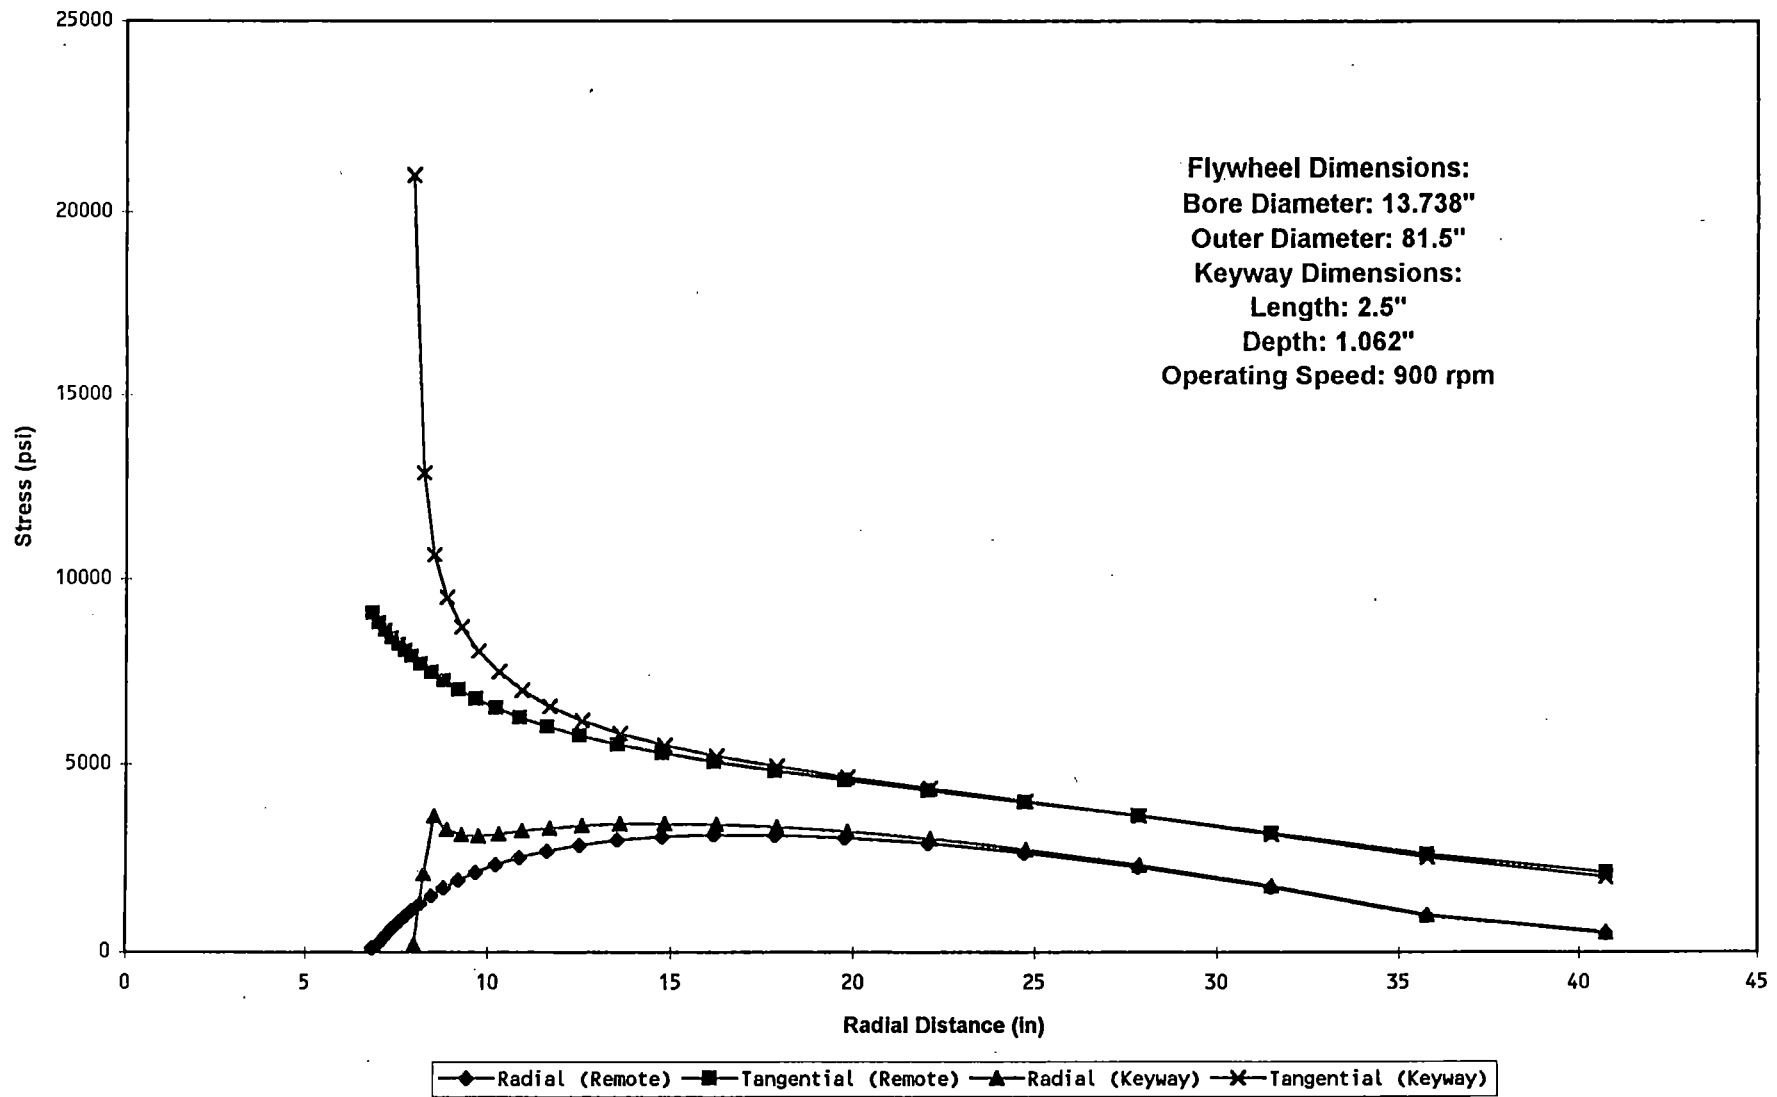
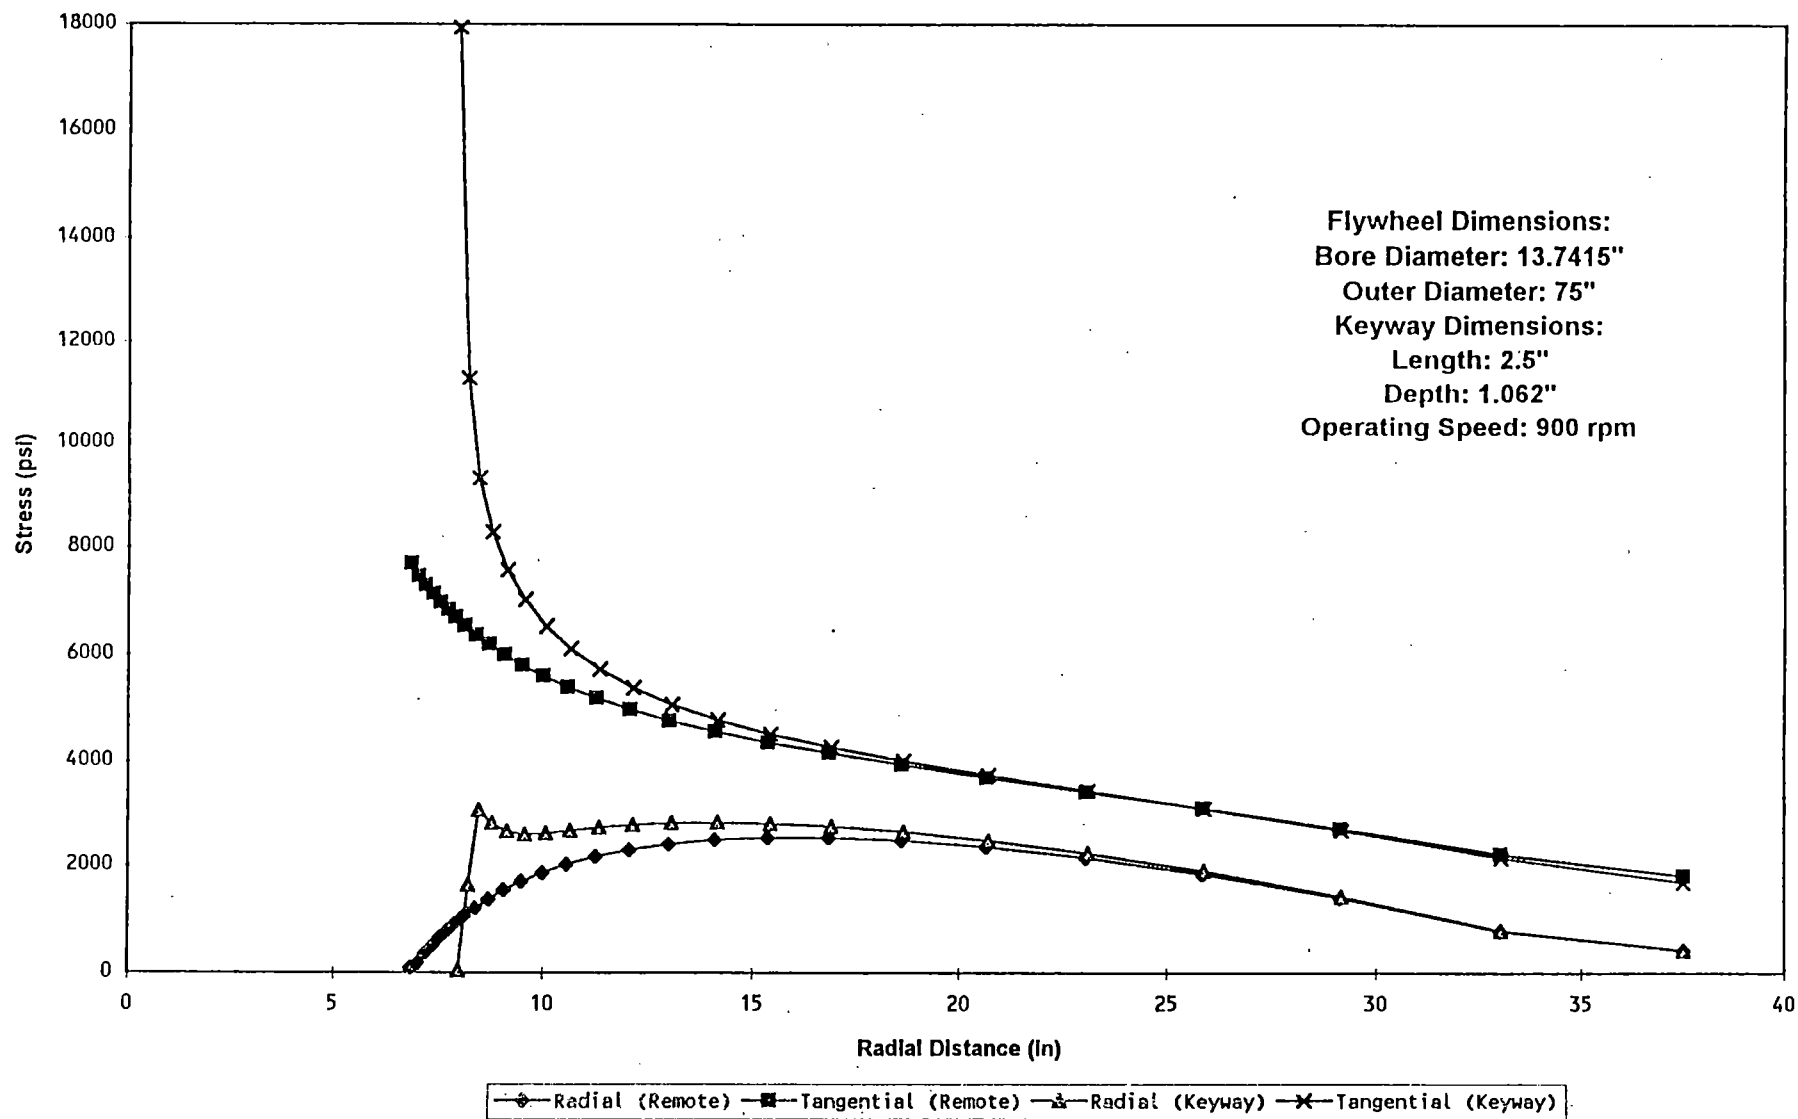
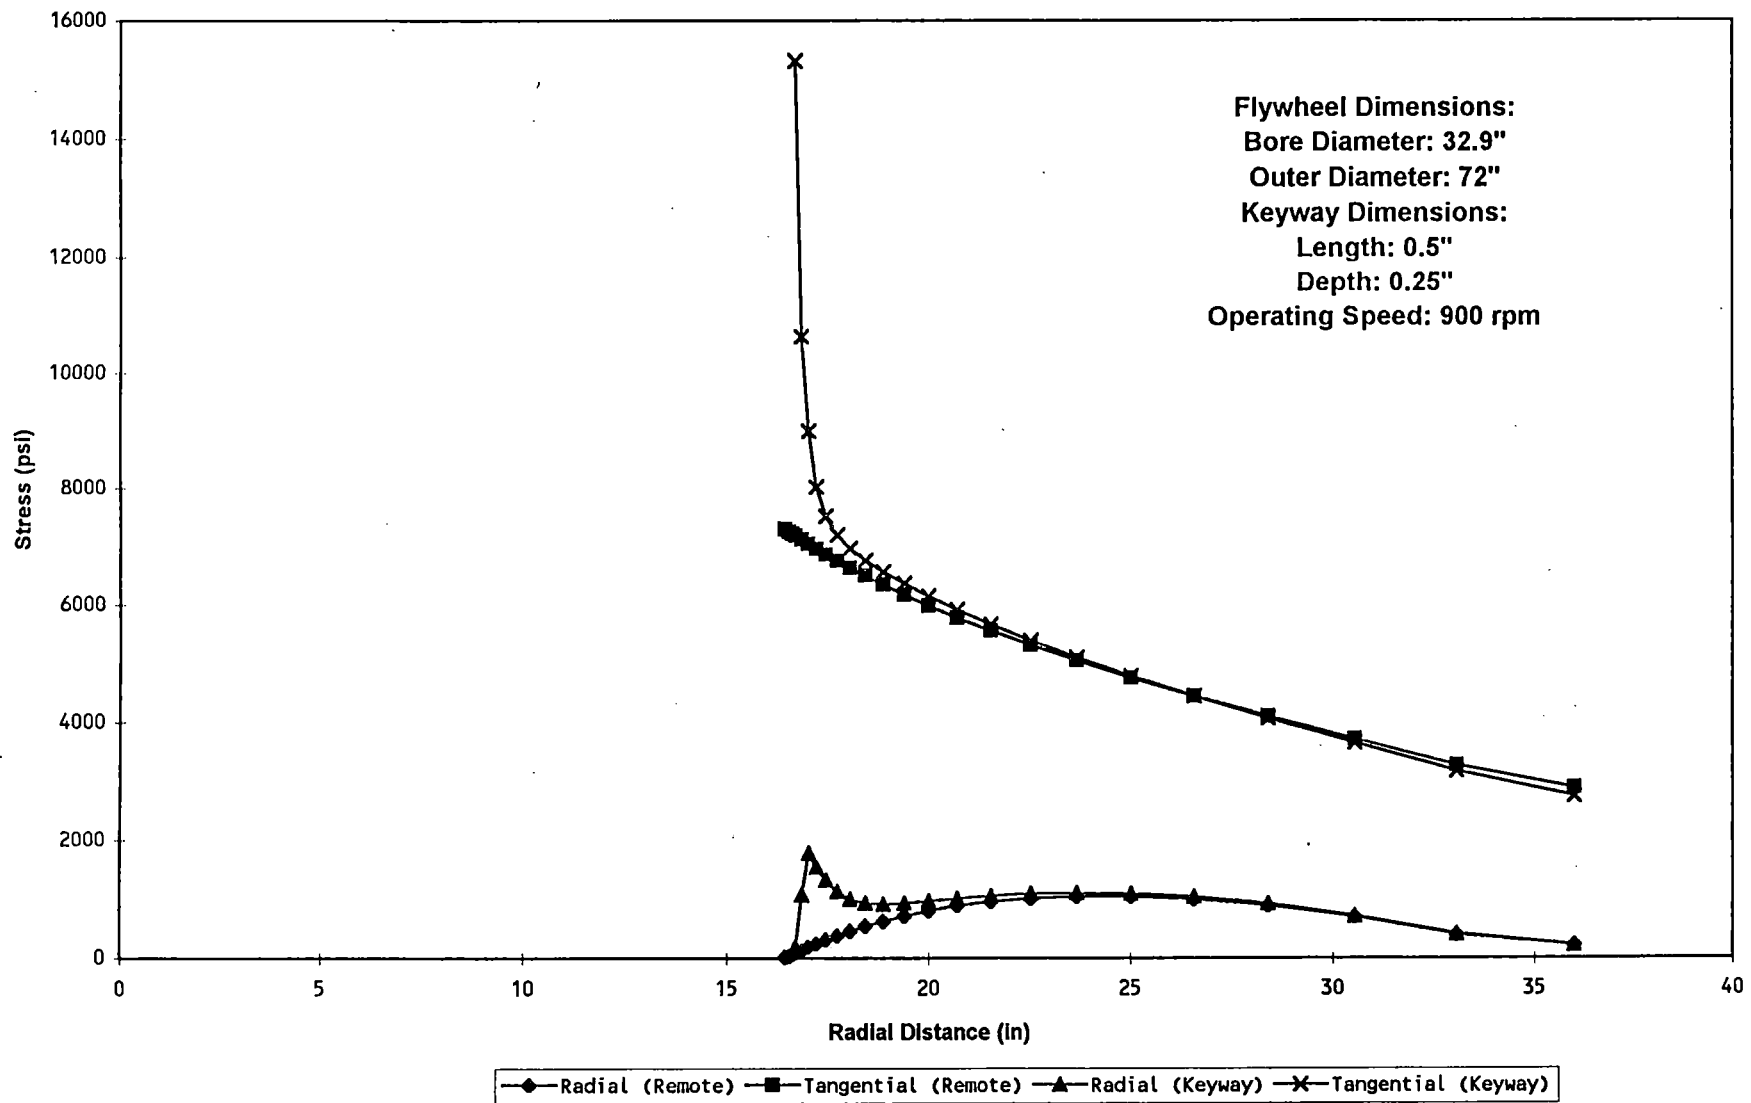
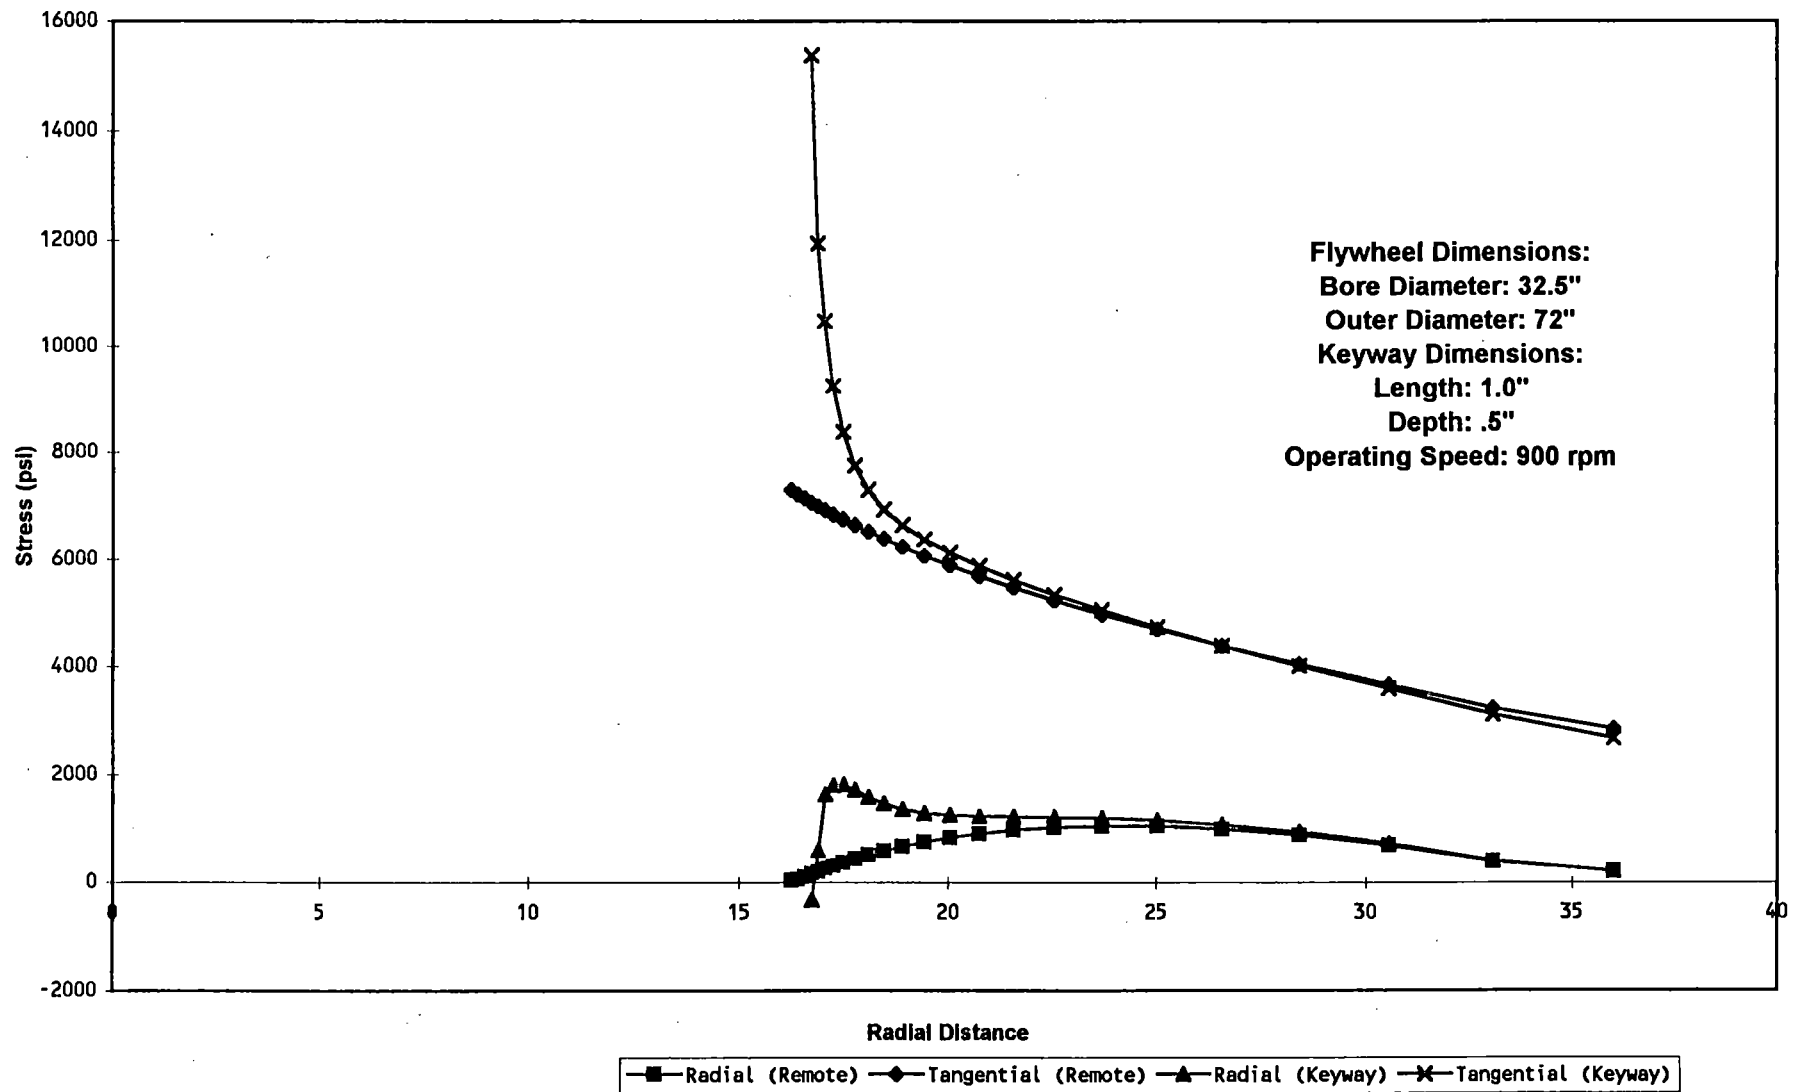
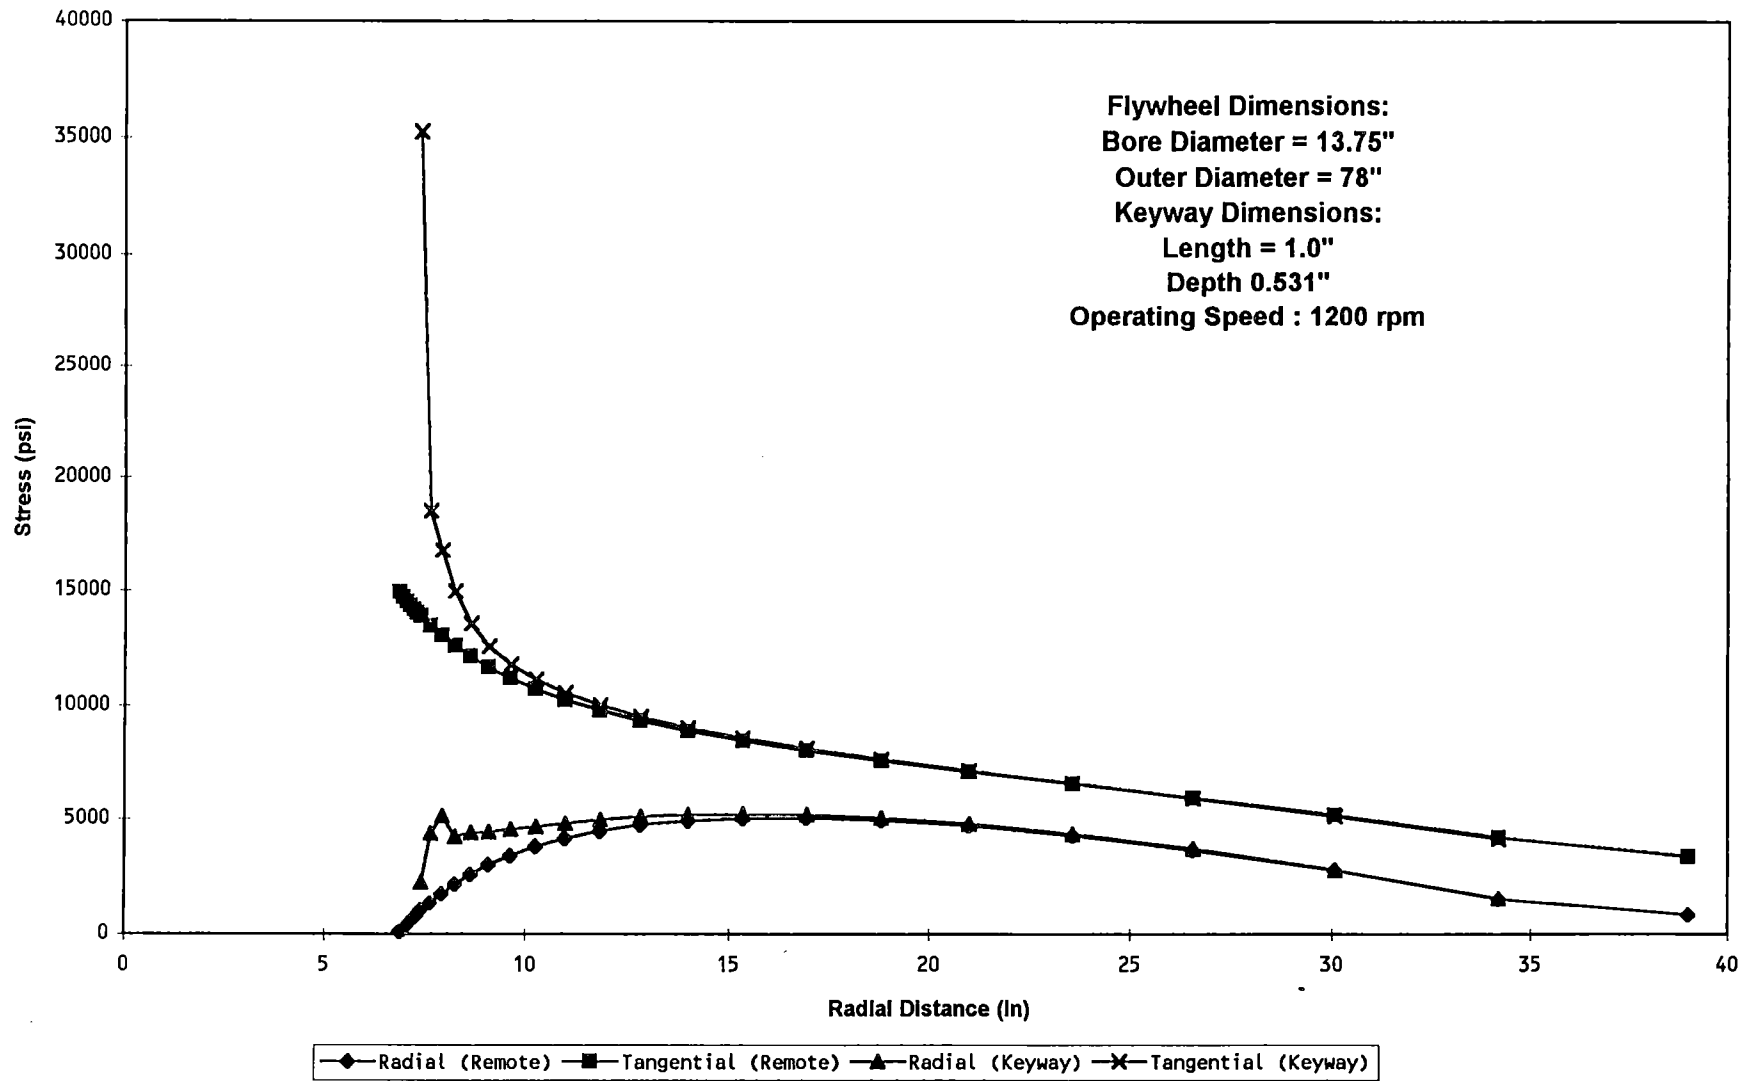
Figure 5-28. Tangential and Radial Stress Distribution from Bore to Outside Diameter (ANO-1)

Figure 5-29. Tangential and Radial Stress Distribution from Bore to Outside Diameter (ANO-2)

Figure 5-30. Tangential and Radial Stress Distribution from Bore to Outside Diameter (Millstone-2)

Figure 5-31. Tangential and Radial Stress Distribution from Bore to Outside Diameter (Palisades)

Figure 5-32. Tangential and Radial Stress Distribution from Bore to Outside Diameter (St. Lucie)

Figure 5-33. Tangential and Radial Stress Distribution from Bore to Outside Diameter (Waterford-3)

The stress distributions from the inner to the outer bore in the tangential and radial directions due to the centrifugal force are presented in Figures 5-28 through 5-33 for the six flywheels. In these figures, the stresses are plotted separately for the keyway region and

It should be noted from Figures 6-1 and 6-2 that in order to use these models, the stress distribution in the critical keyway region has to be established. Hence, the tangential stress distributions obtained for the critical keyway regions in Figures 5-28 through 5-33 were curve-fit using **pc-CRACK** to describe the stress distribution. In curve-fitting these stress distributions, a radial distance of 2 inches from the keyway was considered in order to obtain an accurate fit, since the allowable flaw size is expected to be limited to this value for all the flywheels. The resulting stress intensity factor distribution versus crack size from the keyway for the flywheels are shown in Figures 6-3 through 6-8.
