Report No.: SIR-94-080
Revision No.: 1
Project No.: CEOG-01Q
File No.: CEOG-01Q-401
March 1995

**Relaxation of Reactor Coolant Pump
Flywheel Inspection Requirements**

Structural Integrity Associates, Inc.

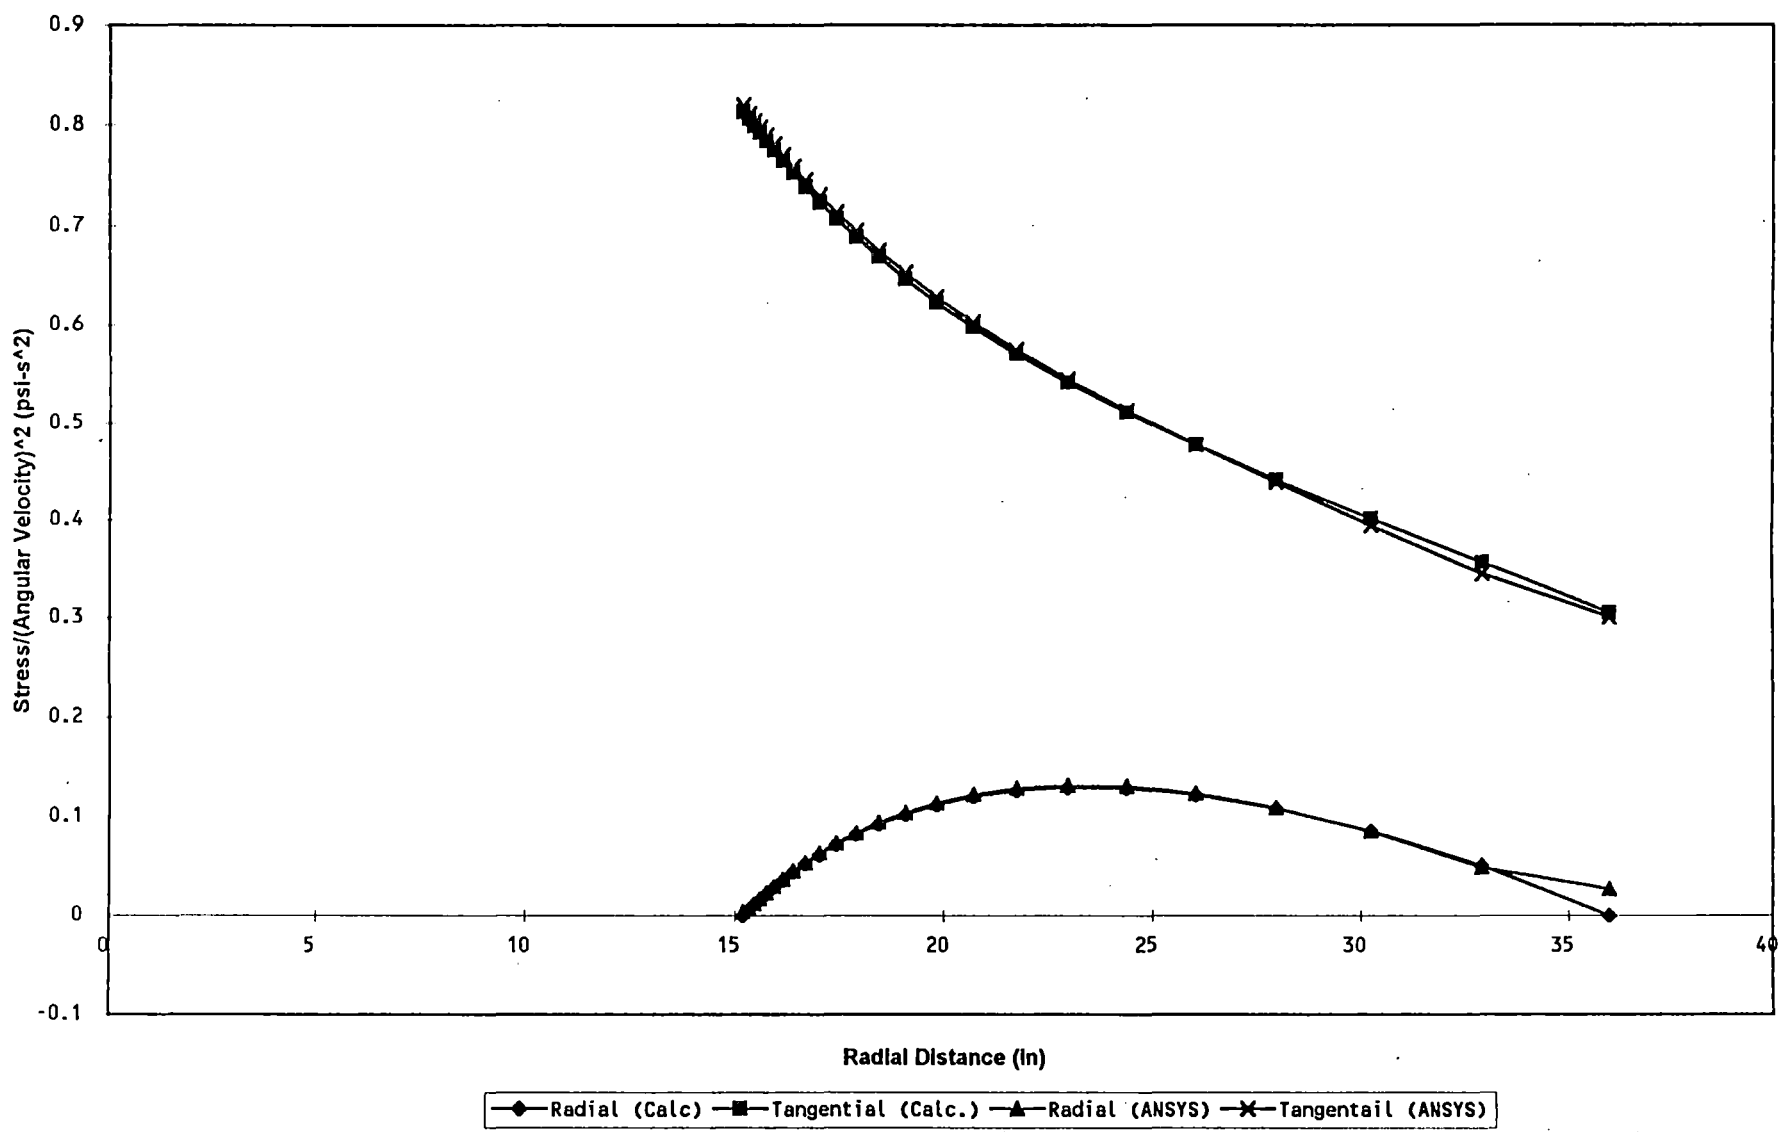
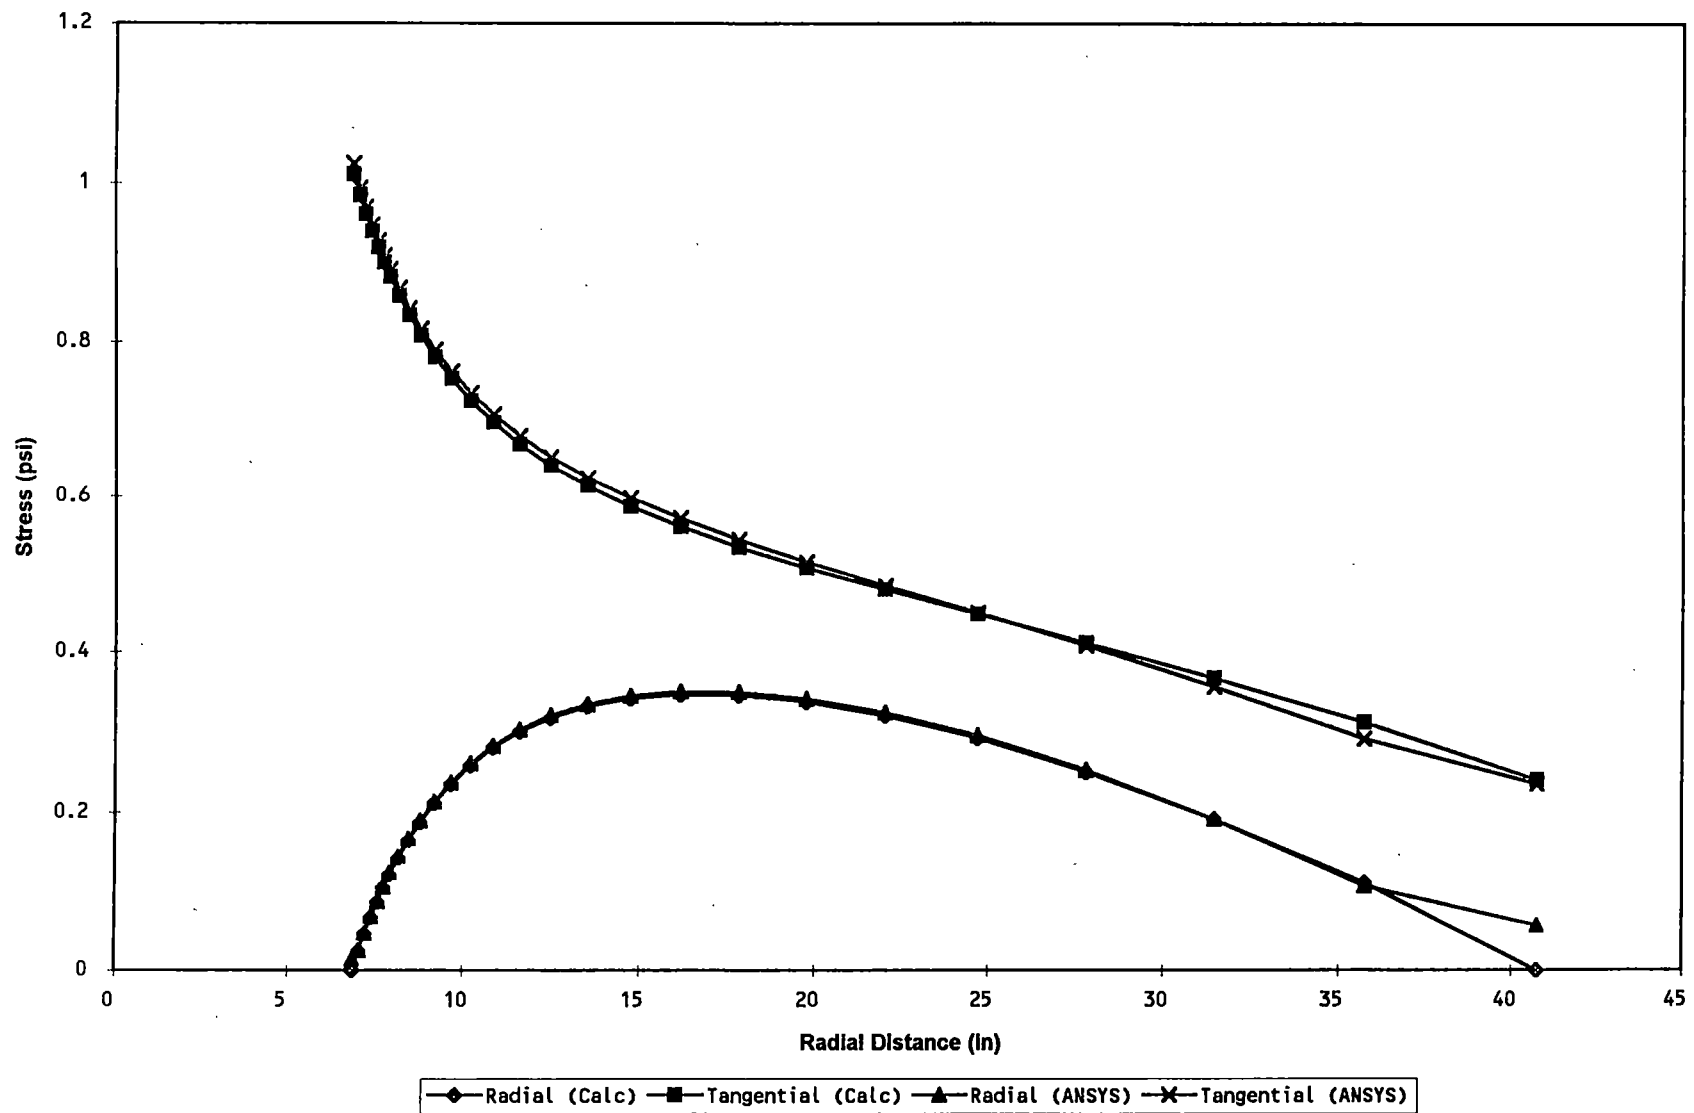
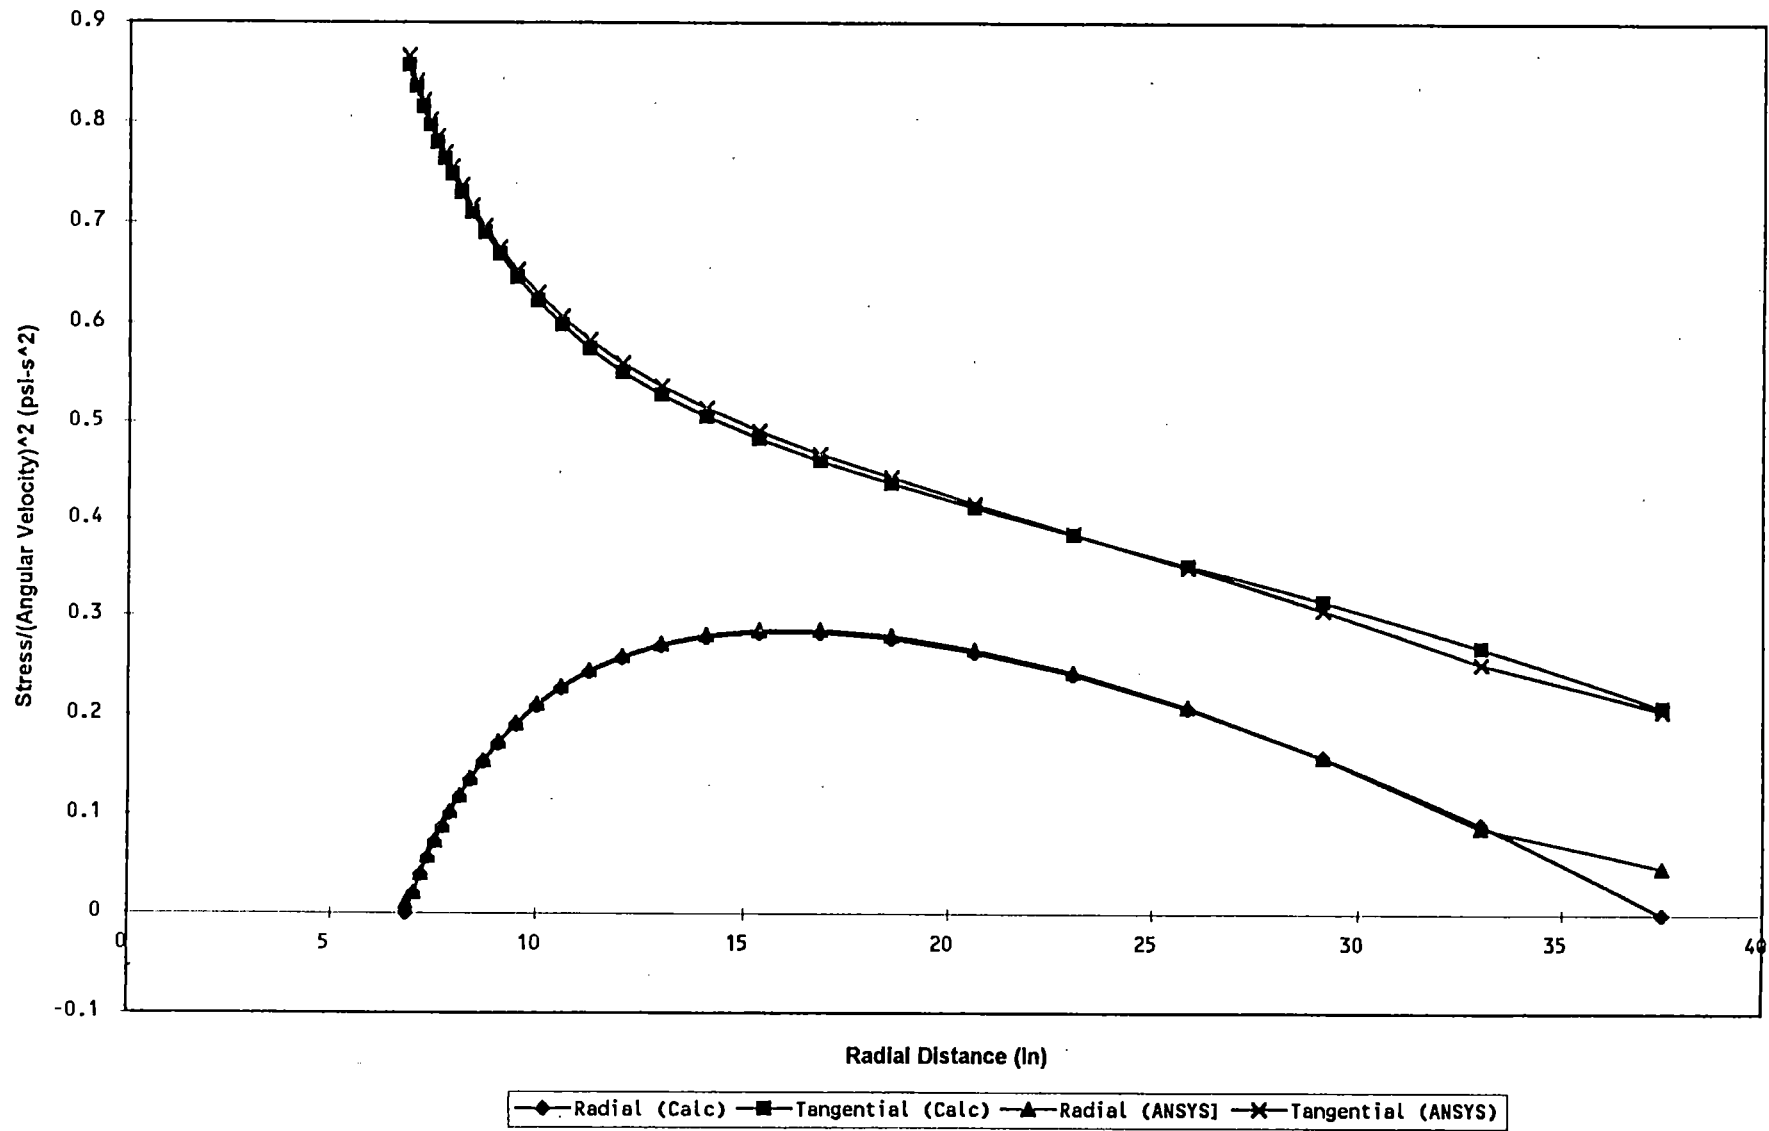
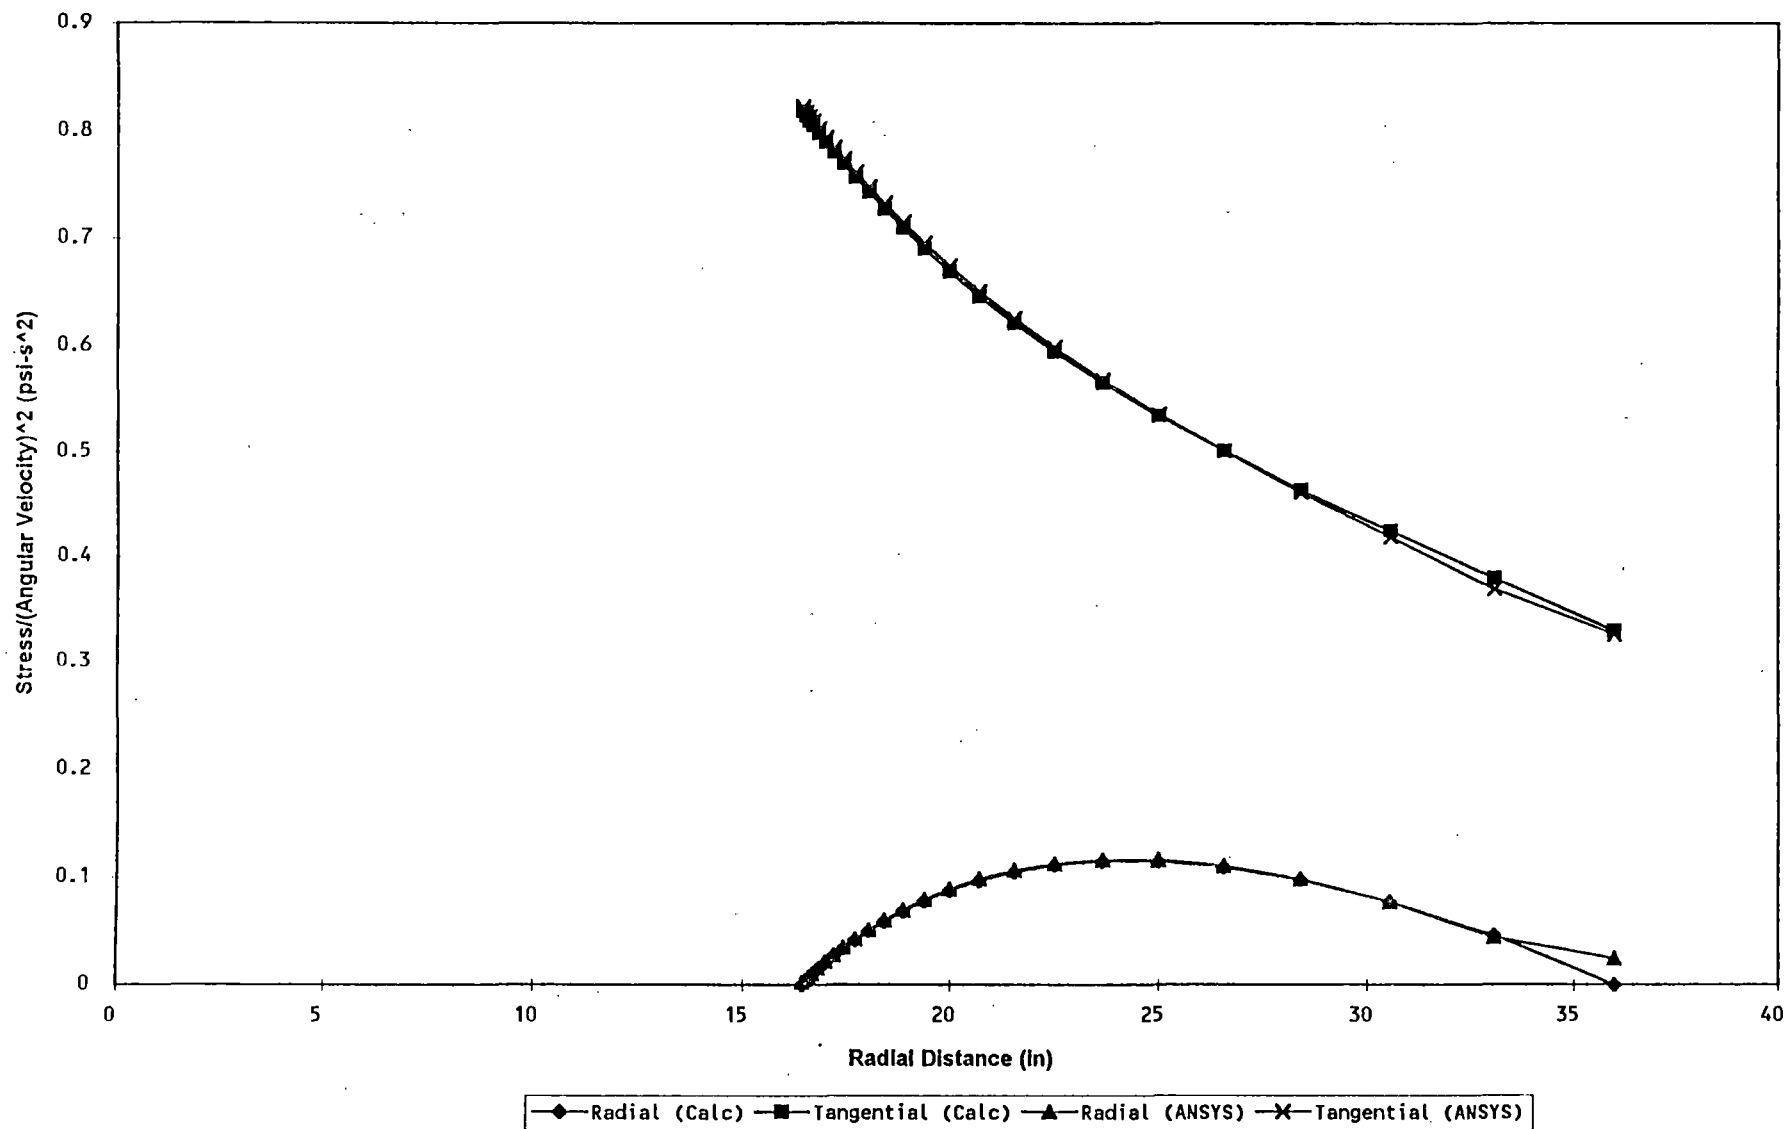
Figure 5-34. Comparison of Finite Element Results for Centrifugal Force With Theoretical Results (ANO-1)

Figure 5-35. Comparison of Finite Element Results for Centrifugal Force With Theoretical Results (ANO-2)

Figure 5-36. Comparison of Finite Element Results for Centrifugal Force With Theoretical Results (Millstone-2)

Figure 5-37. Comparison of Finite Element Results for Centrifugal Force With Theoretical Results (Palisades)

Figures 5-34 through 5-39 provide a comparison between the results of the finite element analyses stress distributions (remote locations away from keyway) and the distributions determined using Equations 5-1 and 5-2. It can be seen that the comparisons are very good for all flywheels analyzed, thus providing added assurance of the validity of the finite element results.

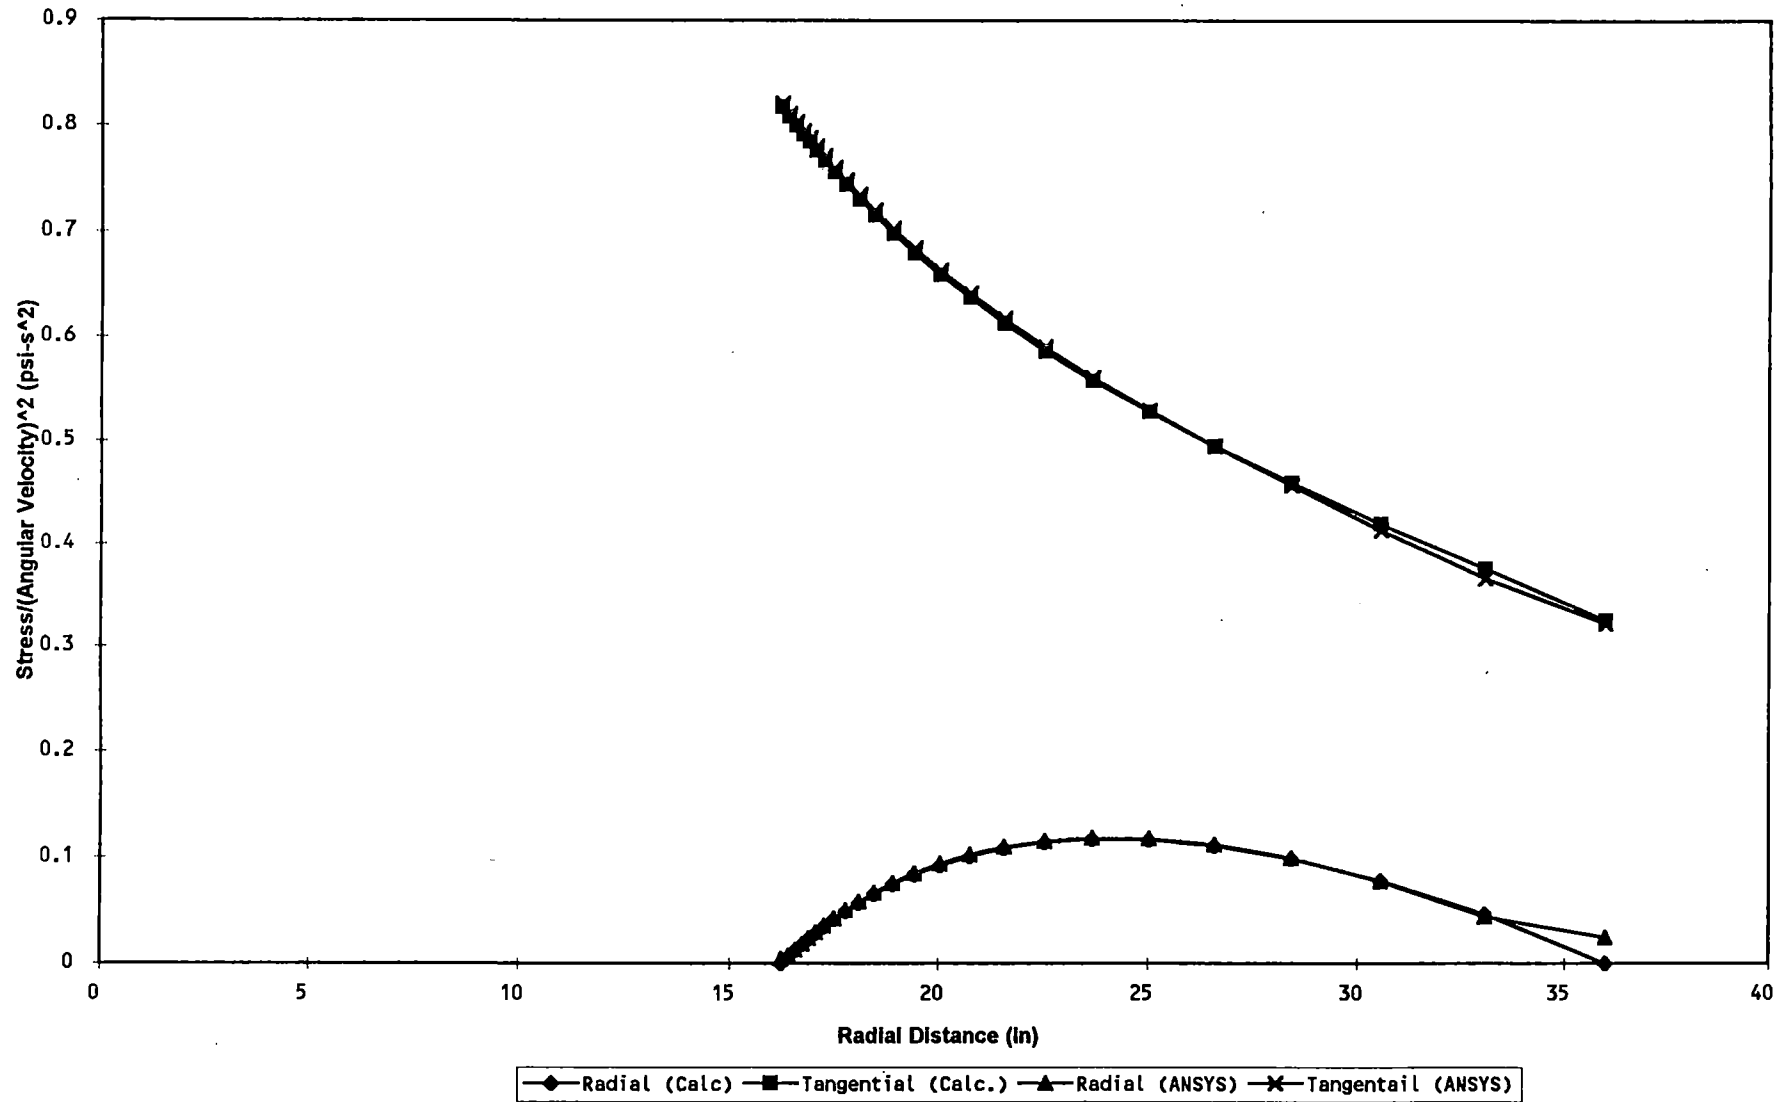
Figure 5-38. Comparison of Finite Element Results for Centrifugal Force With Theoretical Results (St. Lucie)

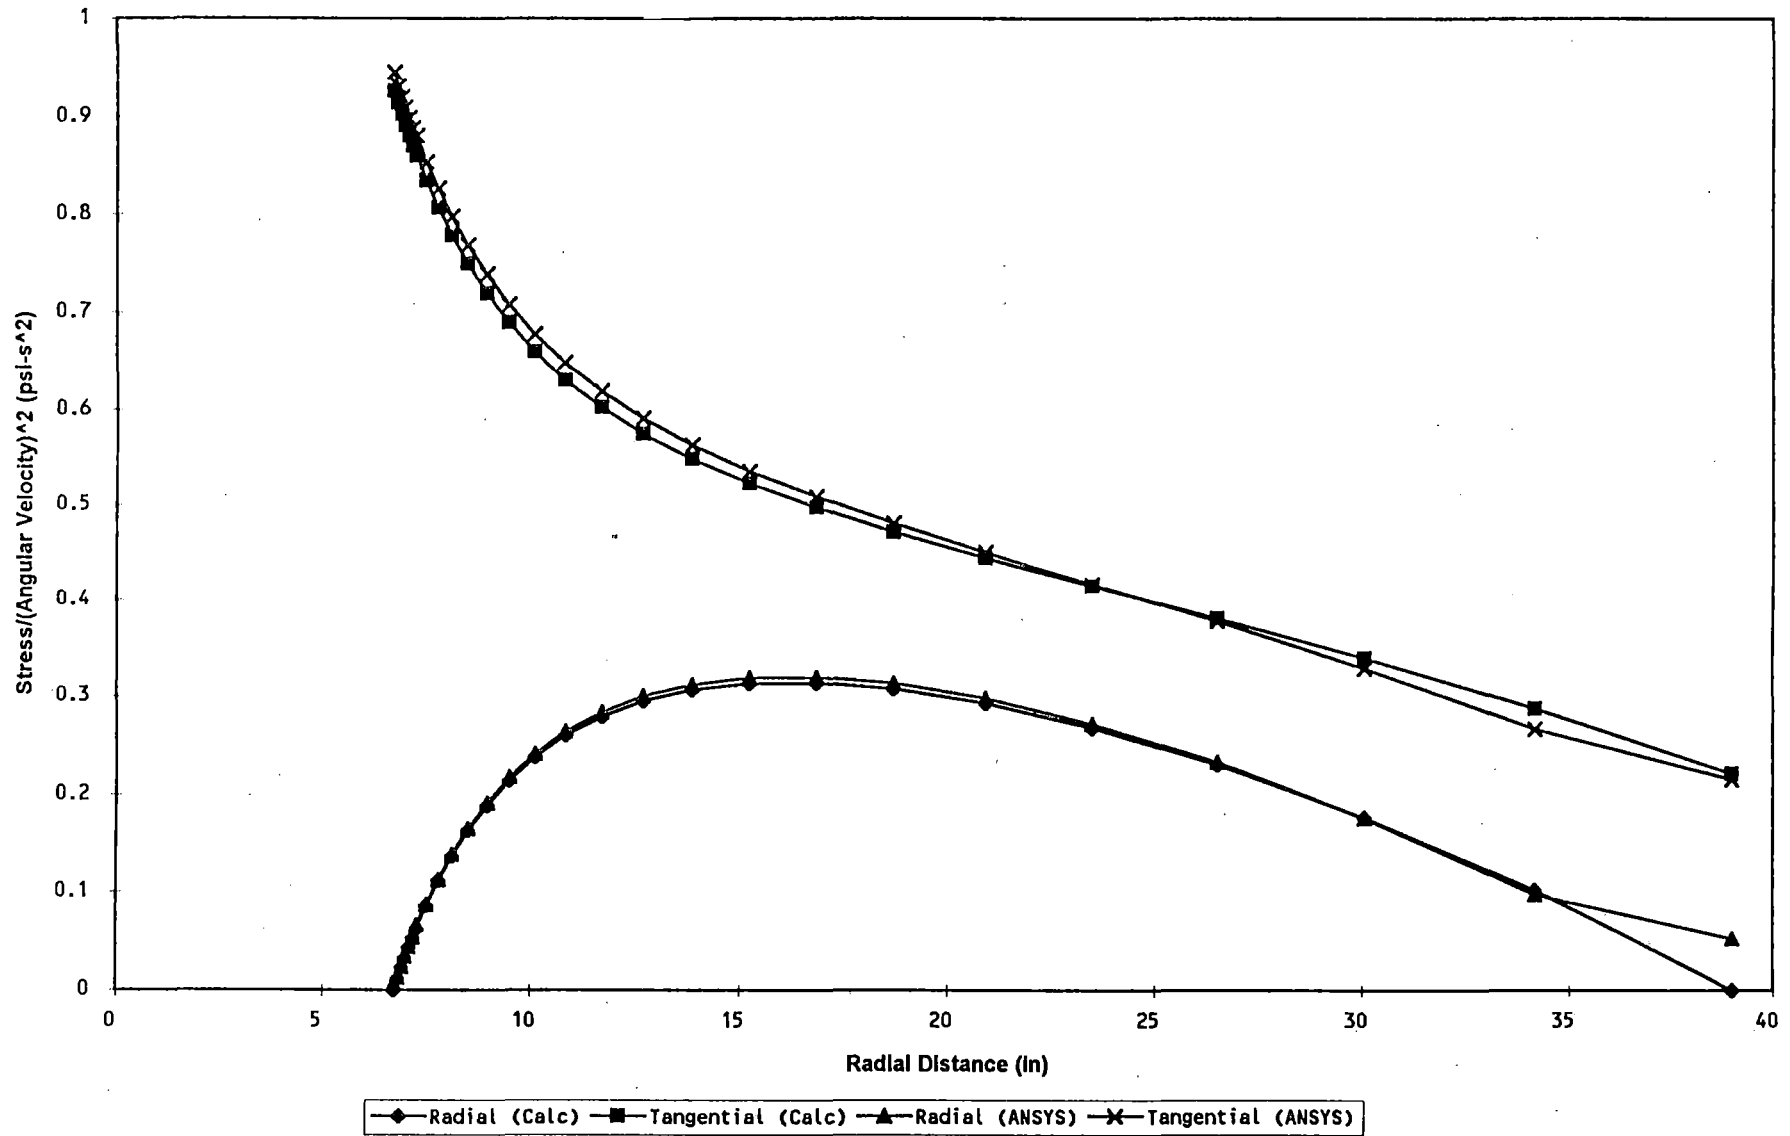
Figure 5-39. Comparison of Finite Element Results for Centrifugal Force With Theoretical Results (Waterford-3)

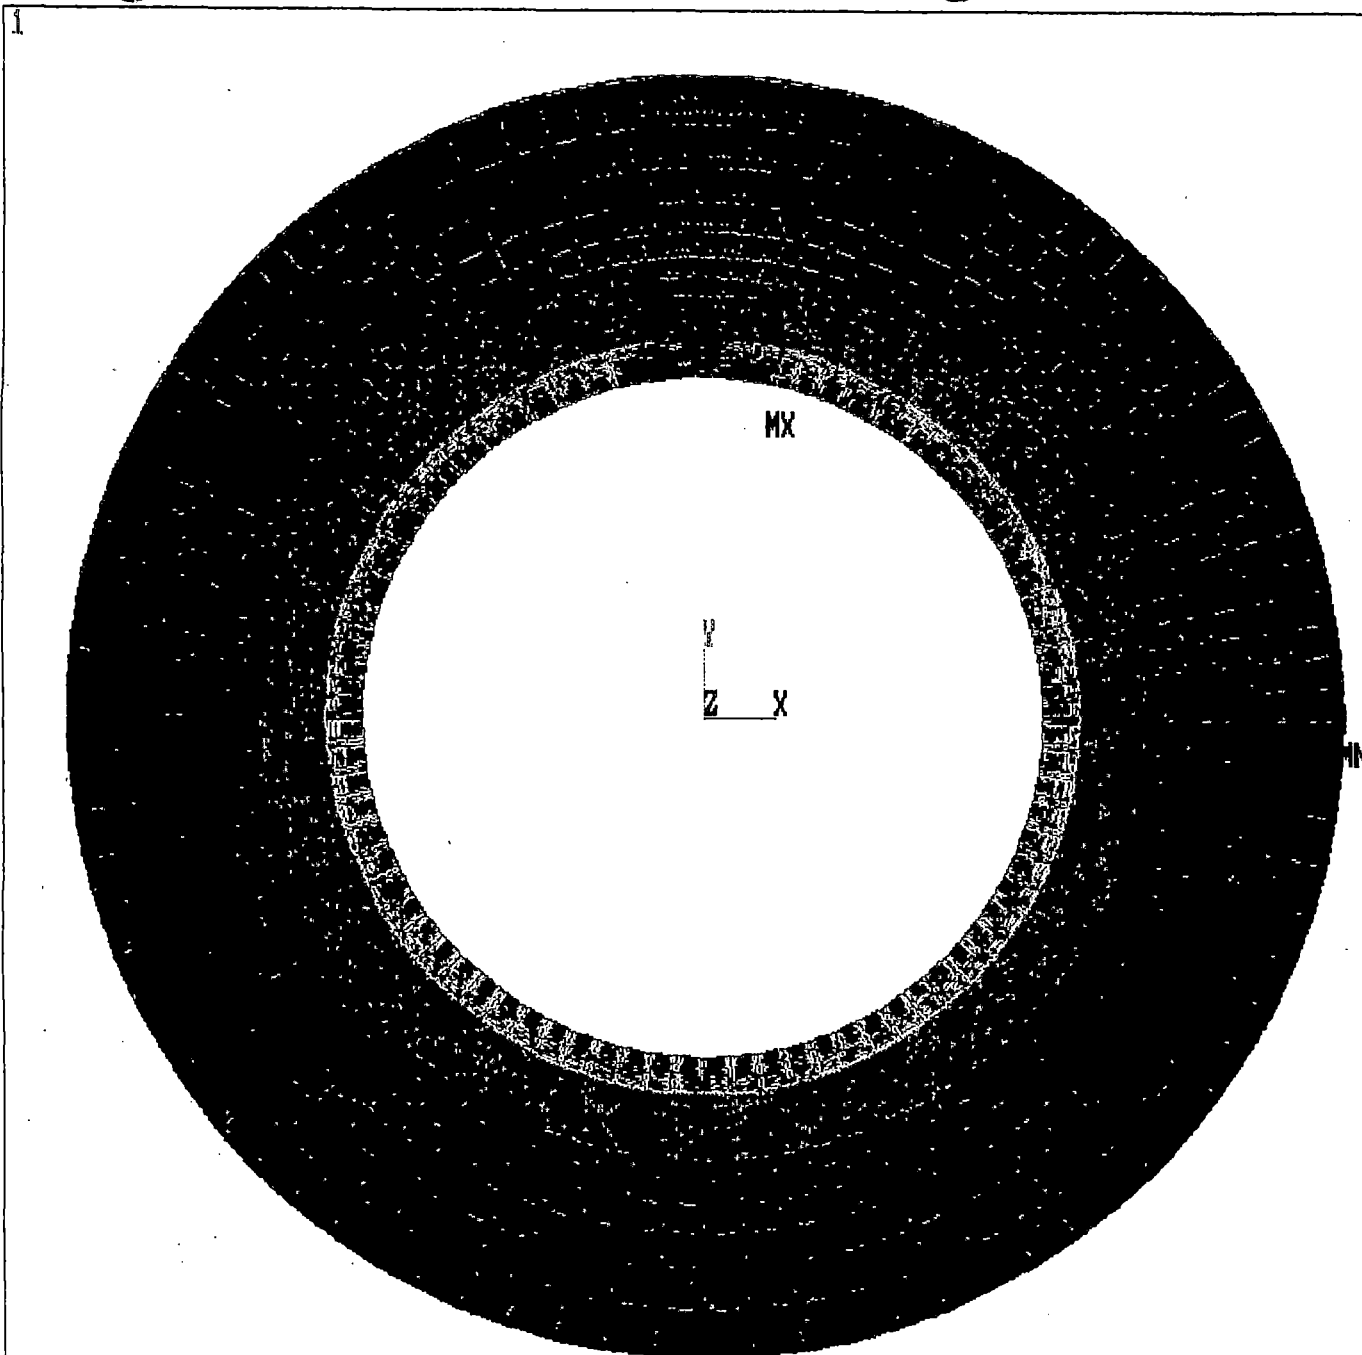
ANSYS-PC 4.4A1
AUG 23 1994
2:13:55
POST1 STRESS
STEP=1
ITER=1
SY (AUG)
CSYS=1
DMX =0.001001
SMN =-499.622
SMNB=-1836
SMX =3781
SMXB=4349

CEOG Flywheel Evaluation, ANO Unit 1 (Shrink Fit Force)

Figure 5-40. Overall Tangential Stress Distribution Due to Shrink-Fit Force (ANO-1)

The results of the 1 mil shrink-fit analysis are shown in Figures 5-40 through 5-63 for the five flywheels. As before, plots are presented for the tangential and radial stresses for both the overall flywheel stress distributions and for the detailed stress distributions in the keyway region. As can be seen from these figures, especially in the detailed keyway region, both the tangential and radial stresses are tensile in the keyway region.

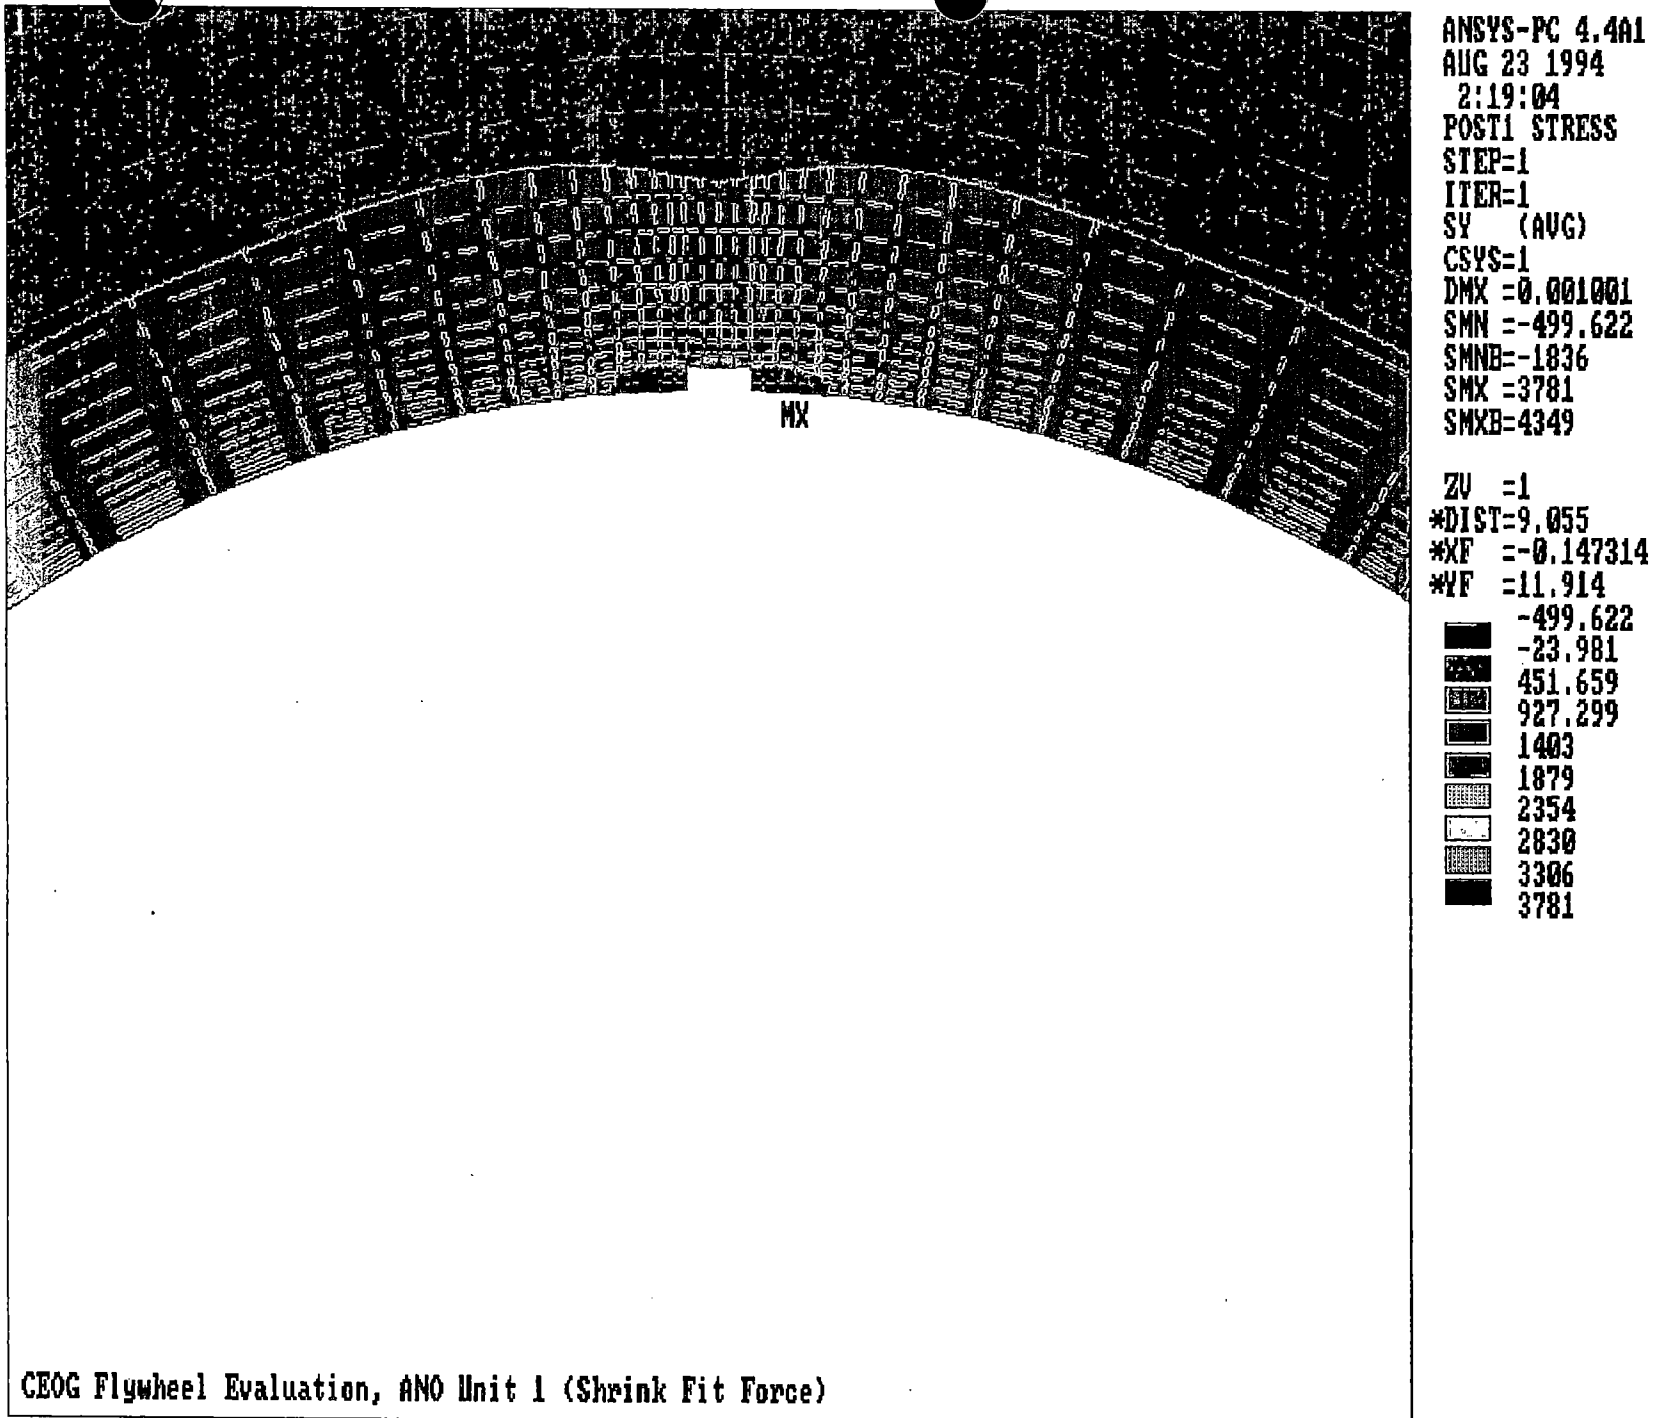
Figure 5-41. Details of Tangential Stress Distribution in Keyway Region Due to Shrink-Fit Force (ANO-1)

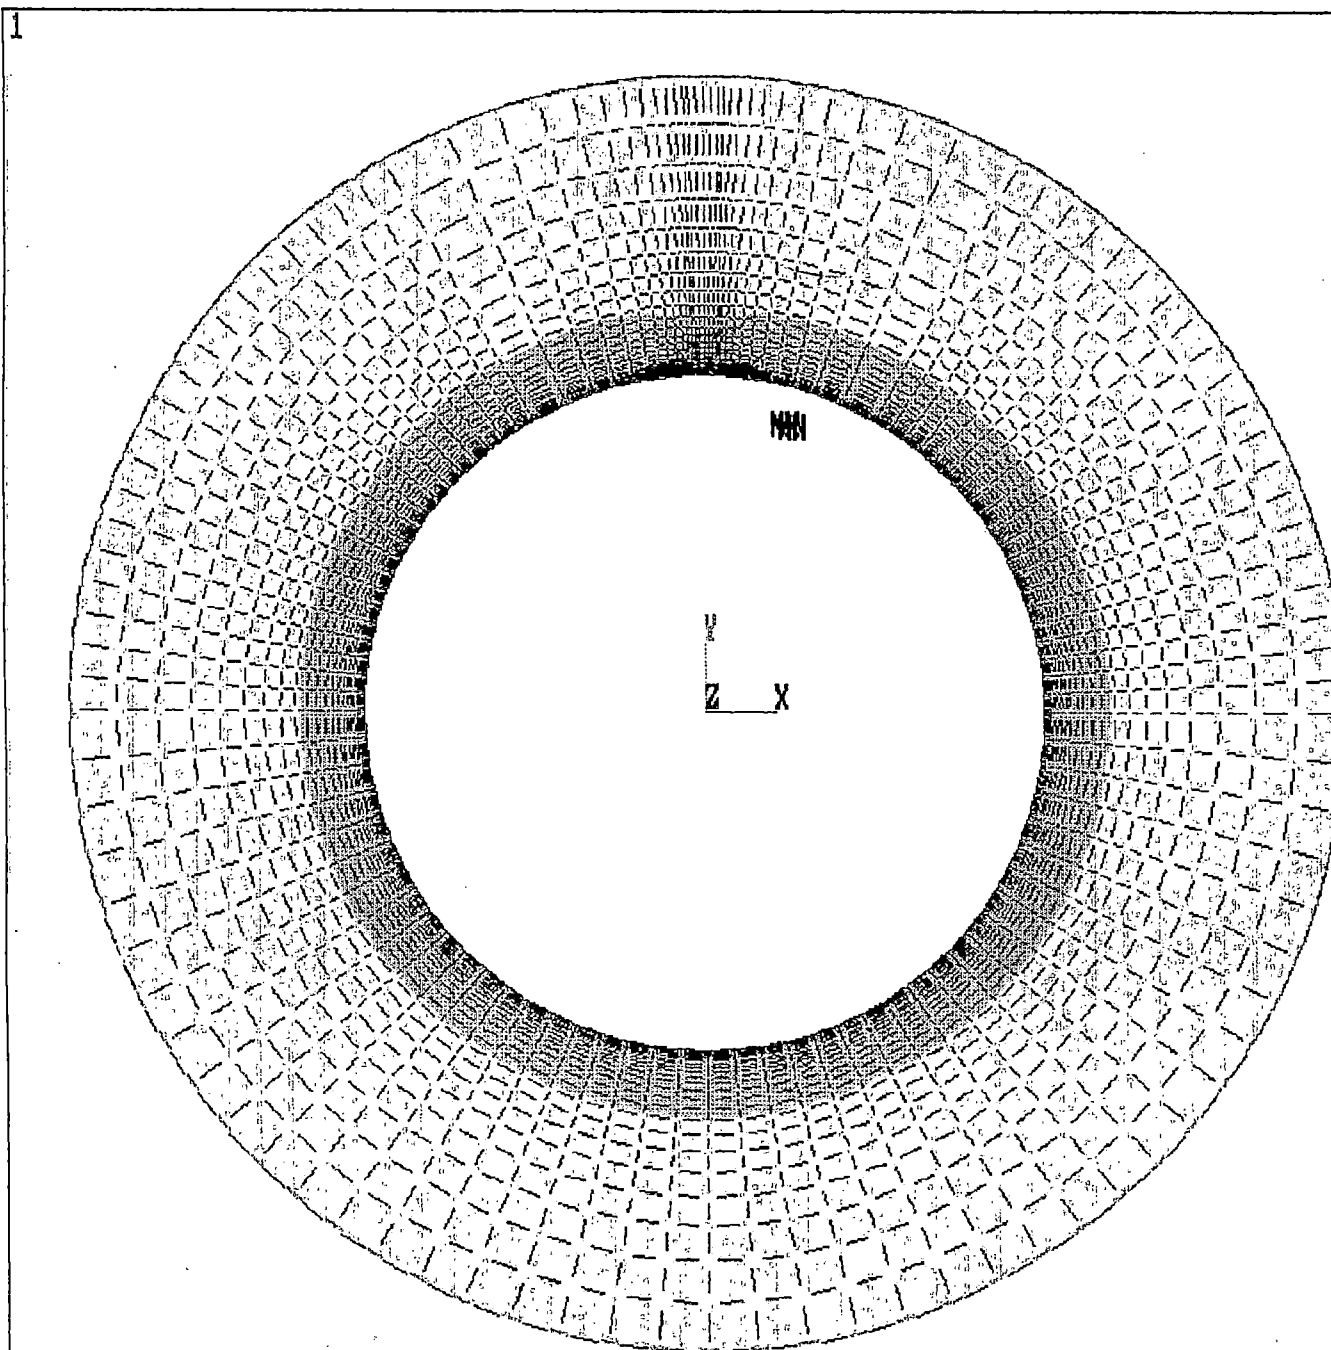
ANSYS-PC 4.4A1
 AUG 23 1994
 2:12:17
 POST1 STRESS
 STEP=1
 ITER=1
 SX (AVG)
 CSYS=1
 DMX =0.001001
 SMN =-5882
 SMNB=-7591
 SMX =232.206
 SMXB=1283

Figure 5-42. Overall Radial Stress Distribution Due to Shrink-Fit Force (ANO-1)

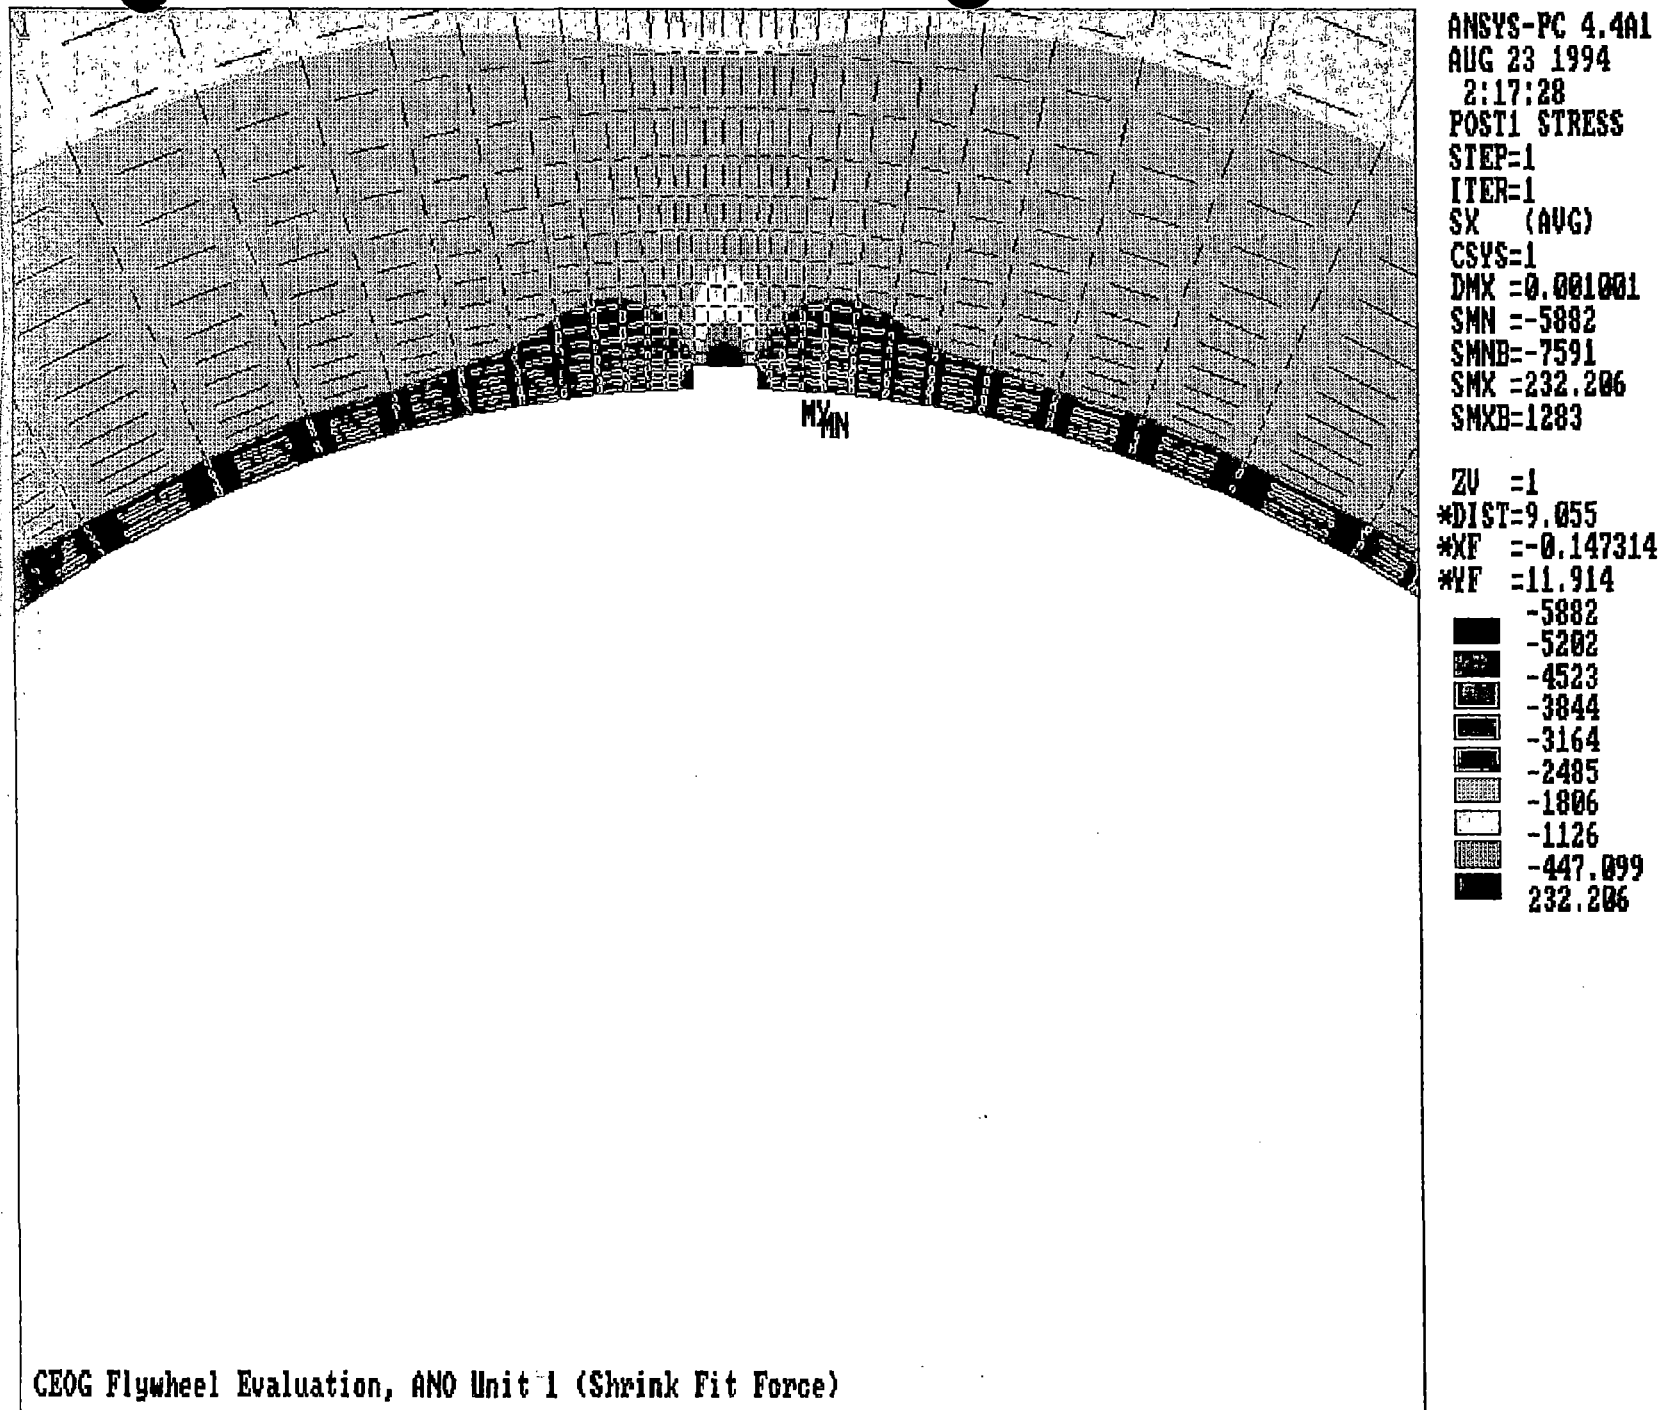
Figure 5-43. Details of Radial Stress Distribution in Keyway Region Due to Shrink-Fit Force (ANO-1)

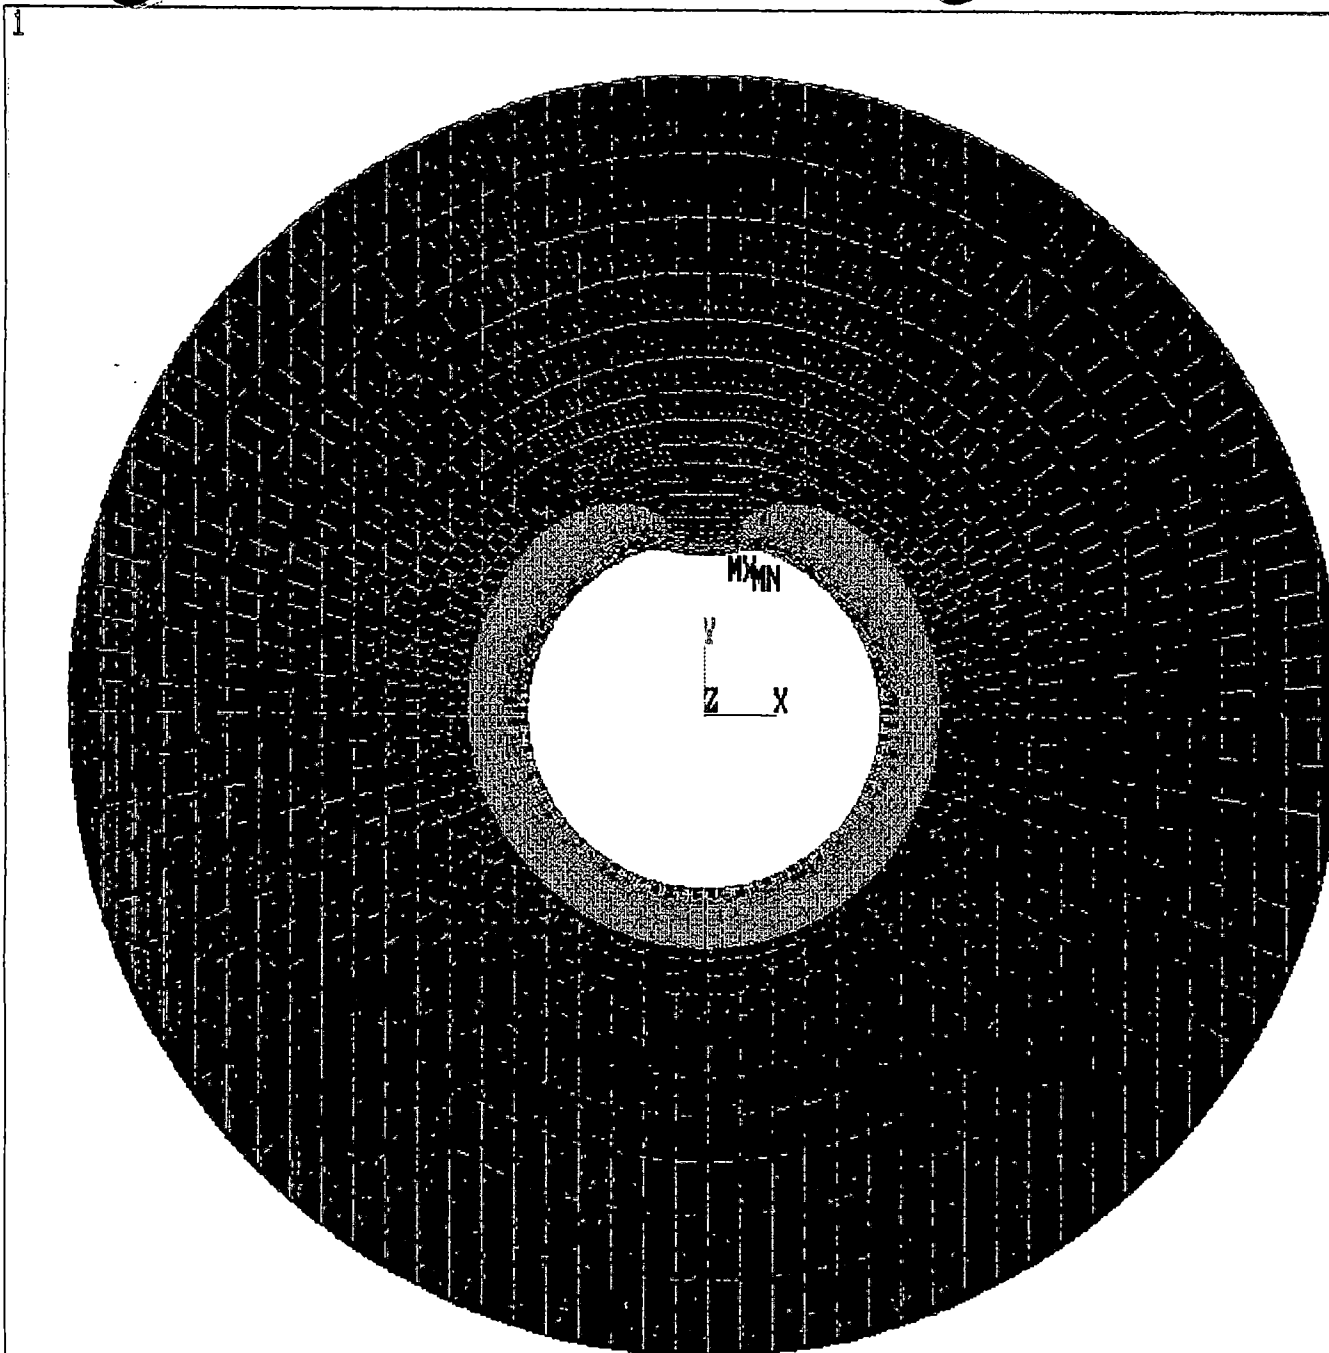
ANSYS-PC 4.4a1
 AUG 23 1994
 3:50:31
 POST1 STRESS
 STEP=1
 ITER=1
 SX (AVG)
 CSYS=1
 DMX =0.001033
 SMN =-12173
 SMNB=-13516
 SMX =172.898
 SMXB=1922

Figure 5-46. Overall Radial Stress Distribution Due to Shrink-Fit Force (ANO-2)
