Report No.: SIR-94-080
Revision No.: 1
Project No.: CEOG-01Q
File No.: CEOG-01Q-401
March 1995

**Relaxation of Reactor Coolant Pump
Flywheel Inspection Requirements**

Structural Integrity Associates, Inc.

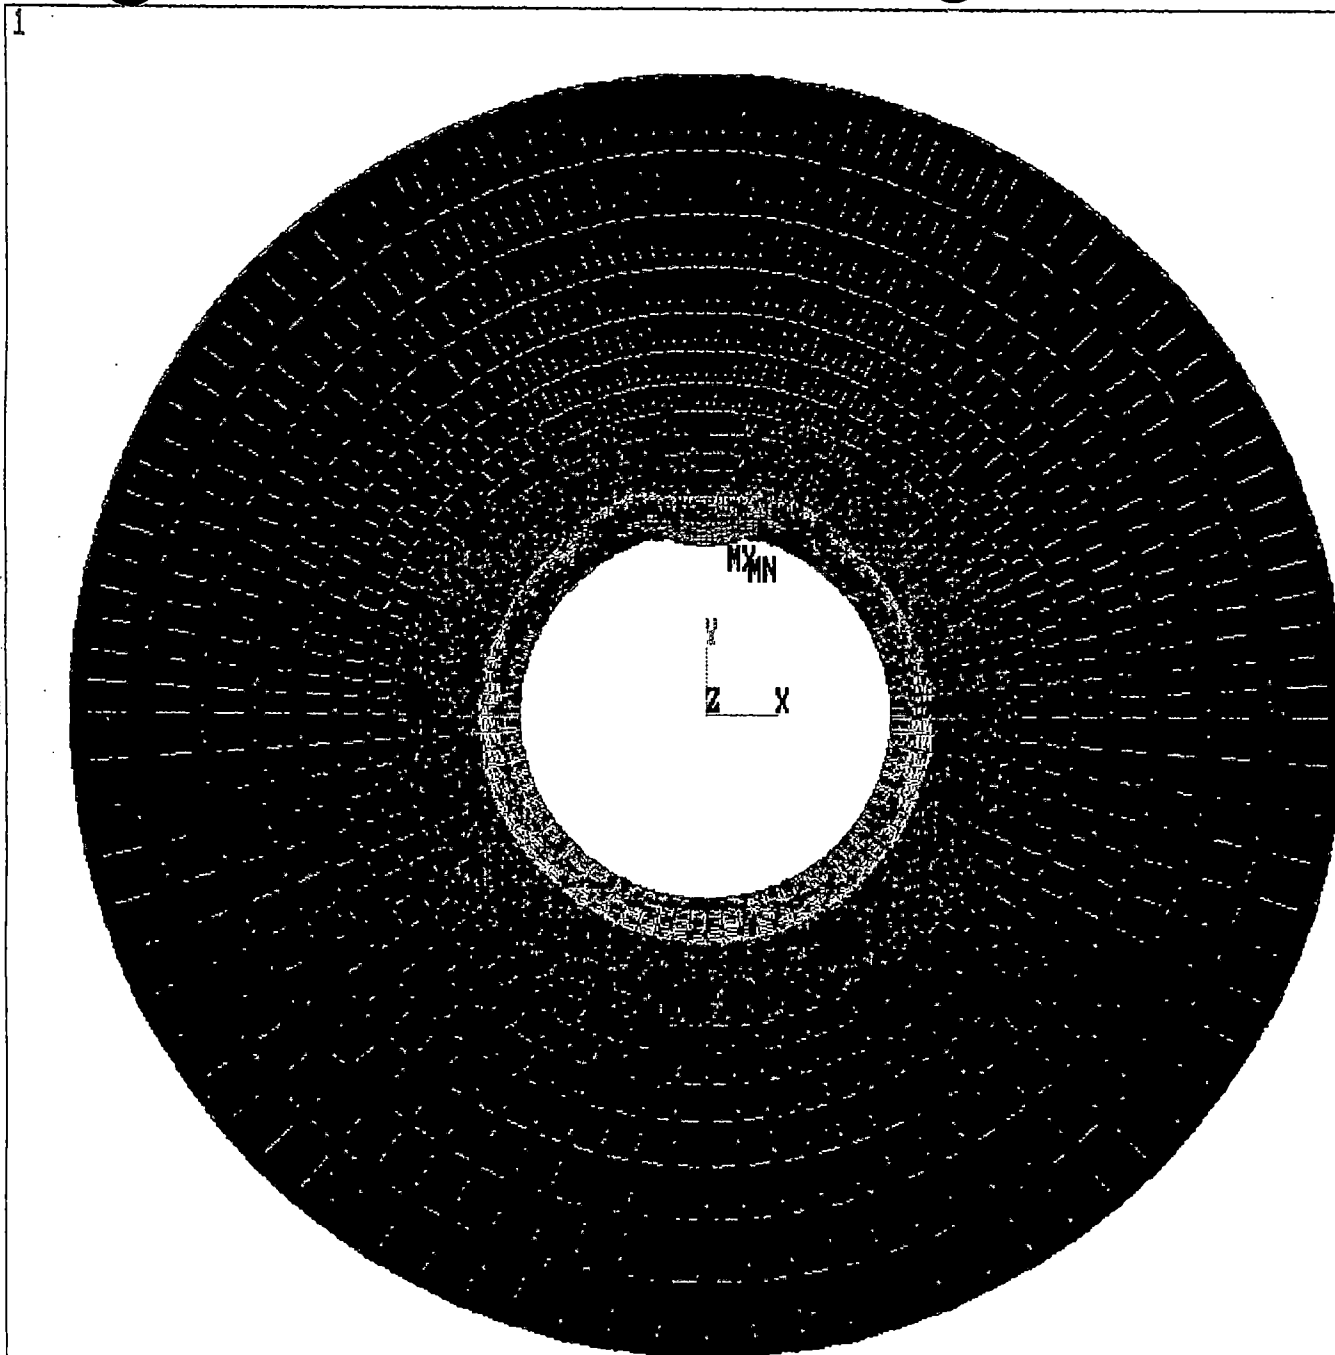
Figure 5-48. Overall Tangential Stress Distribution Due to Shrink-Fit Force (Millstone-2)

The results of the 1 mil shrink-fit analysis are shown in Figures 5-40 through 5-63 for the five flywheels. As before, plots are presented for the tangential and radial stresses for both the overall flywheel stress distributions and for the detailed stress distributions in the keyway region. As can be seen from these figures, especially in the detailed keyway region, both the tangential and radial stresses are tensile in the keyway region.

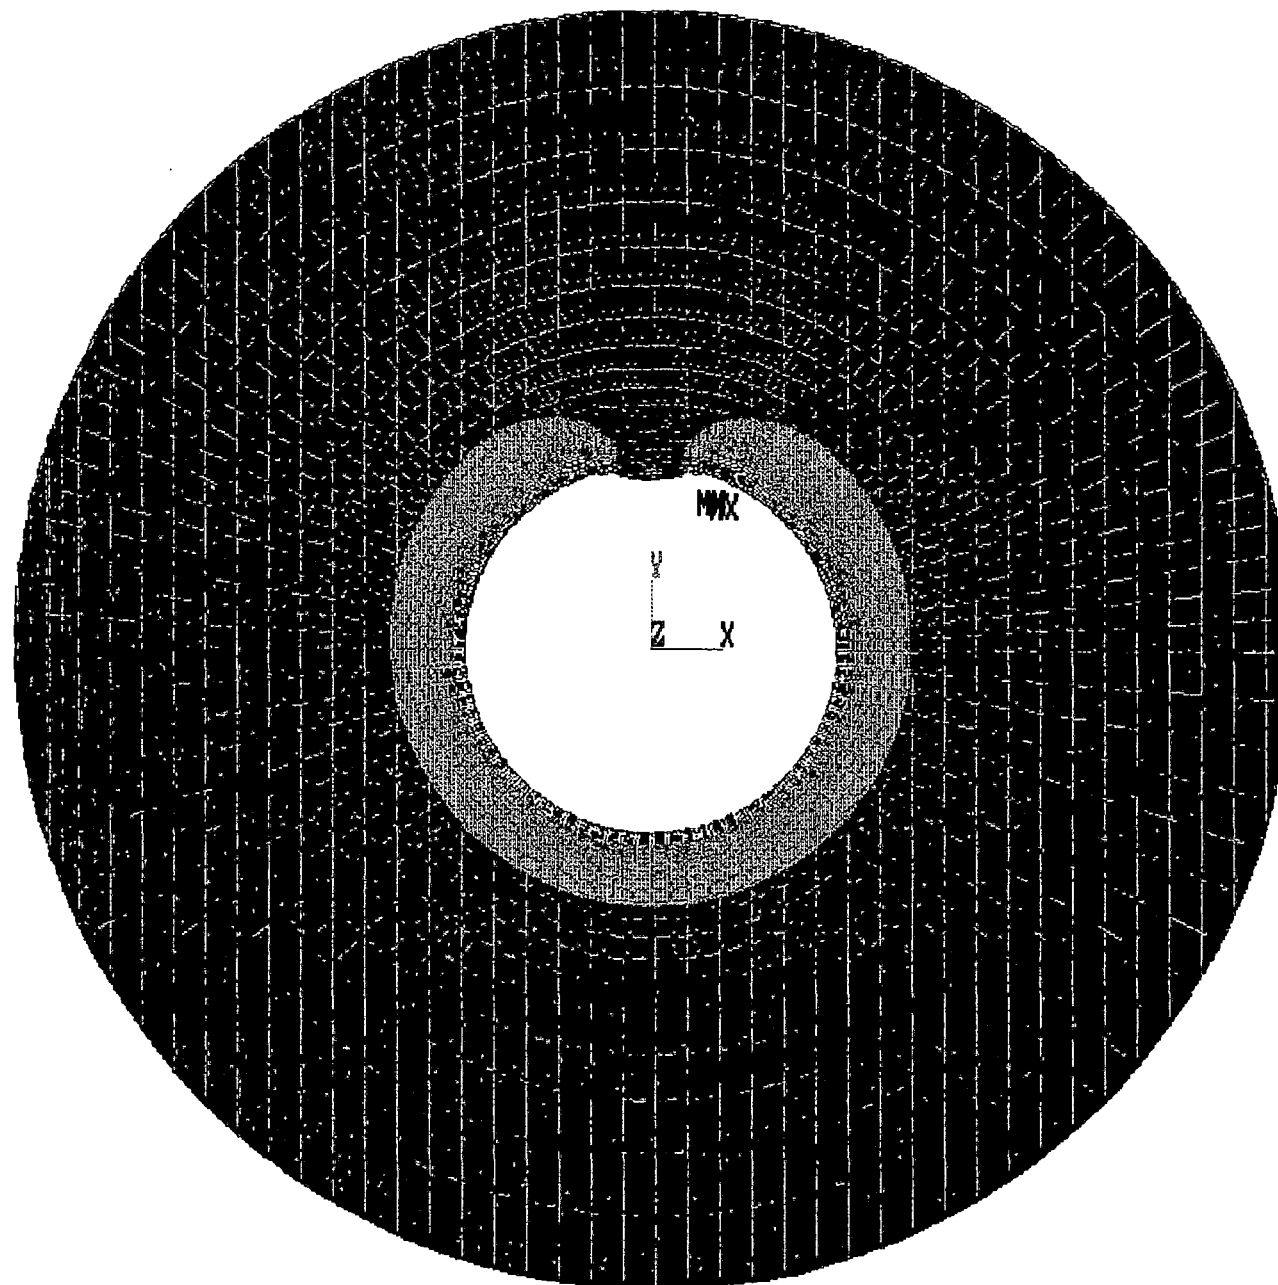
ANSYS-PC 4.401
 AUG 23 1994
 5:47:26
 POST1 STRESS
 STEP=1
 ITER=1
 SX (AUG)
 CSYS=1
 DMX =0.001033
 SMN =-12421
 SMNB=-13791
 SMX =213.45
 SMXB=2031

Figure 5-50. Overall Radial Stress Distribution Due to Shrink-Fit Force (Millstone-2)

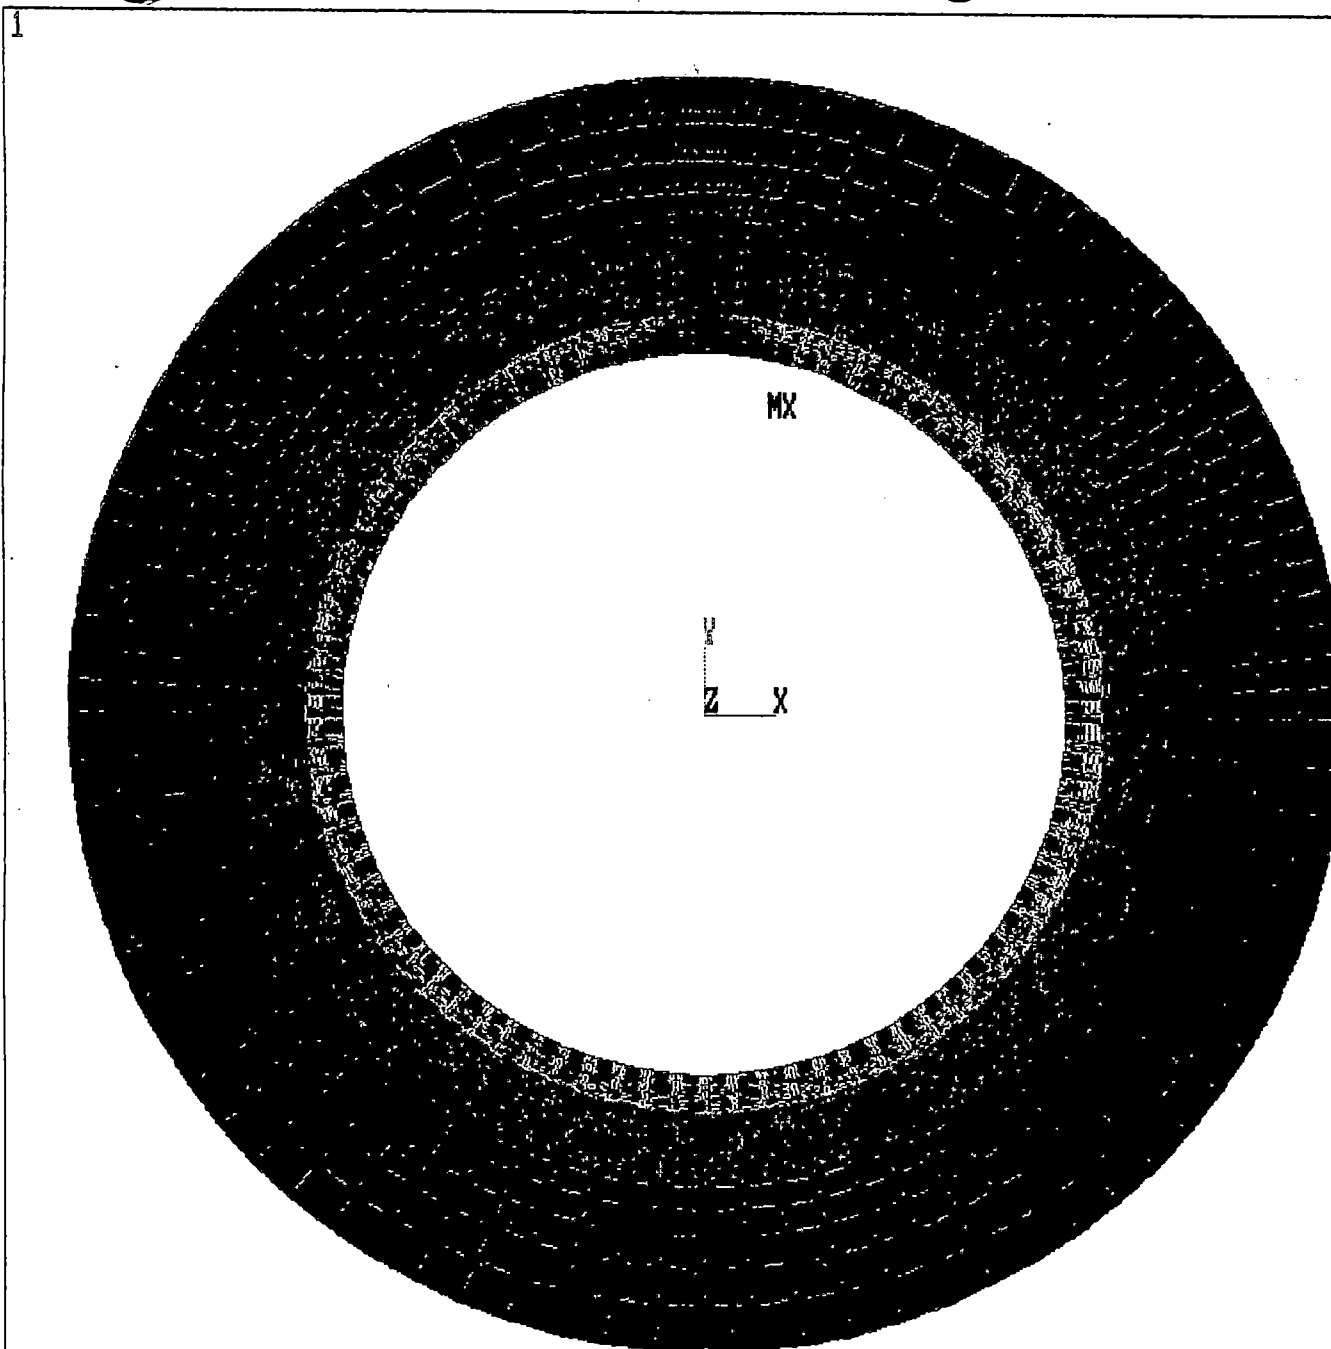
ANSYS-PC 4.4A1
AUG 23 1994
6:16:34
POST1 STRESS
STEP=1
ITER=1
SY (AVG)
CSYS=1
DMX =0.001
SMN =-571.937
SMNB=-1568
SMX =3505
SMXB=4206

Figure 5-52. Overall Tangential Stress Distribution Due to Shrink-Fit Force (Palisades)

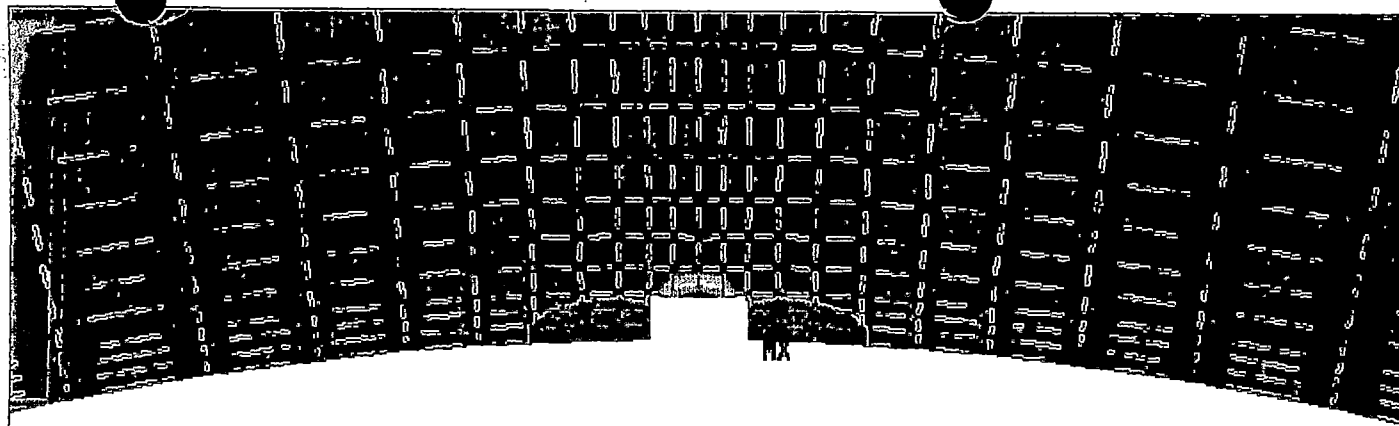
ANSYS-PC 4.4a1
 AUG 23 1994
 6:21:44
 POST1 STRESS
 STEP=1
 ITER=1
 SV (AVG)
 CSYS=1
 DMX =0.001
 SMN =-571.937
 SMNB=-1568
 SMX =3505
 SMXB=4206

Figure 5-53. Details of Tangential Stress Distribution in Keyway Region Due to Shrink-Fit Force (Palisades)

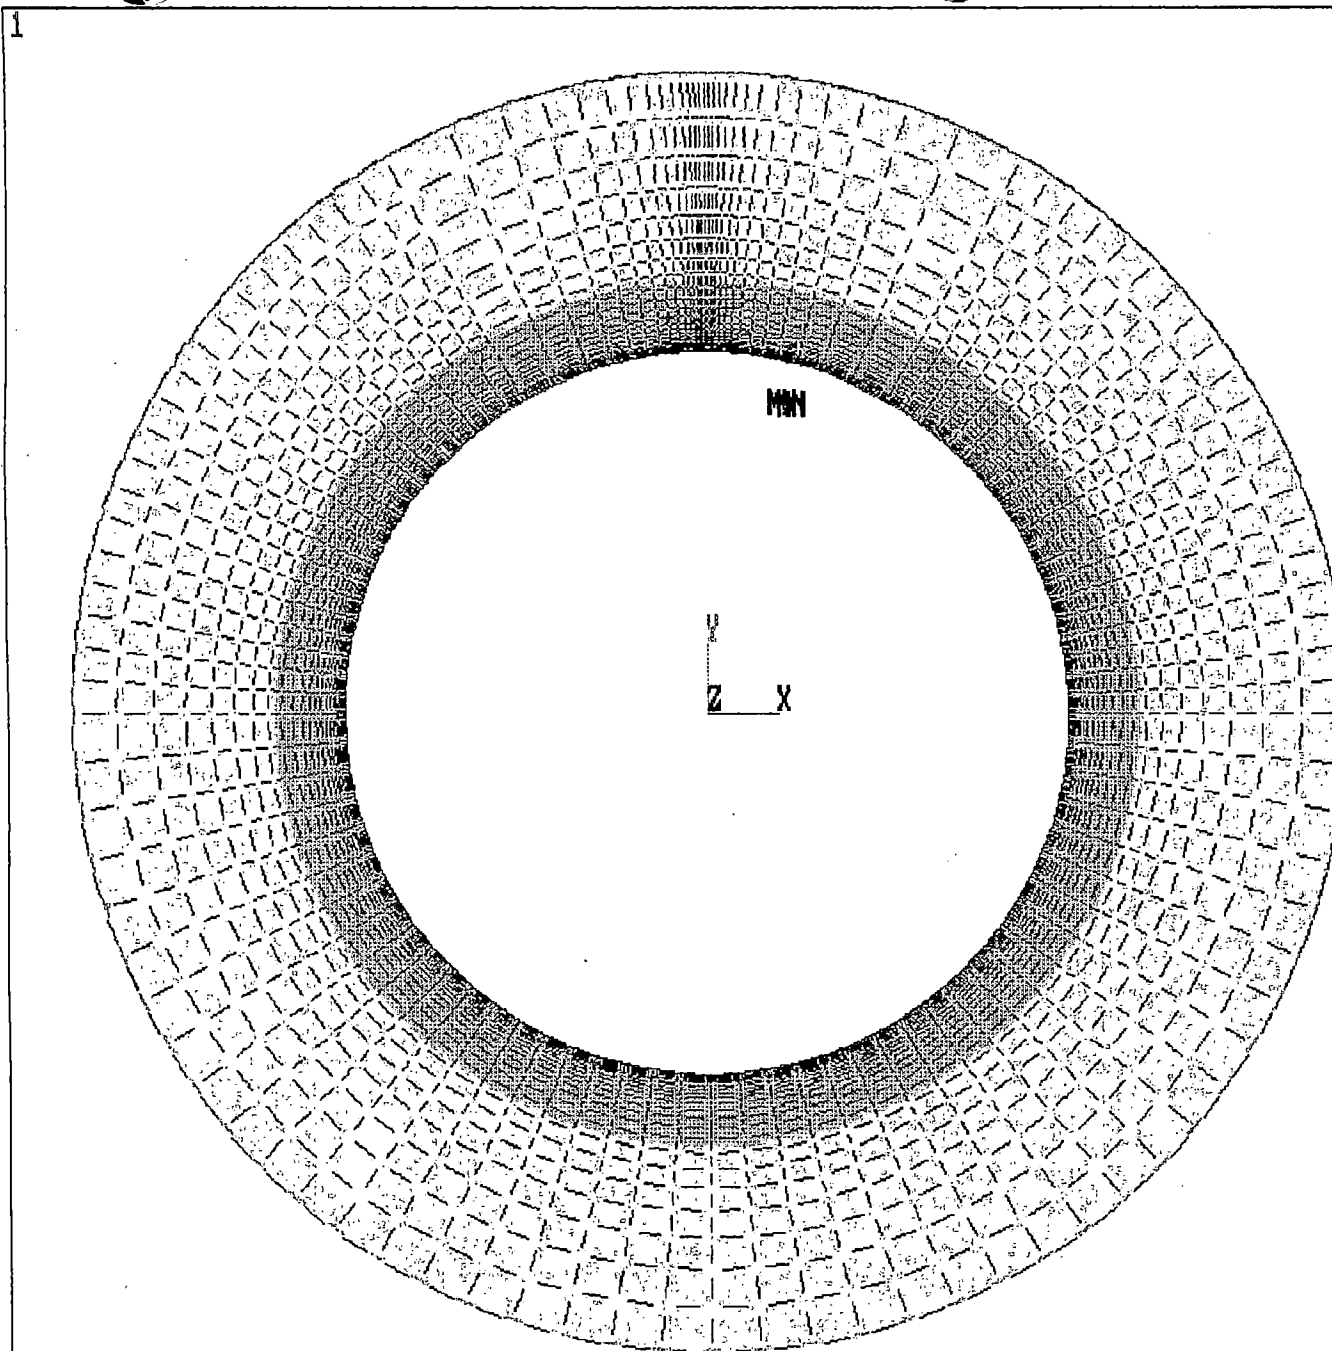
ANSYS-PC 4.4a1
 AUG 23 1994
 6:14:56
 POST1 STRESS
 STEP=1
 ITER=1
 SX (AVG)
 CSYS=1
 DMX =0.001
 SMN =-5870
 SMNB=-7368
 SMX =72.403
 SMXB=1056

Figure 5-54. Overall Radial Stress Distribution Due to Shrink-Fit Force (Palisades)

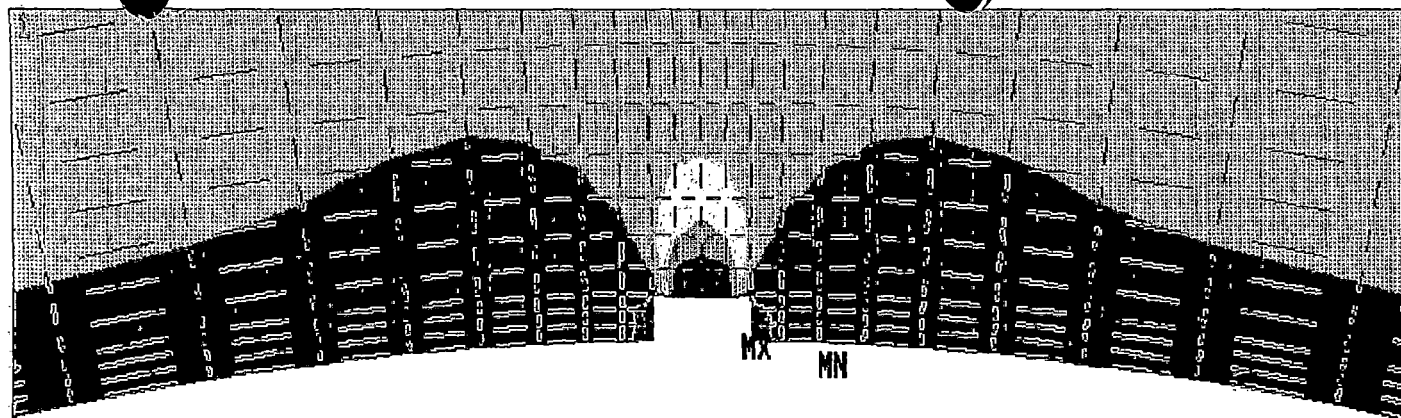
ANSYS-PC 4.4a1
 AUG 23 1994
 6:19:51
 POST1 STRESS
 STEP=1
 ITER=1
 SX (AVG)
 CSYS=1
 DMX =0.001
 SMN =-5870
 SMNB=-7368
 SMX =72.403
 SMXB=1056

Figure 5-55. Details of Radial Stress Distribution in Keyway Region Due to Shrink-Fit Force (Palisades)

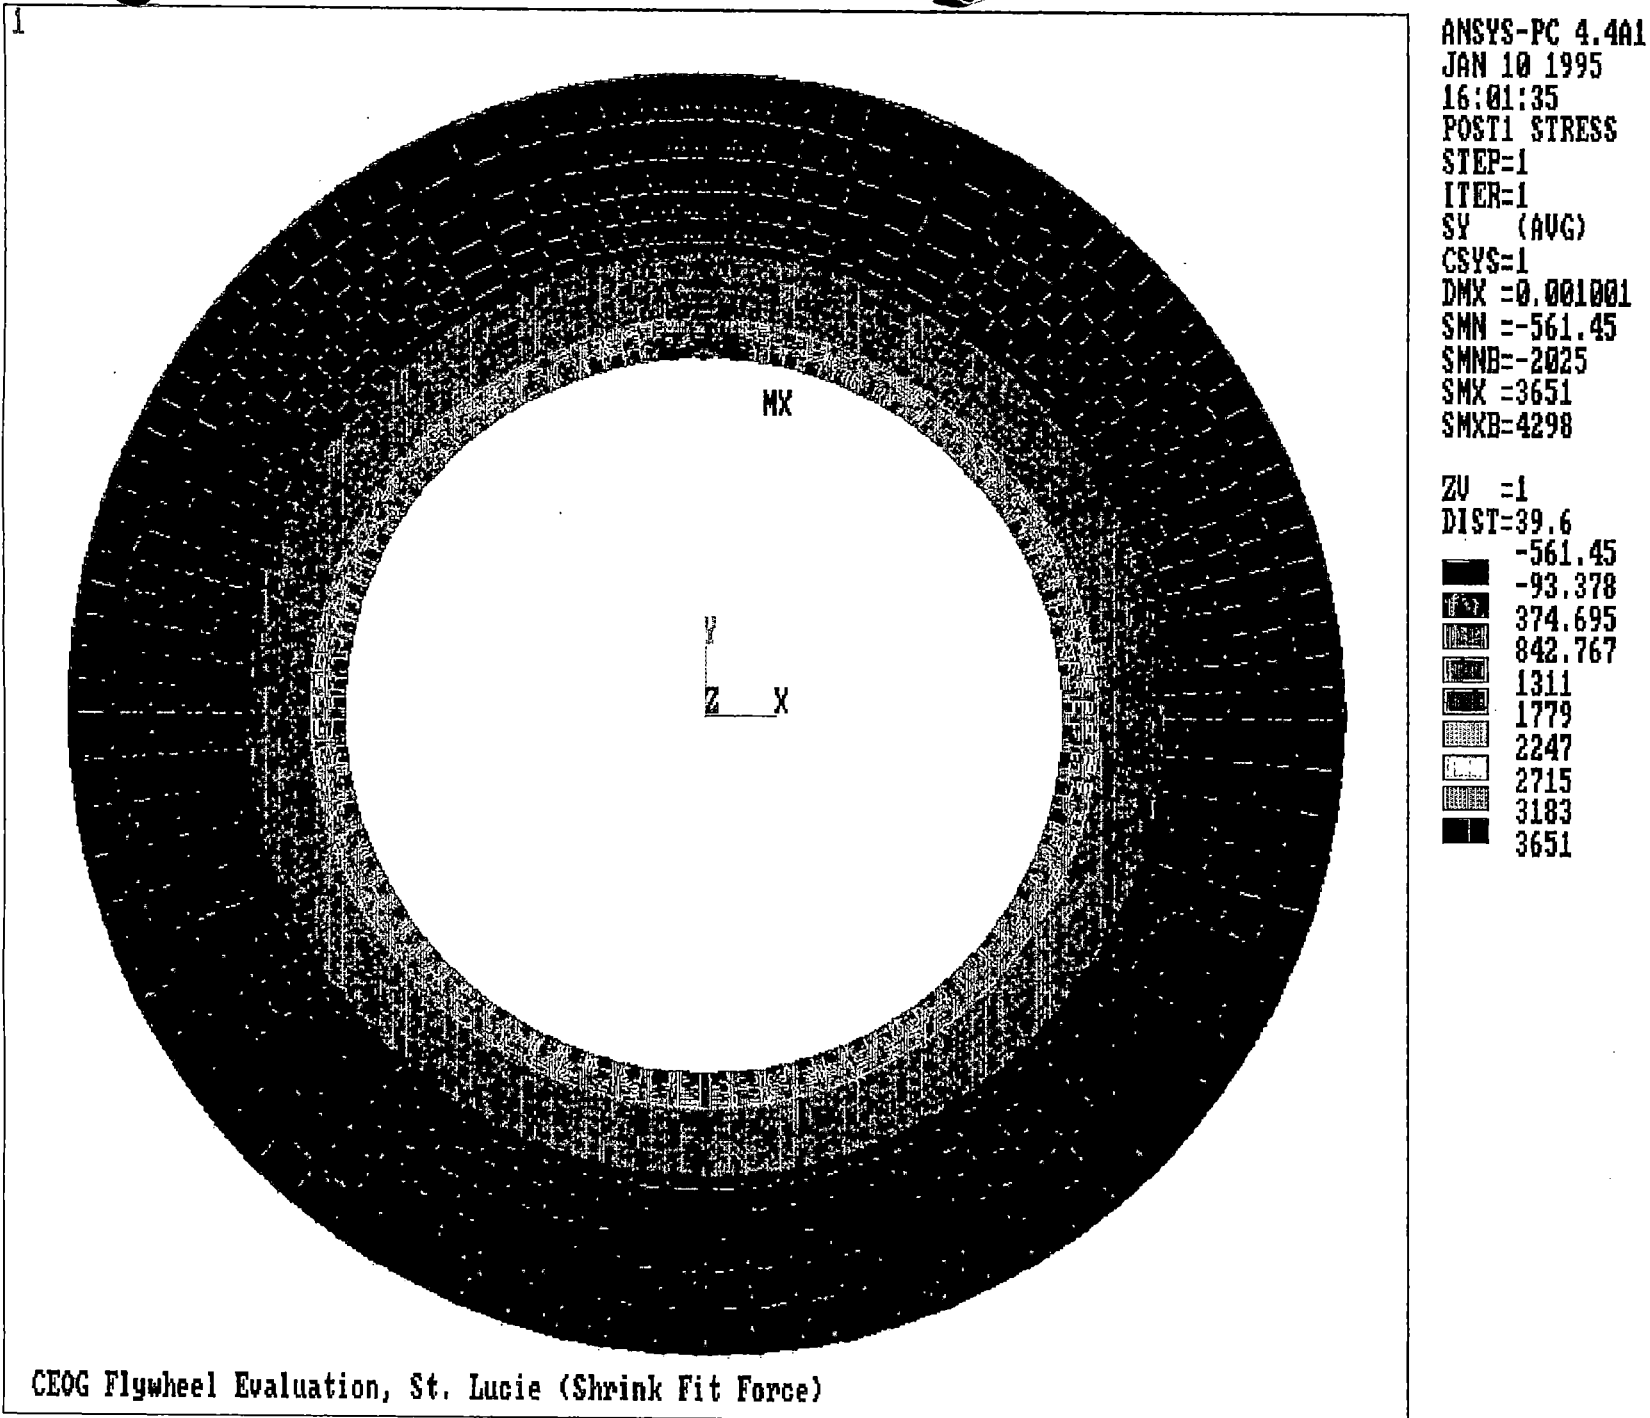
Figure 5-56. Overall Tangential Stress Distribution Due to Shrink-Fit Force (St. Lucie)

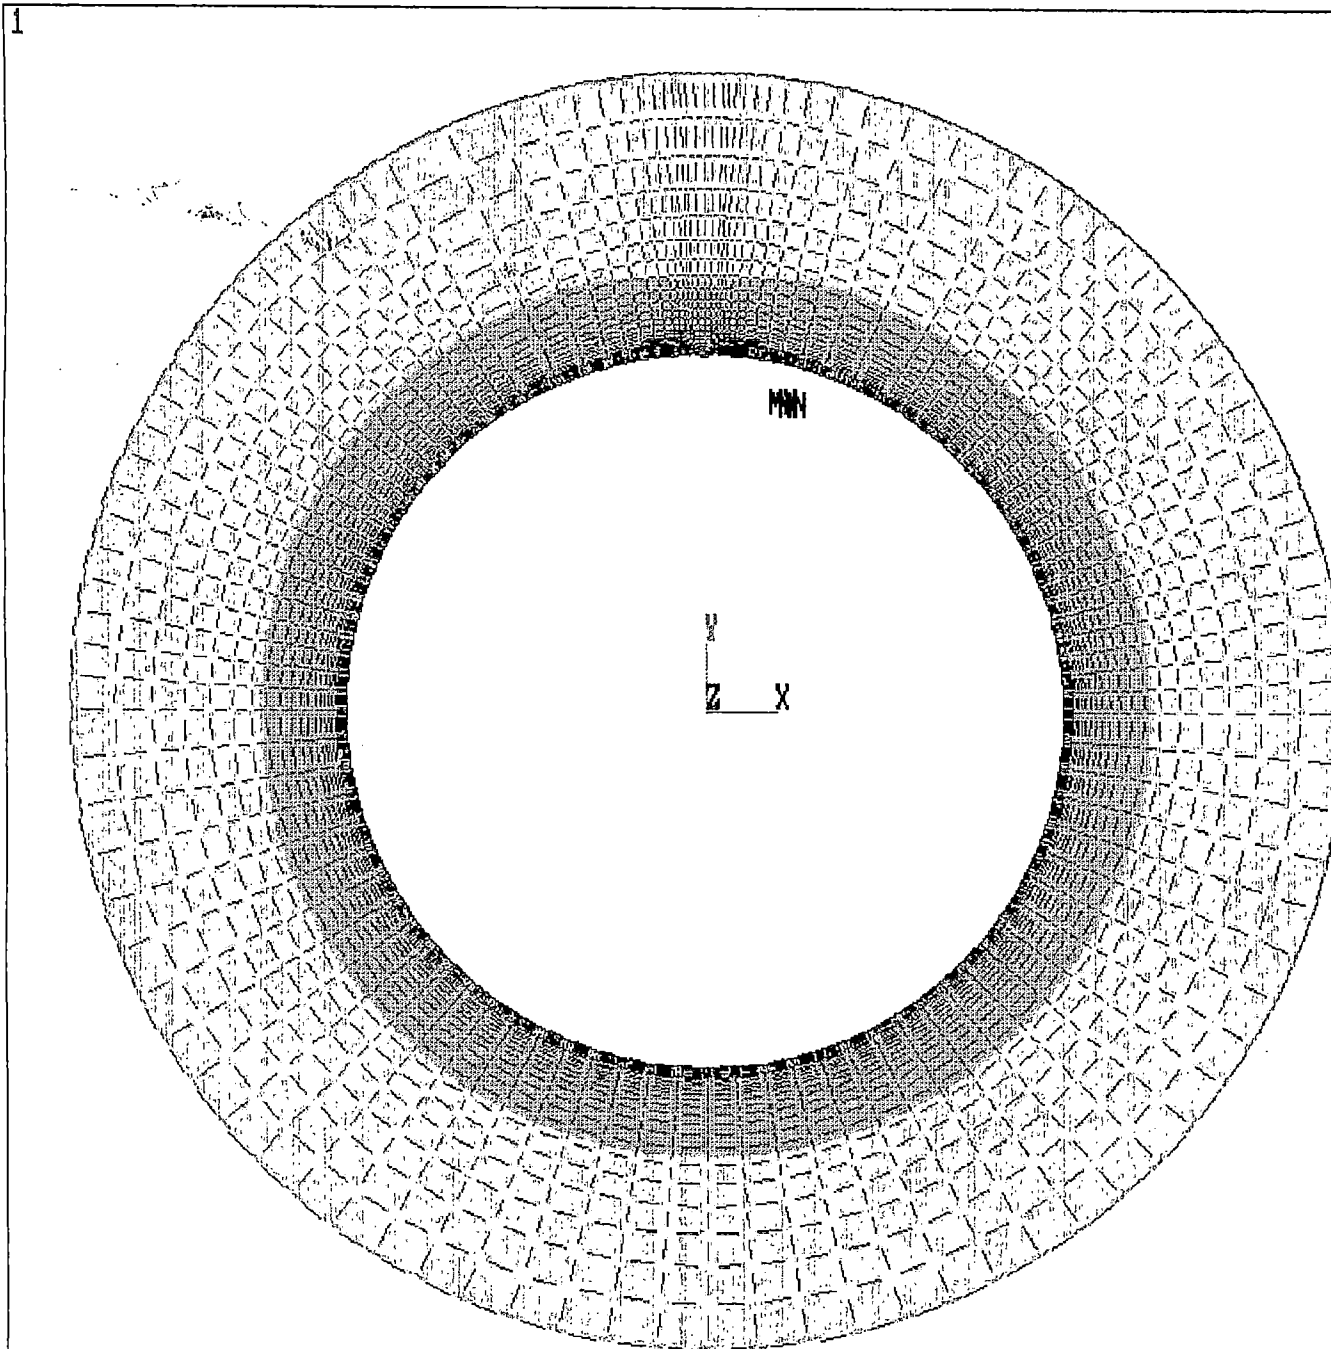
ANSYS-PC 4.4A1
 JAN 10 1995
 15:58:26
 POST1 STRESS
 STEP=1
 ITER=1
 SX (AVG)
 CSYS=1
 DMX =0.001001
 SMN =-6097
 SMNB=-7986
 SMX =358.555
 SMXB=1519

Figure 5-58. Overall Radial Stress Distribution Due to Shrink-Fit Force (St. Lucie)

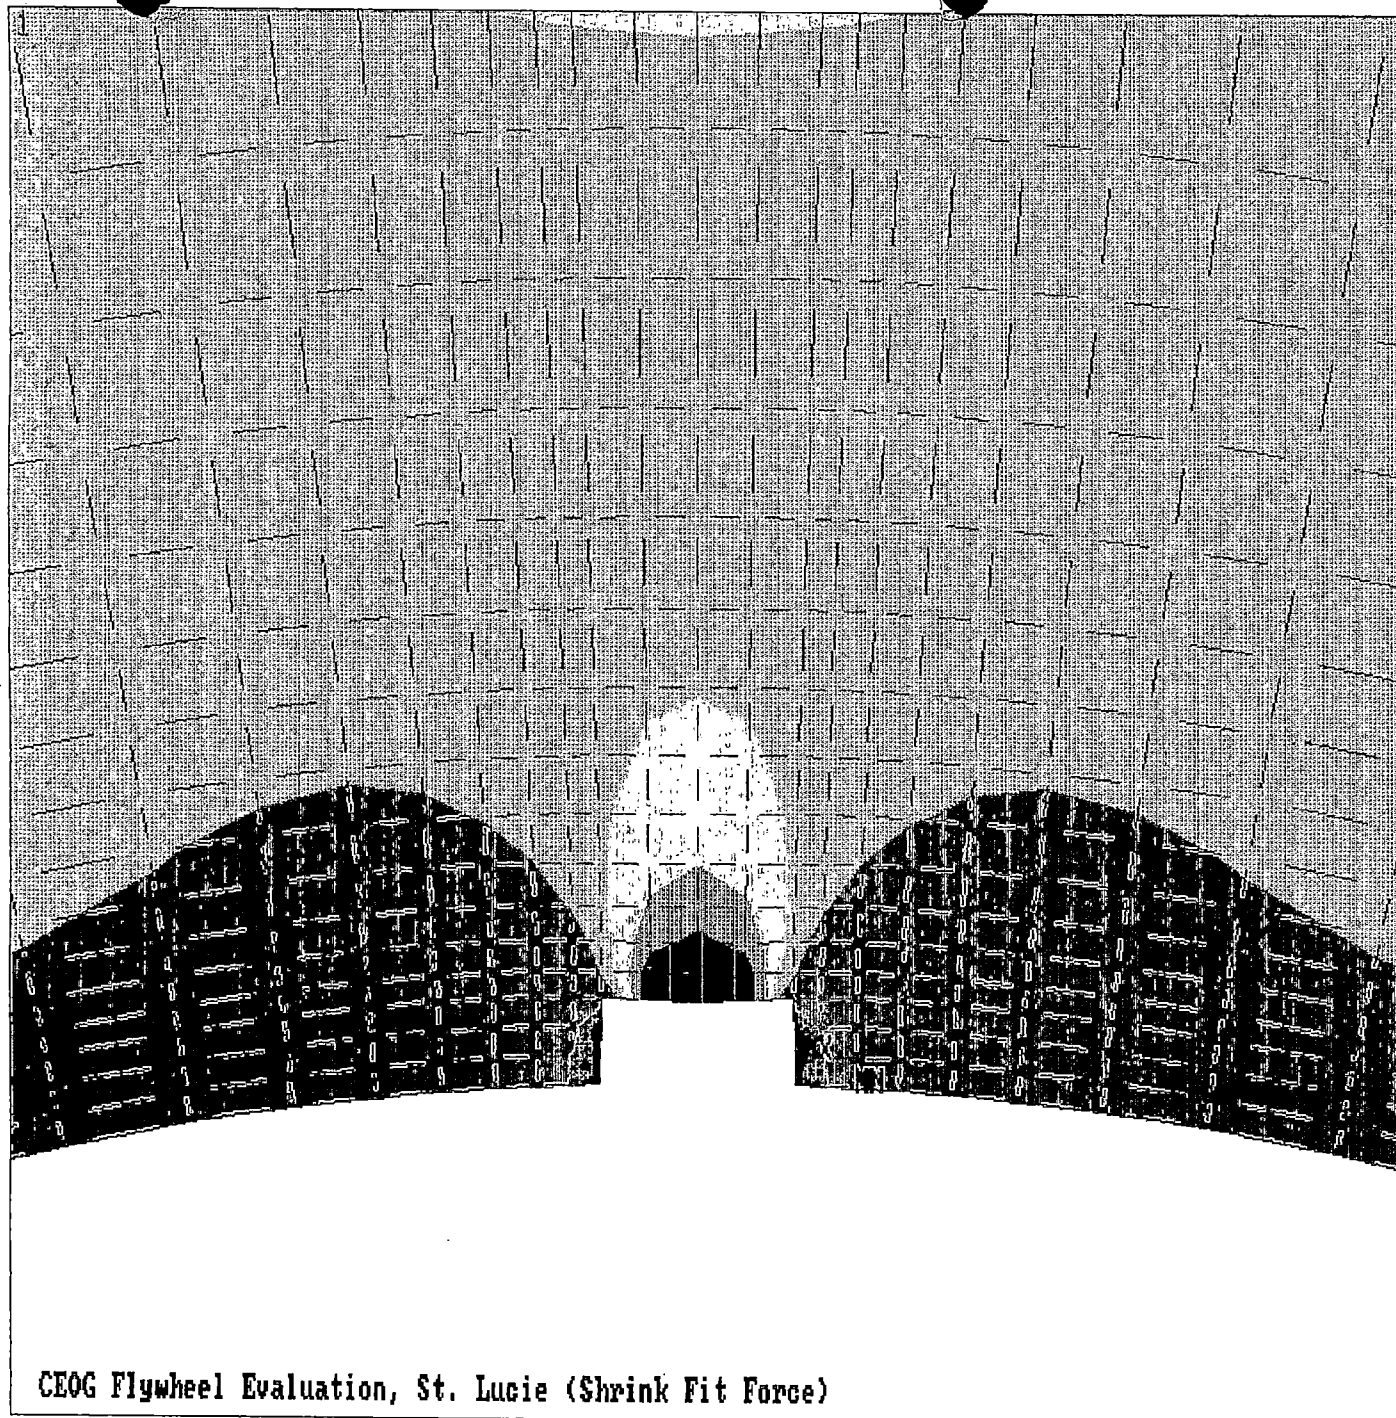
ANSYS-PC 4.4a1
 JAN 10 1995
 16:06:14
 POST1 STRESS
 STEP=1
 ITER=1
 SX (AVG)
 CSYS=1
 DMX =0.001001
 SMN =-6097
 SMNB=-7986
 SMX =358.555
 SMXB=1519

Figure 5-59. Details of Radial Stress Distribution in Keyway Region Due to Shrink-Fit Force (St. Lucie)

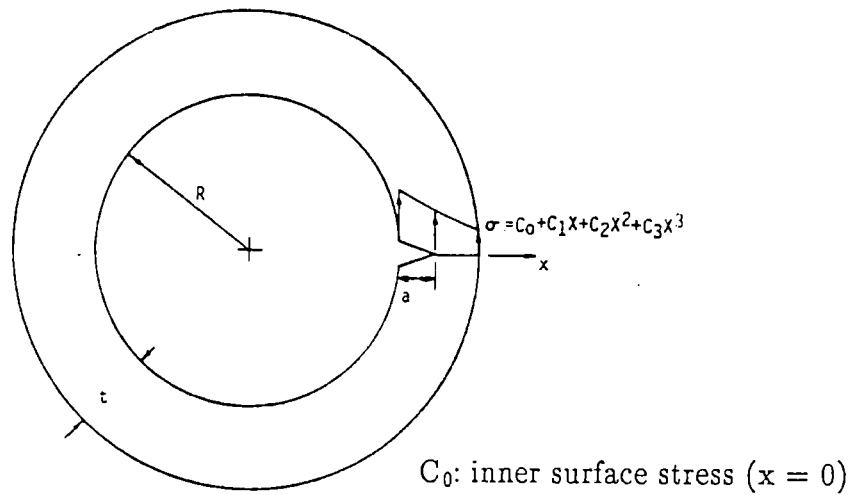
REQUIRED INPUTS:

- t: wall thickness
- a: crack depth ($a_{\max} \leq 0.8t$)

Figure 6-1. LEFM Crack Model H from **pc-CRACK** - Longitudinal Crack in Cylinder ($t/R = 1.2$)

To accurately account for the effect of the keyway, other fracture mechanics models were considered for the evaluation using the stress distributions obtained in Section 5. For the larger bore flywheels of ANO-1, Palisades and St. Lucie 1 & 2, a model consisting of a longitudinal crack in a cylinder, as shown in Figure 6-1, was chosen. This model, though conservative in that it applies to infinitely long cracks, matches the t/R ratio for the

It should be noted from Figures 6-1 and 6-2 that in order to use these models, the stress distribution in the critical keyway region has to be established. Hence, the tangential stress distributions obtained for the critical keyway regions in Figures 5-28 through 5-33 were curve-fit using **pc-CRACK** to describe the stress distribution. In curve-fitting these stress distributions, a radial distance of 2 inches from the keyway was considered in order to obtain an accurate fit, since the allowable flaw size is expected to be limited to this value for all the flywheels. The resulting stress intensity factor distribution versus crack size from the keyway for the flywheels are shown in Figures 6-3 through 6-8.

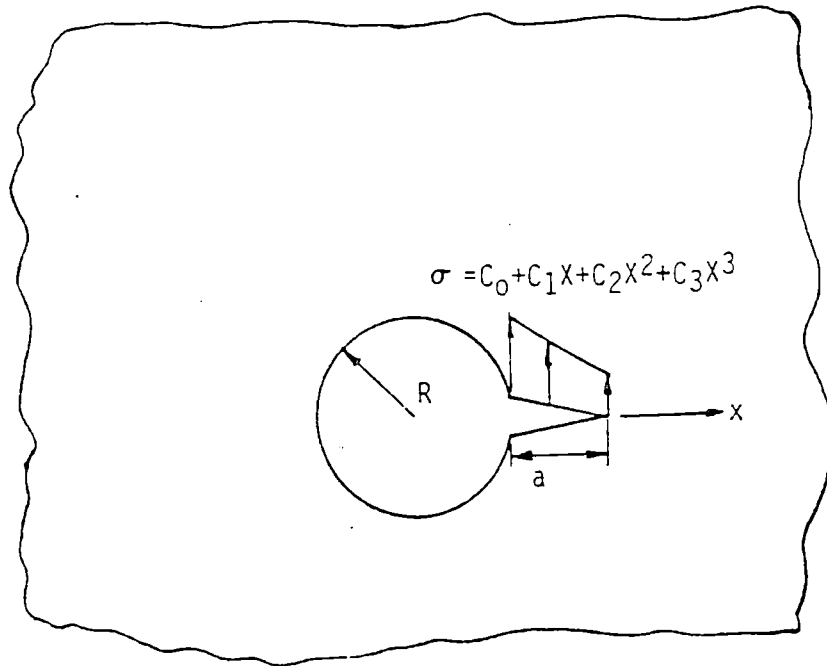
C_0 : surface stress ($x = 0$)

REQUIRED INPUTS:

- R: hole radius
- a: crack depth ($a_{\max} \leq 2.0R$)

Figure 6-2. LEFM Crack Model I from **pc-CRACK** - Crack Emanating from Hole in an Infinite Plate

flywheels, as can be seen from Table 2-1. For the smaller bore flywheels of ANO-2, Millstone-2 and Waterford 3, which have considerably larger t/R ratios, a model consisting of a crack emanating from a hole in an infinite plate, shown in Figure 6-2, was chosen. Both of these models are featured in the **pc-CRACK** [15], computer program library and therefore were readily available for use in the evaluation.

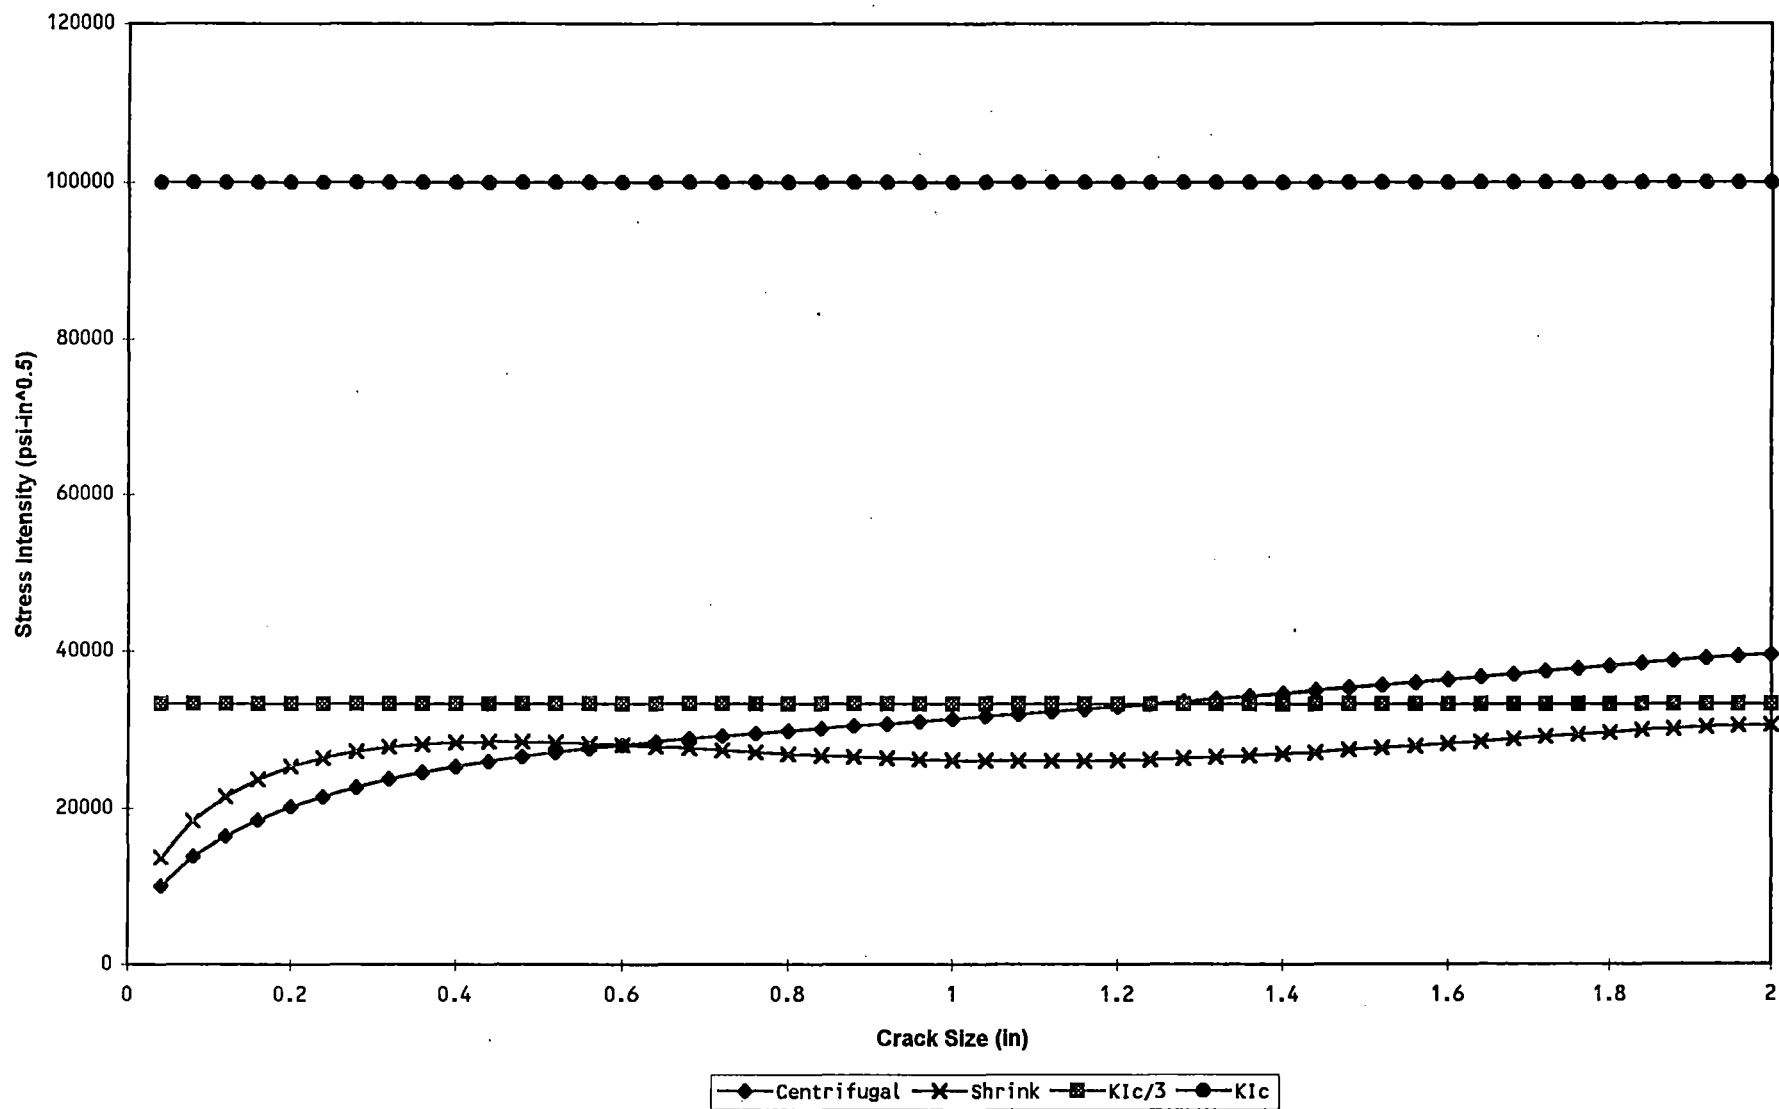
Figure 6-3. Comparison of Applied Stress Intensity Factor Versus Allowable Stress Intensity Factor for Normal Operating Conditions (ANO-1)

The same models used for the determination of stress intensity factors for the centrifugal stresses were used to determine the stress intensity factors for the shrink-fit stresses. Once again, the shrink-fit stresses determined in the previous section were curve-fit using the **pc-CRACK** software over a relatively short distance (about 2 inches) from the bore. Shrink-fit displacements have been determined to be 12.5 mils for the large-bore diameter flywheels, (ANO-1, Palisades, St. Lucie 1 & 2) and 5.2 mils for the small-bore diameters (ANO-2, Millstone, Waterford). Therefore, the stresses have been scaled accordingly. The resulting stress intensity factor distribution versus crack size are shown in Figures 6-3 through 6-8 for all the flywheels.

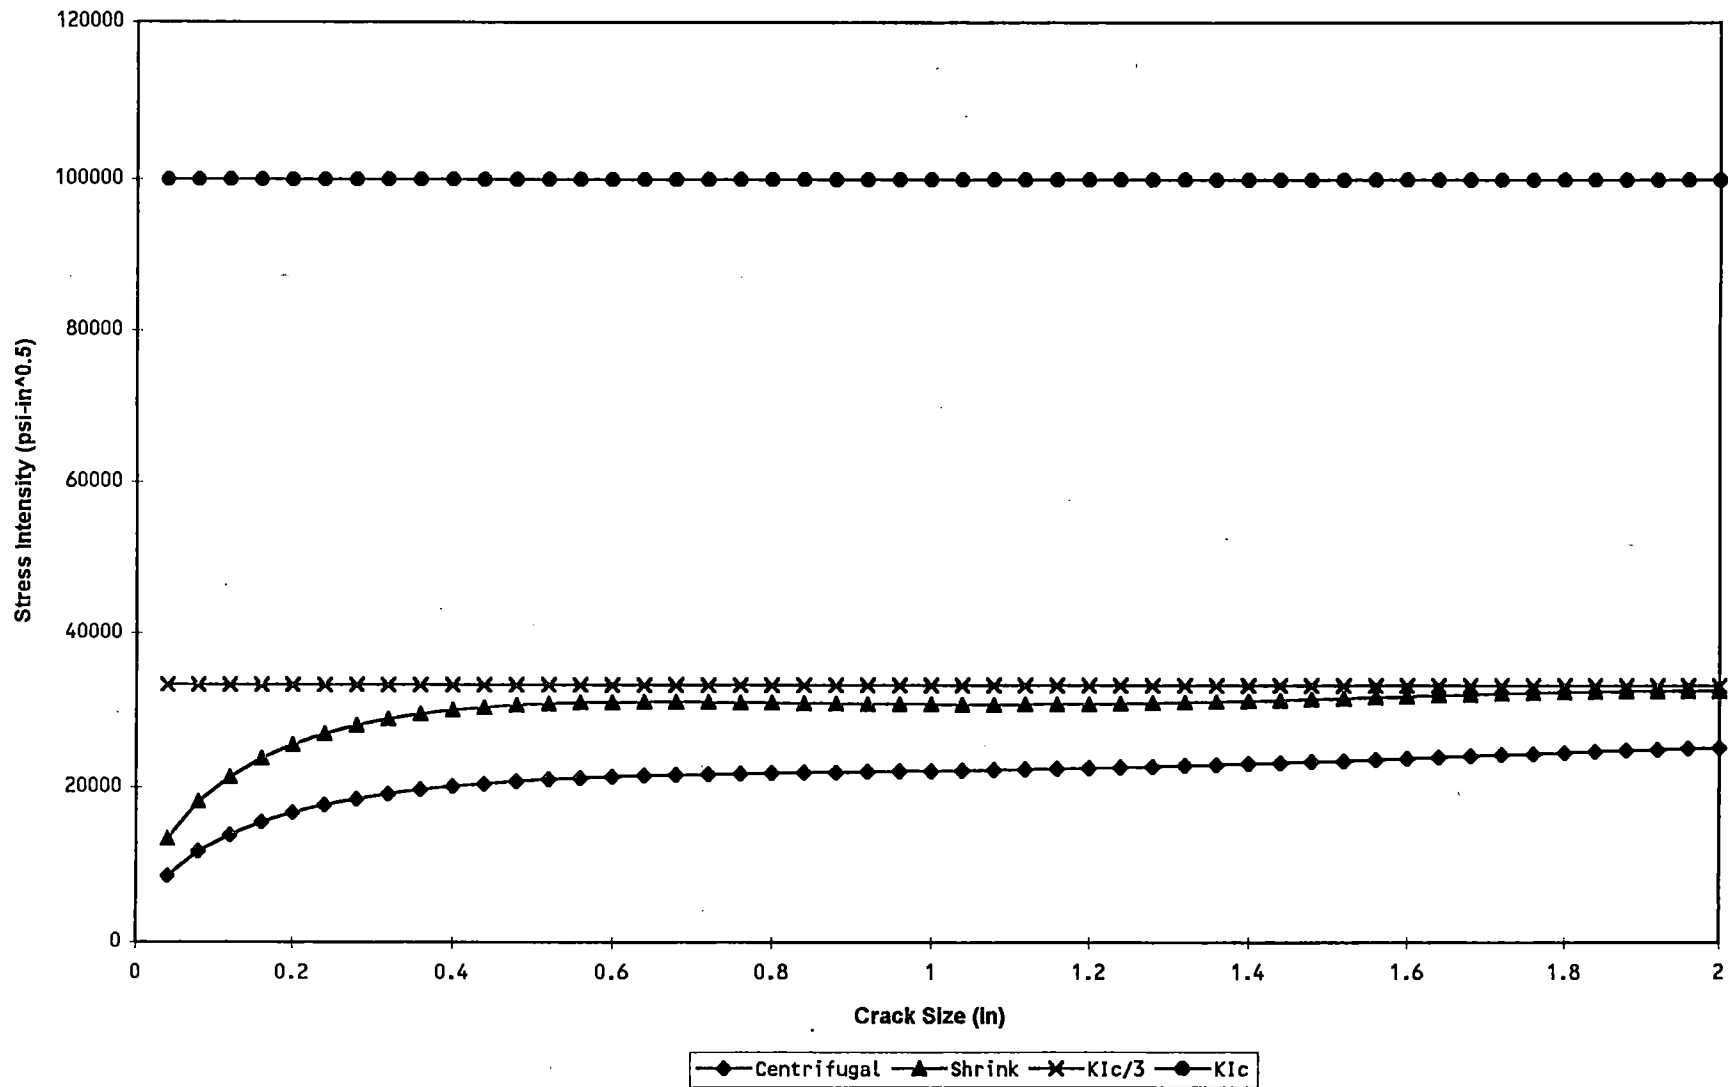
Figure 6-4. Comparison of Applied Stress Intensity Factor Versus Allowable Stress Intensity Factor for Normal Operating Conditions (ANO-2)

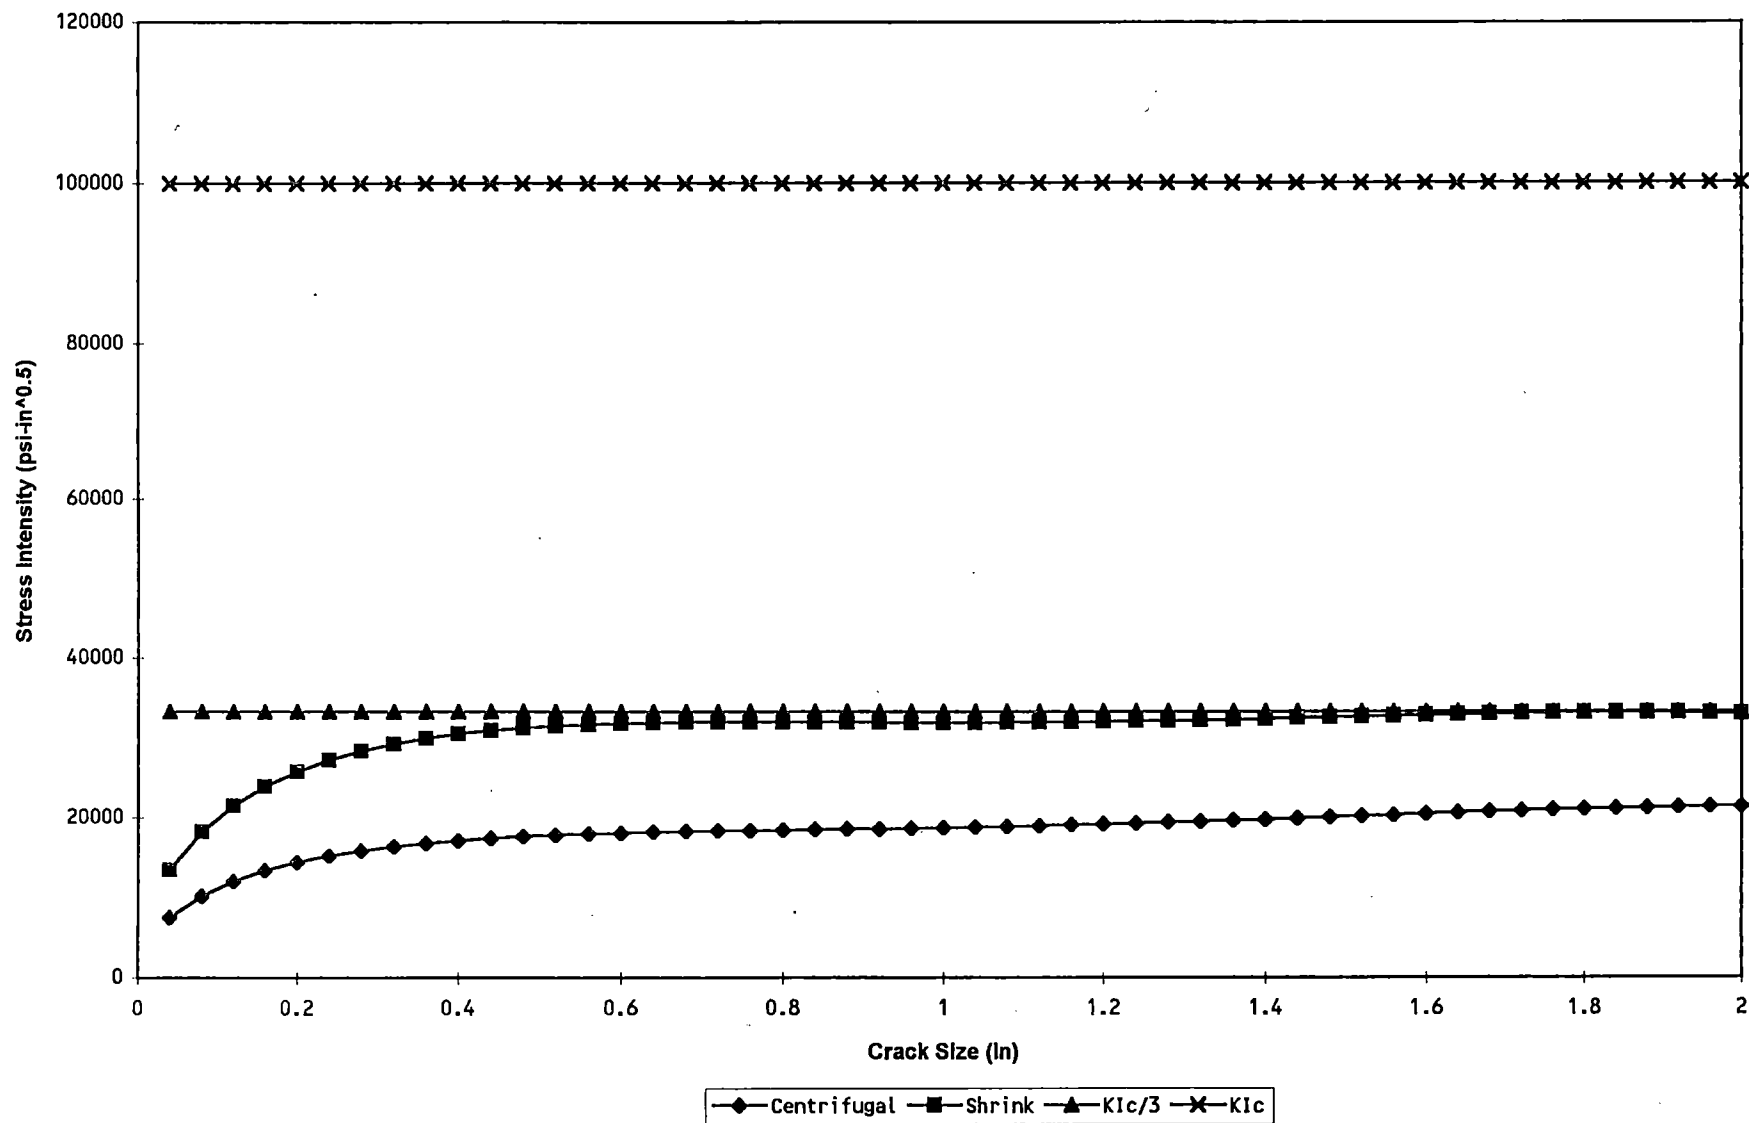
Figure 6-5. Comparison of Applied Stress Intensity Factor Versus Allowable Stress Intensity Factor for Normal Operating Conditions (Millstone-2)
