Report No.: SIR-94-080
Revision No.: 1
Project No.: CEOG-01Q
File No.: CEOG-01Q-401
March 1995

**Relaxation of Reactor Coolant Pump
Flywheel Inspection Requirements**

Structural Integrity Associates, Inc.

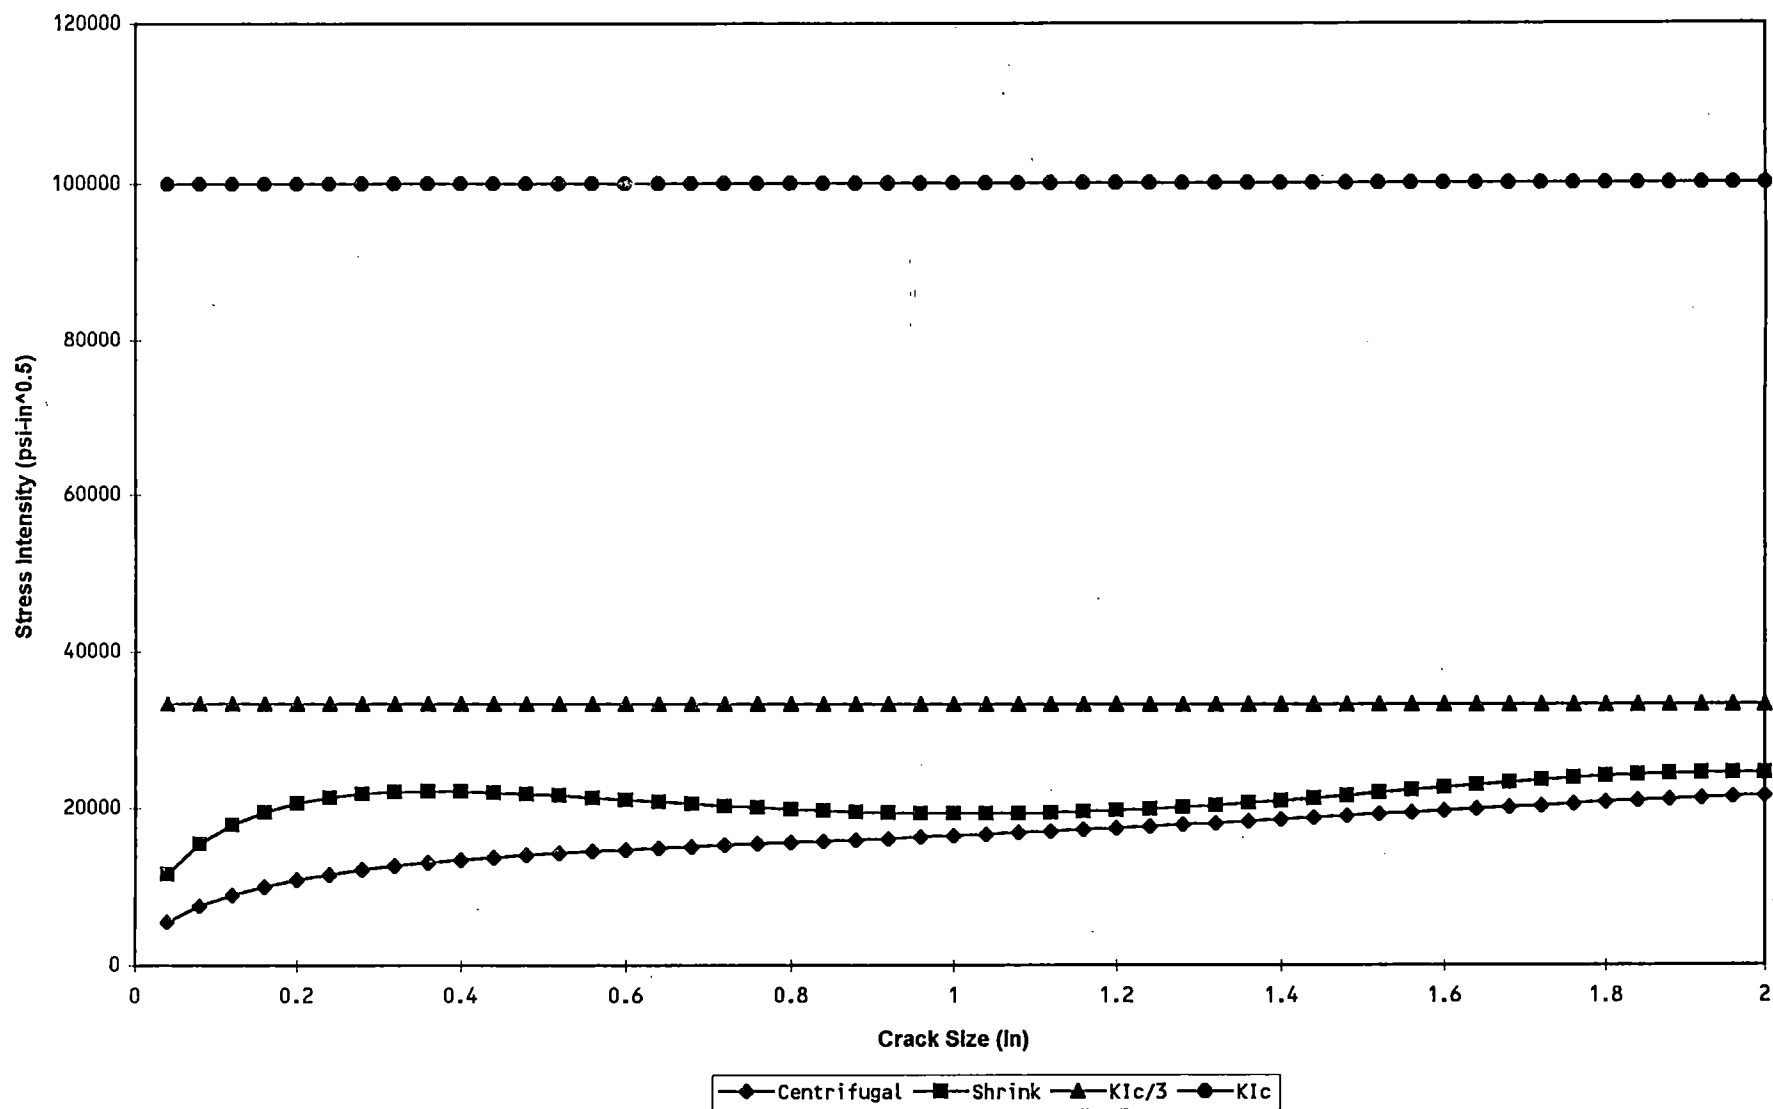
Figure 6-6. Comparison of Applied Stress Intensity Factor Versus Allowable Stress Intensity Factor for Normal Operating Conditions (Palisades)

It should be noted from Figures 6-1 and 6-2 that in order to use these models, the stress distribution in the critical keyway region has to be established. Hence, the tangential stress distributions obtained for the critical keyway regions in Figures 5-28 through 5-33 were curve-fit using **pc-CRACK** to describe the stress distribution. In curve-fitting these stress distributions, a radial distance of 2 inches from the keyway was considered in order to obtain an accurate fit, since the allowable flaw size is expected to be limited to this value for all the flywheels. The resulting stress intensity factor distribution versus crack size from the keyway for the flywheels are shown in Figures 6-3 through 6-8.

The same models used for the determination of stress intensity factors for the centrifugal stresses were used to determine the stress intensity factors for the shrink-fit stresses. Once again, the shrink-fit stresses determined in the previous section were curve-fit using the **pc-CRACK** software over a relatively short distance (about 2 inches) from the bore. Shrink-fit displacements have been determined to be 12.5 mils for the large-bore diameter flywheels, (ANO-1, Palisades, St. Lucie 1 & 2) and 5.2 mils for the small-bore diameters (ANO-2, Millstone, Waterford). Therefore, the stresses have been scaled accordingly. The resulting stress intensity factor distribution versus crack size are shown in Figures 6-3 through 6-8 for all the flywheels.

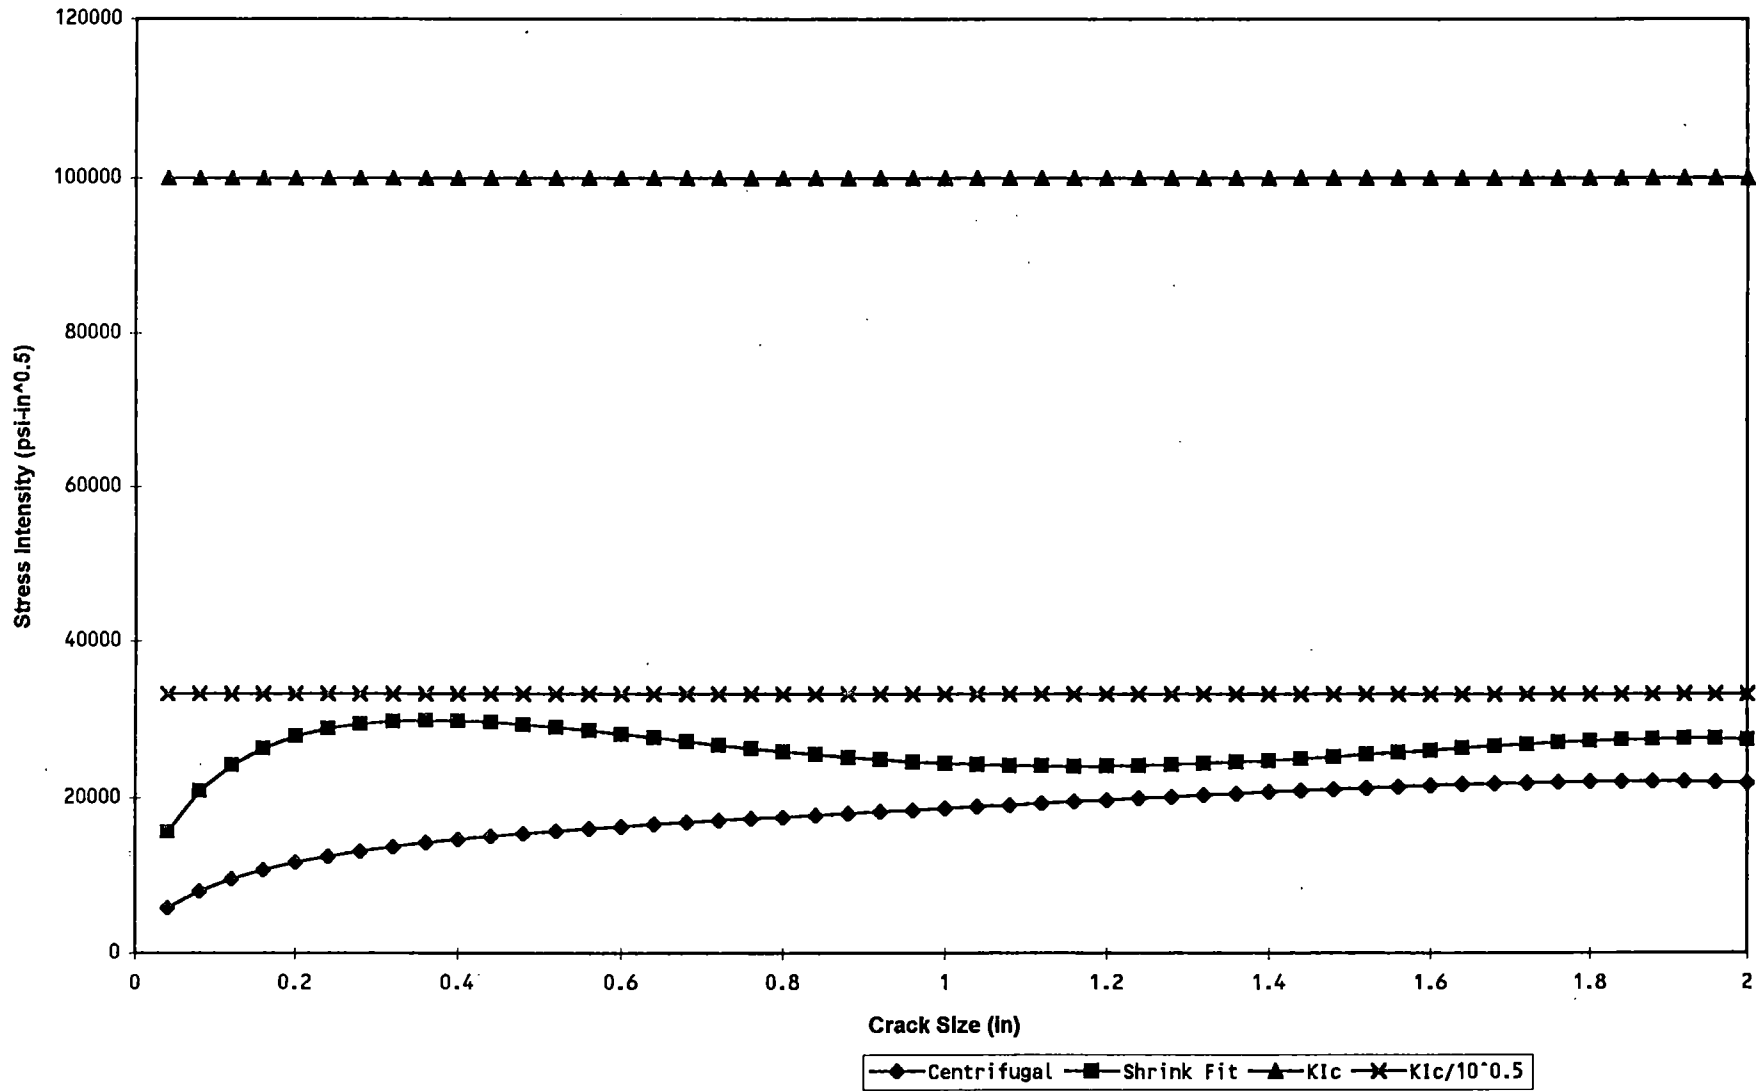
Figure 6-7. Comparison of Applied Stress Intensity Factor Versus Allowable Stress Intensity Factor for Normal Operating Conditions (St. Lucie Units 1 and 2)

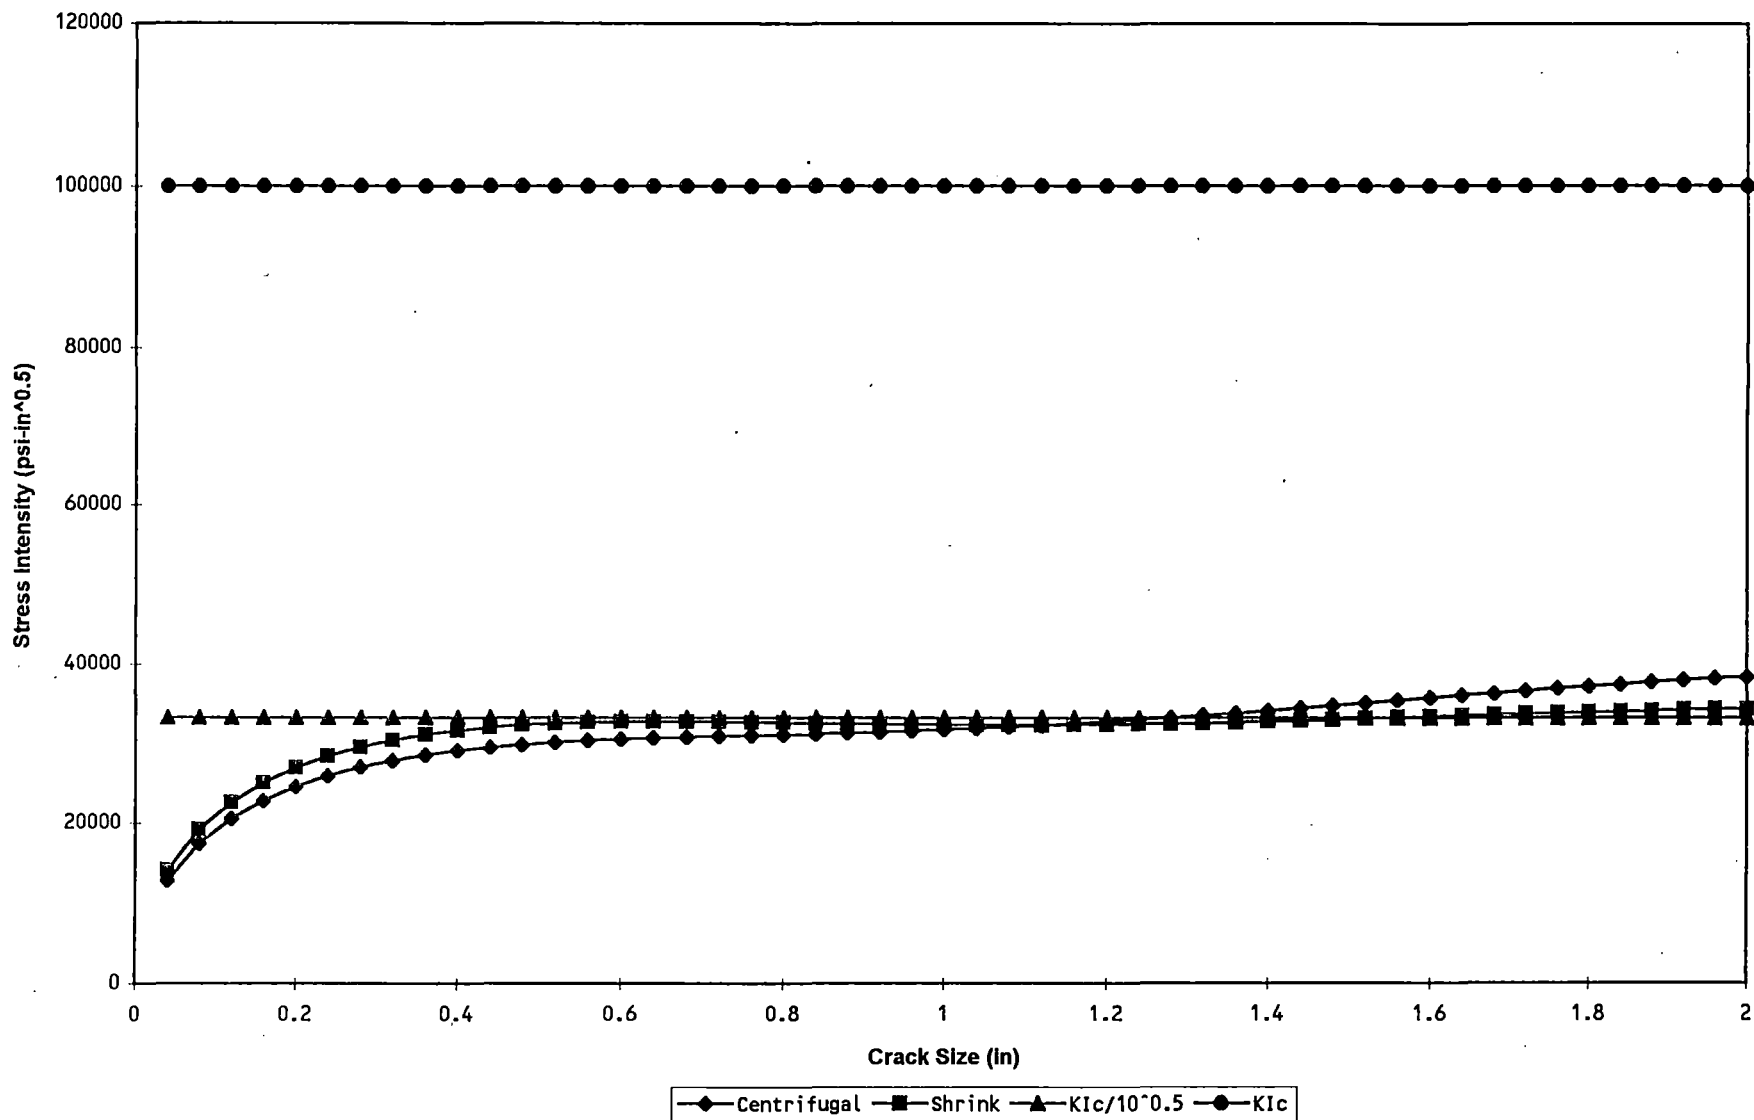
Figure 6-8. Comparison of Applied Stress Intensity Factor Versus Allowable Stress Intensity Factor for Normal Operating Conditions (Waterford-3)

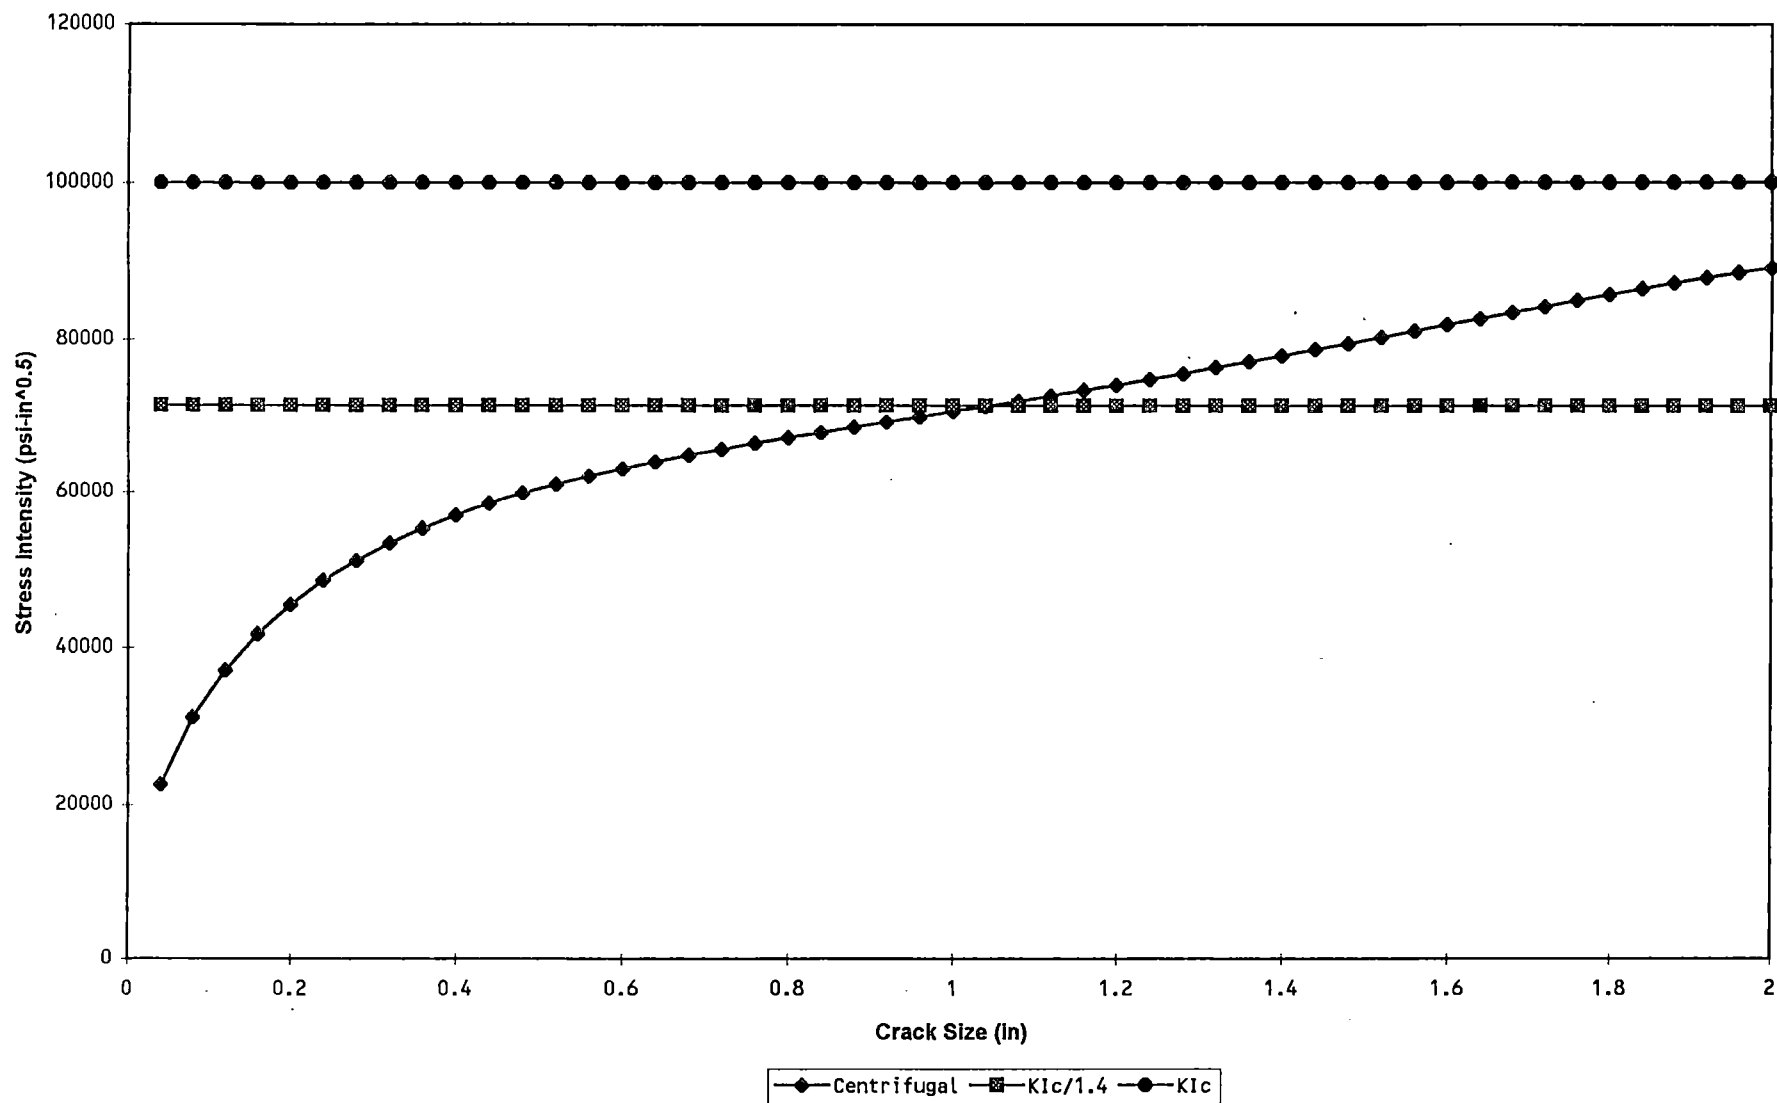
Figure 6-9. Comparison for Applied Stress Intensity Factor Versus Allowable Stress Intensity Factor for Accident Conditions (ANO-1)

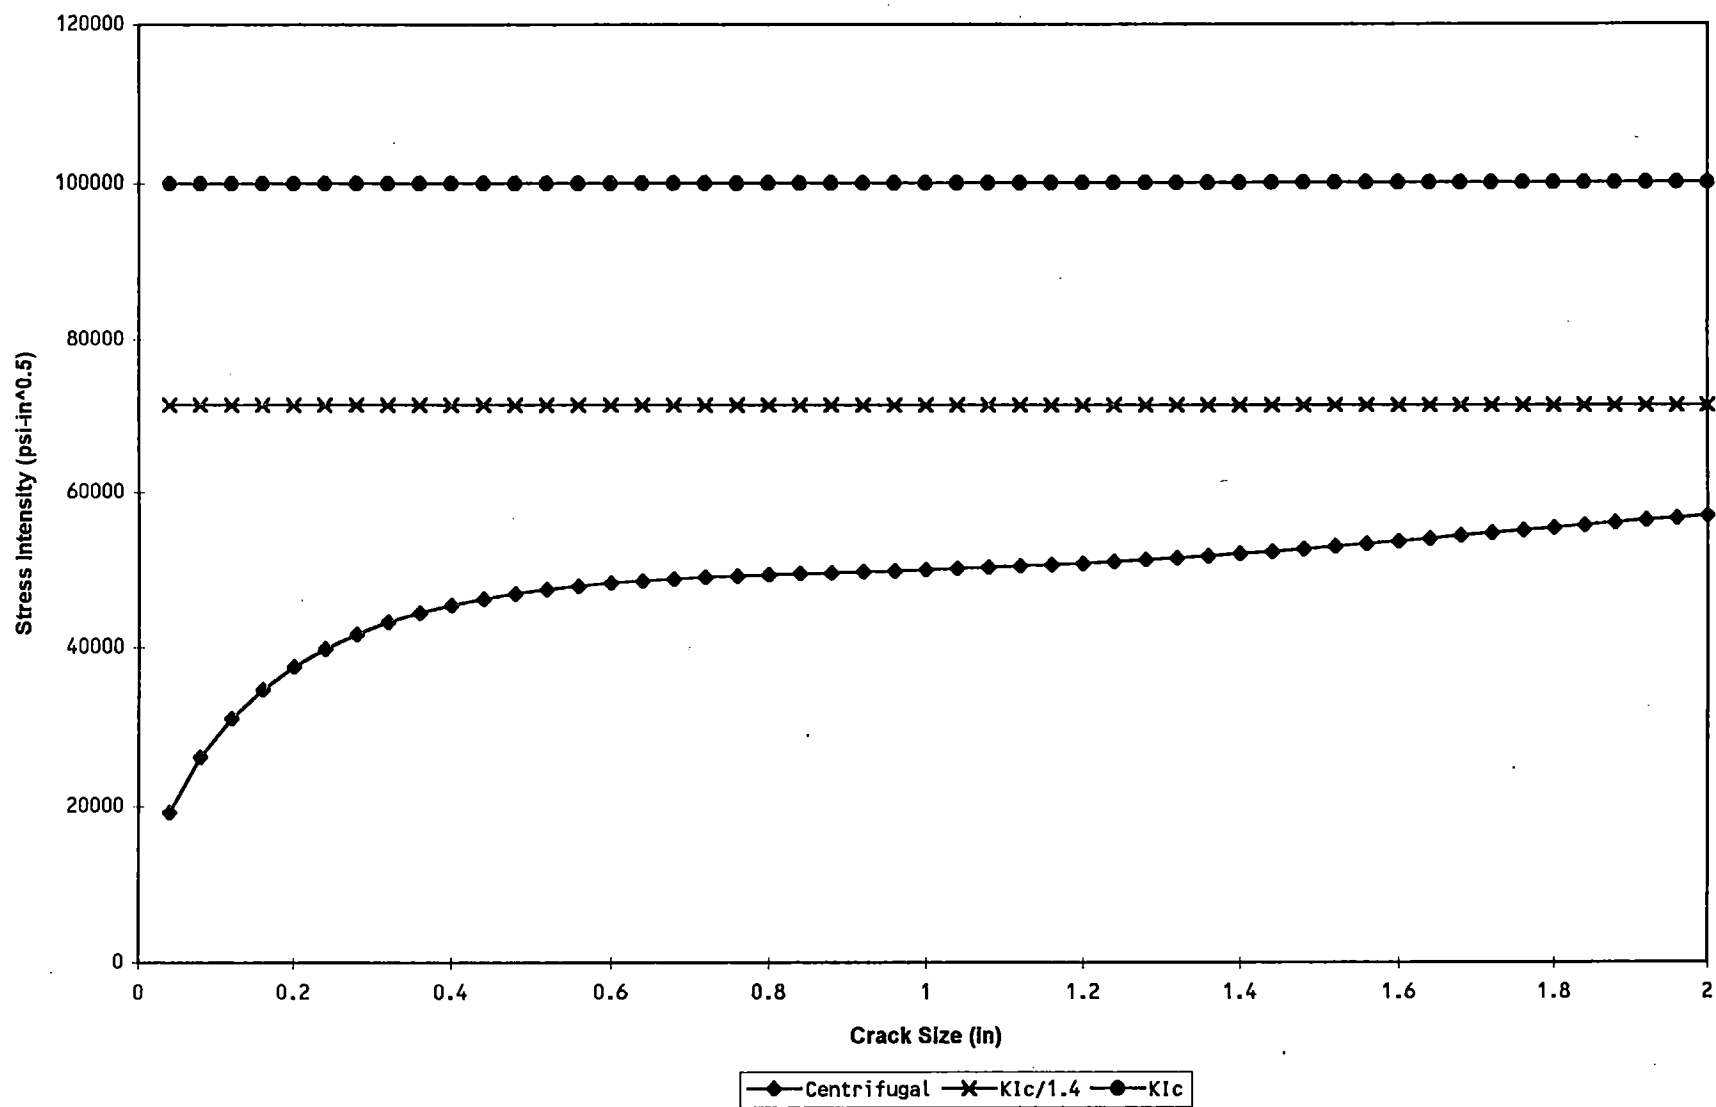
Figure 6-10. Comparison for Applied Stress Intensity Factor Versus Allowable Stress Intensity Factor for Accident Conditions (ANO-2)

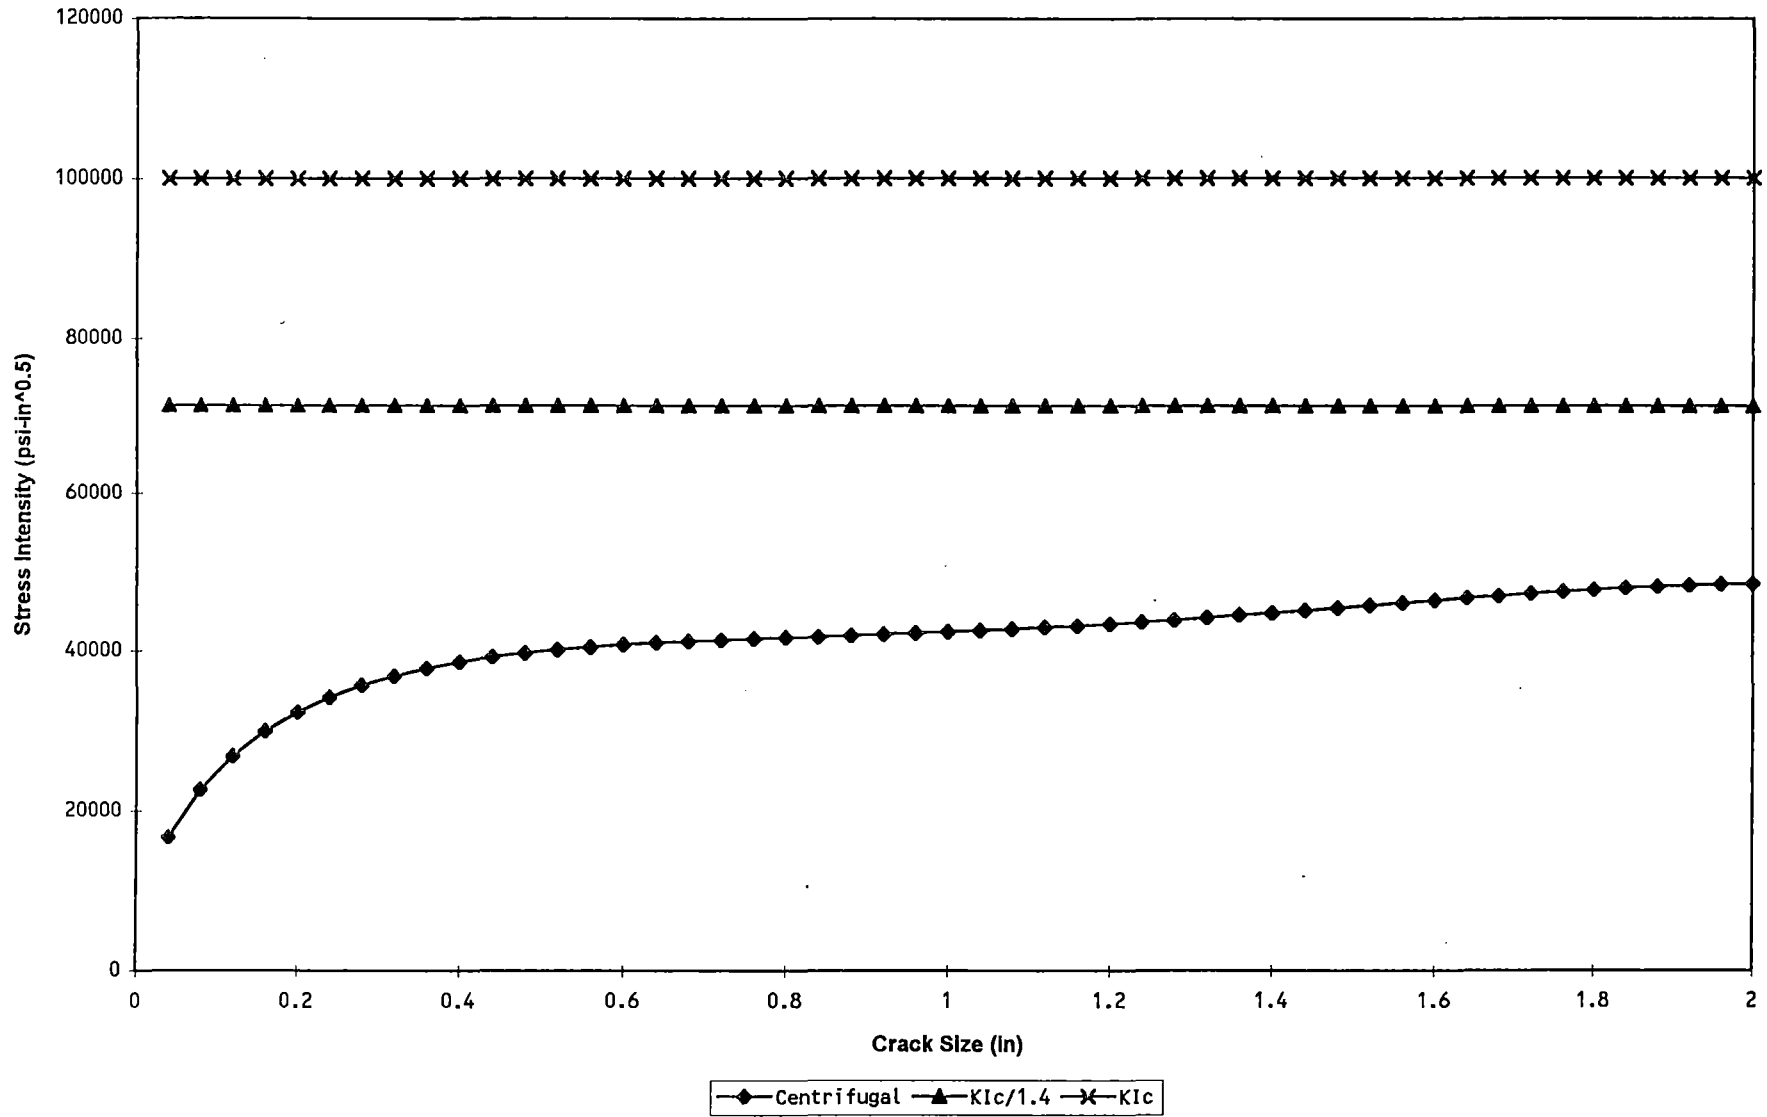
Figure 6-11. Comparison for Applied Stress Intensity Factor Versus Allowable Stress Intensity Factor for Accident Conditions (Millstone-2)

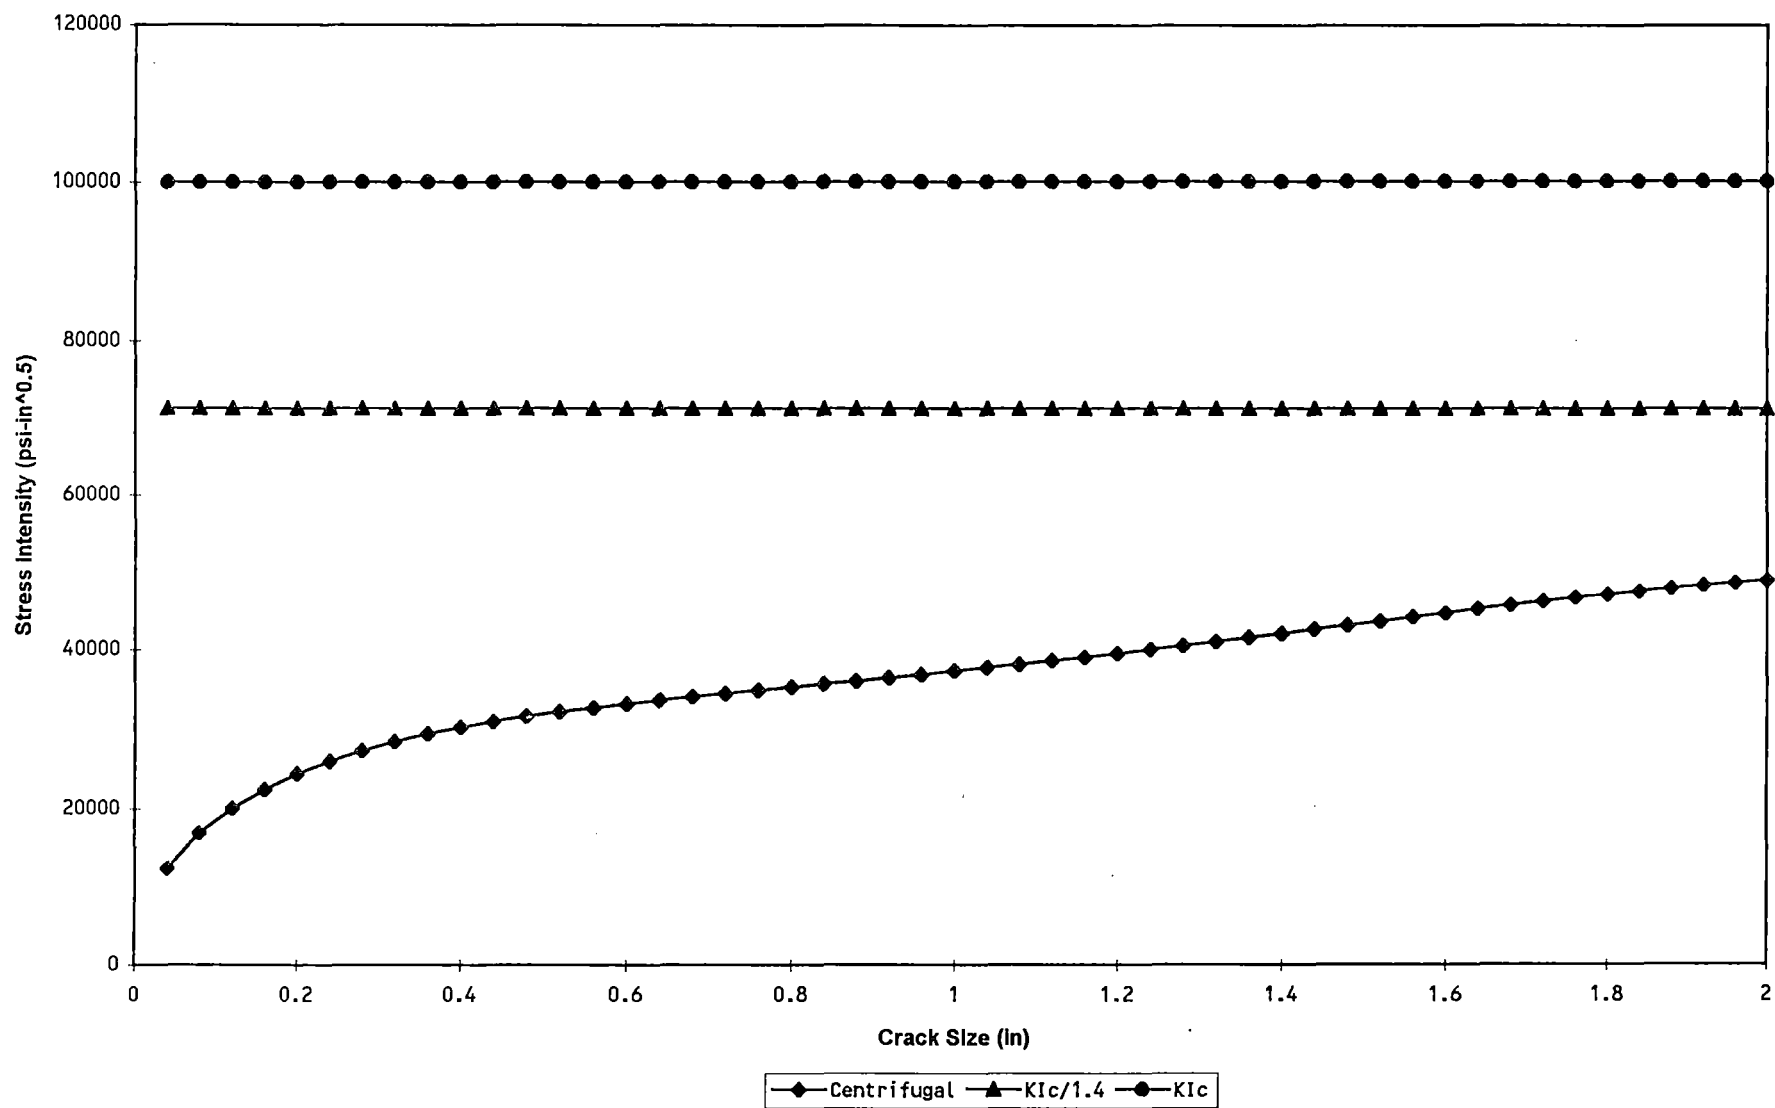
Figure 6-12. Comparison for Applied Stress Intensity Factor Versus Allowable Stress Intensity Factor for Accident Conditions (Palisades)

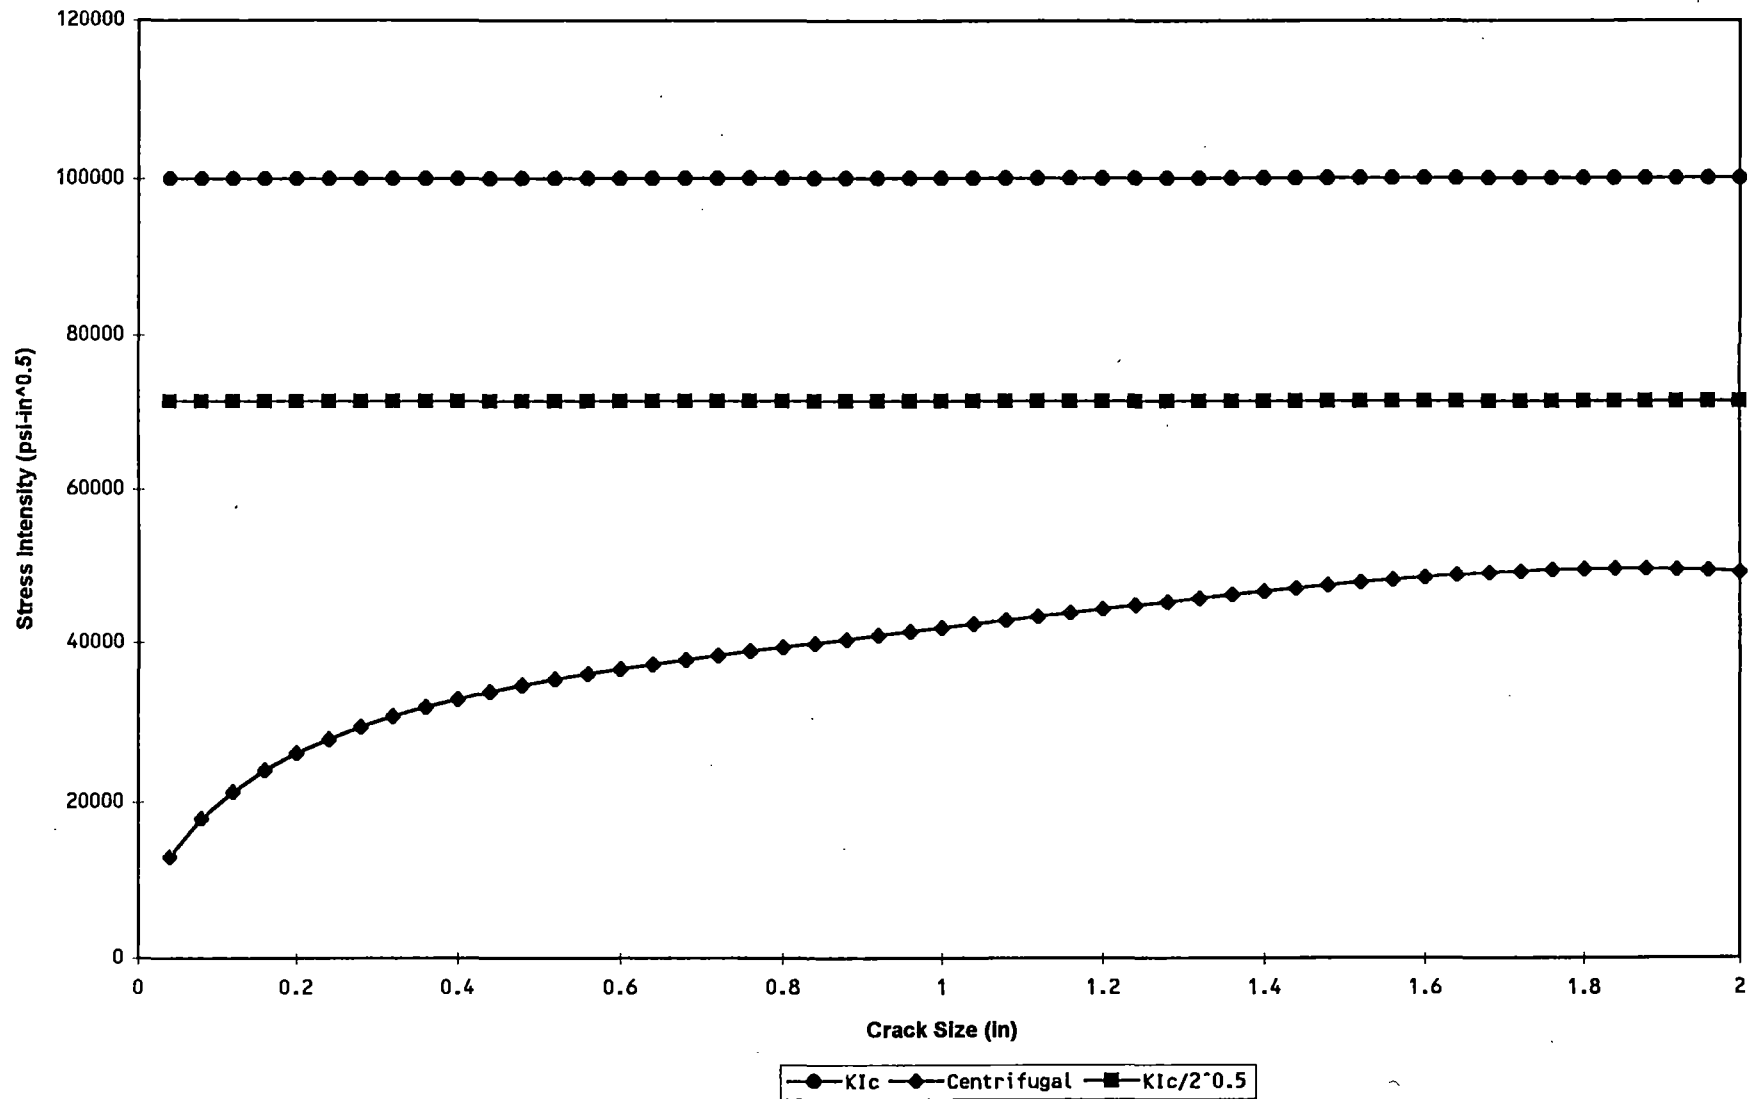
Figure 6-13. Comparison for Applied Stress Intensity Factor Versus Allowable Stress Intensity Factor for Accident Conditions (St. Lucie Units 1 and 2)

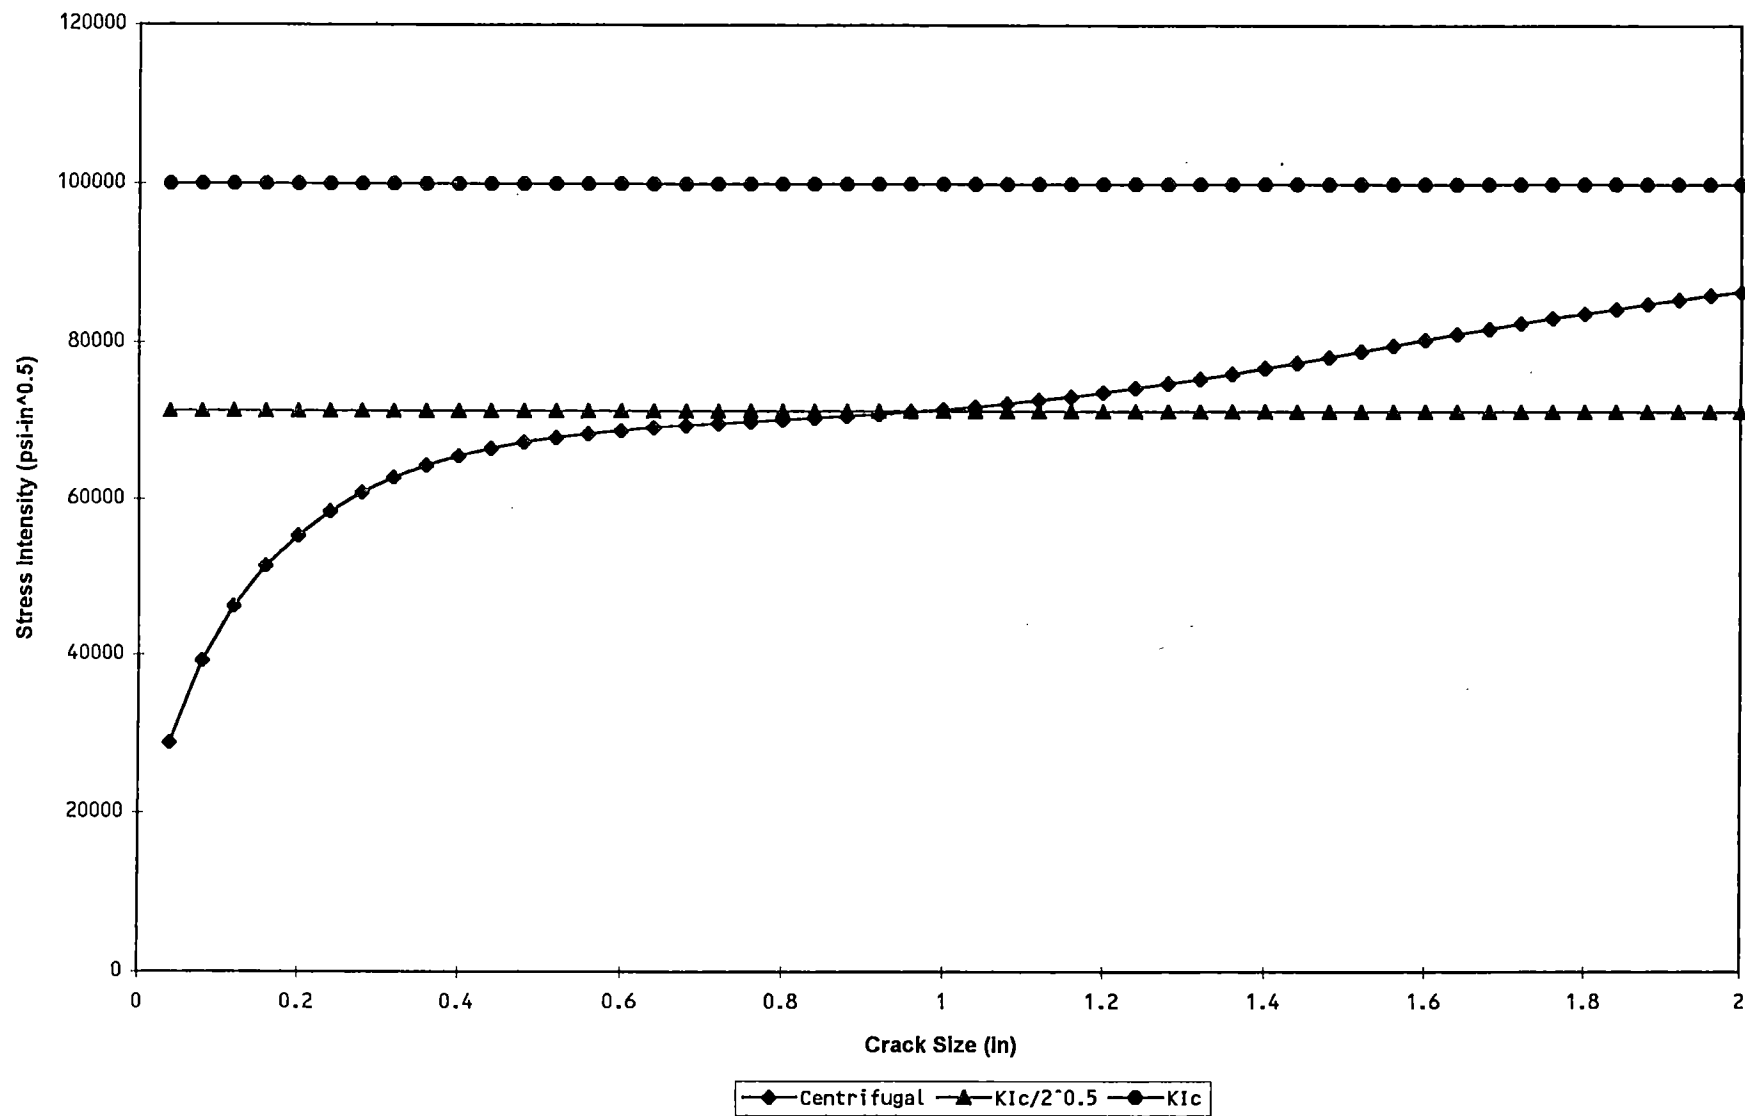
Figure 6-14. Comparison for Applied Stress Intensity Factor Versus Allowable Stress Intensity Factor for Accident Conditions (Waterford-3)
