SUBJECT: **Submission of IP2 Steam Generator Examination Program Results for the 2018 (2R23) Refueling Outage in Accordance with Technical Specification 5.6.7**  
Indian Point Unit No. 2  
Docket No. 50-247  
License No. DPR-26

The scope of the inspection included all four steam generators, which are Westinghouse Model 44F with thermally treated Alloy 600 tubes. At the time of the inspection, the steam generators had accumulated approximately 170 effective full power months (EFPM) of operation since the first in-service inspection performed in 2002. Based upon the inspection results, all four steam generators were found to be in compliance with Condition Monitoring requirements.

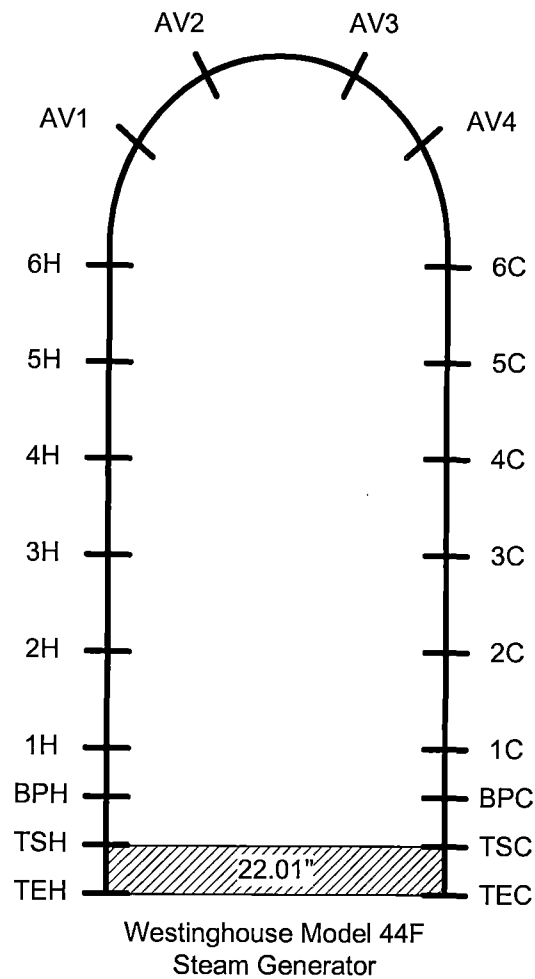
**Indian Point 2  
Steam Generator  
Location Landmarks**

AV = Anti-Vibration Bar (AVB)  
C = cold leg  
H = hot leg  
# = support plate (TSP)  
BP = baffle plate (FDB)  
TS = tubesheet  
TE = tube end
