INFORMATION SUBMITTED IN ADDITION TO THAT  
PROVIDED IN CONSUMERS POWER COMPANY SUBMITTALS  
OF MARCH 26, 1976 AND APRIL 5, 1976

# CV-3027, CV-3056 PROPOSED MODIFICATION

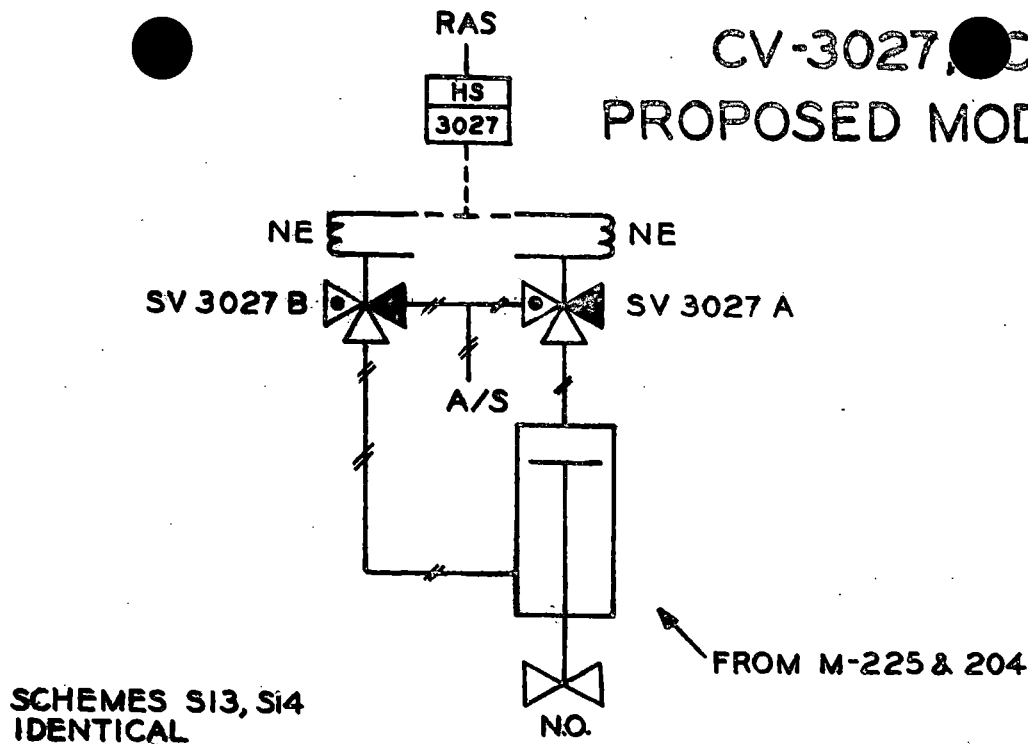
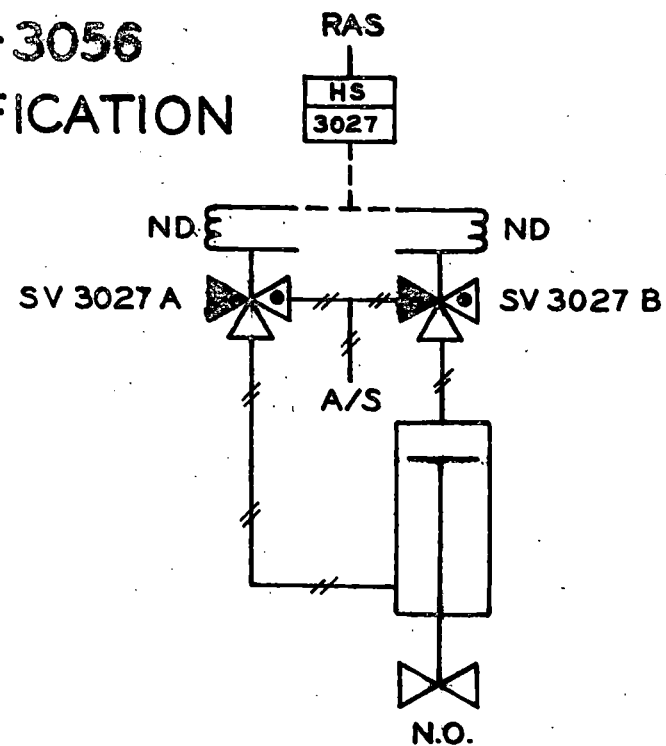
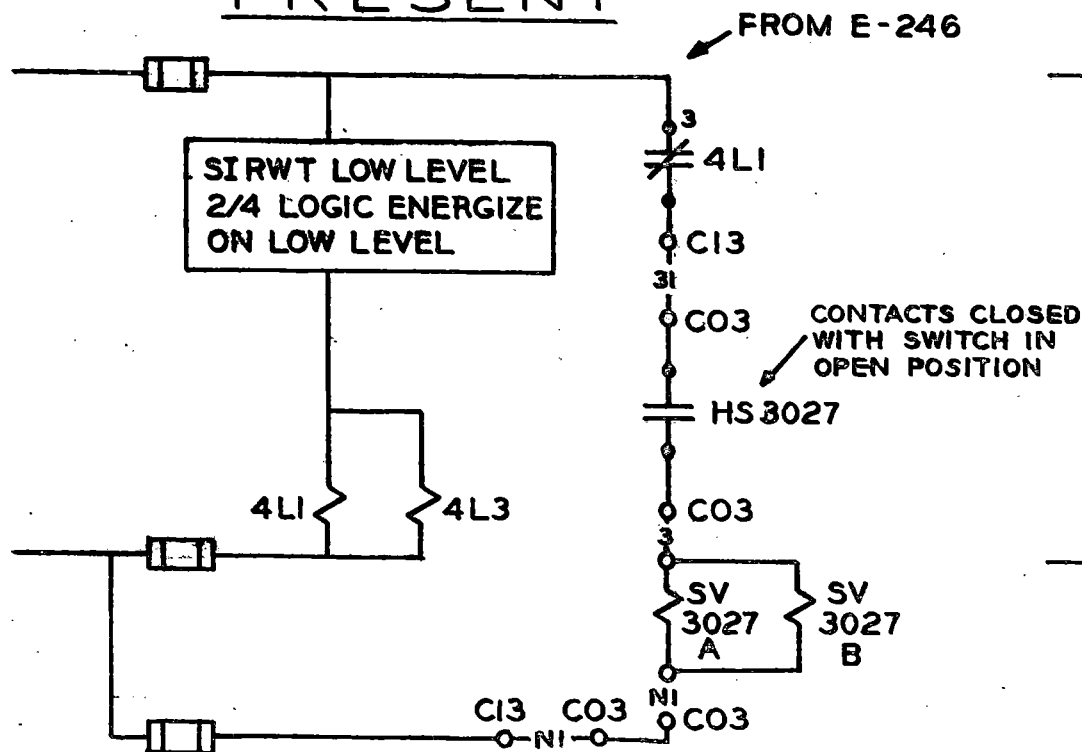
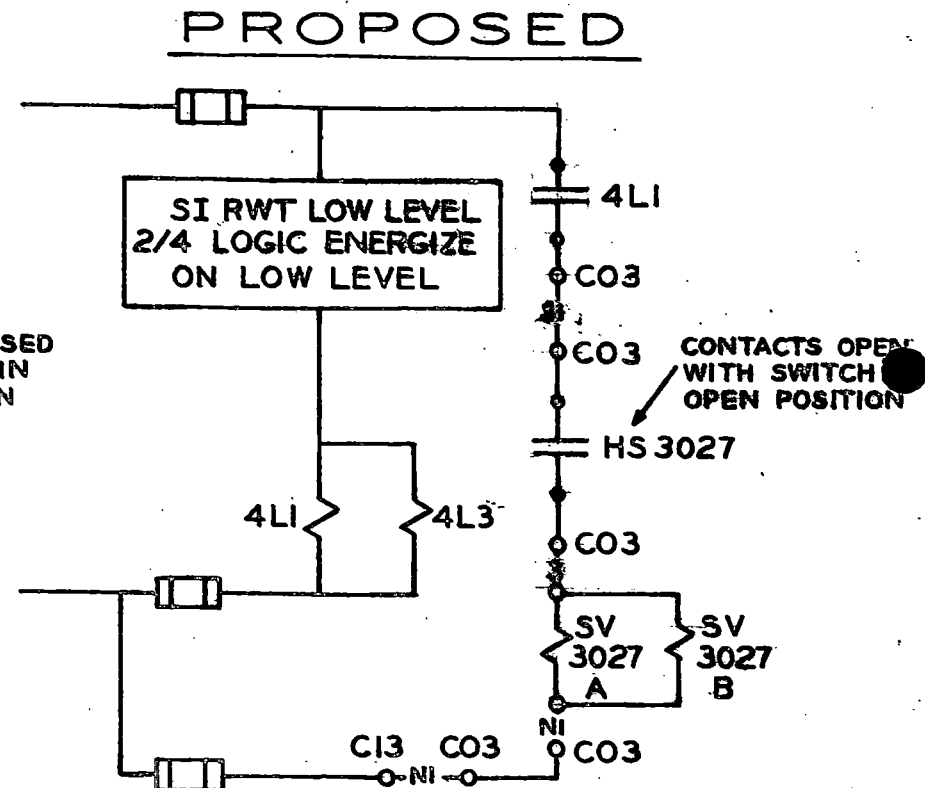
A stick diagram of the valve operator and solenoid valve arrangement is shown on the following figure. This stick diagram provides a good representation of how the valve is actuated. On the same diagram the existing electrical scheme is also shown. As can be seen from that scheme, a single electrical failure (closing of the contacts of HS-3027 or HS-3056) would cause the appropriate valve to go closed as well as any failure which causes the de-energization of both solenoids of each valve.

The same figure shows a stick diagram of the proposed modification to the solenoid valves and a proposed circuit modification. The result of these proposed modifications is that on a loss of electrical power the solenoid

valves for 3027 and 3056 are powered from different d-c buses resulting in the valve failing open. The modified circuit eliminates any electrical single failure which will cause the valve to fail shut. The two valves in series and their separate circuits provide protection against a postulated single failure causing both valves to remain open and thus the mini-flow line not being isolated during the recirculation phase.

The valves are Walworth gate valves with a Miller piston operator. Air pressure is required to alter the position of the valves. Two three-way d-c operated solenoid valves are provided, one on the opening side and one on the closing side, to supply and vent air from the valve such that commanded operations are achieved. The solenoid valves, as originally installed, would cause the valve to fail closed on loss of electric power. Loss of air supply would result in the valve failing as is.

The rearrangement of this circuit now requires that operator action be taken to close the mini-flow valves prior to initiation of the recirculation phase (approximately 30 minutes after the LOCA event). In addition, operator action to close these valves is not desirable until the primary coolant system pressure is decreased below the discharge head capability of both the high- and low-pressure safety injection pumps. The closure of the contacts associated with this hand switch in conjunction with a low level in the SIRW tank will initiate mini-flow valve closure. Thus, the closure of the hand switch contacts in conjunction with a nonvalid low level SIRW tank signal could cause the mini-flow valves to go closed prematurely. Thus, we will include in the appropriate operating procedures a requirement that the hand switch associated with the mini-flow valves be positioned such that the mini-flow valves will close automatically on a low level in the SIRW tank after the primary coolant system pressure has decreased to a value below the shutoff discharge pressure of the high-pressure and low-pressure safety injection pumps and prior to SIRW tank low level.

During a telephone conversation on April 5, 1976 with members of the NRC staff, it was suggested that indicating lights be installed to monitor the status of the contacts associated with the valve actuation circuitry. This would preclude an undetected contact failure followed by a single failure in the other contacts or circuitry associated with this actuation scheme causing a mini-flow valve to shut. Because of the series contact arrangement we have not been able to identify a satisfactory manner of providing the contact status indicator lights. The only arrangements we have been able to devise that would appear to work in a satisfactory manner from the standpoint of the lights involve placing a trickle current on the solenoid valve operating coils. As these coils pick up under very light current conditions which would cause the mini-flow valves to go closed, we do not believe that this is desirable. The switch and relay types that are used in the mini-flow valve circuitry are types that have been used extensively throughout the Palisades Plant. With respect to contact failures, these switches and relays have proven very reliable. We, therefore, have concluded that there is not a need for continuous monitoring of the contact position and instead are incorporating in plant procedures a requirement that contact operability be verified during refueling outages as well as proper contact position. We believe that this will provide reasonable assurance that undetected contact closure will not occur.
