Subject: Position Paper: Suspension of Groundwater Extraction and Evaporation Pond Operations,  
Shiprock, New Mexico, Disposal Site (NRC Docket No. WM-0058)

Enclosed for U.S. Nuclear Regulatory Commission (NRC) review is a Position Paper prepared by the U.S. Department of Energy (DOE), Office of Legacy Management (LM) entitled *Position Paper: Suspension of Groundwater Extraction and Evaporation Pond Operations, Shiprock, New Mexico, Disposal Site* (Document No. S16070).

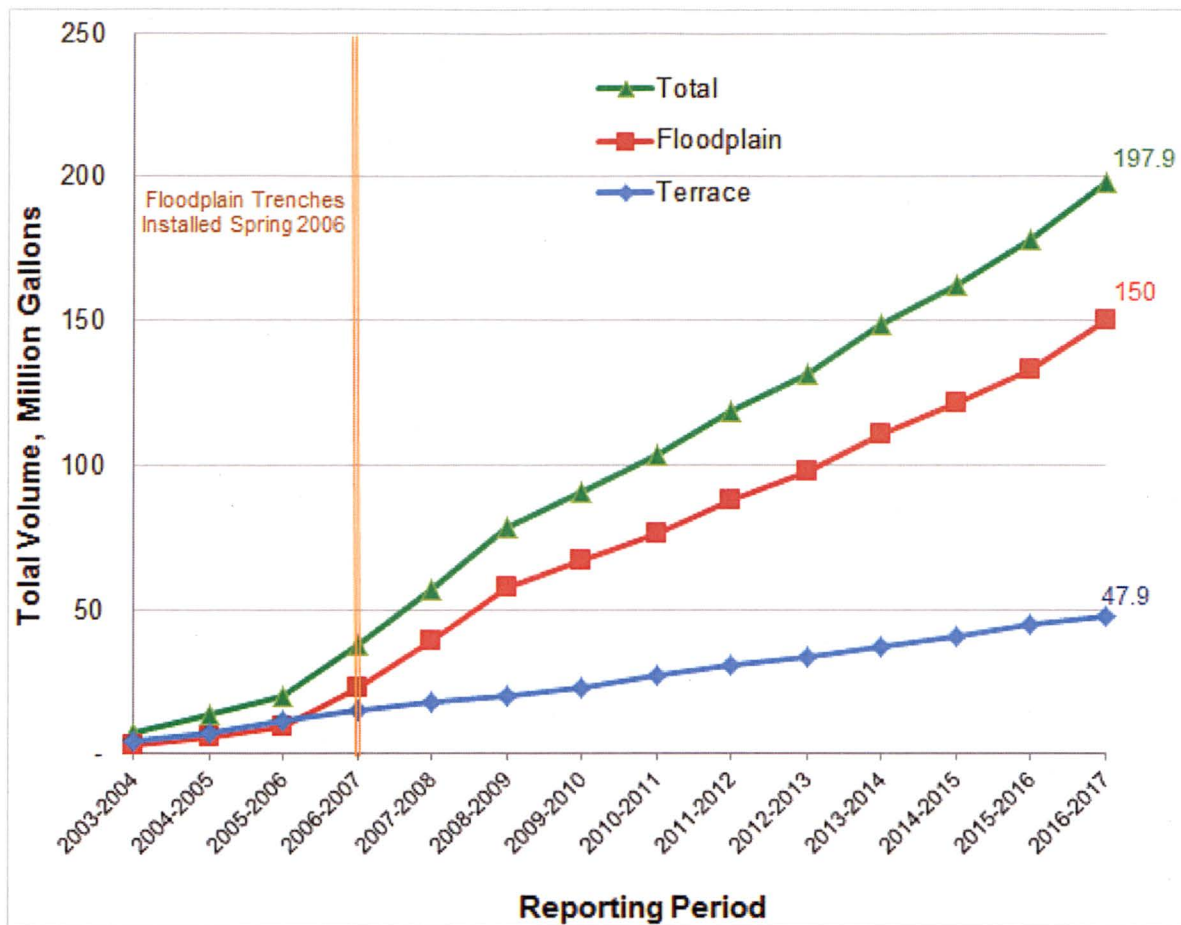
Figure 2. Total Groundwater Volume Pumped to the Shiprock Site Evaporation Pond

This section summarizes the effectiveness of active groundwater extraction in meeting compliance objectives for the floodplain and terrace areas of the site and concludes with a discussion of the current status of the evaporation pond. As shown in Figure 2, the remediation system has removed over 197 million gallons of contaminated groundwater (through April 2017) since pond construction was completed in 2002.

Groundwater in the floodplain system is extracted from two wells (wells 1089 and 1104) adjacent to the San Juan River north of the disposal cell, two collection trenches, and a seep collection sump (Figure 1). Approximately 150 million gallons of groundwater have been extracted from the floodplain aquifer system to date (May 2017). The volume of water transmitted to the pond increased significantly following the installation of the floodplain trenches in 2006 (Figure 2).

Groundwater in the east terrace is currently extracted from an interceptor drain in Bob Lee Wash and nine extraction wells. Approximately 48 million gallons of groundwater have been extracted from this region since 2003 (Figure 2).

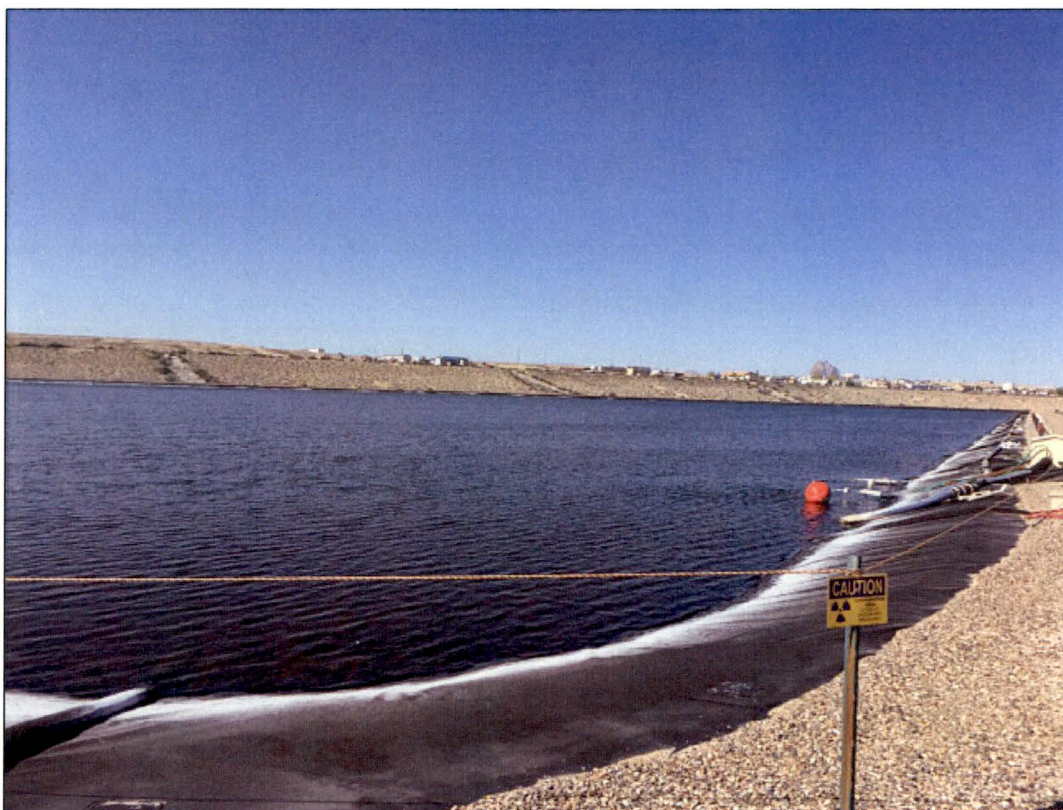
*Figure 5. Current Evaporation Pond Conditions*

LM recommends suspension of pumping to the evaporation pond to facilitate planning and decommissioning of the evaporation pond. As of April 2017, the pond held approximately 25 million gallons of contaminated water and an unknown volume of contaminated sediment (Figure 5). The polypropylene pond liner is increasingly exhibiting signs of deterioration. To ensure that operation of the evaporation pond continues in a manner protective of human health and the environment, these actions should be conducted well in advance of the 20-year design life of the pond liner. Planning for decommissioning activities and evaporation of the current volume of water in the pond will require several years.
