2.5.3 Surface Faulting

This subsection evaluates the potential for tectonic and non-tectonic surface deformation within a 25-mile radius (site vicinity) of Units 6 & 7. Information contained in [Subsection 2.5.3](#) was developed in accordance with RGs 1.165 and 1.208 in order to demonstrate compliance with 10 CFR 100.23(c). RG 1.208 contains guidance on characterizing seismic sources, and it defines a “capable tectonic source” as a tectonic structure that can generate both vibratory ground motion and tectonic surface deformation, such as faulting or folding at or near the earth’s surface, in the present seismotectonic regime.

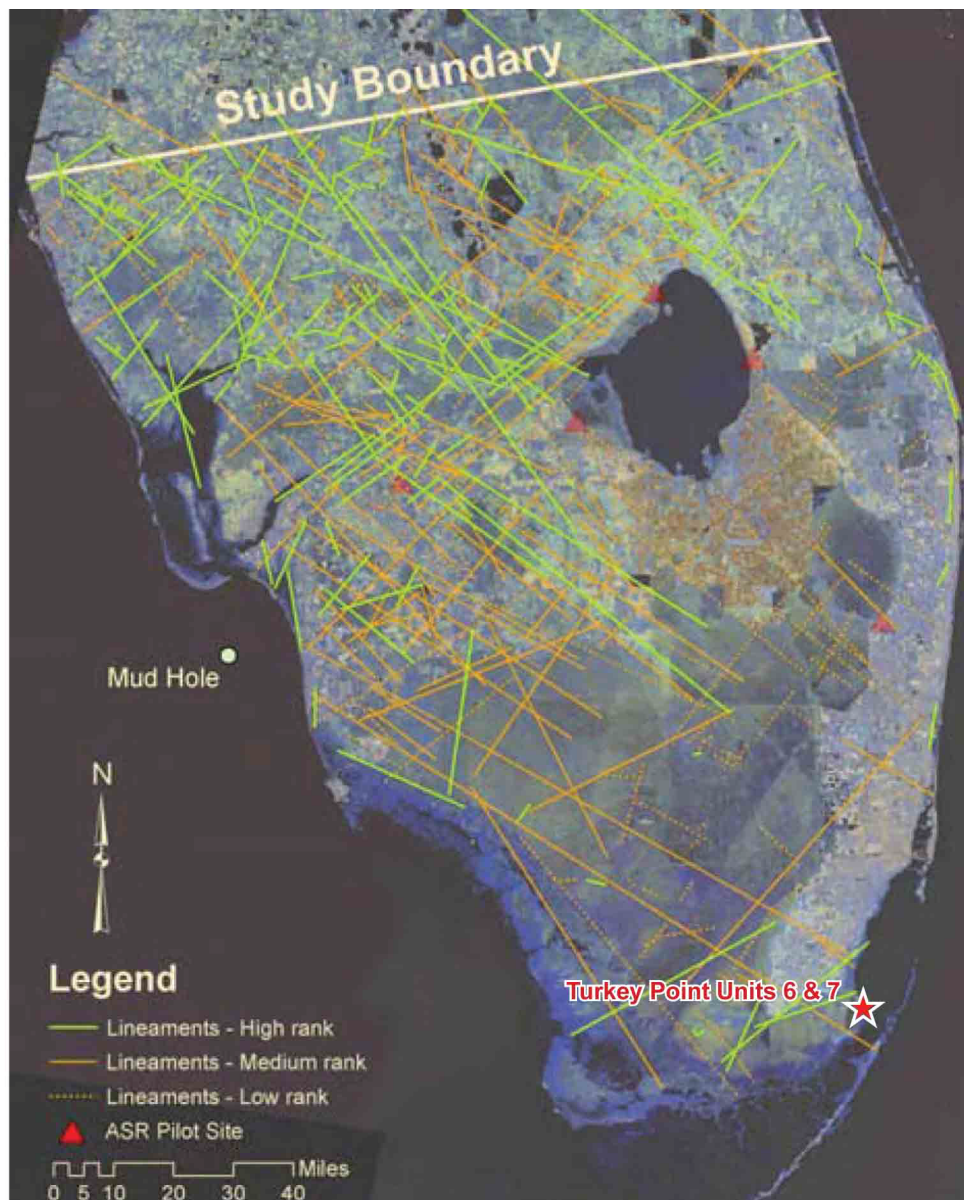
Source: Reference 232

Figure 2.5.3-204 Lineament Analysis of South Florida for ASR Regional Study
