DEPARTMENT OF MECHANICAL,  
AEROSPACE, AND NUCLEAR ENGINEERING

RCF 19-04  
August 22, 2019

Reportable Occurrence (NRC Event Number 54222)  
at the Rensselaer Polytechnic Institute Critical Experiments Facility

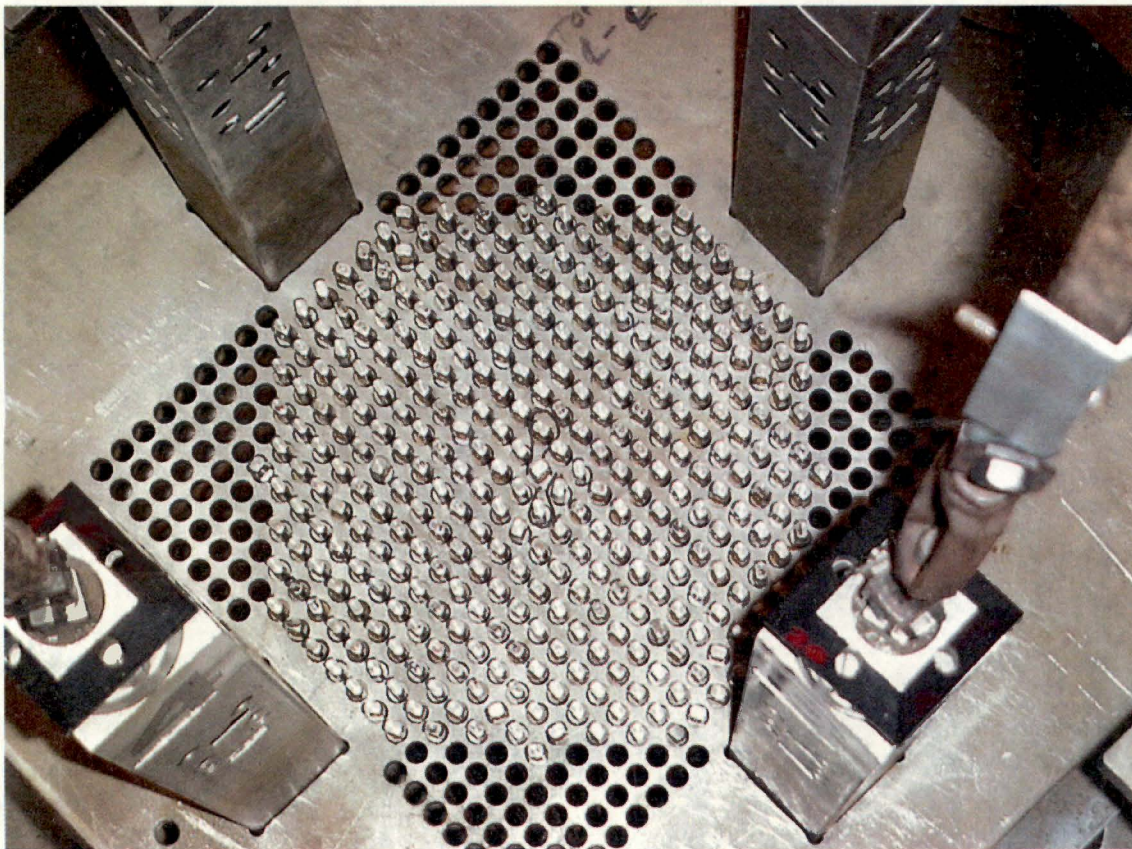
Figure 1: Top View of RCF Fuel Array (333-pins) and Control Rods

The Rensselaer Polytechnic Institute (RPI) Critical Experiments Facility (RCF) is a low power, 100-watt license limit, research and training reactor located in Schenectady, NY. The RCF uses four control rods and five nuclear instrumentation channels for reactor control. Figure 1 shows the four control rods spaced around and outside the array of fuel pins. The neutron detectors for the five nuclear instrumentation channels are not in view but are also outside the fuel array.
