Evaluation of Nondestructive Examination Responses from Chloride-Induced Stress Corrosion Cracks

Fabrication of Base Metal Test Specimens

September 2019

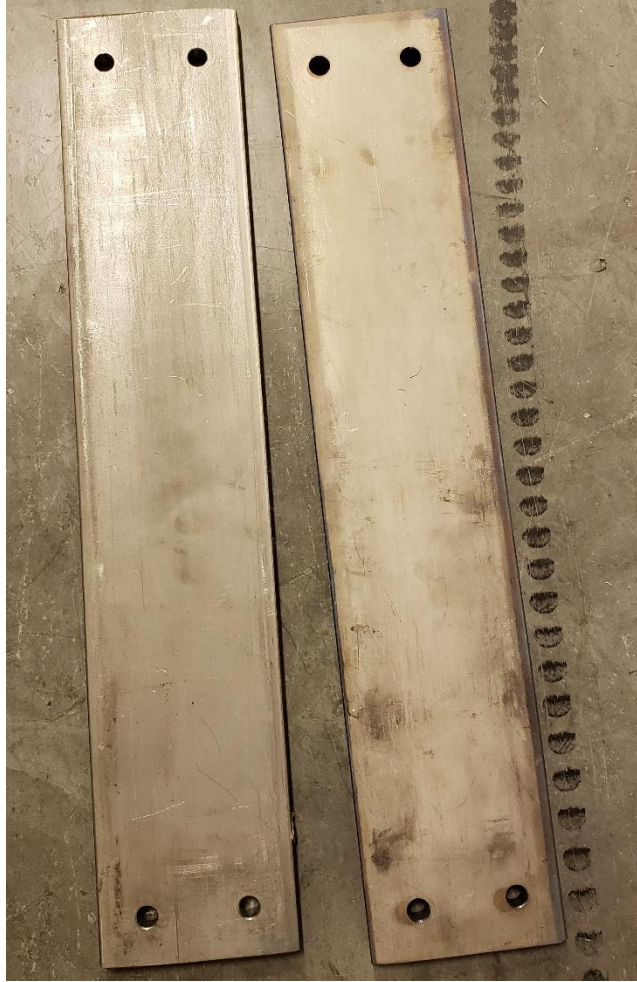
Figure 2-2. Photograph of scoping phase specimens prior to application of masks.

Rectangular plate specimens of 304L stainless steel were selected to simulate a dry storage canister wall. The size of the plates was selected to ensure the final NDE specimens are large enough to accommodate instrumentation for ECT, bulk ultrasound testing, and guided-wave ultrasound testing. Guided-wave ultrasound testing techniques limit the minimum size of the specimens as they need to be large enough to ensure minimal edge effects and large enough to simulate the transducer-to-flaw distances anticipated for field applications (e.g., in some vertical systems, access to the canister surface is constrained in regions adjacent to channels on the overpack liner). Scoping phase specimens are not subject to the same size requirements and are made smaller to reduce consumption of material and to facilitate more convenient iteration of test parameters. Depictions of the geometries and dimensions for the final NDE specimens and for the scoping phase test specimens are provided in Figure 2-1. Photographs of the scoping phase specimens and final NDE specimens prior to application of masks are included in Figures 2-2 and 2-3, respectively. The plates for the final NDE specimens were ordered from plate stock already fabricated to the desired dimensions. For the scoping phase specimens, 4 × 24-inch plates were ordered and then cut down to 20 inches in length.

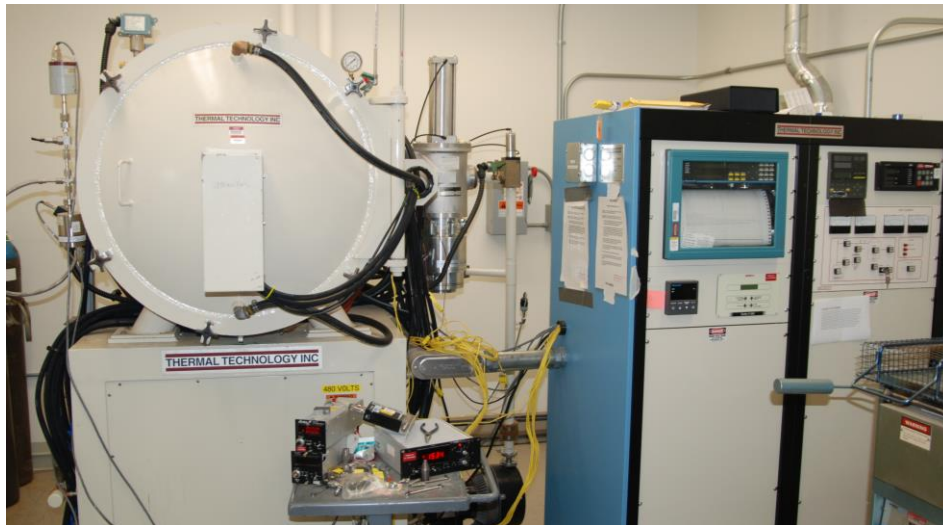
Figure 2-4. Photograph of the vacuum furnace used for sensitizing specimens.

Sensitization of some specimens was performed to encourage SCC formation. In these cases, sensitization was performed by soaking the specimens in a furnace at 600°C for 40 hours. A photograph of the vacuum furnace used for sensitization of specimens is included in Figure 2-4.

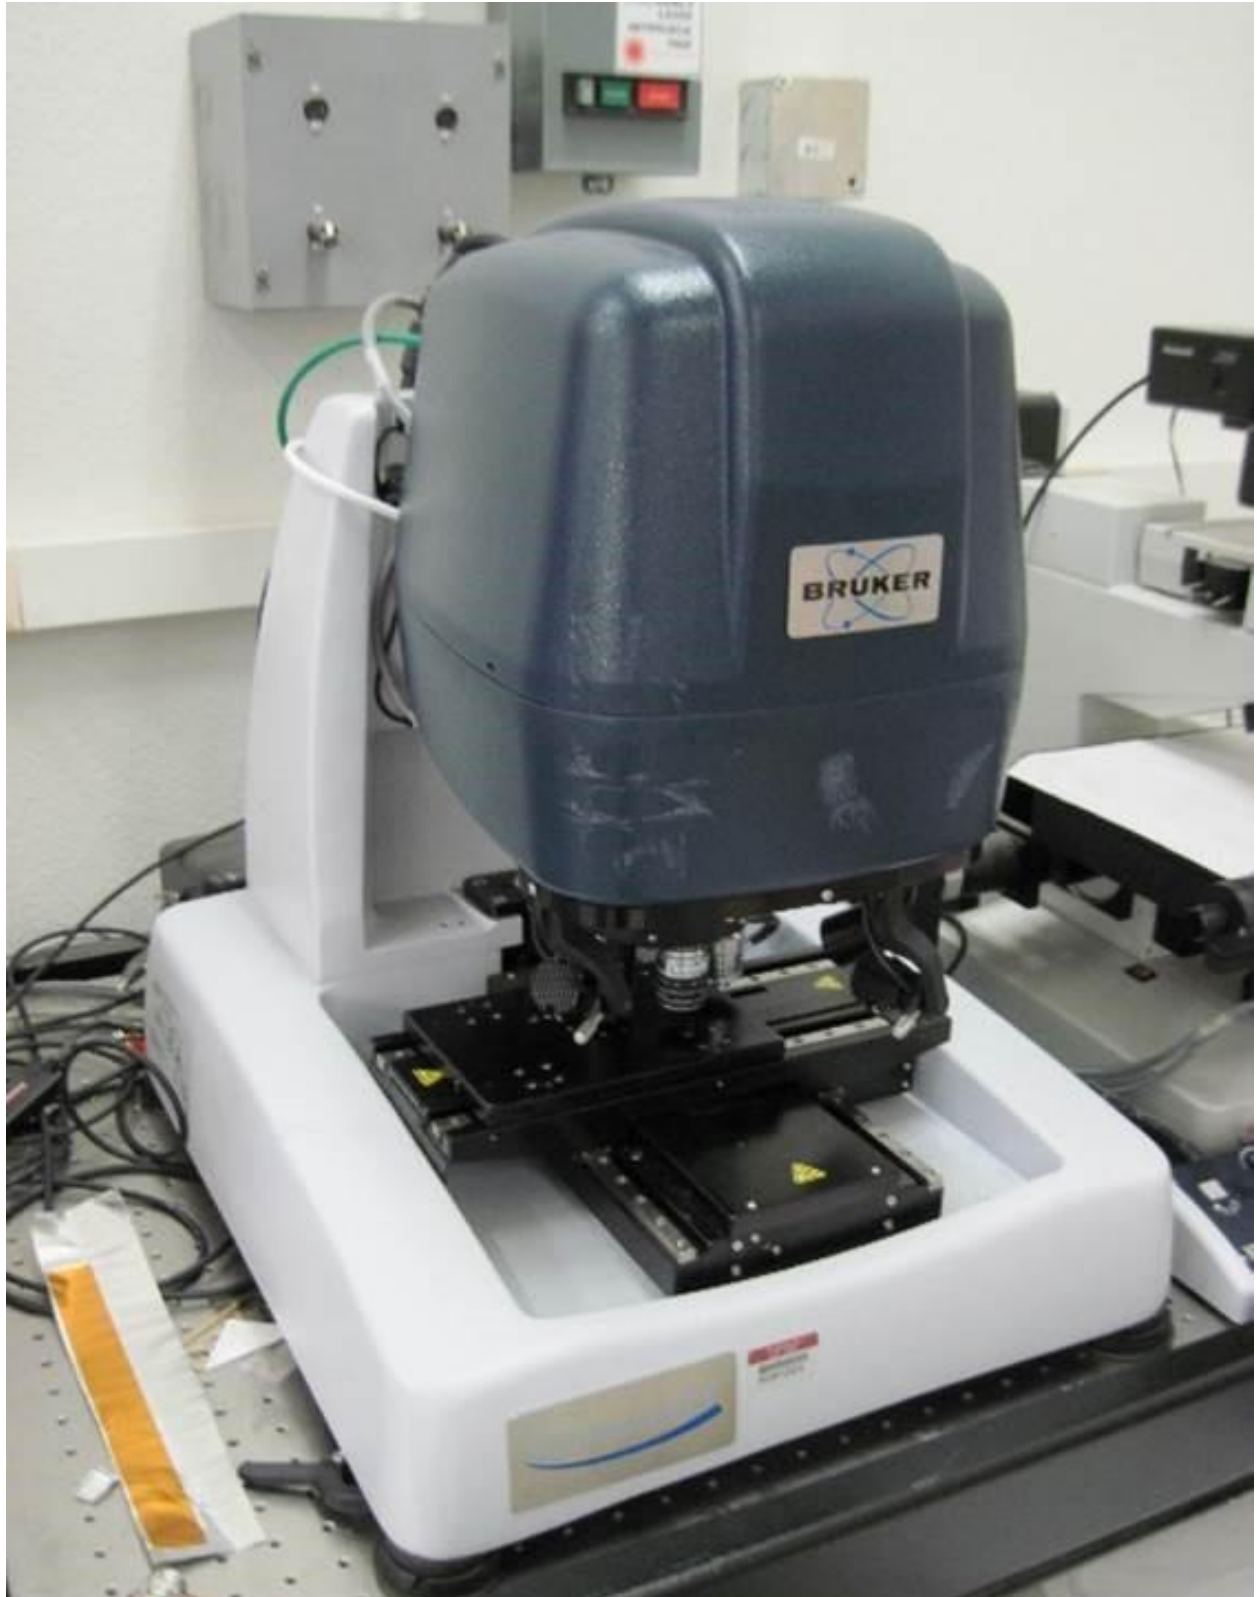
Figure 4-8. Photograph of optical profilometer.

Finally, an optical profilometer was employed to characterize the crack opening displacement (COD) of the crack fabricated in Scoping Specimen 7. A photograph of the optical profilometer is included in Figure 4-8.
