SUBJECT: Calvert Cliffs Nuclear Power Plant
Unit No. 1 and Unit No. 2
Docket Nos. 50-318 and 50-319
Core Misloading Analysis

ATTACHMENT

CORE MISLOADING EVENT

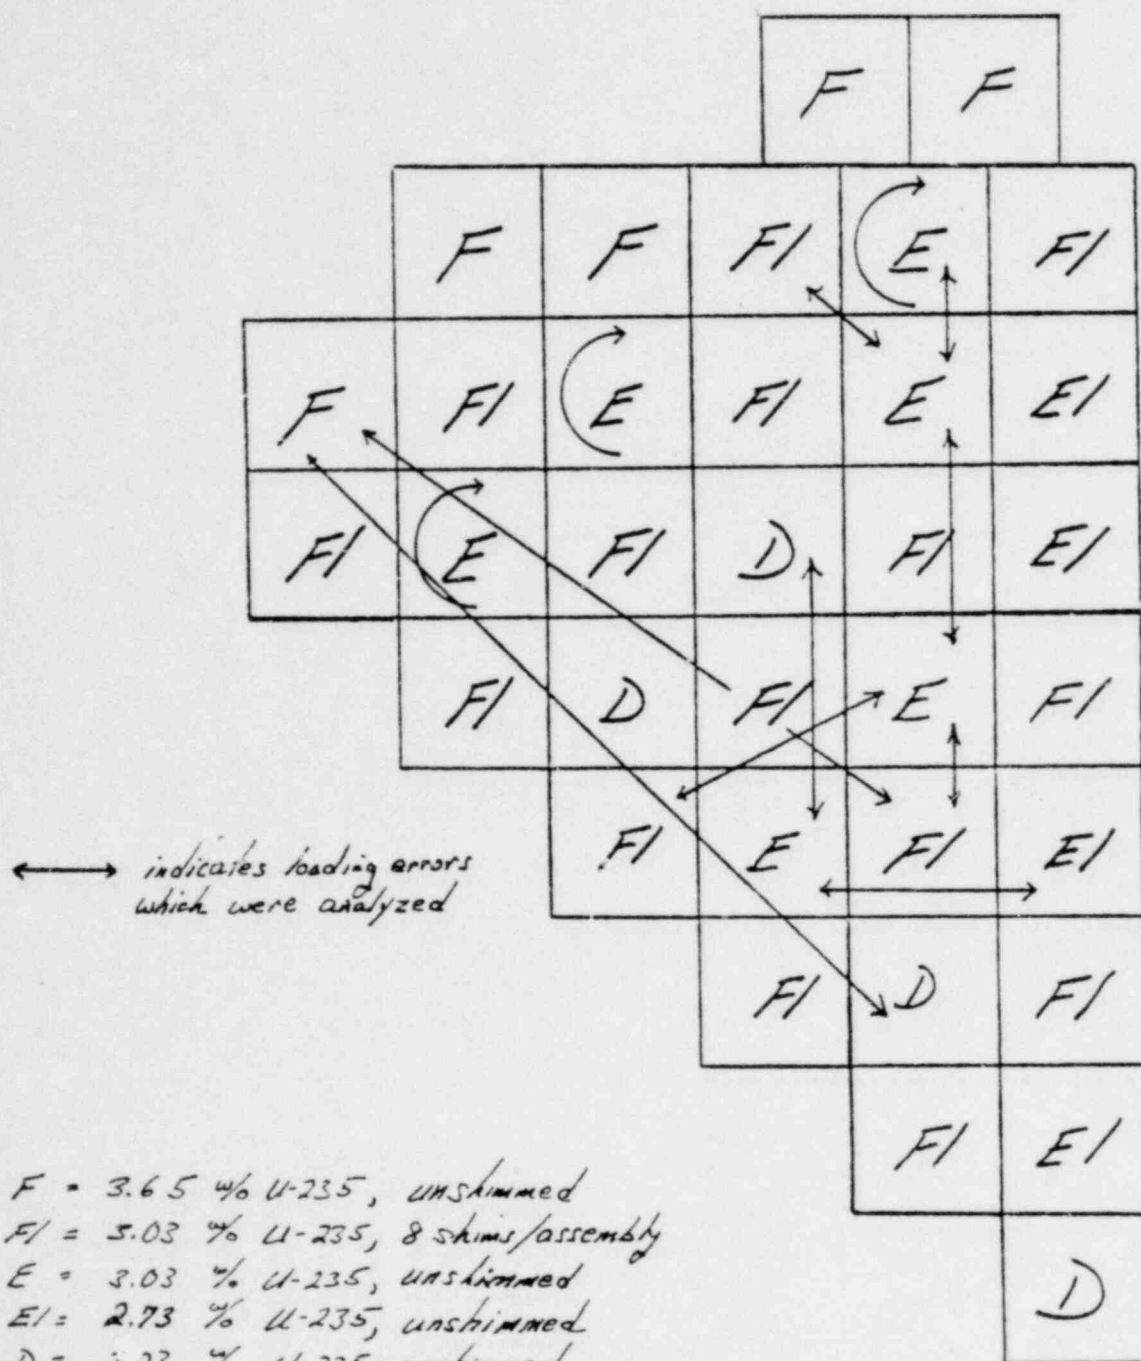
Calvert Cliffs II Cycle 4 Core Loading

$F = 3.65\% \text{ U-235, unshimmed}$
 $FI = 3.03\% \text{ U-235, 8 shims/assembly}$
 $E = 3.03\% \text{ U-235, unshimmed}$
 $EI = 2.73\% \text{ U-235, unshimmed}$
 $D = 3.03\% \text{ U-235, unshimmed}$

(NOTE: Indicated enrichments are nominal and initial)

Figure 1 shows the normal loading for Calvert Cliffs Unit 2, Cycle 4 along with the loading errors which were analyzed. These analyses indicate that the interchange of assemblies with large reactivity differences produce CEA worth asymmetries which exceed the 3.5¢ detectability criterion and are therefore detectable. The interchanges which fall into this category are:

- interchange of an F assembly with any other assembly,
- interchange of an F/ assembly with an E/ or D assembly, and
- interchange of an E assembly with a D assembly.

- interchange of assemblies within the same exposure batch,
- misorientation of an assembly, and
- interchange of an F/ assembly with an E assembly.

Table 1 shows that the most adverse undetectable loading error is the interchange of a Batch F/ assembly (fresh, shimmed fuel) with a Batch E assembly (unshimmed fuel with one cycle of exposure) thereby producing an island of five Batch F/ assemblies (see Figure 1). This type of loading error is undetectable at beginning of cycle due to the similar reactivities of the Batch F/ and E assemblies. However, the reactivity difference between the Batch F/ and E assemblies increases with burnup due to the burnout of the burnable poison shims within the F/ assembly. This, in turn, causes the power distribution differences between the normally loaded and misloaded cores to increase with burnup. Although undetectable by the CEA symmetry test at beginning of cycle, this type of loading error would most likely be identified by incore instrumentation and/or by tilt monitoring before the maximum peaking increase identified in Table 1 was reached. The interchange of assemblies within a batch and the misorientation of an assembly are considerably less adverse than the interchange of a fresh, shimmed assembly with an exposed assembly.
