KANSAS GAS AND ELECTRIC COMPANY

The referenced letter requested additional information in the area of geotechnical engineering. Transmitted herewith are responses to questions in the referenced letter. The outstanding response to question 241.5 WC, Items 2 thru 5, will be forwarded to you on October 1, 1981. This information will be formally incorporated into the Wolf Creek Generating Station, Unit No. 1 Final Safety Analysis Report in Revision 6. This information is hereby incorporated into the Wolf Creek Generating Station, Unit No. 1 Operating License Application.

WOLF CREEK GENERATING STATION
UNIT NO. 1
FINAL SAFETY ANALYSIS REPORT

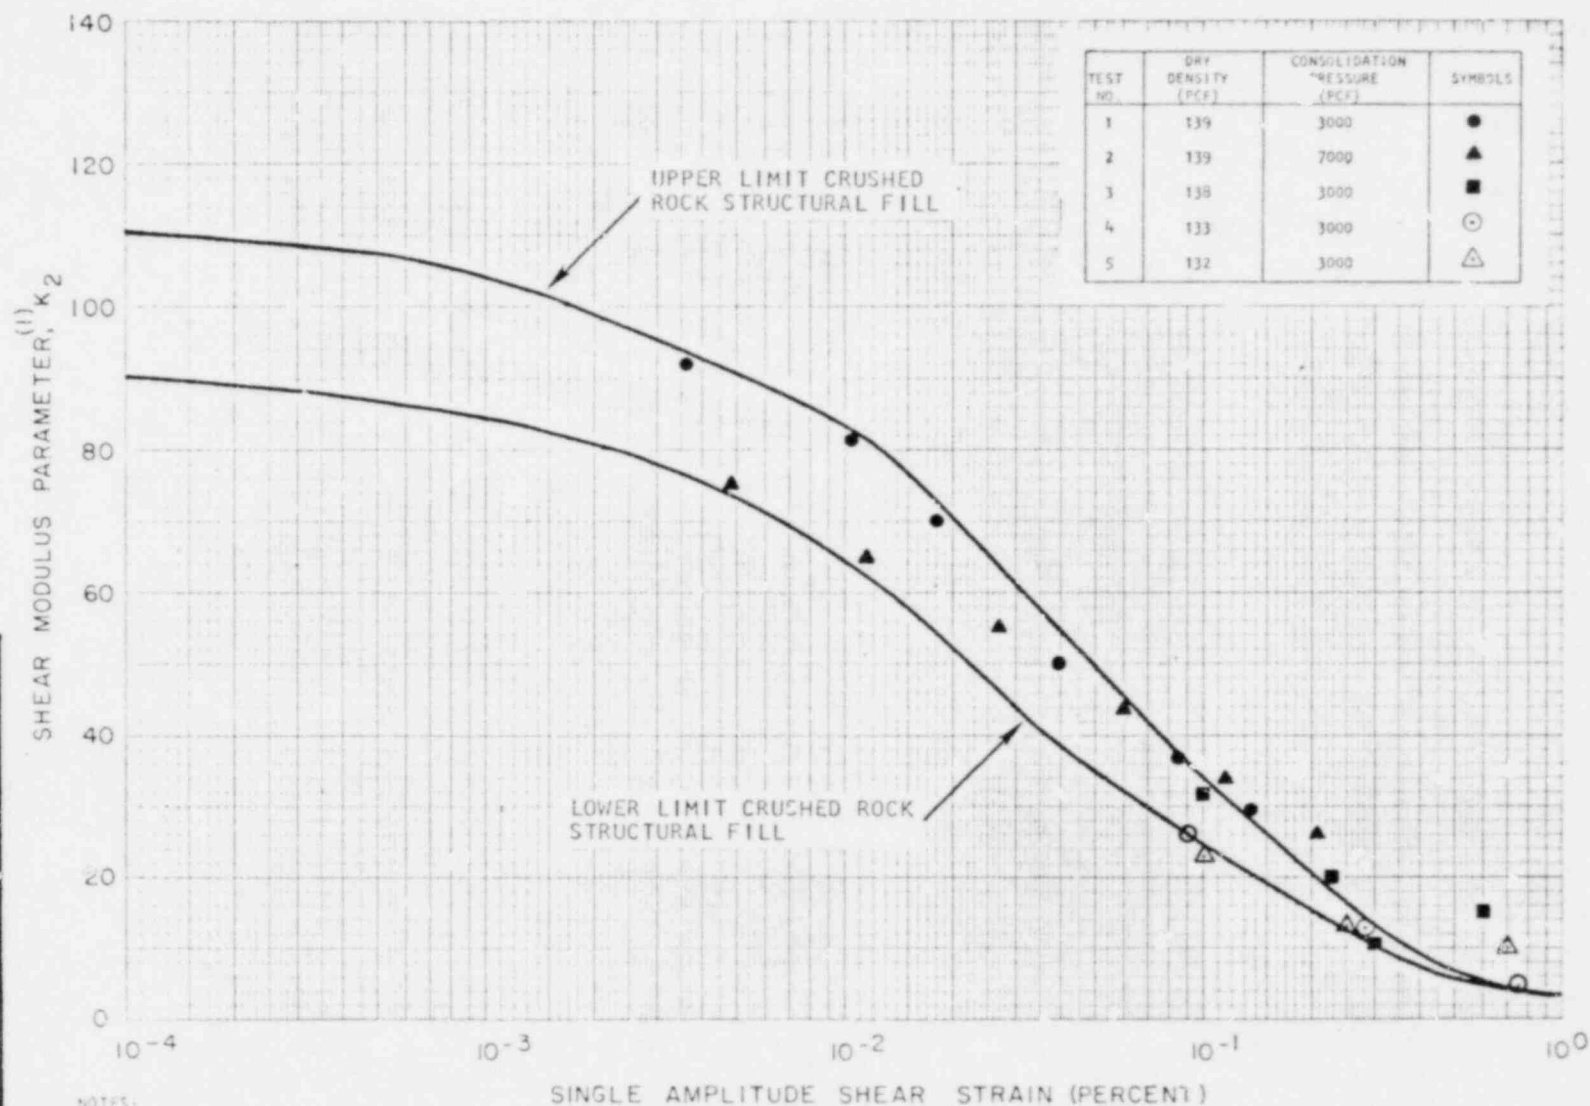
FIGURE 241.1-1
RECOMMENDED SHEAR MODULUS
VERSUS SHEAR STRAIN CURVE FOR
CRUSHED ROCK STRUCTURAL FILL

1. $G = 100K_2 (\delta_m)^{1/2}$
WHERE G IN PSF IS THE SHEAR MODULUS,
 K_2 IS A CONSTANT, AND δ_m IS THE MEAN
EFFECTIVE STRESS, ALSO IN PSF.

R241.1 Data points have been added to Figures 2.5-97d and e, Figure 241.1-1 and 241.1-2. No dynamic tests were performed on the pipe bedding material, since several alternative materials were to be used as pipe bedding. The pipe bedding materials ranged in gradation from gravelly sand to medium sand with little or no fines (see response to Question 241.3). The shear modulus range and strain degradation curves (Figure 2.5-97c) were, therefore, chosen as those for dense sands and gravelly sands as presented in "Soil Behavior Under Earthquake Loading Conditions"; State of the Art Evaluation of Soil Characteristics for Seismic Response Analysis; Shannon and Wilson, 1972.

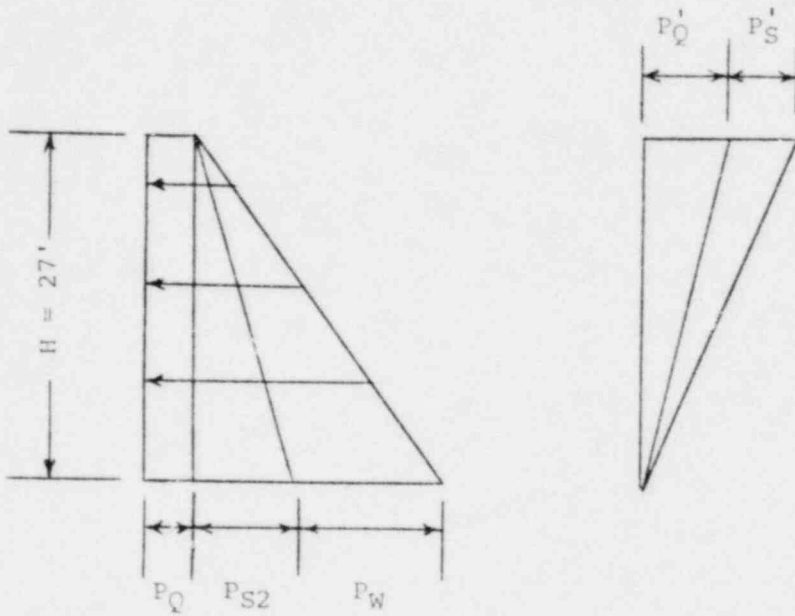
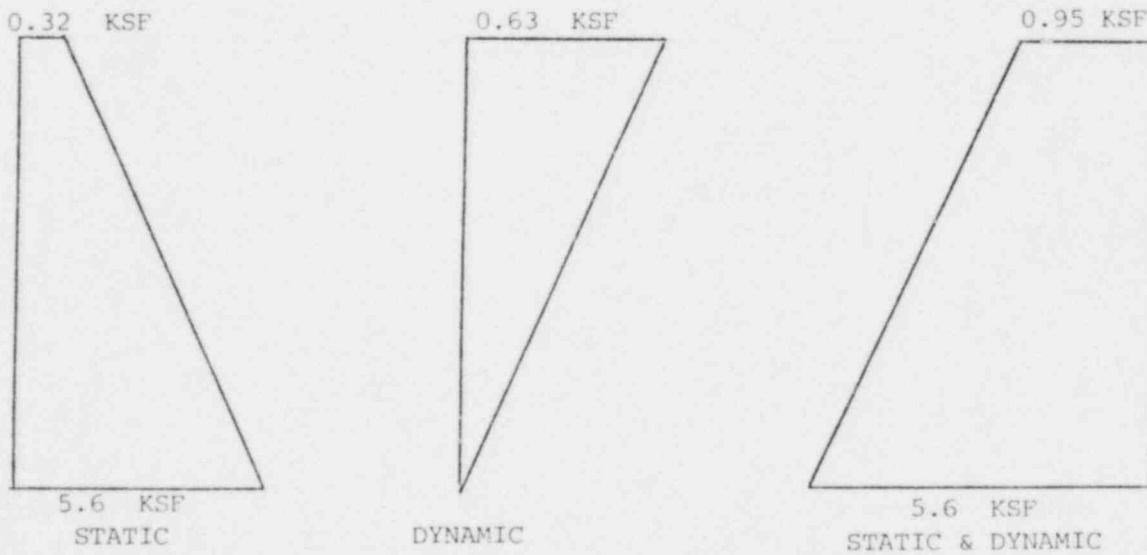
AUXILIARY BUILDING
EXTERIOR WALL DESIGN

NOTE: THE WATERTABLE WAS ASSUMED TO BE AT GRADE LEVEL.

TOTAL WITH LOAD FACTORS	
STATIC $\times 1.7$ (KSF)			DYN $\times 1.9$ (KSF)		EARTH PRESS	EARTH PRESS
P_Q	P_{S2}	P_W	P'_Q	P'_S	@ EL. 2000'	@ EL. 1973'
0.32	2.43	2.85	0.10	0.53	0.95 KSF	5.6 KSF

P_Q , which is the static pressure due to surcharge loading, varied according to the imposed load due to the building adjacent to the exterior wall of the auxiliary building.

R241.7 The plots of the magnitude and distribution of lateral earth and water pressures as well as dynamic lateral pressures are provided in Figures 241.7-1 through 241.7-6.

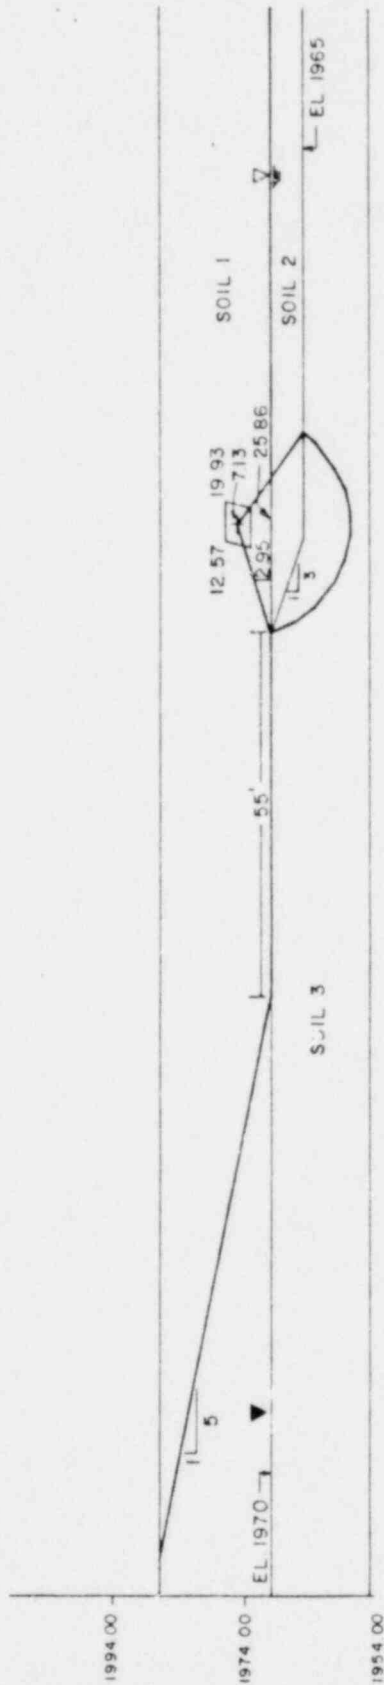
SOIL	SOIL DESCRIPTION	SOIL PARAMETERS		
		UNIT WT γ_t PCF	COHESION C PSF	FRICTION ANGLE ϕ DEGREE
1	DUMMY LAYER	---	---	---
2	WATER	62.4	0	0
3	RESIDUAL	124	400	20
4	ROCK	150	5000	35

MINIMUM SAFETY FACTOR = 7.13

The BISHOP computer program was used to investigate the stability of slopes for all the above design conditions (Figures 2.5-113a through h). The details of this program are given in Section 3.12. The soil properties used in the analyses are given in Table 2.5-55. The shale was conservatively assumed to have the properties of residual clay for the stability analyses.

The effective stress method of analysis was used for evaluating the steady state condition with and without an SSE of 0.12g. The minimum factors of safety obtained for the static case are 7.13 for the three horizontal to one vertical slope and 3.37 for the five horizontal to one vertical slope; the minimum factors of safety with SSE effects are found to be 3.37 and 1.86, respectively. These factors are higher than required, as indicated in Table 2.5-57.

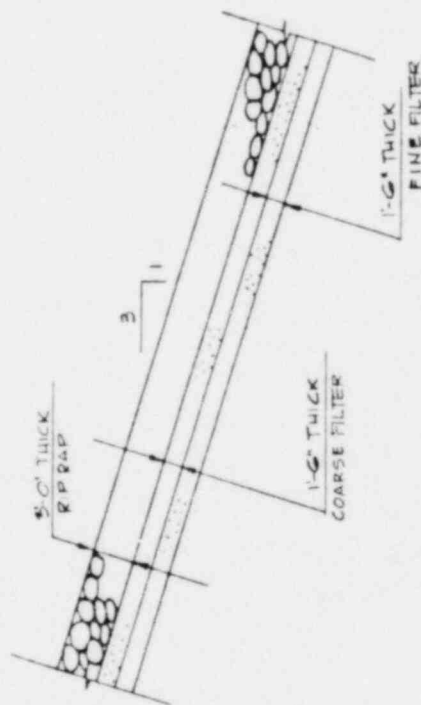
TYPICAL SECTION
MAIN DAM

DETAIL 'A'

Vertical settlement readings have been taken monthly and as of July 10, 1981, the maximum vertical settlement is 0.72 inches at Station 4+00. The height of dam embankment is the greatest at this location (Figure 2.5-116) and the observed settlement is well within the estimated settlement of 1.35 inches for an embankment height of 17 feet and has no influence on the safety of the UHS dam.

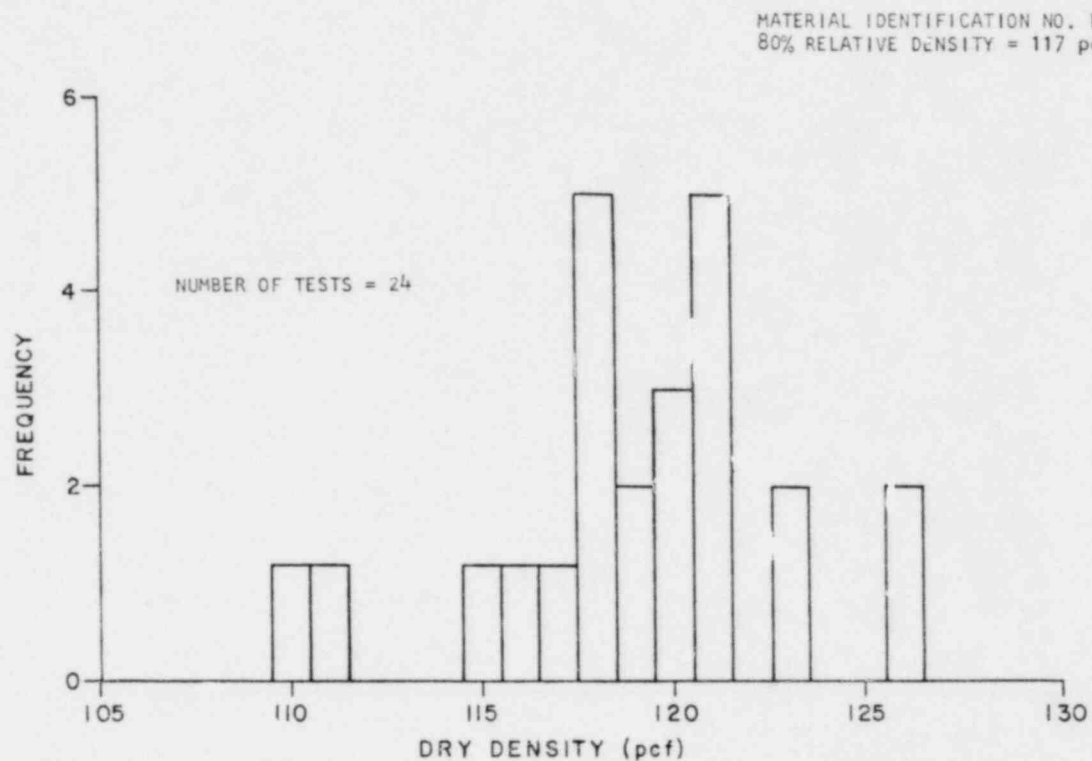
FIGURE 2/1.13-2

1. RETESTS ON AREAS WHERE TESTS DID NOT MEET COMPACTION CRITERIA ARE INCLUDED IN THIS PLOT.

UHS DAM - FINE TIPRAP BEDDING
STATISTICAL DISTRIBUTION PLOT

R241.13 The summary of the field density tests are shown on Figures 241.13-1 and 241.13-2. Based on the field tests, 16 of the 195 field tests failed to meet the compaction criteria by 1 to 4 percent compaction. However, all failed areas were recompacted, or the failing material removed and replaced. Moisture content data are summarized on Figure 241.13-4.

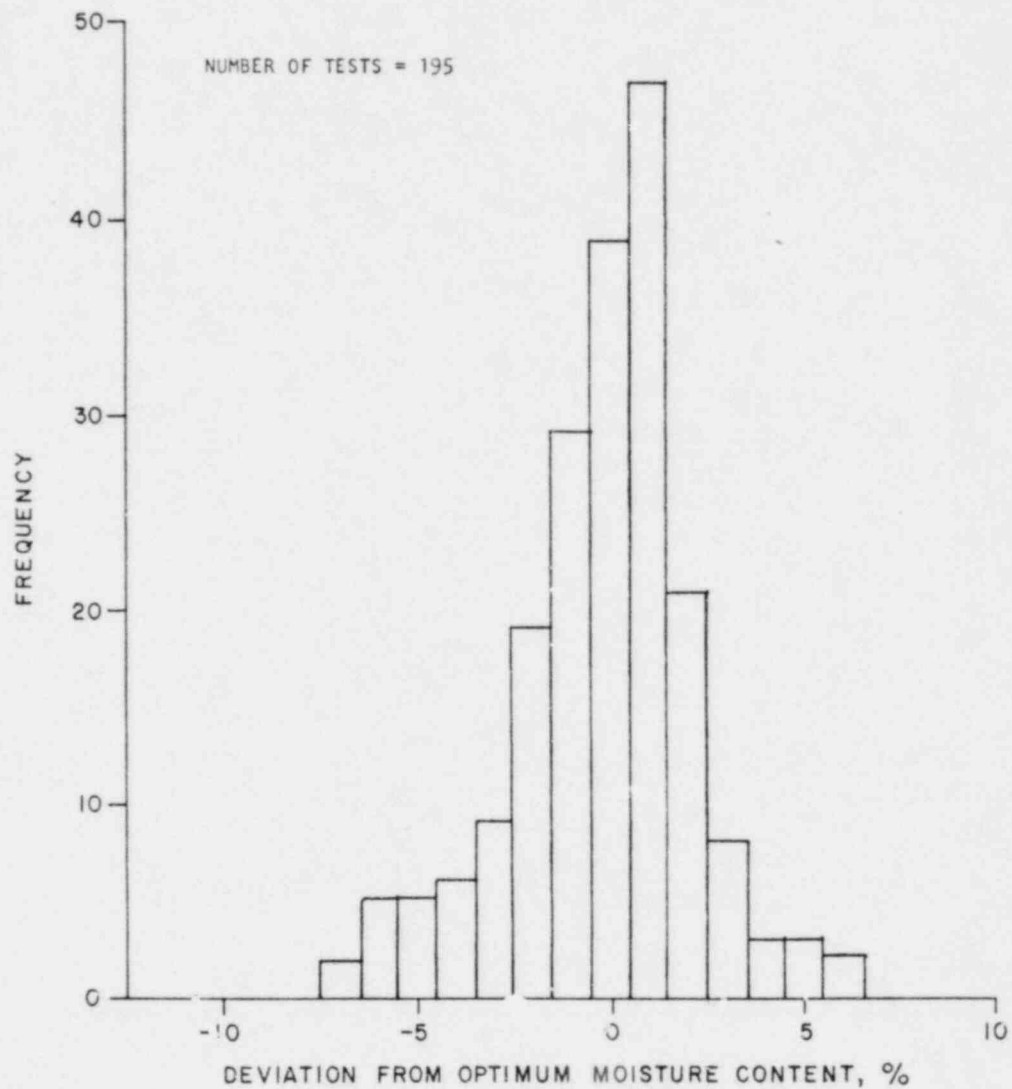
FIGURE 241.13-4
UHS DAM
STATISTICAL DISTRIBUTION PLOT

1. RETESTS ON AREAS WHERE TESTS DID NOT MEET COMPACTION CRITERIA ARE INCLUDED IN THIS PLOT.
