Wisconsin Electric POWER COMPANY
231 W. MICHIGAN, P.O. BOX 2046, MILWAUKEE, WI 53201

DOCKET NOS. 50-266 AND 50-301
REPLY TO INSPECTION REPORT
NOS. 50-266/82-17 AND 50-301/82-17
POINT BEACH NUCLEAR PLANT, UNITS 1 AND 2

RESPONSE TO INSPECTION REPORT NOS.
50-266/82-17 (DETP) AND 50-301/82-17 (DETP)

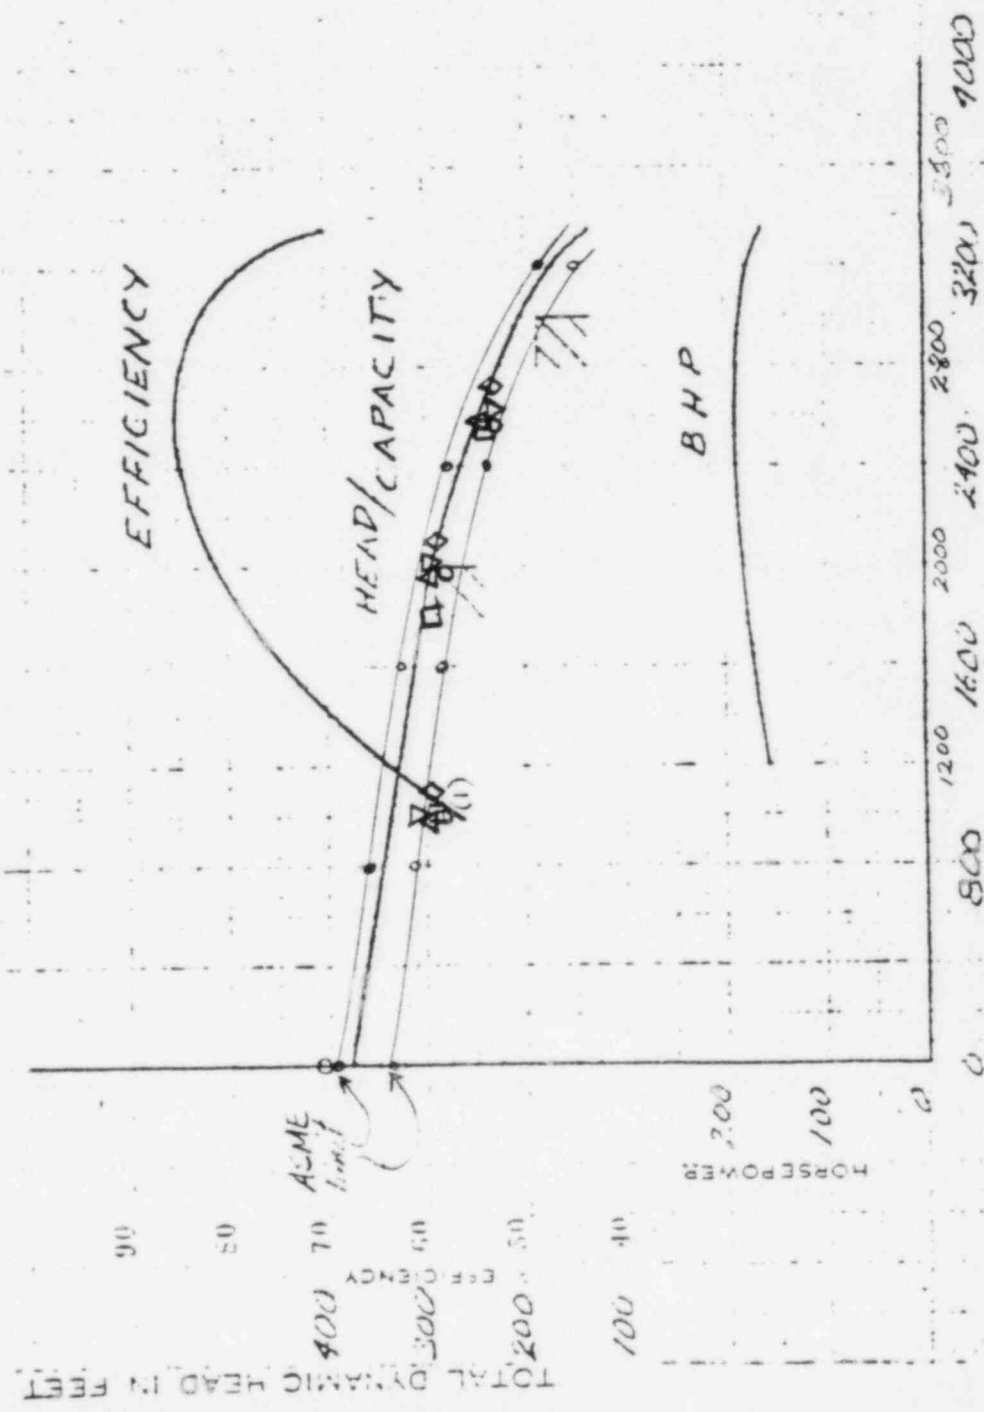
3 IMPELLERS @ 1 1/8" x 11 3/32" DIA.

Note - total developed head includes 15' of suction lift

EFFICIENCY

HEAD/CAPACITY

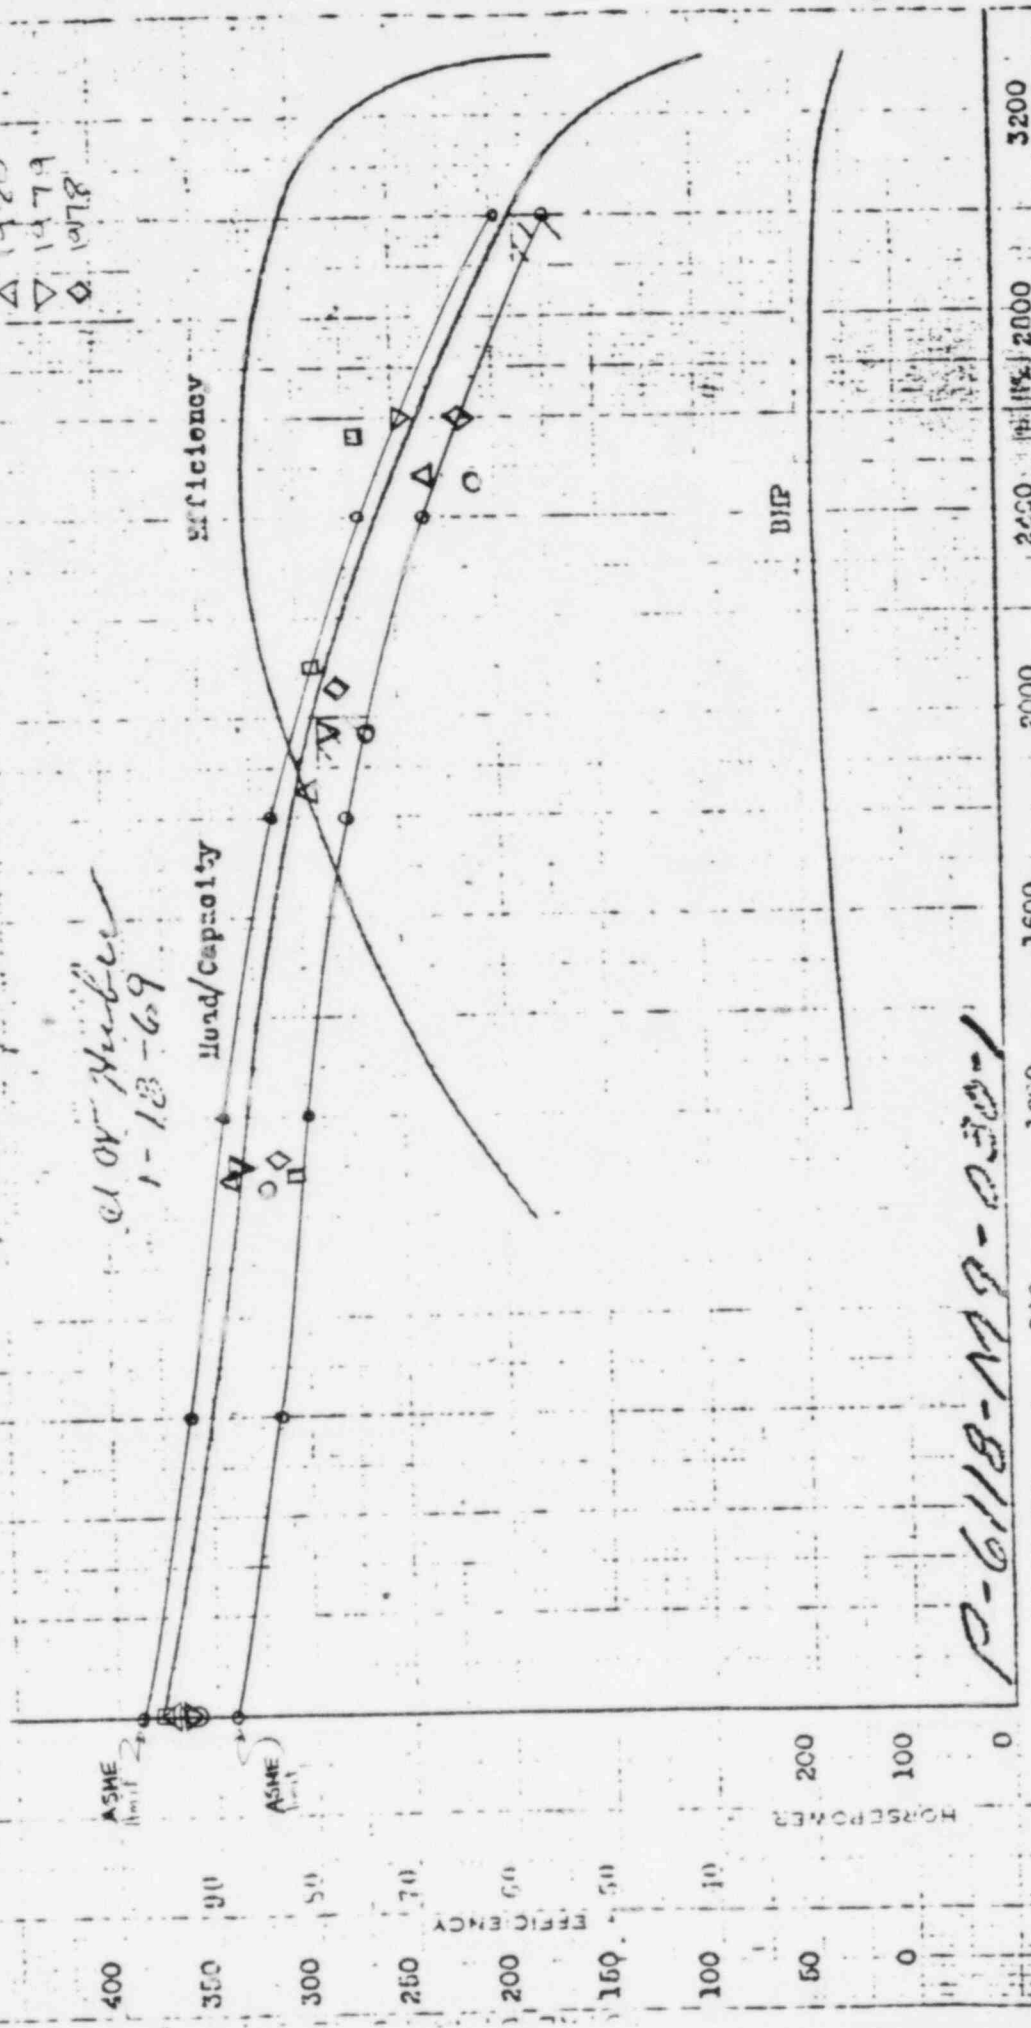
P-6118-179-030-1

Note - total developed
head includes 15'
of suction lift

GALLONS PER MINUTE

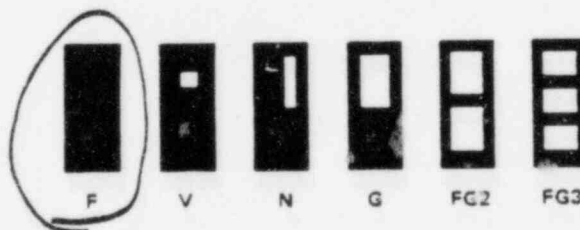
F = FLUSH PANEL
 V = VISION LIGHT
 N = NARROW LIGHT
 G = HALF-GLASS LIGHT
 FG2 = TWO GLASS LIGHTS
 FG3 = THREE GLASS LIGHTS

STEELCRAFT®
