HPI Nozzle Enhanced UT Development

ENHANCED UT DEVELOPMENT

Performed by:
B&W Nuclear Service Company
for
Toledo Edison Company

DOCUMENT NUMBER: 47-1178263-01

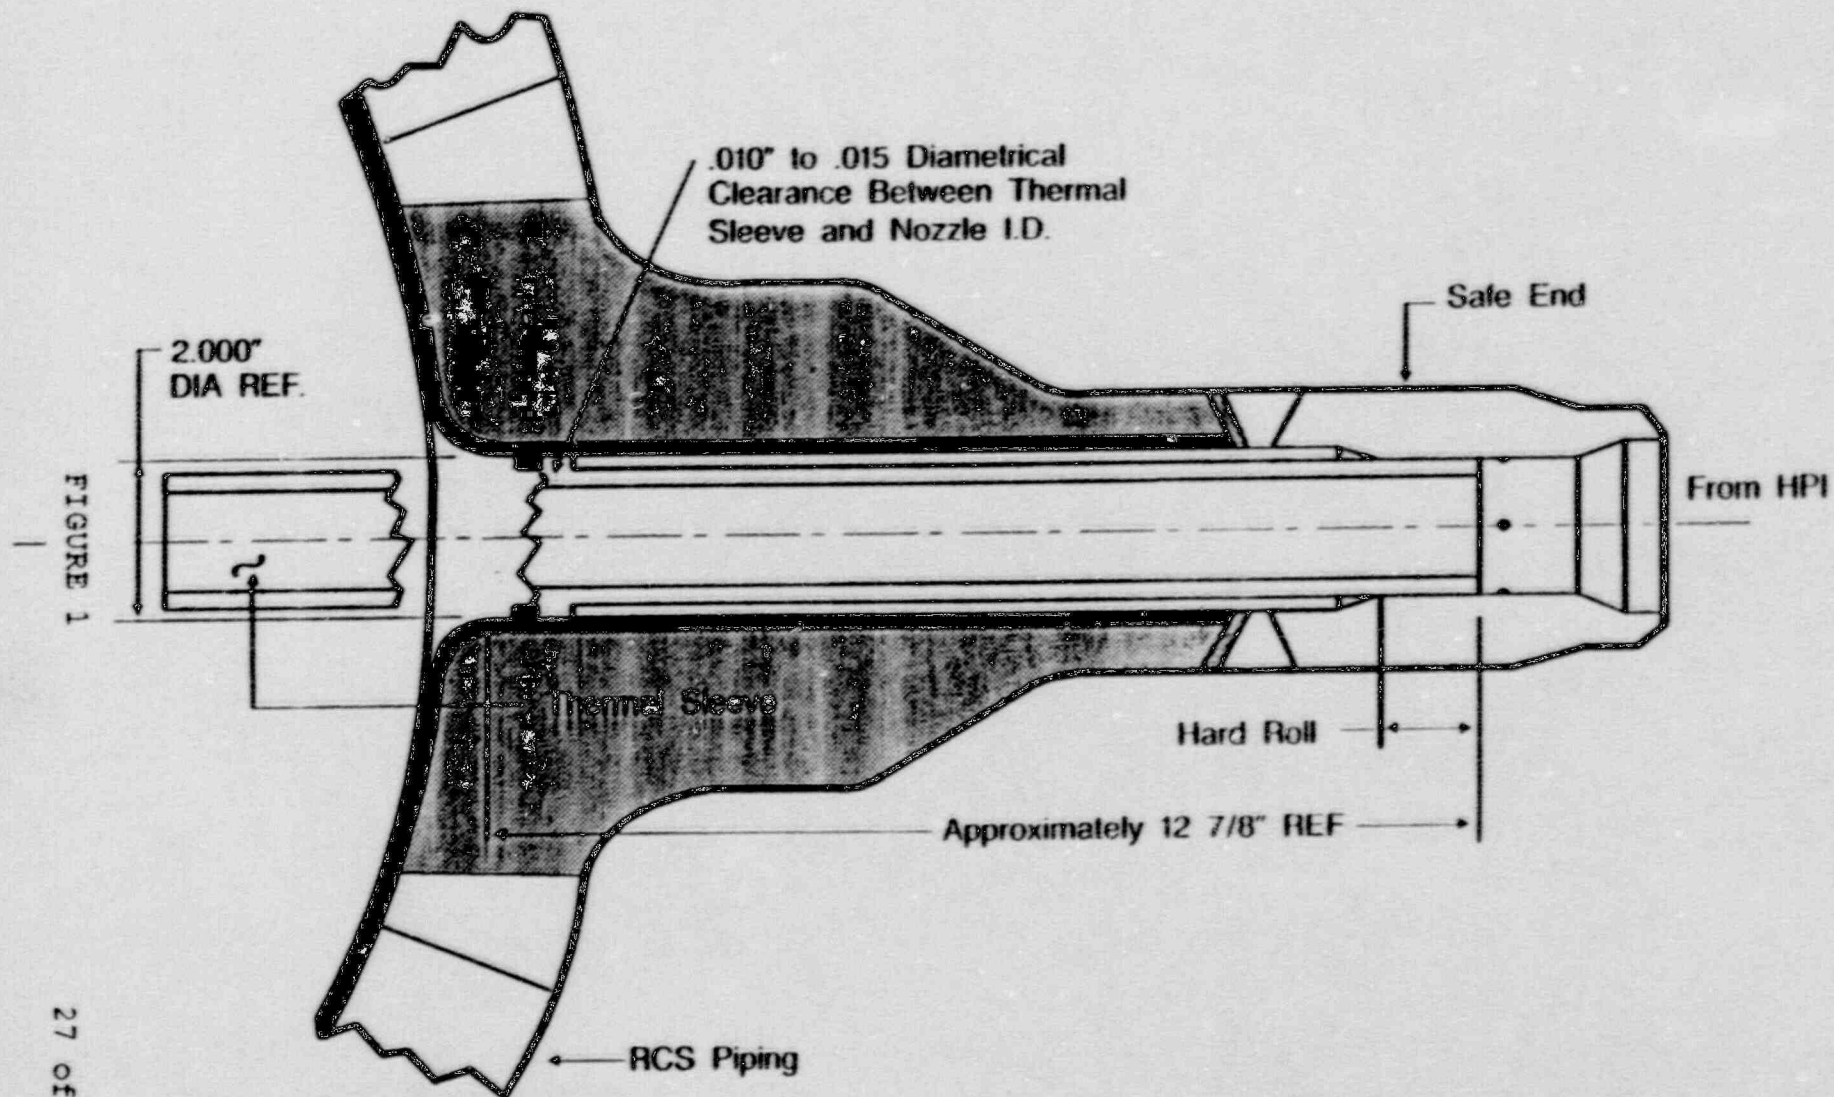
Makeup/HPI Nozzle Original Thermal Sleeve Design

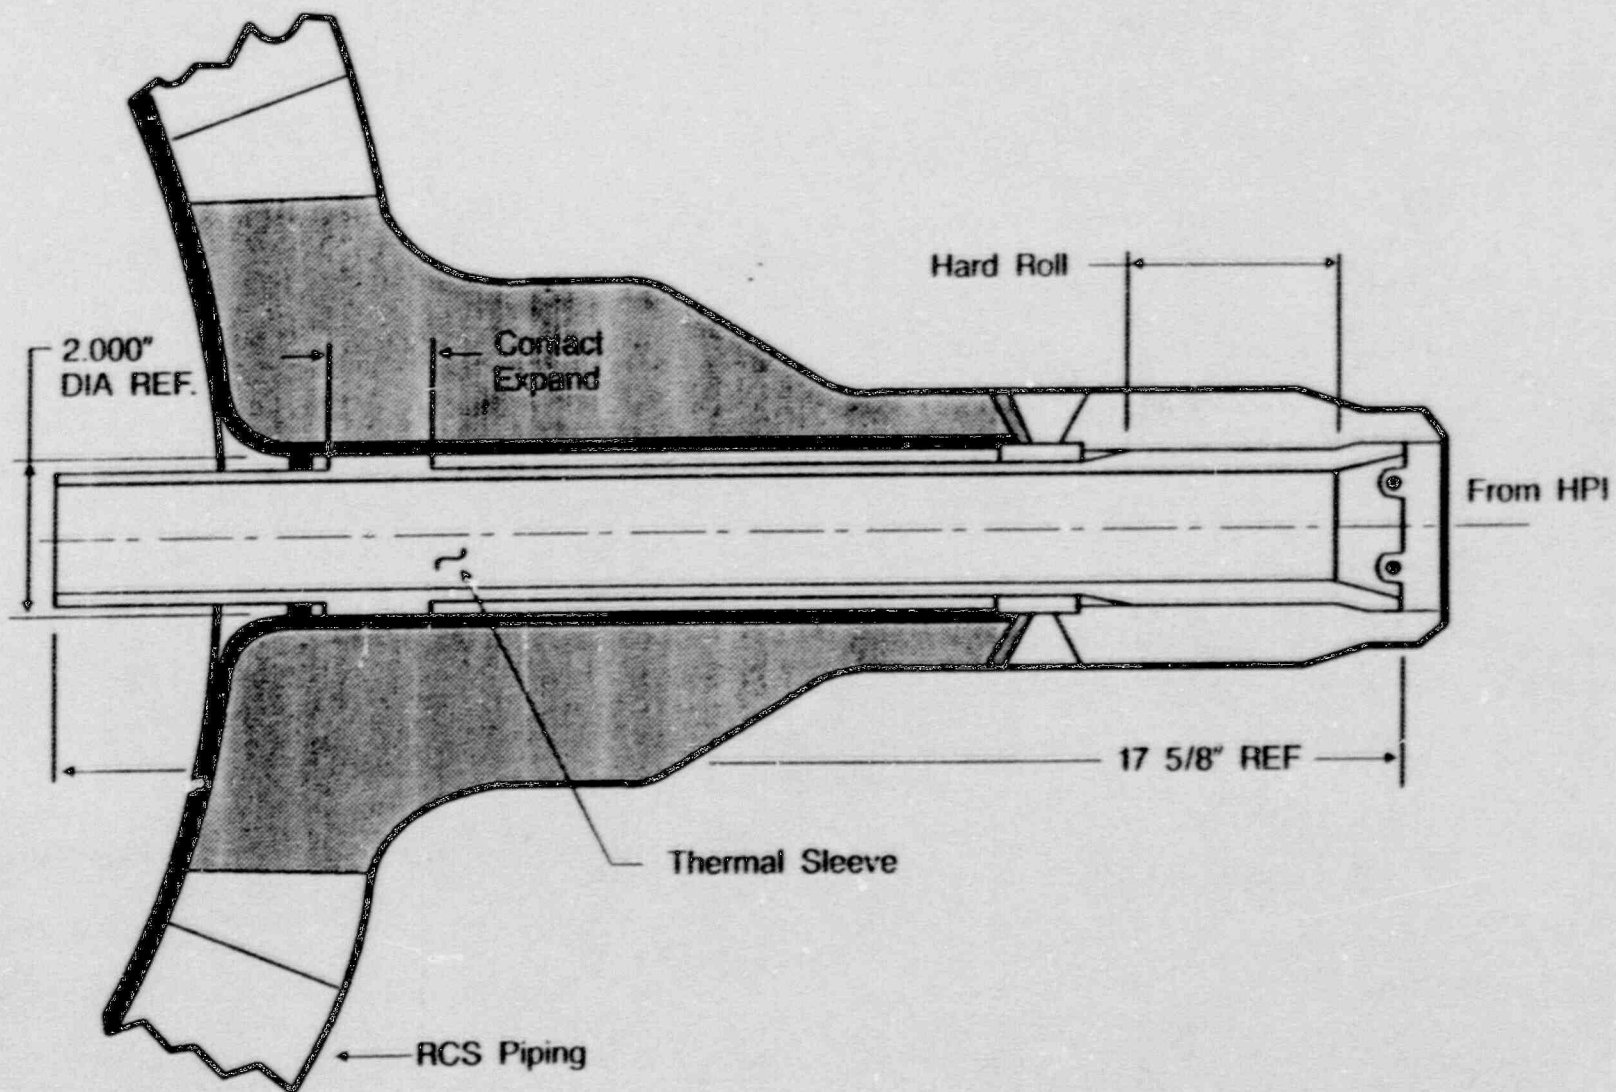
Makeup/HPI Nozzle Replacement Thermal Sleeve Design

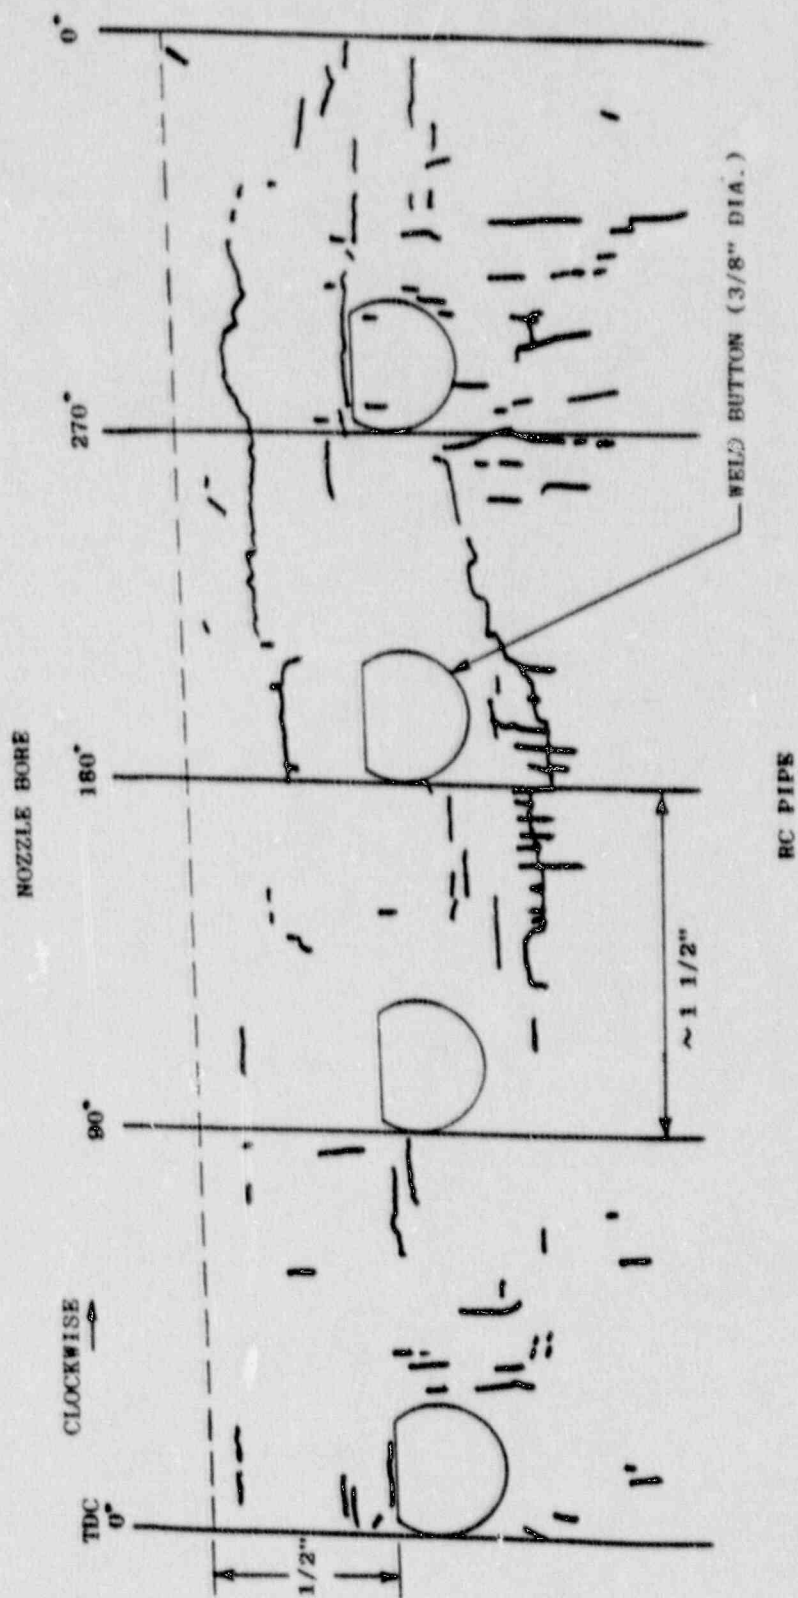
FIGURE 5

DAVIS BESSE HP159 FT INDICATIONS

Figure 5 is an illustration of the indications found in the nozzle mouth by dye penetrant examination.

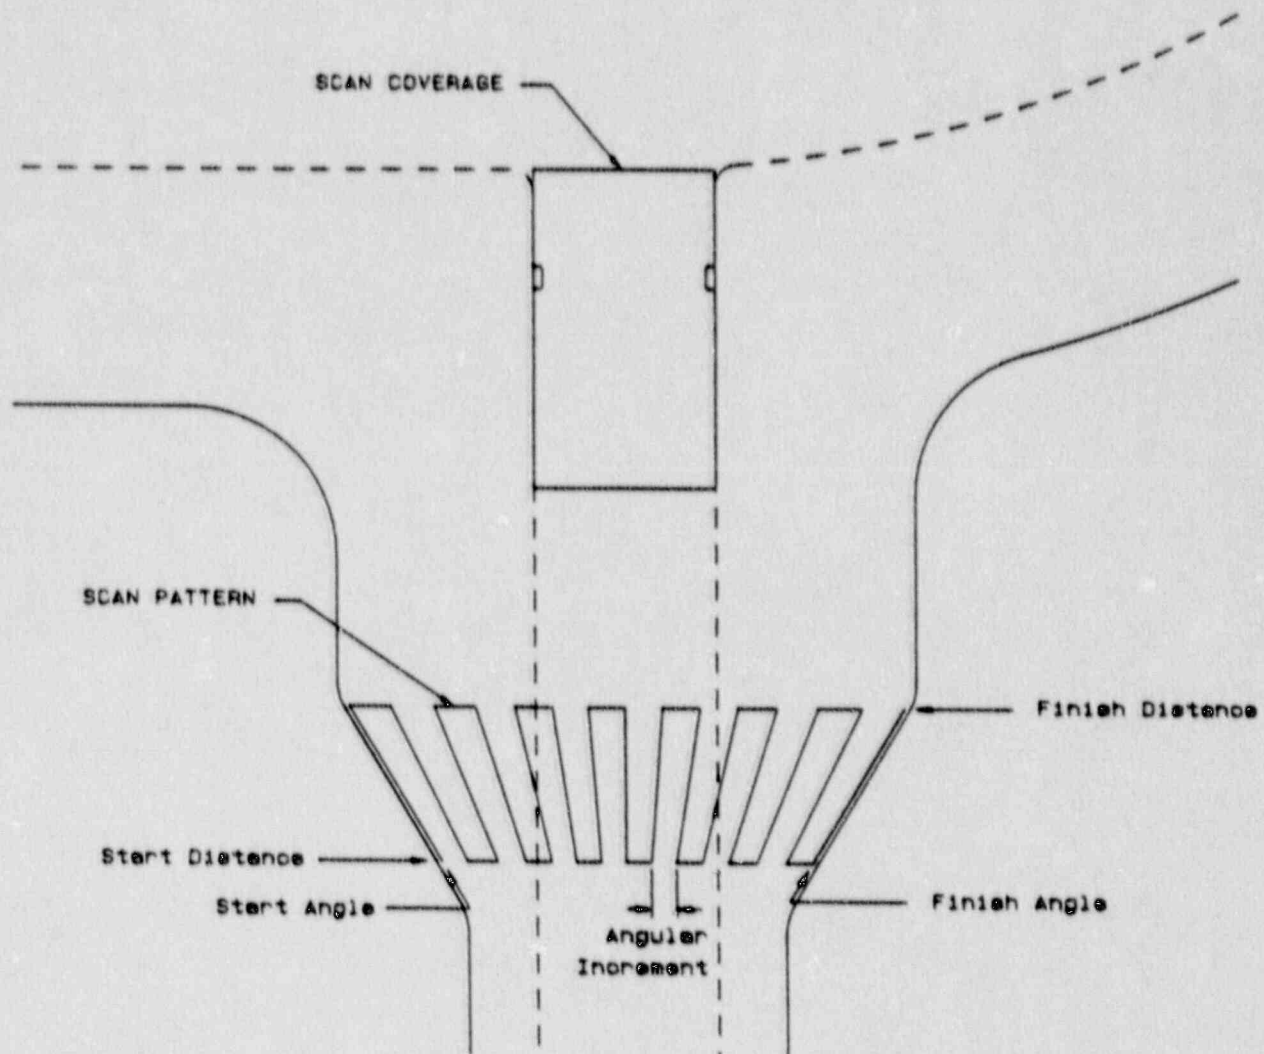
FIGURE 7

AXIAL TAPER SCAN

(For Detection of Circumferential Flaws in the Bore)

Nominal Beam Angle(s) : 45
Wave Mode : Shear
Detection Transducer :
Diameter : 3/8 inch
Frequency : 1.5 MHz

Circumferential flaws in the nozzle bore will be detected by scanning from the tapered portion of the HPI nozzle (see Figure 7). This scan will detect circumferential flaws in the base metal as shown in Figure 9. Scans separate from those used for detection will be used to size circumferential flaws in the nozzle bore. Sizing will be performed by scanning from the shoulder of the nozzle (see Figure 8). Figure 9 shows the transducer locations and the coverage provided for the sizing scans.

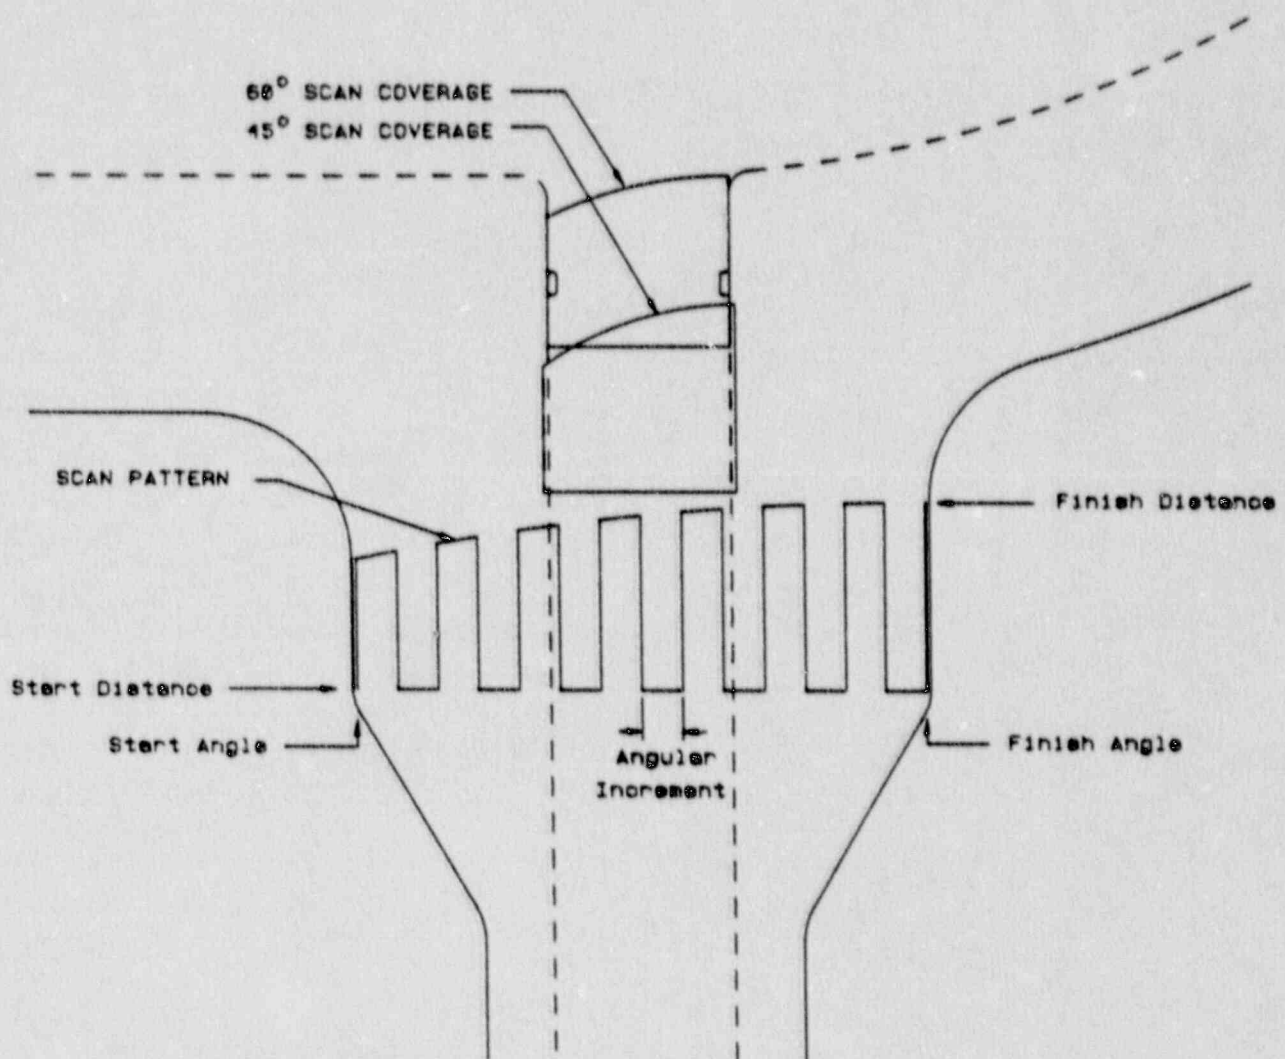
FIGURE 8

AXIAL SHOULDER SCAN

(For Sizing of Circumferential Flaws in the Bore)

Nominal Beam Angle(s) :	45, 60
Wave Mode :	Shear
Sizing Transducer :	
Diameter :	3/8 inch
Frequency :	5 MHz
Sizing Technique :	Tip Diffraction

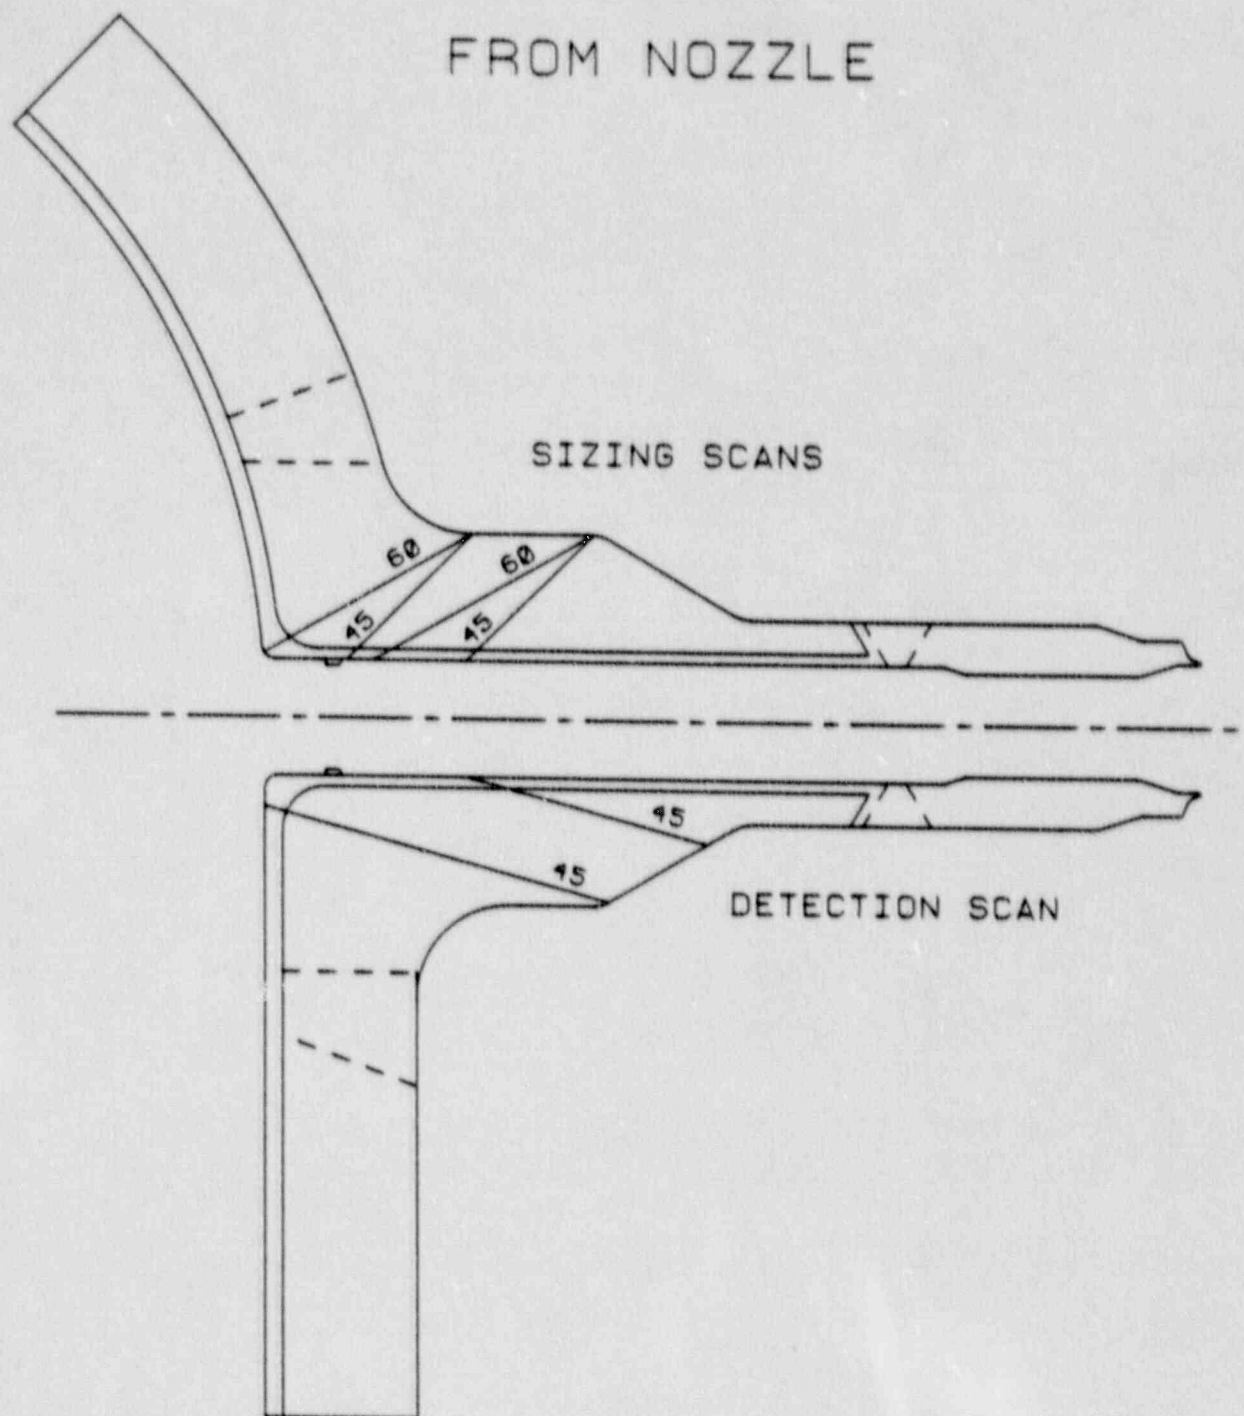
FIGURE 9

AXIAL SCAN COVERAGE FROM NOZZLE

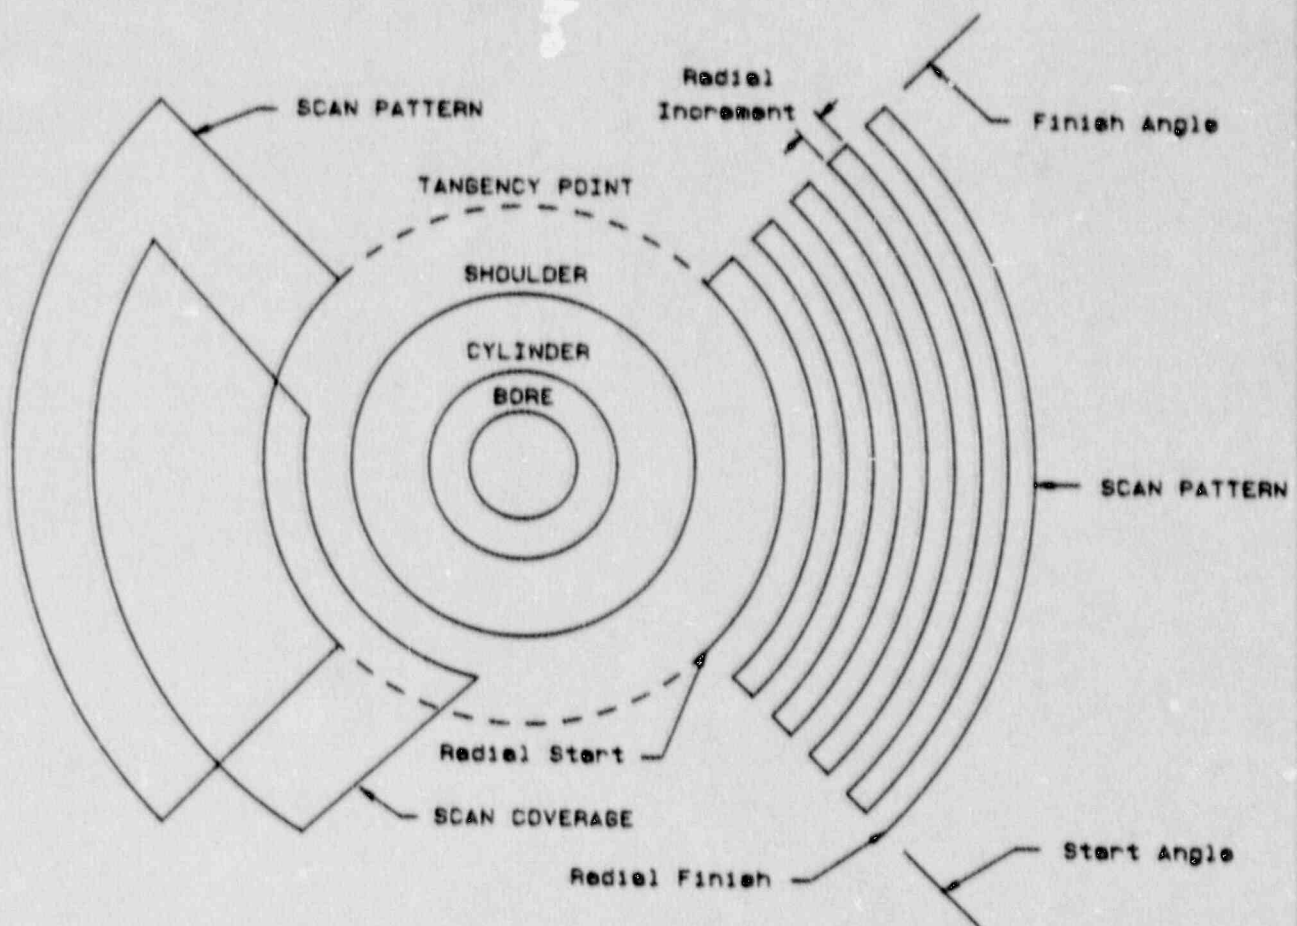
FIGURE 10

CIRCULAR SCAN

From RC Pipe Surface
(Pipe Side Radial Flaws)

Nominal Beam Angle(s) :	45
Wave Mode :	Shear
Detection Transducer :	
Diameter :	3/8 inch
Frequency :	2.25 MHz
Sizing Transducer :	
Diameter :	3/8 inch
Frequency :	5 MHz
Sizing Technique :	Tip Diffraction

Flaws which extend radially outward from the nozzle opening will be detected and sized by different scans as a function of their distance from the center of the nozzle bore. The use of circular scans from the RC pipe (Figure 10) and tangential scans from the RC pipe (Figures 12 and 13) provide overlapping coverage for radial flaws. Sizing of radial flaws in this region will be based on tip diffraction techniques.

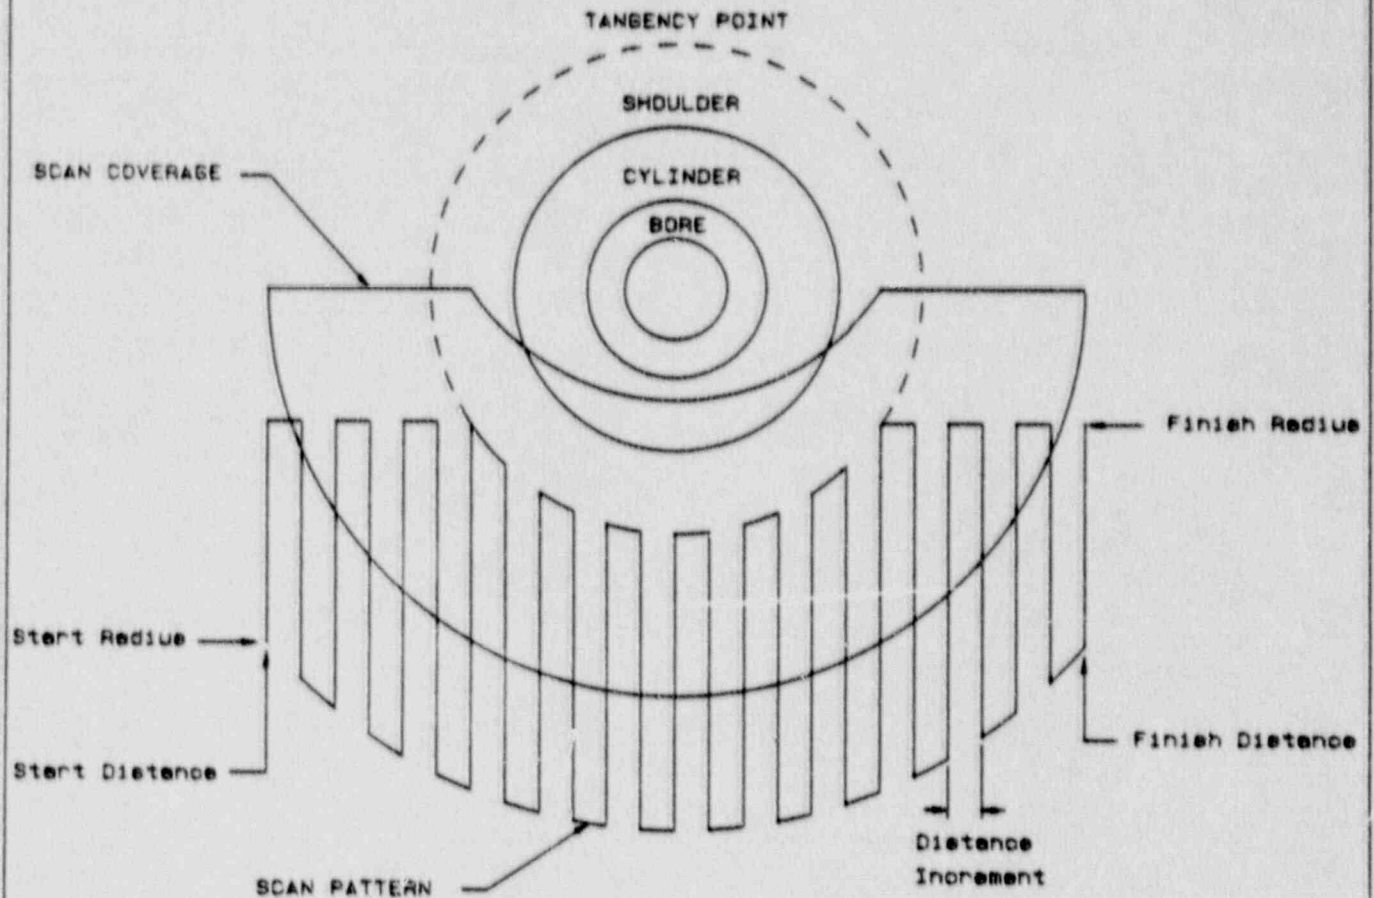
TANGENT SCAN

From RC Pipe Surface

(Axial Flaws in the Nozzle Bore)

(Radial and Circumferential Flaws in the Knuckle)

Nominal Beam Angle(s)	:	57, 66, 75
Wave Mode	:	Shear
Detection Transducer	:	
Diameter	:	1/2 inch
Frequency	:	2.25 MHz
Sizing Transducer	:	
Diameter	:	1/2 inch
Frequency	:	5 MHz
Sizing Technique	:	See Figure 14

pipe (see Figure 12 and 13). The sizing techniques will vary depending on the exact location of the flaw. Flaws which extend through the knuckle radius, forming a corner flaw as shown in Figure 14, have two measurable dimensions, one of which lies along the RC pipe wall and the other along the nozzle wall. These dimensions form two legs of a right triangle. Sizing of this type of flaw will be performed by a "geometric" technique. In this case the depth of the corner flaw will be constructed assuming a triangular geometry using the dimensions which lie along each wall at a right angle to each other.

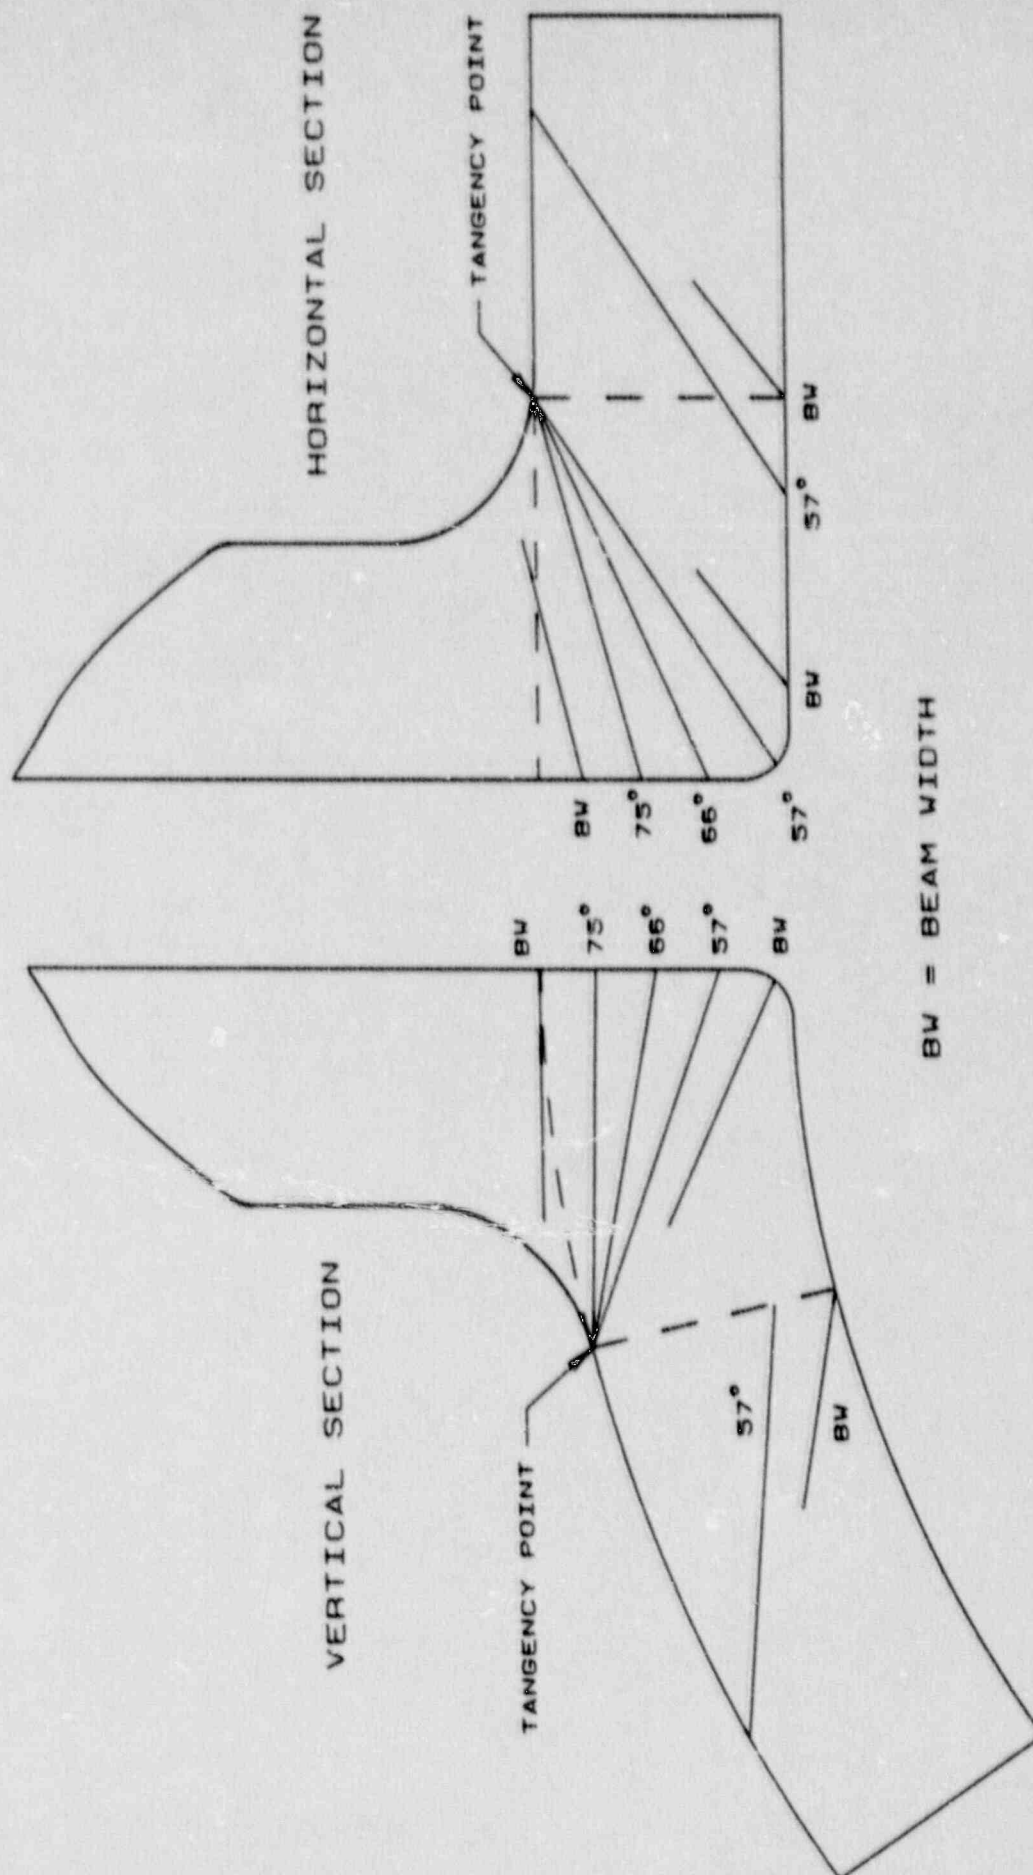
FIGURE 13

TANGENT SCAN COVERAGE

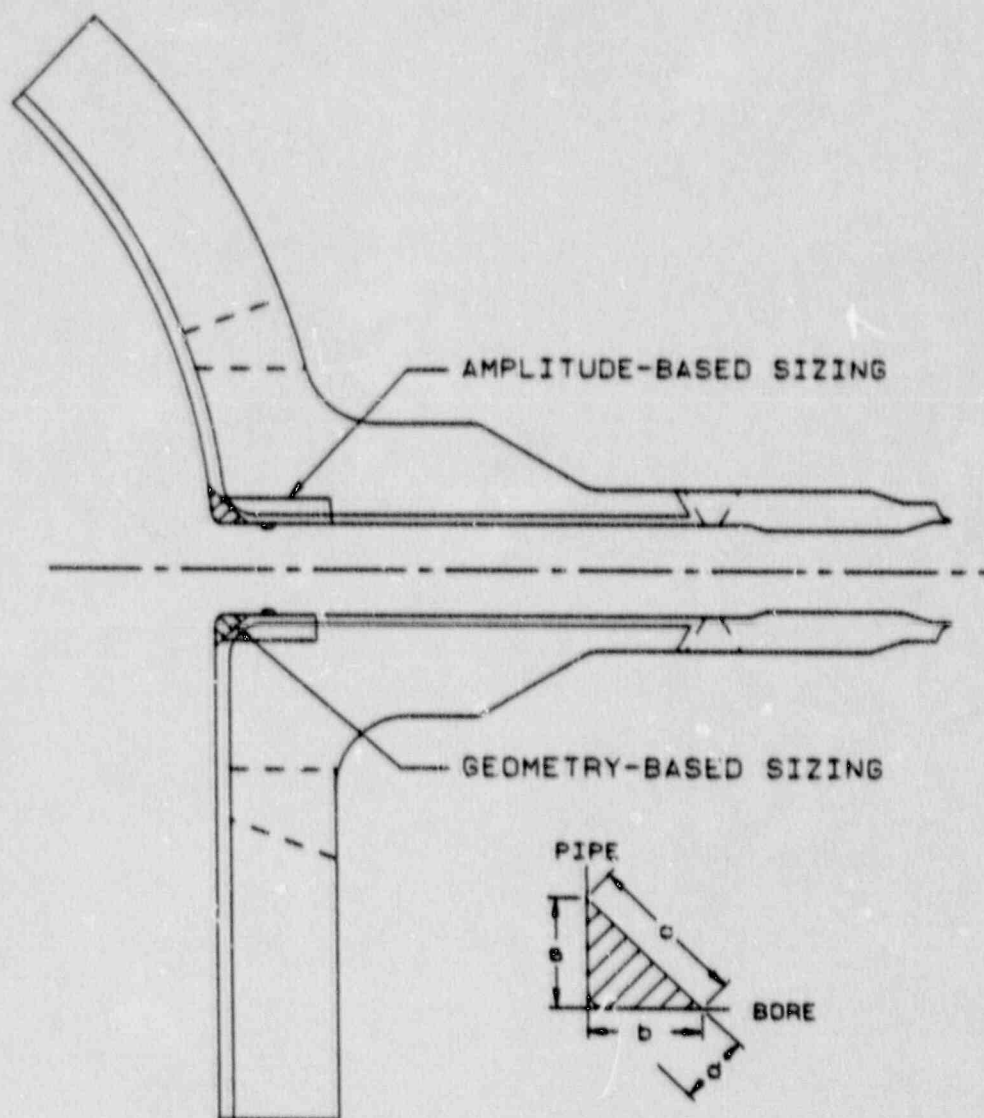
SIZING TECHNIQUES

- TIP DIFFRACTION SIZING USED THROUGHOUT EXCEPT AS NOTED
- AMPLITUDE-BASED SIZING USED FOR AXIAL FLAWS IN THE BORE
- GEOMETRY-BASED SIZING USED FOR AXIAL FLAWS IN THE KNUCKLE
- SUPPLEMENTAL SIZING TECHNIQUES WILL BE APPLIED ON A CASE BY CASE BASIS FOR ANY DETECTED FLAWS

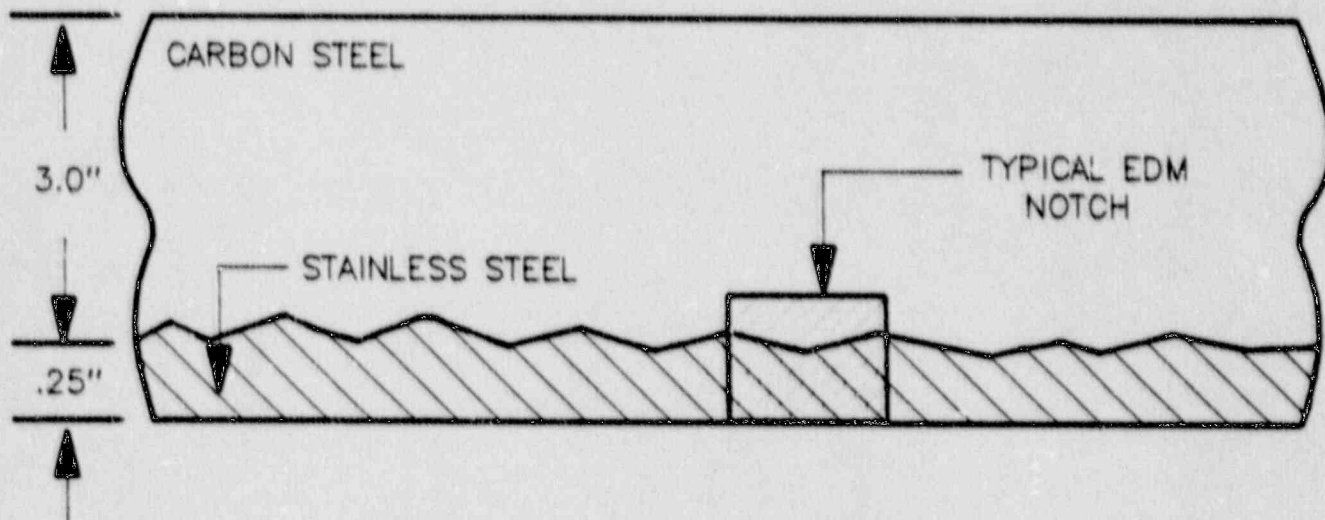
FIGURE 15

BWNS TEST BLOCK

- DEVELOP DETECTION TECHNIQUE
- DEVELOP SIZING TECHNIQUE
- DEFINE TRANSDUCER PARAMETERS
- DETERMINE DETECTABILITY AS A FUNCTION OF FLAW ORIENTATION

Figure 15 is an illustration typical of the types of reflectors used for this portion of the program. One

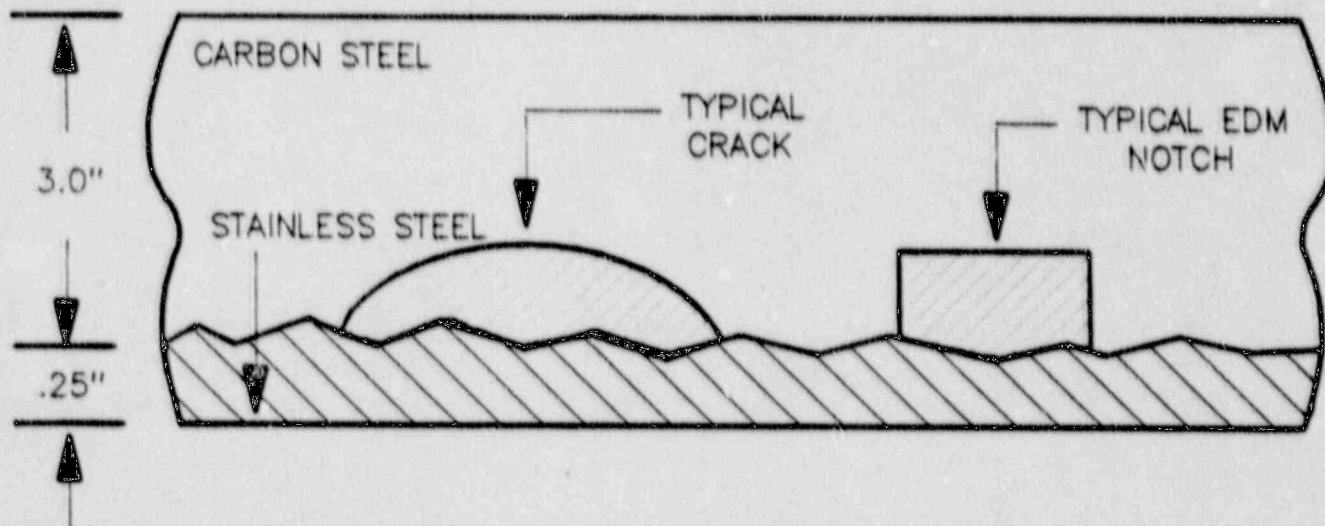
FIGURE 16

EPRI NEAR SURFACE TEST BLOCKS (2)

- "FINE TUNE" DETECTION/SIZING TECHNIQUES
- DETERMINE DETECTION PROBABILITIES
- DETERMINE FALSE CALL PROBABILITIES
- DETERMINE SIZING ACCURACY

Figure 16 illustrates the basic parameters of the EPRI test blocks. The defects were installed in the base material and then cladding was applied over the defects. Two test blocks were provided. The test blocks contained 24 flaws which were oriented within ± 15 degrees of the scans. The flaws included 16 EDM notches and 8 cracks. The 16 notches varied in depth (clad/base metal interface to tip) from approximately 0.15 inch to 0.46 inch. The 8 cracks varied in depth from 0.185 inch to 0.49 inch. The cracks were installed using a process developed to simulate tight flaws such as those which might be expected due to thermal fatigue.

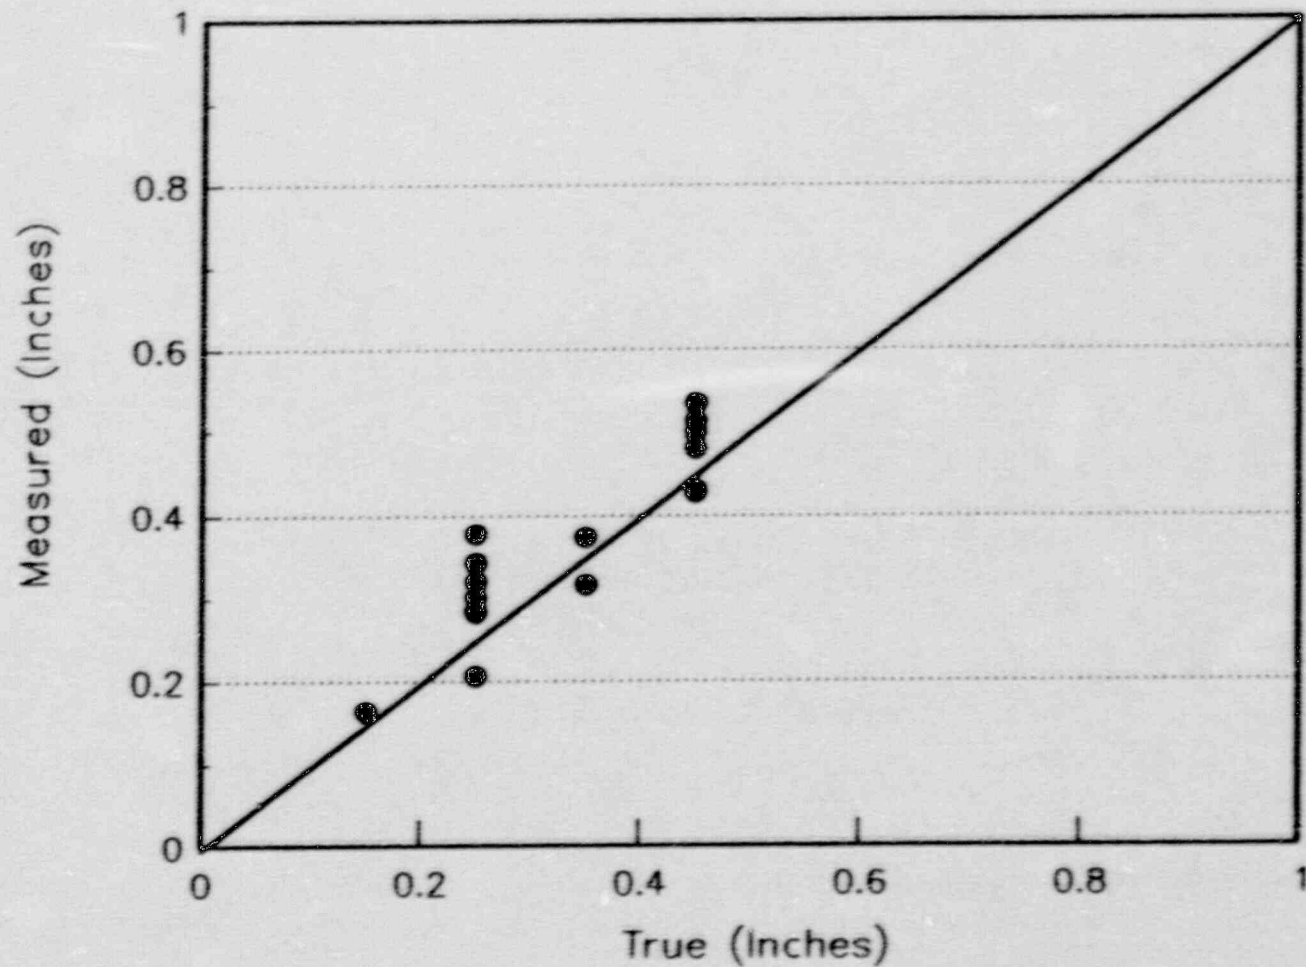
FIGURE 17

EPRI TEST BLOCKS

SELECTED TECHNIQUE

POPULATION: 16 NOTCHES

RMS Error .057 Inch

- o The longitudinal wave transducers did not detect as many flaw tips as compared to an equivalent shear wave angle. However, all flaws were detected with both the longitudinal and shear waves.
- o Tip diffraction sizing with longitudinal waves resulted in larger sizing errors than with shear waves.
- o Figure 17 presents the results for the EDM notches using selected techniques. Evaluation of the sizing of the 16 notches yielded an RMS error of 0.057 inch.
- o Figure 18 presents the results for the cracks using selected techniques. Evaluation of the sizing of the 8 cracks yielded an RMS error of 0.064 inch.

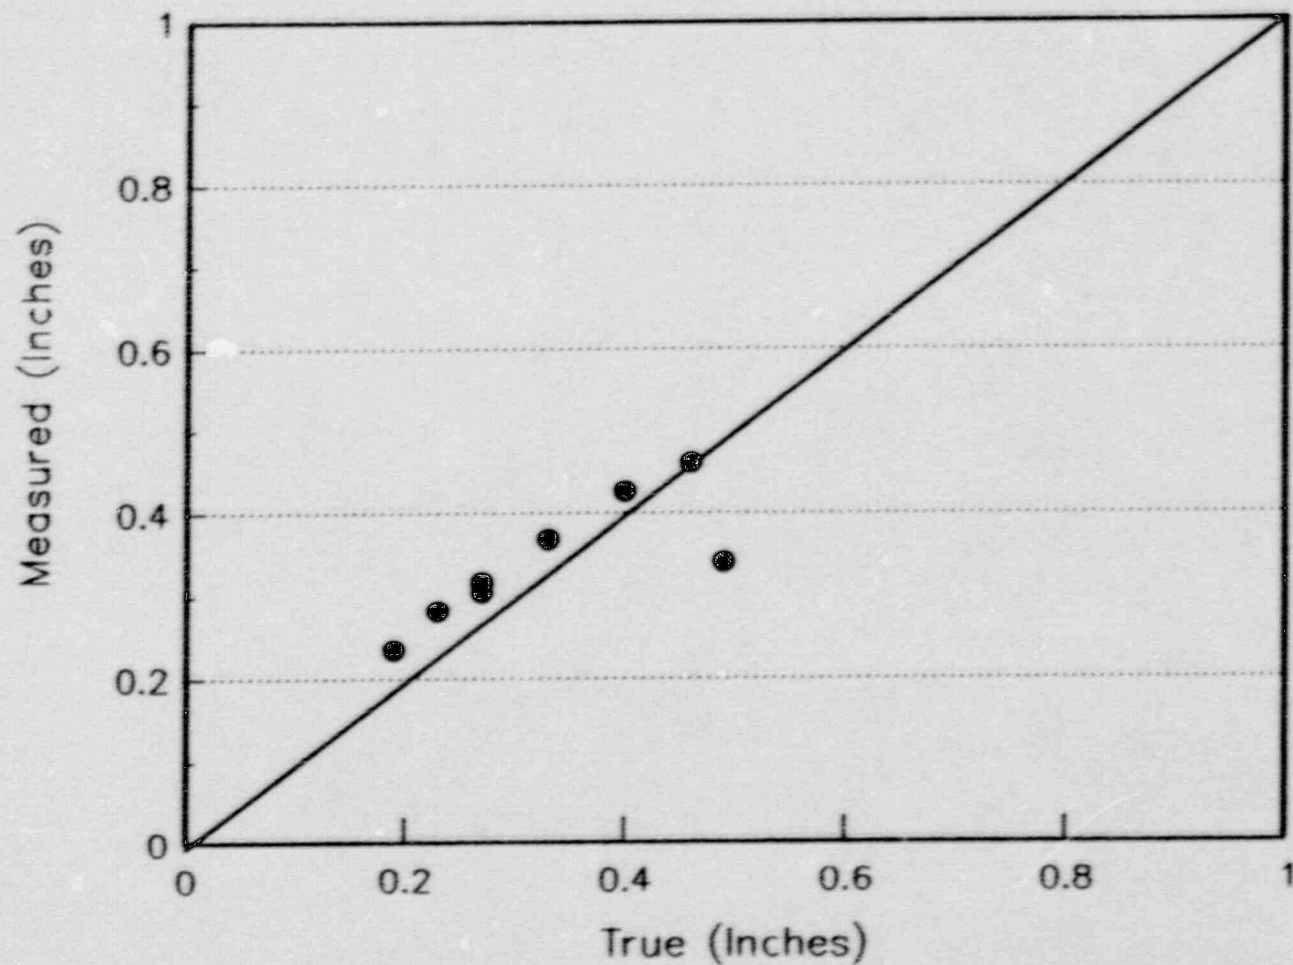
FIGURE 18

SELECTED TECHNIQUE

POPULATION: 8 CRACKS

RMS Error .064 Inch

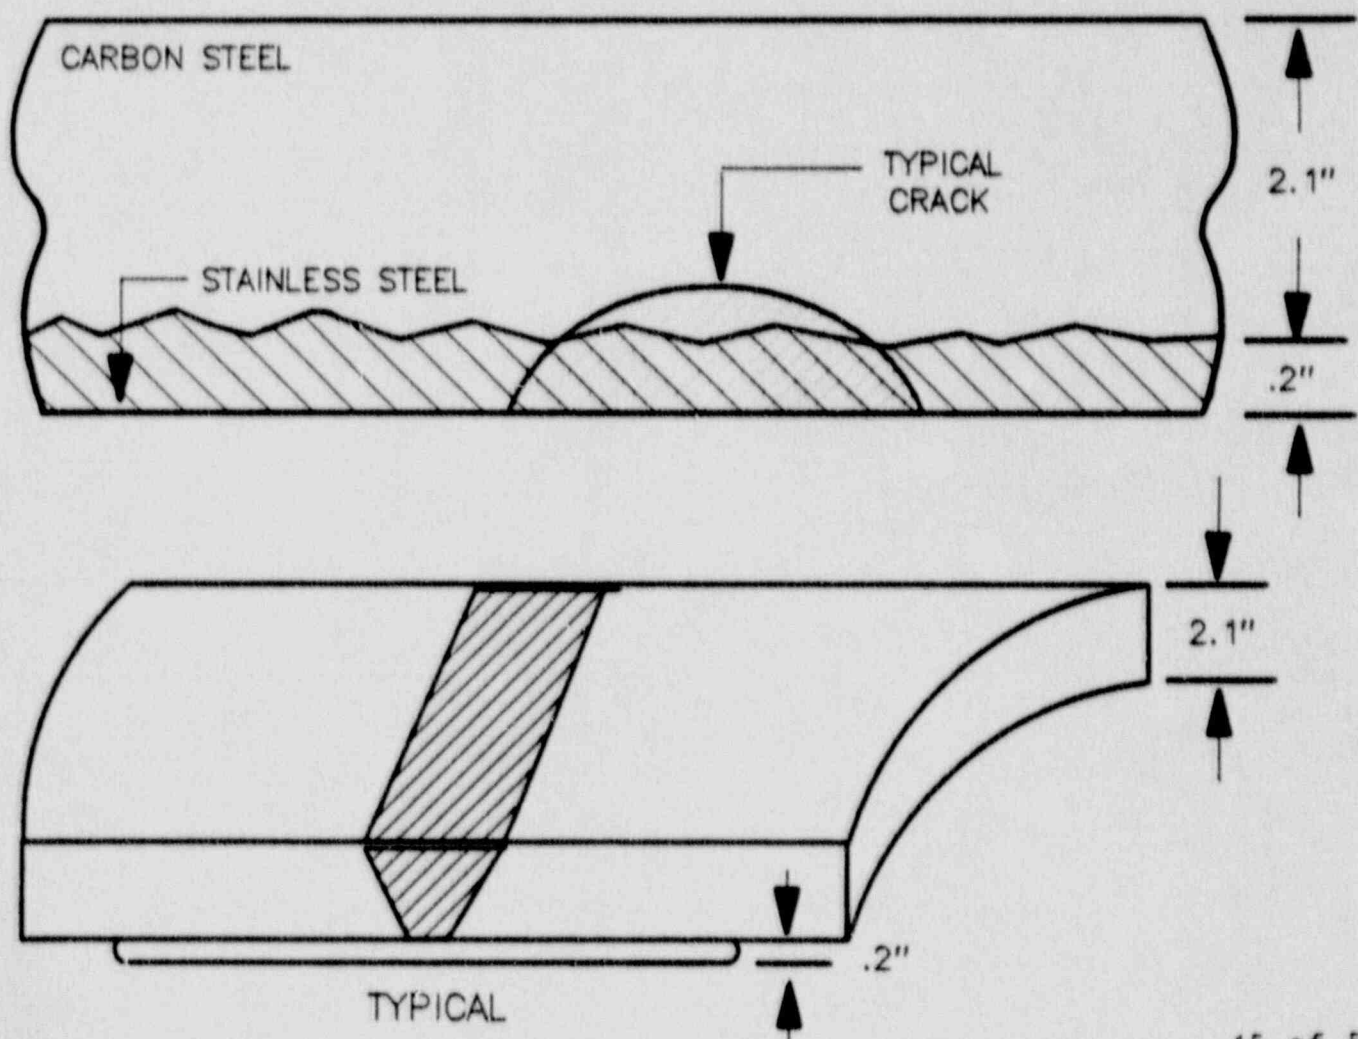
FIGURE 19

BATTELLE PIPING TEST BLOCKS

- DETERMINE DETECTION PROBABILITIES
- DETERMINE FALSE CALL PROBABILITIES
- DETERMINE SIZING ACCURACY

The 9 blocks (see Figure 19) provided by PNL consisted of carbon steel base material with stainless steel cladding. A centrally located, full penetration weld ran the width of each block. All of the flaws except one are located in the weld metal. The installed flaws are representative of thermal fatigue flaws and extended through the cladding into the base material. The set of flaws in these blocks ranges from 0.27 to 0.89 inch in depth. As these flaws are thermal fatigue cracks, true depth had been defined by PNL based upon manual ultrasonic measurements of the installed cracks. Plates were welded over the cladding to ensure that scanning would be blind.

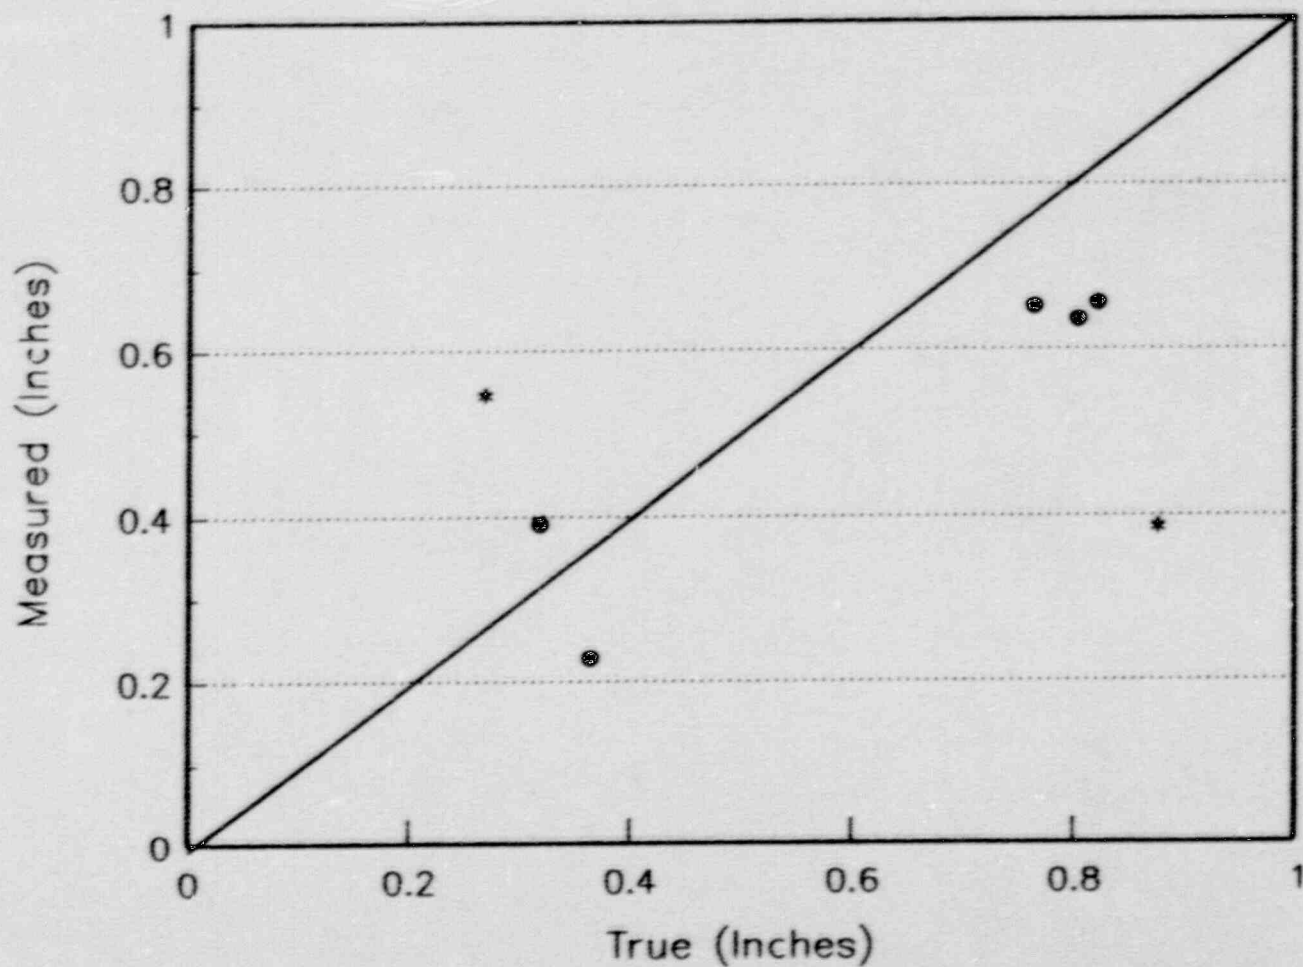
BATTELLE TEST BLOCKS

SELECTED TECHNIQUE

POPULATION: 7 CRACKS

RMS Error .247 Inch

* Invalid measurements due to interference from weld inclusions
