HPI Nozzle Enhanced UT Development

ENHANCED UT DEVELOPMENT

Performed by:
B&W Nuclear Service Company
for
Toledo Edison Company

DOCUMENT NUMBER: 47-1178263-01

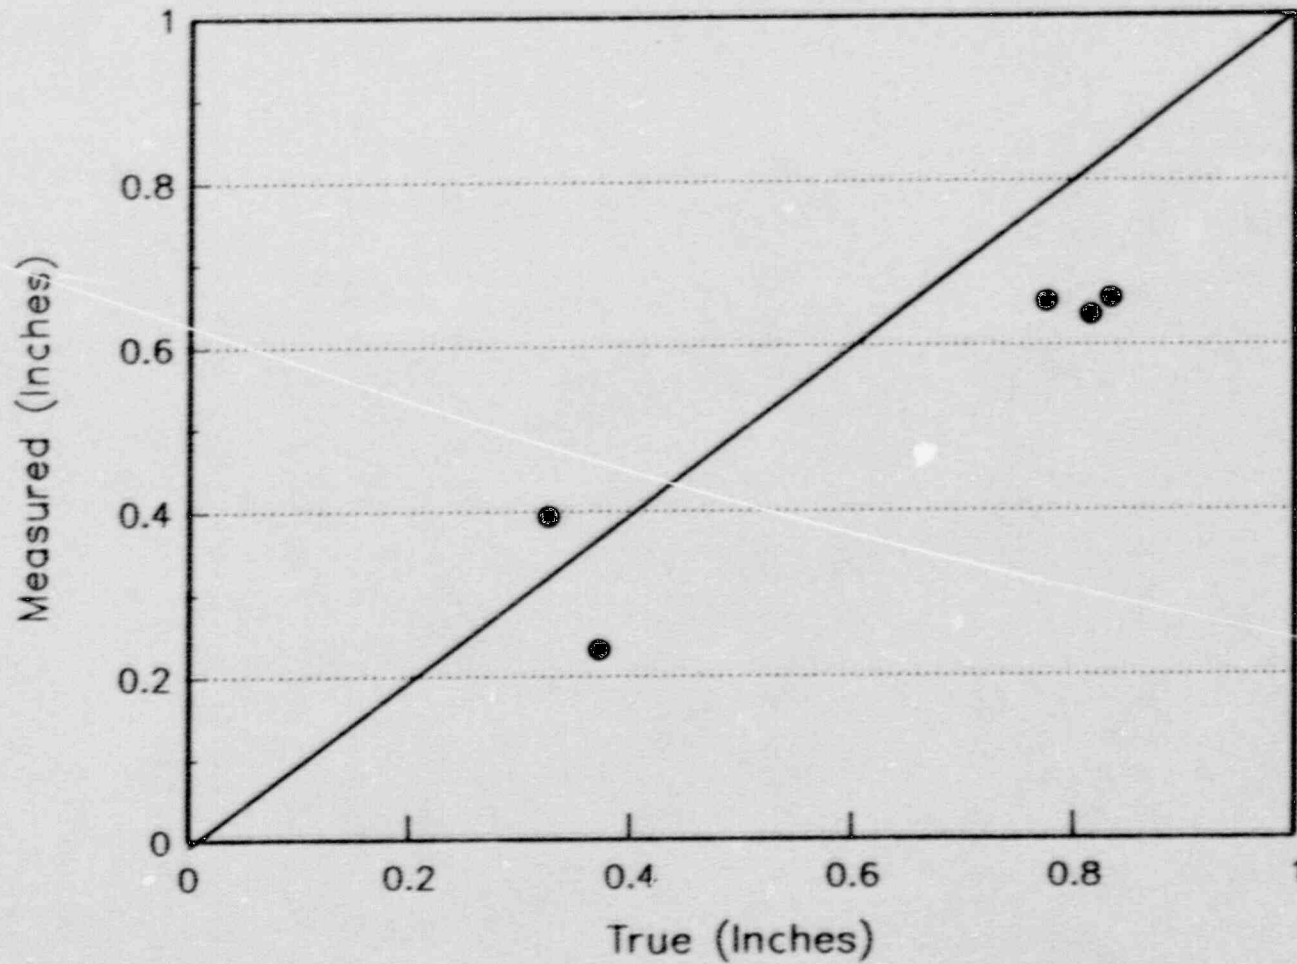
FIGURE 21

SELECTED TECHNIQUE

POPULATION: 5 CRACKS

RMS Error .145 Inch

- o Most of the region of interest in the examination of the HPI/Makeup nozzle at Davis-Besse Unit 1 lies outside of a weld zone. In these areas, sizing will not be affected by extraneous indications. Results of the PNL block evaluation more appropriate to the Davis-Besse situation are shown in Figure 21. These results from the five flaws where flaw tips were not interfered with deviates from PNL's baseline ultrasonic sizing by an RMS error of 0.145 inch.

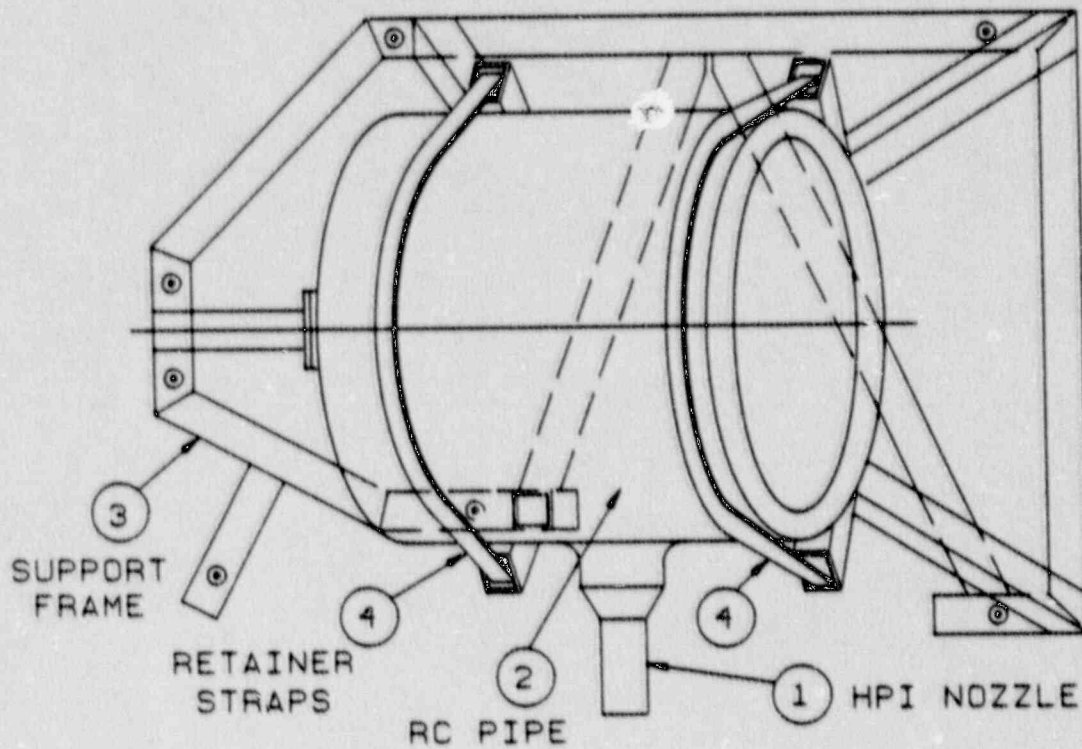
FIGURE 22

NOZZLE / RC PIPE MOCKUP

The Nozzle/RC pipe mockup is illustrated in Figures 22 and 23. Care was taken in the design and construction of the mockup to make it sufficiently similar in configuration, material, and manufacturing process to conclude that it is ultrasonically identical to the HPI nozzles at Davis-Besse Unit 1. Cracks and notches were implanted in the mockup at the EPRI NDE Center. The sizes and locations of these flaws are such that a determination can be made of the detection, location and sizing capability for small flaws spanning the examination region.

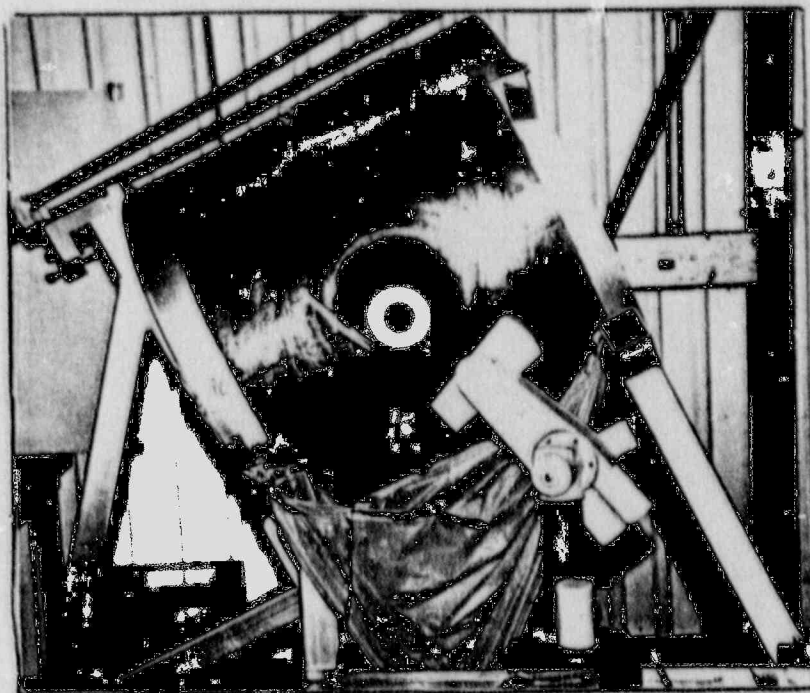
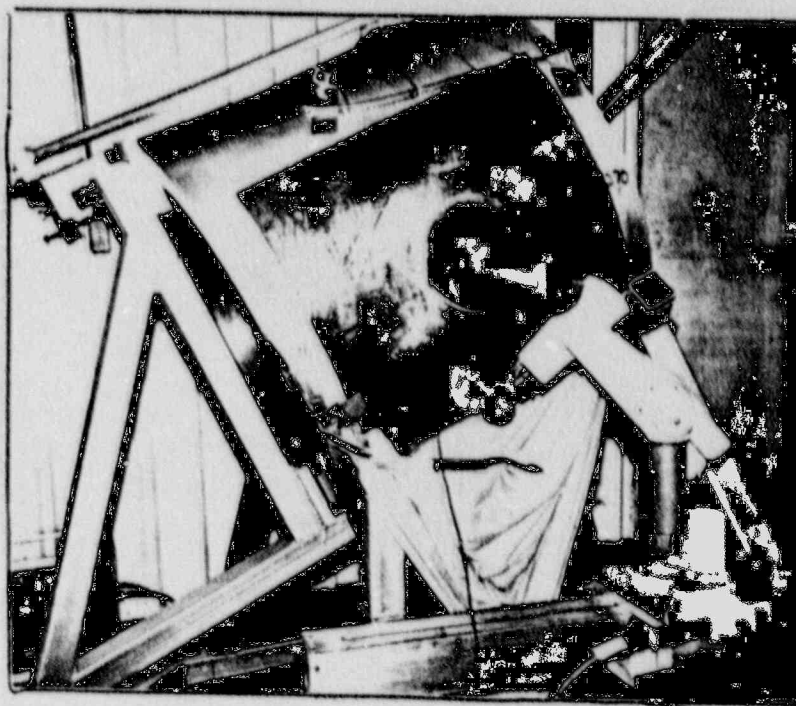
FIGURE 23

NOZZLE / RC PIPE MOCKUP PHOTOGRAPHS

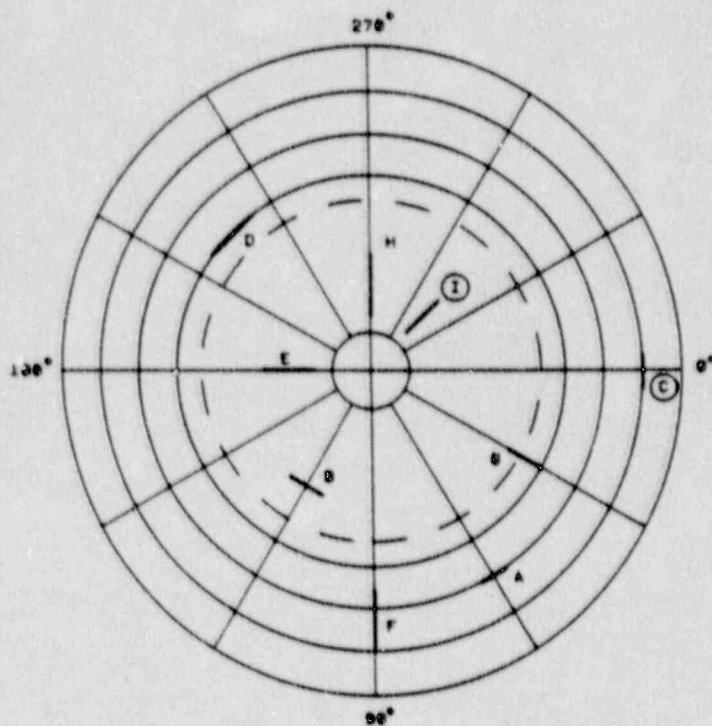
DESIGNATION	DESCRIPTION	ORIENTATION	DESIGN	
			LENGTH	DEPTH
A	EDM NOTCH	90° OFF-RADIAL	0.75°	T+.05°
B	EDM NOTCH	90° OFF-RADIAL	1.00°	T+.15°
(C)	CRACK	90° OFF-RADIAL	0.90°	.50 T
D	EDM NOTCH	90° OFF-RADIAL	1.50°	T+.30°
E	EDM NOTCH	RADIAL	1.35°	T+.05°
F	EDM NOTCH	RADIAL	1.50°	T+.30°
G	EDM NOTCH	RADIAL	1.00°	.50 T
H	EDM NOTCH	RADIAL	1.05°	T+.15°
(I)	CRACK	RADIAL	1.2°	.50 T

NOTE : EDM NOTCH WIDTH IS .014°
T REPRESENTS CLADDING THICKNESS

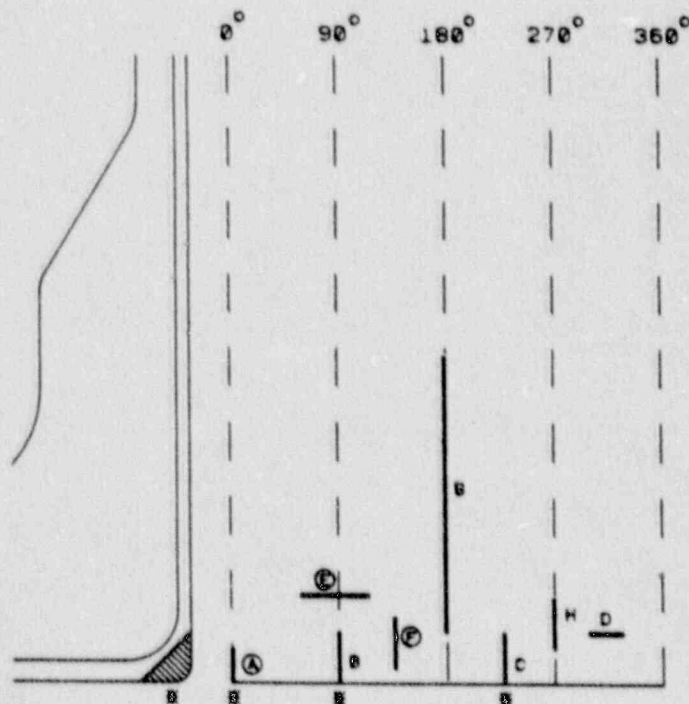
DESIGNATION	DESCRIPTION	ORIENTATION	DESIGN	
			LENGTH	DEPTH
(A)	CRACK	AXIAL	1.00°	.90 T
B	EDM NOTCH	AXIAL	2.00°	T+.15°
C	EDM NOTCH	AXIAL	2.00°	T+.05°
D	EDM NOTCH	CIRCUM.	0.50°	T+.15°
(E)	CRACK	CIRCUM.	1.00°	.90 T
(F)	CRACK	AXIAL	0.75°	.90 T
G	EDM NOTCH	AXIAL	4.00°	T+.15°
H	EDM NOTCH	AXIAL	0.75°	T+.05°

NOTE : EDM NOTCH WIDTH IS .014°
T REPRESENTS CLADDING THICKNESS

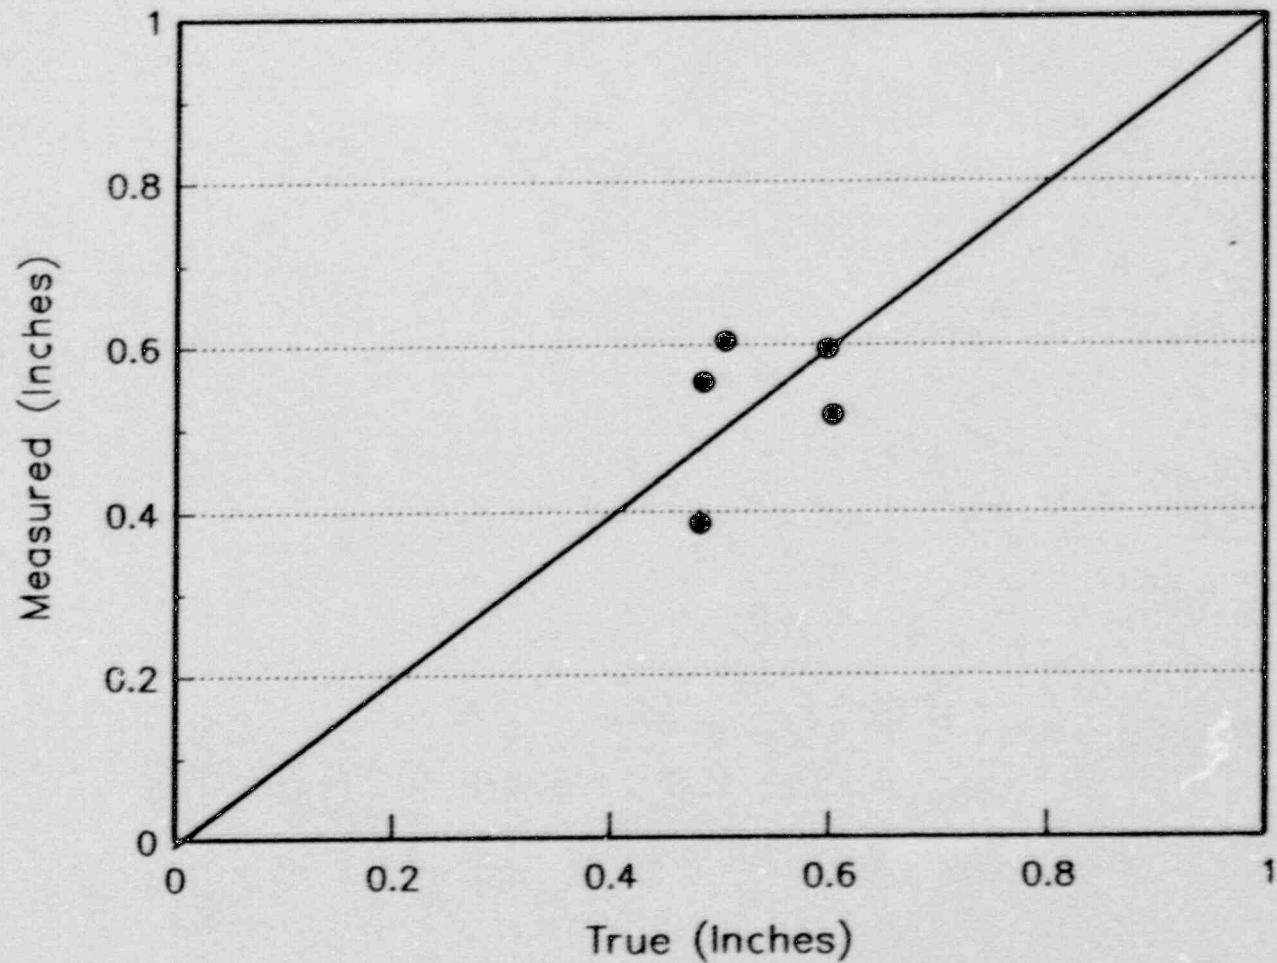
FIGURE 25

SELECTED TECHNIQUE

POPULATION: 5 RC PIPE NOTCHES

RMS Error .081 Inch

Figure 25 shows the results for flaws located in the RC pipe. The flaws detected in the RC pipe were sized with tip diffraction techniques resulting in an RMS error of 0.081 inch.

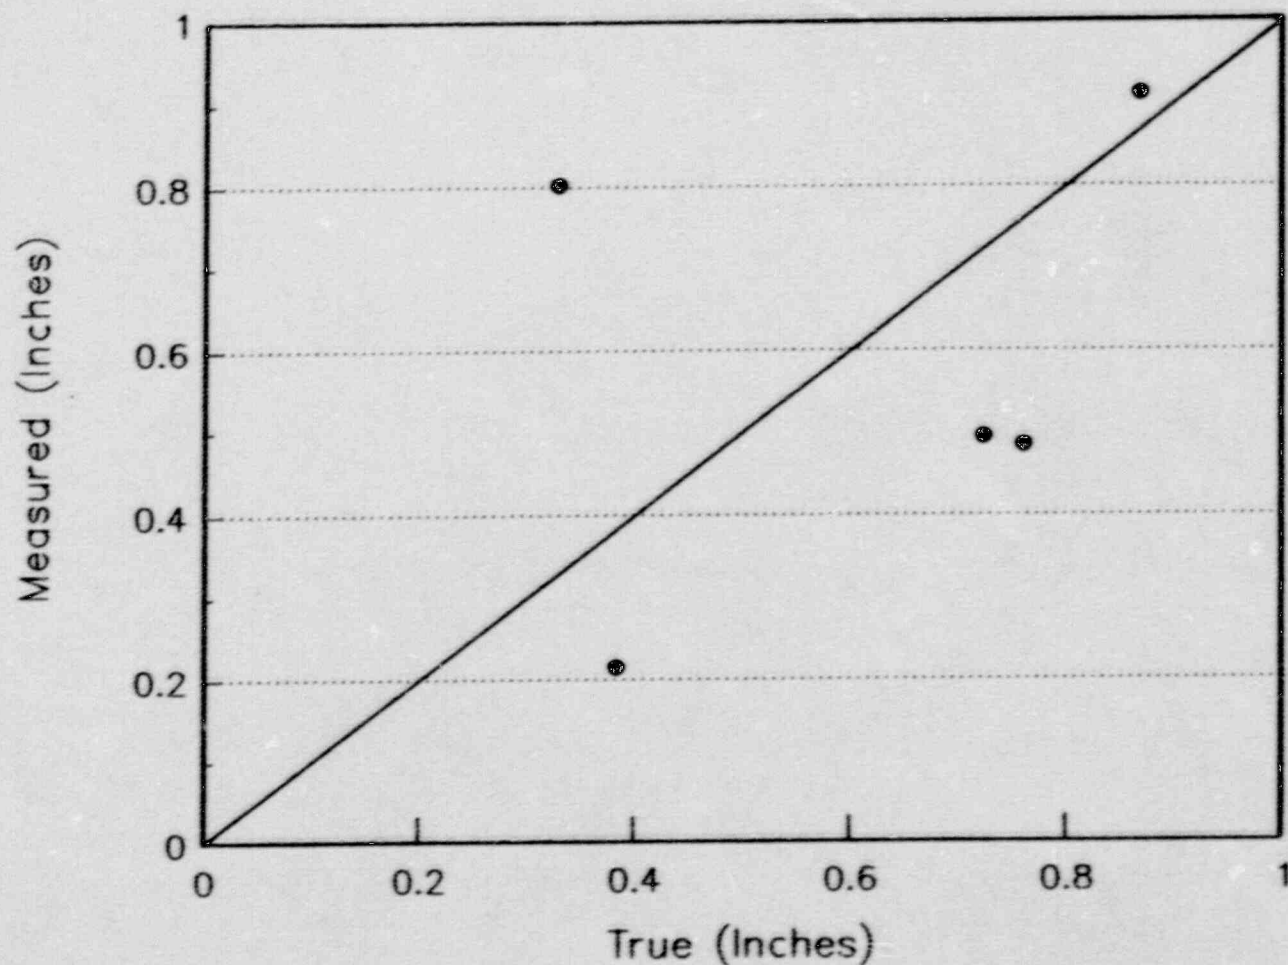
FIGURE 26

SELECTED TECHNIQUE

POPULATION: 5 BORE CRACKS AND NOTCHES

RMS Error .279 inch

Figure 26 shows the results for flaws located in the nozzle bore. All but one of the detected flaws were sized. The sizing was performed with amplitude-based and
