LIMERICK GENERATING STATION

SUBJECT: Licensee Event Report
Limerick Generating Station - Unit 1

This LER reports the closure of a primary containment isolation valve, an Engineered Safety Feature actuation, caused by a faulty microswitch internal to a pressure differential switch.

Reference:	Docket No. 50-352
Report Number:	1-93-002
Revision Number:	00
Event Date:	February 6, 1993
Report Date:	March 03, 1993
Facility:	Limerick Generating Station P.O. Box 2300, Sanatoga, PA 19464-2300

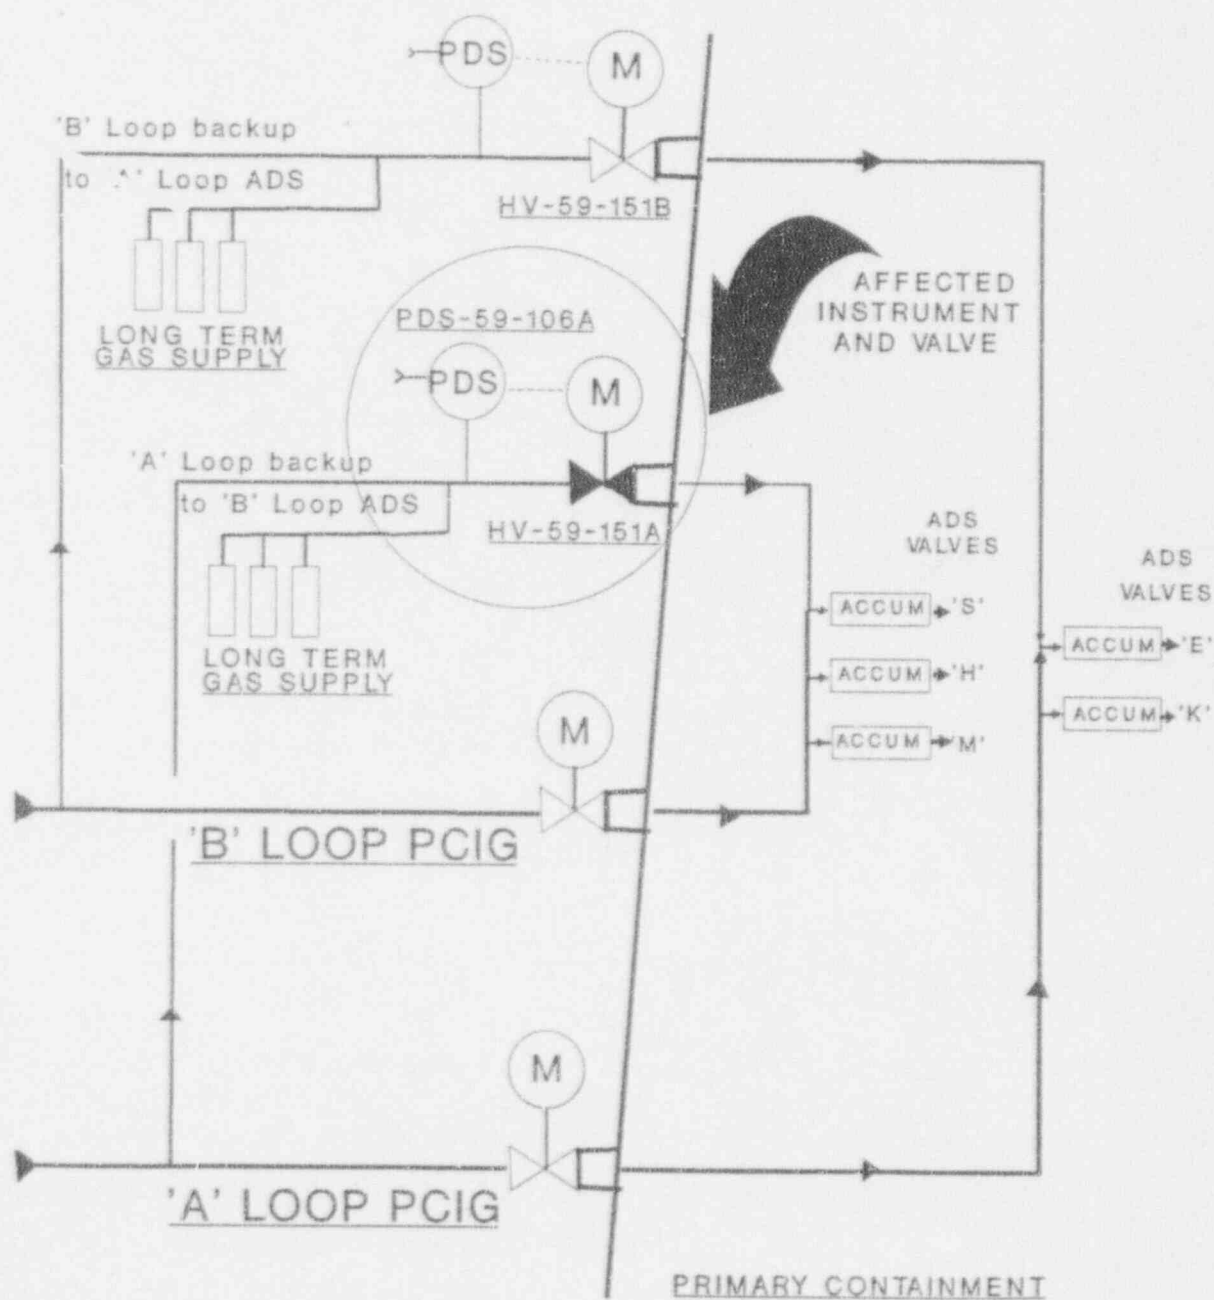
FIGURE 1
SIMPLIFIED DRAWING OF PRIMARY CONTAINMENT
INSTRUMENT GAS

The actual consequences of this event were minimal. There was no release of radioactive material to the environment as a result of this event. No actual loss of pressure differential condition existed prior to or during this event. The PCIV responded as directed by the PDS. The closure of HV-059-151A isolated the 'A' Loop Backup and Long Term Instrument Gas Supply to three of the five ADS valves. The 'B' loop normal gas supply and the individual PCIG system accumulators to each of the three ADS valves were unaffected by the closure. The other two ADS valves, supplied by the 'A' loop of the PCIG system, and the 'B' loop backup, were unaffected by the PCIV closure (see Figure 1). Therefore, the ADS valves remained operable throughout the event. In the event of an accident requiring the operation of the solenoid valves to open the ADS valves, the normal PCIG supply and the PCIG accumulators were available.
