Re: Indian Point Unit No. 2  
Docket No. 50-247

By letter dated August 31, 1978, you requested additional information regarding our facility fire protection program. We are providing in Enclosures 1, 2 and 3 of this letter responses to the questions and staff positions contained in Enclosures 1, 2 and 4 of your letter. As discussed with members of your staff, our response to Enclosure 3 of your letter is in preparation and will be provided shortly.

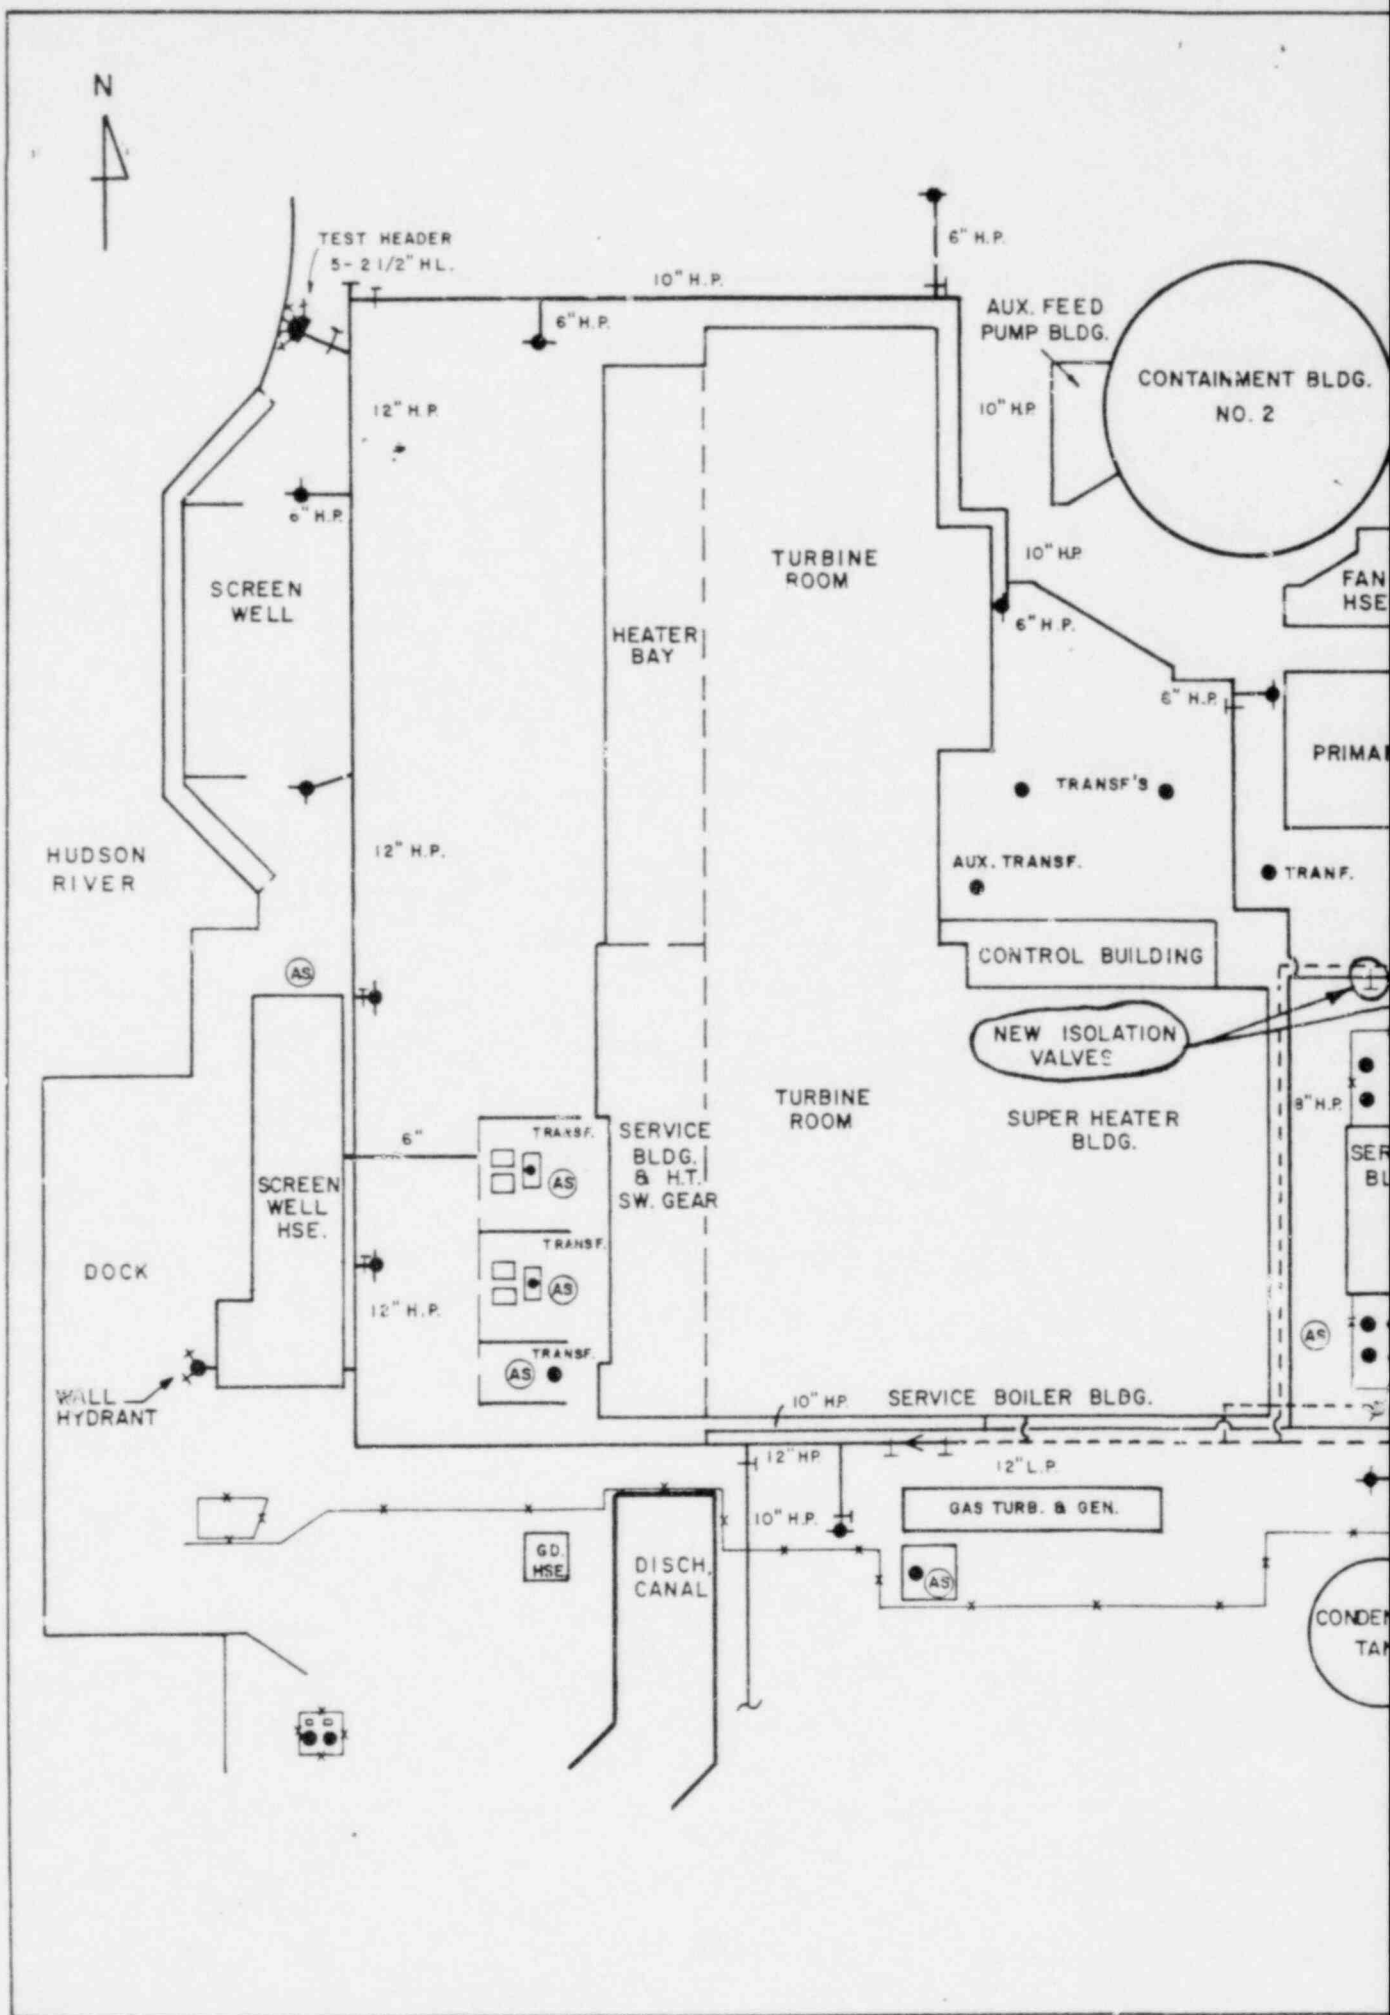
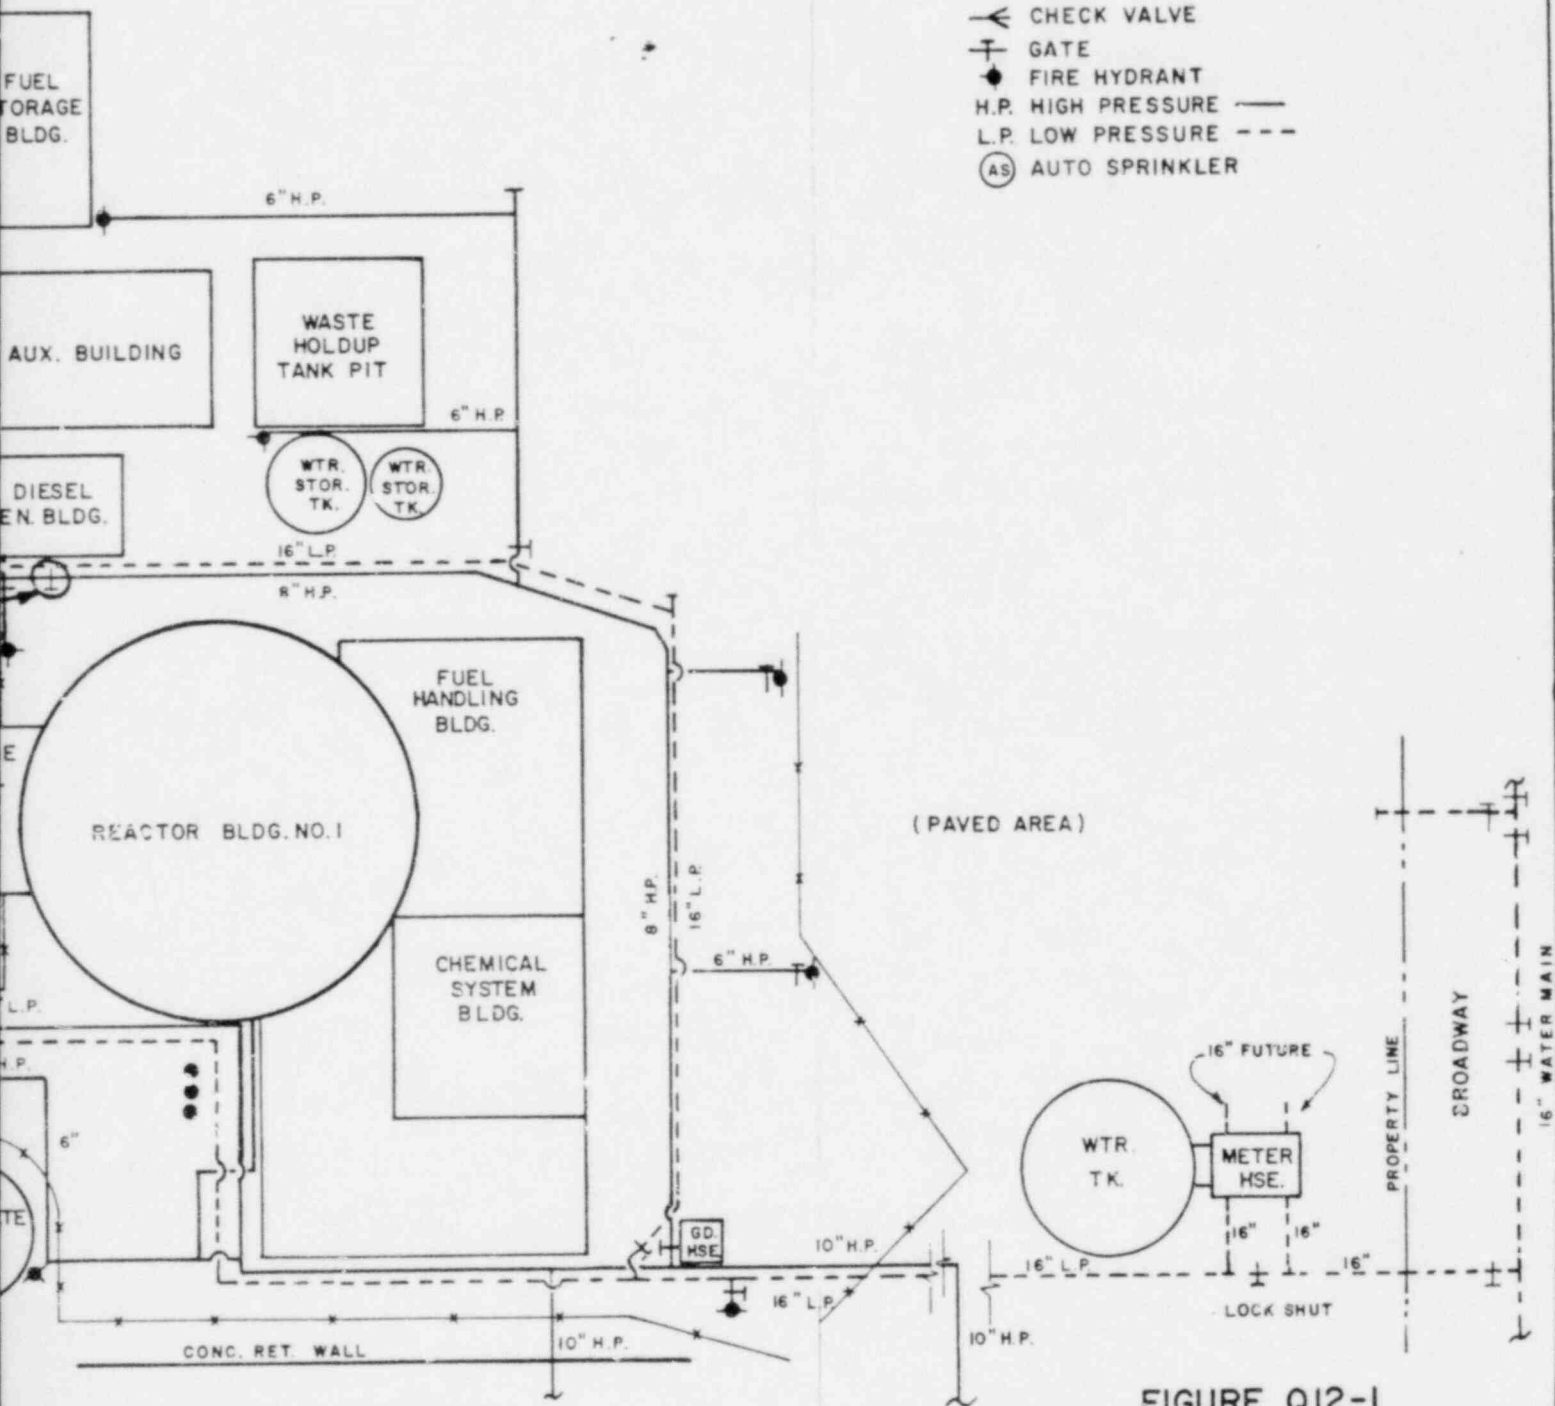
**FIGURE Q12-1**  
**INDIAN POINT STATION**  
**FIRE PROTECTION SYSTEM**

A physical layout of the fire water system is shown in Figure Q12-1.

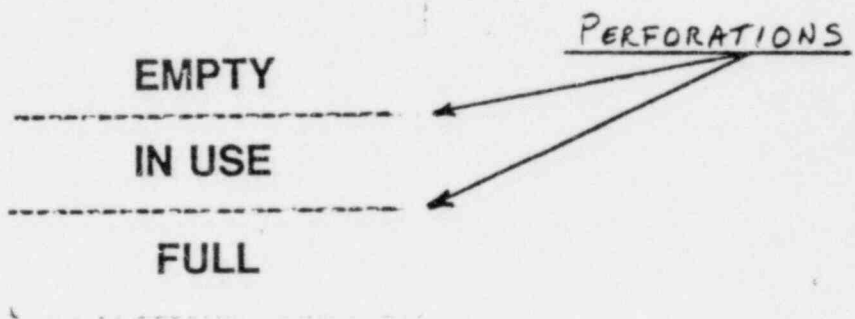
Figure P29-1

# COMPRESSED AIR
