**Commonwealth Edison**

Subject: LaSalle County Station Unit 1  
Response to NRC Inspection  
Report No. 50-373/81-48  
NRC Docket No. 50-373

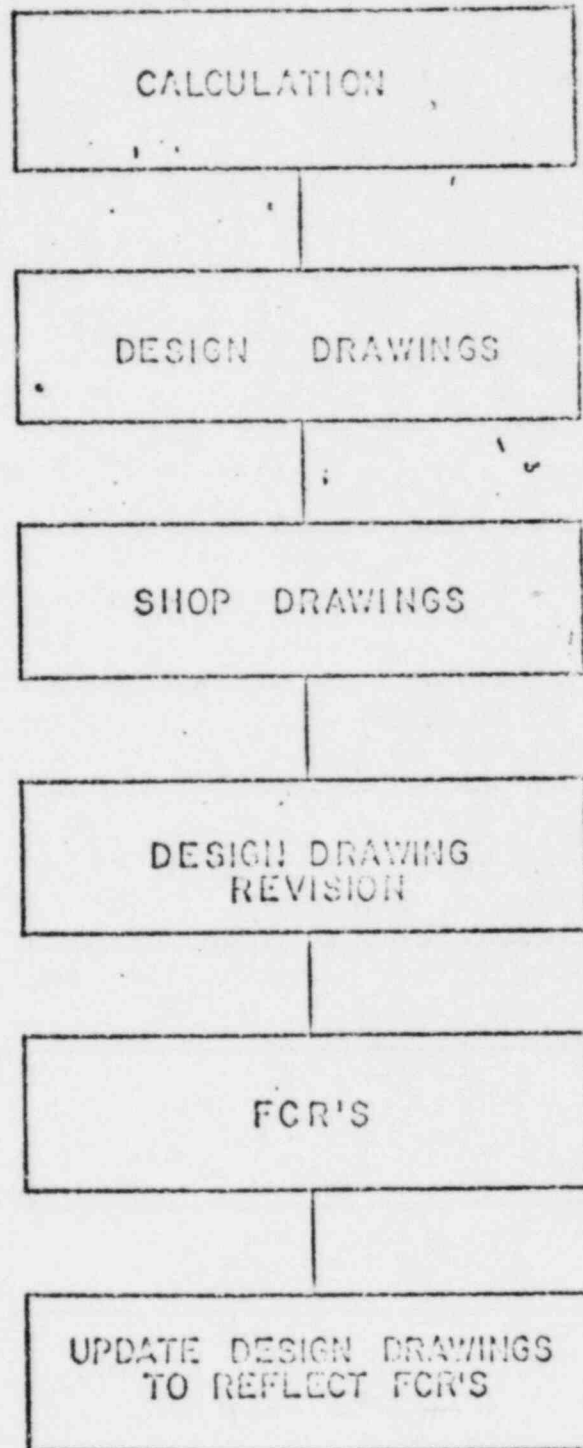
FIGURE - 1.

# DESIGN PROCESS

The steps taken in completion of Design Process are shown in the flow chart shown in Figure 1.
