Crystal River Unit 3  
Docket No. 50-302

Attachment 2

**Technical Basis  
for the  
Crystal River Unit 3  
Plant Specific Procedure  
to resolve  
NRC Generic Letter 87-02**

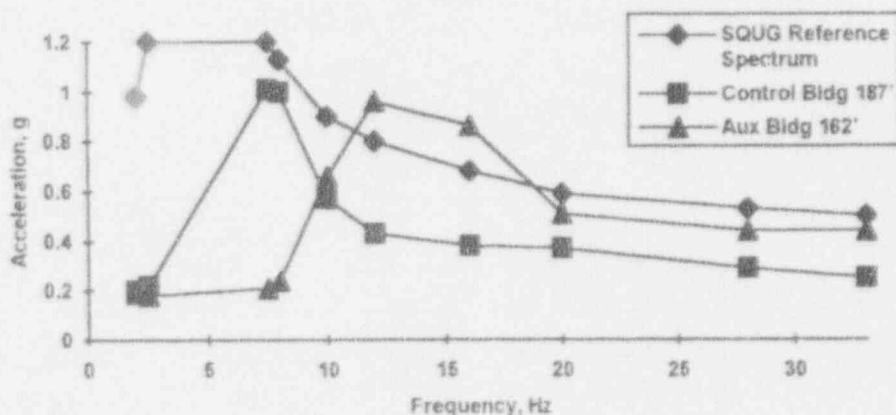
**Figure A1 - CR3 In-Structure Spectra and SQUG Reference Spectrum**

**CR3 In-Structure Spectra.** The following figure summarizes the SQUG Reference Spectrum and CR3 in-structure response spectra (5% damping) at elevations 187 and 162.

Figure A1 shows that the CR3 in-structure spectra are less than the SQUG Reference Spectrum, except around about 11 Hz to 19 Hz at Auxiliary Building elevation 162 (67 ft above free field grade). There are three items of CR3 SSEL equipment at elevations where in-structure spectra exceed the SQUG Reference Spectra. Thus, except for these three items of equipment, the agreed-upon SQUG-defined seismic capacity of the CR3 SSEL equipment (that is, the SQUG Reference Spectrum) exceeds the seismic demand on it. In other words, except for three items of SSEL equipment the CR3 SSEL equipment meet the GIP capacity/demand screening guidelines and commitment.

The purpose of the following discussion is to explain the technical basis for more realistic, but pessimistic, CR3 in-structure spectra at frequencies around about 11 Hz to 19 Hz where the calculated CR3 in-structure spectra in the Auxiliary Building at elevation 162 exceed the SQUG Reference Spectrum. The result of this discussion is that all CR3

**Conclusion.** The seismic demand spectra for all CR3 SSEL equipment, including SSEL equipment at elevation 162 or below with frequencies around 11 Hz to 19 Hz, is found to be less than the SQUG Reference Spectrum (which is the NRC accepted equipment capacity spectrum based on earthquake experience) for all frequencies. Thus, all CR3 SSEL equipment is considered to have a seismic capacity in excess of the seismic demand (if all applicable equipment caveats are met). Note that this conclusion applies only to the adequacy of the capacity of the equipment itself. (The adequacy of the capacity of equipment anchorage must be reviewed separately for each item of SSEL equipment, as discussed elsewhere in this report.)

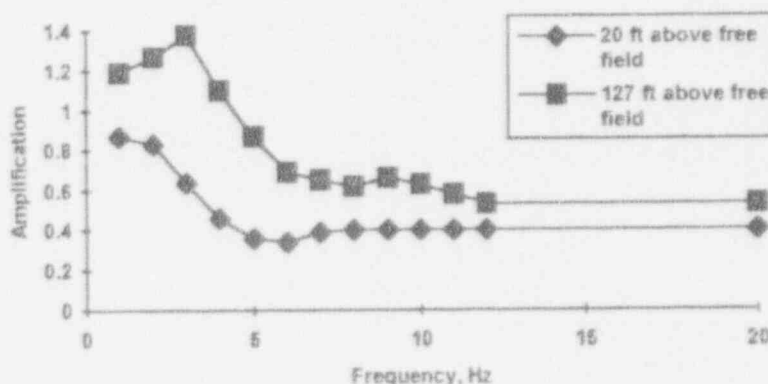
Figure A2 - In-Structure Amplifications from Earthquake Data

Only one set of data are available where horizontal earthquake recordings were made in the *free field* and in nuclear plant *structures*. The data are for measurements in three different reactors in Japan. The three reactors recorded 19, 18, and 14 earthquakes, respectively. Typically, more than one recording was made in each earthquake (for example, the earthquake motion was recorded in the two horizontal directions at a specific in-structure or free-field location.) In-structure recordings were made at 20 and 127 ft above the free field. Figure A2 is a plot of amplification versus frequency for these two elevations. Amplification is defined as the *frequency by frequency quotient* of the *recorded in-structure spectra* (5% damped) at elevation (20 ft or 127 ft) and the *recorded free field spectra*, versus frequency.

The data in Figure A2 show that the maximum recorded horizontal amplification is about 1.4 at 127 ft above free field. The amplification at 20 ft is based on the average<sup>1</sup> of 48 records, while the amplification at 127 ft is based on the average of 71 records. Statistically, since the amplifications are based on such a large number of records, this means that the amplification estimates are robust.

These data are from a reactor building at a *soil site*. However, CR3 is a *rock site*. Therefore, to use these amplifications at a rock site like CR3 we must correct them for the effects of the different foundation materials (rock instead of soil). This is usually assumed to mean the amplifications in Figure A2 for a soil site will be increased if the same earthquakes had occurred at a rock site. However, there are data that do not support this assumption. See the section below titled "*Confirming Earthquake Data*." Nevertheless, in this section we will proceed using the assumption that because CR3 is a rock site the amplifications in Figure A2 must be *increased* to apply them to CR3.

For the next softest soil condition, 1,000 fps (which is more representative of the soil properties for the Figure A2 data--see Reference A3), the above worst case factor becomes 3.4 instead of 4.9.

The sensitivity study factors of 2.5 to 1.8 are considered to be acceptable and probably pessimistic factors for the rock conditions at CR3 versus the soil conditions in the earthquake data in Figure A2. This means that, around about 11 Hz to 19 Hz, the earthquake amplifications shown in Figure A2 for a soil site are not expected to be amplified more than about 2.5. Thus, the total amplification of the CR3 SSE spectra around about 11 Hz to 19 Hz is the factor of 0.53 from the data in Figure A2 times the factor of 2.5 from the analytical studies, or a total amplification of about 1.3. Since an amplification of 1.3 around about 11 Hz to 19 Hz is less than the maximum tolerable amplification of 5 discussed above (obtained by working backwards), this means that more realistic, but still pessimistic, CR3 in-structure spectra around about 11 Hz to 19 Hz are less than the SQUG Reference Spectrum.

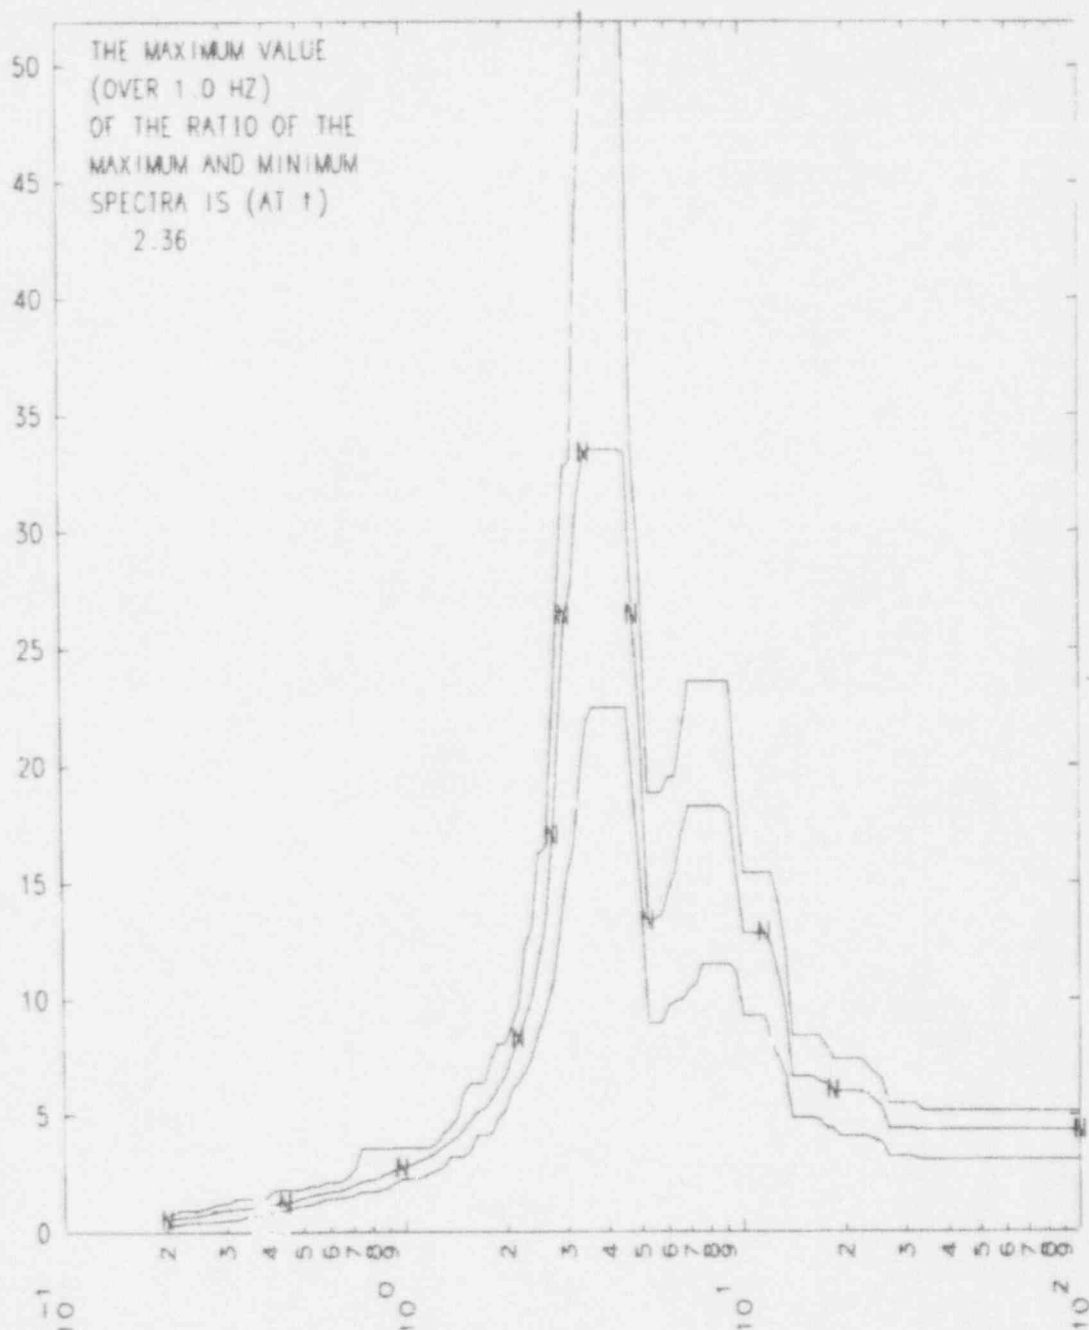
Figure 11 from Reference A4

MATHEMATICAL MODEL FOR MAIN STEAM VALVE HOUSE & QUENCH SPRAY AREA

KEY = 3 NODE = 6 DIRECTION = 1 DT = 0.0100 SEC CODE = 02/15/80R  
STRUCTURAL DAMPING IN ALL MODES 5.0% AVERAGE DVFFV BROADENED 15%

MAX. MEAN + MIN. ACC. SPECTRA (RG EQ, GEES) VS FREQUENCY (HZ) 2.0% DAMP

Amplification is properly defined as an average (of the quotients). That variations in in-structure "amplification" are obtained from one time history to another does not imply that the capability of the structure to amplify motion varies from one earthquake to another. This can be seen the easiest from analytical studies where the analytical model of the structure is exactly the same from one analysis to another, yet variations in "amplification" result when different time histories are used as inputs to the analysis (see the discussion below on Figure 11).

5. For example, see Figure 11 of Reference A4--which plots the upper and lower bounds of 3,072 spectra instead of "only" 10. Figure 11 shows that variations in in-structure spectra of more than a factor of 2 are possible with 2% damped spectra. In Figure 11, the maximum variability is a factor of 2.36 at about 3.5 Hz. Figure 11 is included on Page A-9 for the convenience of the reader.

Section 4.2.4 of the GIP also refers to Reference A4--the same reference from which Figure 11 was obtained--in defining realistic, median-centered spectra.

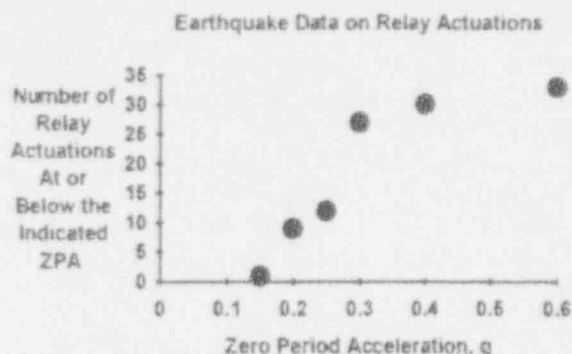
4. Note that data from mercury switches and sudden pressure relays have been omitted from this table. However, this does not change the conclusions. On the contrary, it results in a marginally pessimistic interpretation of the data--see the probabilities below.

We fit a normal distribution to these data (the above data yield a mean of 0.3g, standard deviation of 0.12, coefficient of variation, CCV, of  $0.12/0.3 = 0.4$ ), and used a standard table of the normal distribution, to interpret them statistically as follows: The probability of relay actuation for ZPAs at and below the CR3 SSE ZPA of 0.1g is about  $4.7 \times 10^{-2}$ . This probability happens to decrease slightly when actuations of devices like mercury and sudden pressure switches are included.

We believe these data are skewed pessimistically. In other words, we believe the actual probability of relay actuation is less than  $4.7 \times 10^{-2}$ . The reason is that the data are exclusively "failure" (actuation) data, rather than data that include *success* and *failure*. In addition, the data are based on a relatively large population of *weak link cases* over a relatively large population of *facilities and sites*. We believe this means these data include *more different kinds of root causes of actuation than should be expected to exist at a single site such as CR3*. This conclusion that these data are pessimistic is partially assessed in the following evaluation, which includes some effects of success data.
