In the Matter of)	
)	Docket Nos. 50-329-OM
CONSUMERS POWER COMPANY)	50-330-OM
)	50-329-OL
(Midland Plant, Units 1)	50-330-OL
and 2))

During the hearings which were held in November and December, 1982, Applicant agreed to provide (or in one case, to consider providing) the parties and the Board with the following additional information:

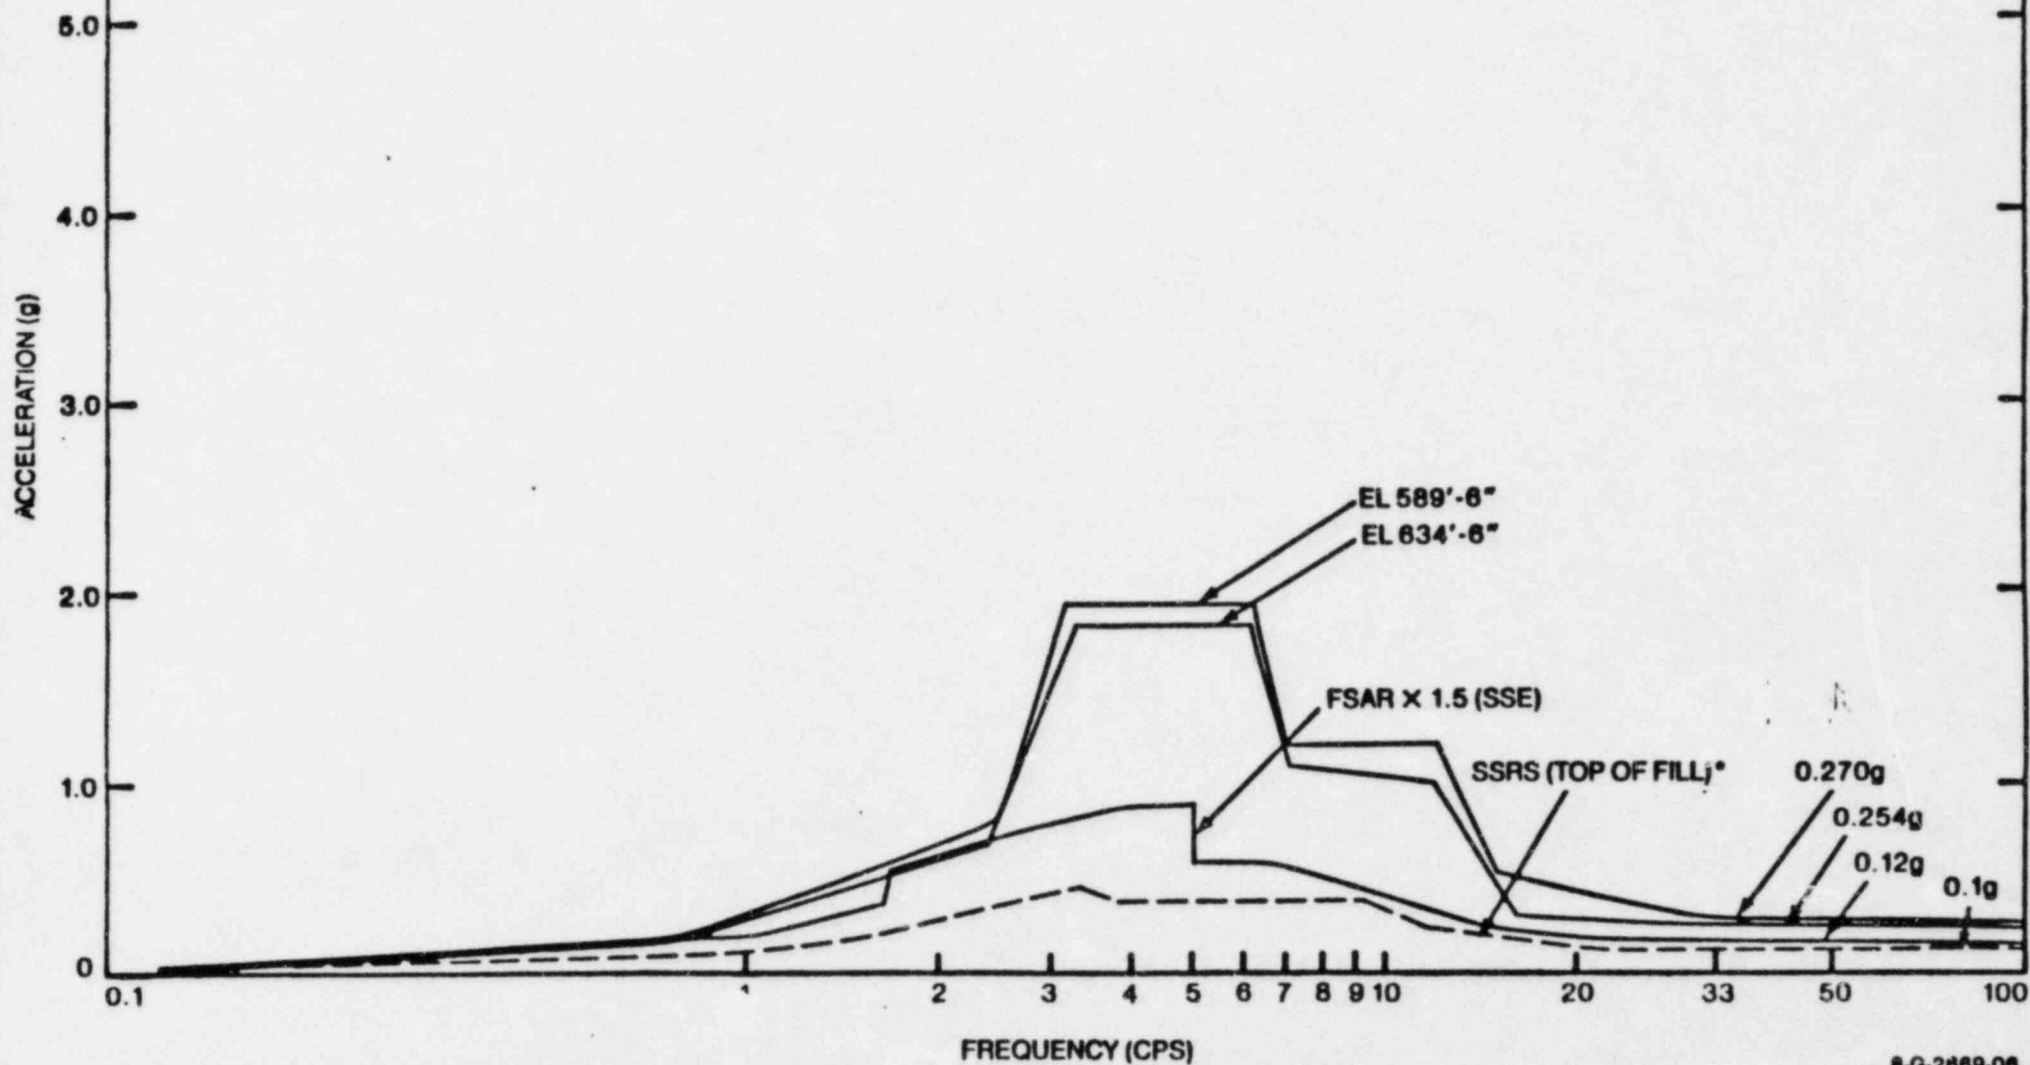
Figure 6

SERVICE WATER PUMP STRUCTURE
VERTICAL DIRECTION
DAMPING RATIO: 0.5%
SSE GROUND ACCELERATION

Figures 1 through 3, which are applicable to the supply lines, compare the floor response spectra at different elevations inside the SWPS to the site specific response spectra for the top of the fill and to 1.5 x FSAR SSE ground response spectra. Figures 4 through 6 make the same comparison for the return lines. Figure 1, for example, shows that for the enveloping spectra the zero period acceleration is 0.332g, compared to 0.149g for the SSRS and 0.18g for 1.5 x FSAR SSE. (For underground piping outside the building the zero period acceleration is an appropriate basis for comparison.)

The seismic analyses described in A and B above used floor response spectra derived from 0.5% damping rather than the current FSAR requirement of 2% damping. This is a significant source of additional conservatism for piping inside the structure, but it does not add significant conservatism for underground piping outside the SWPS. All of the spectra shown in Figures 1 through 6 are for 0.5% damping.^{2/}

^{2/} There is a minor drafting error in all of the figures which has no effect on the matters discussed in this affidavit. The NRC Staff and Applicant have agreed that the SSRS developed by Western Geophysical should be modified to coincide with the Housner spectrum at long periods (low frequencies). This is not shown in the attached figures. However, the low frequency portions of the response spectra are not important in the seismic analysis of buried piping. In other words, only the right sides of Figures 1 through 6 are relevant for purposes of this discussion.
