Subject: Byron Station Units 1 and 2
Braidwood Station Units 1 and 2
Waterhammer Prevention
NRC Docket Nos. 50-454/455 and 50-456/457

This is to provide information regarding the prevention of steam generator waterhammer at Byron and Braidwood stations. This supplements the information which was provided to the NRC in reference (a).

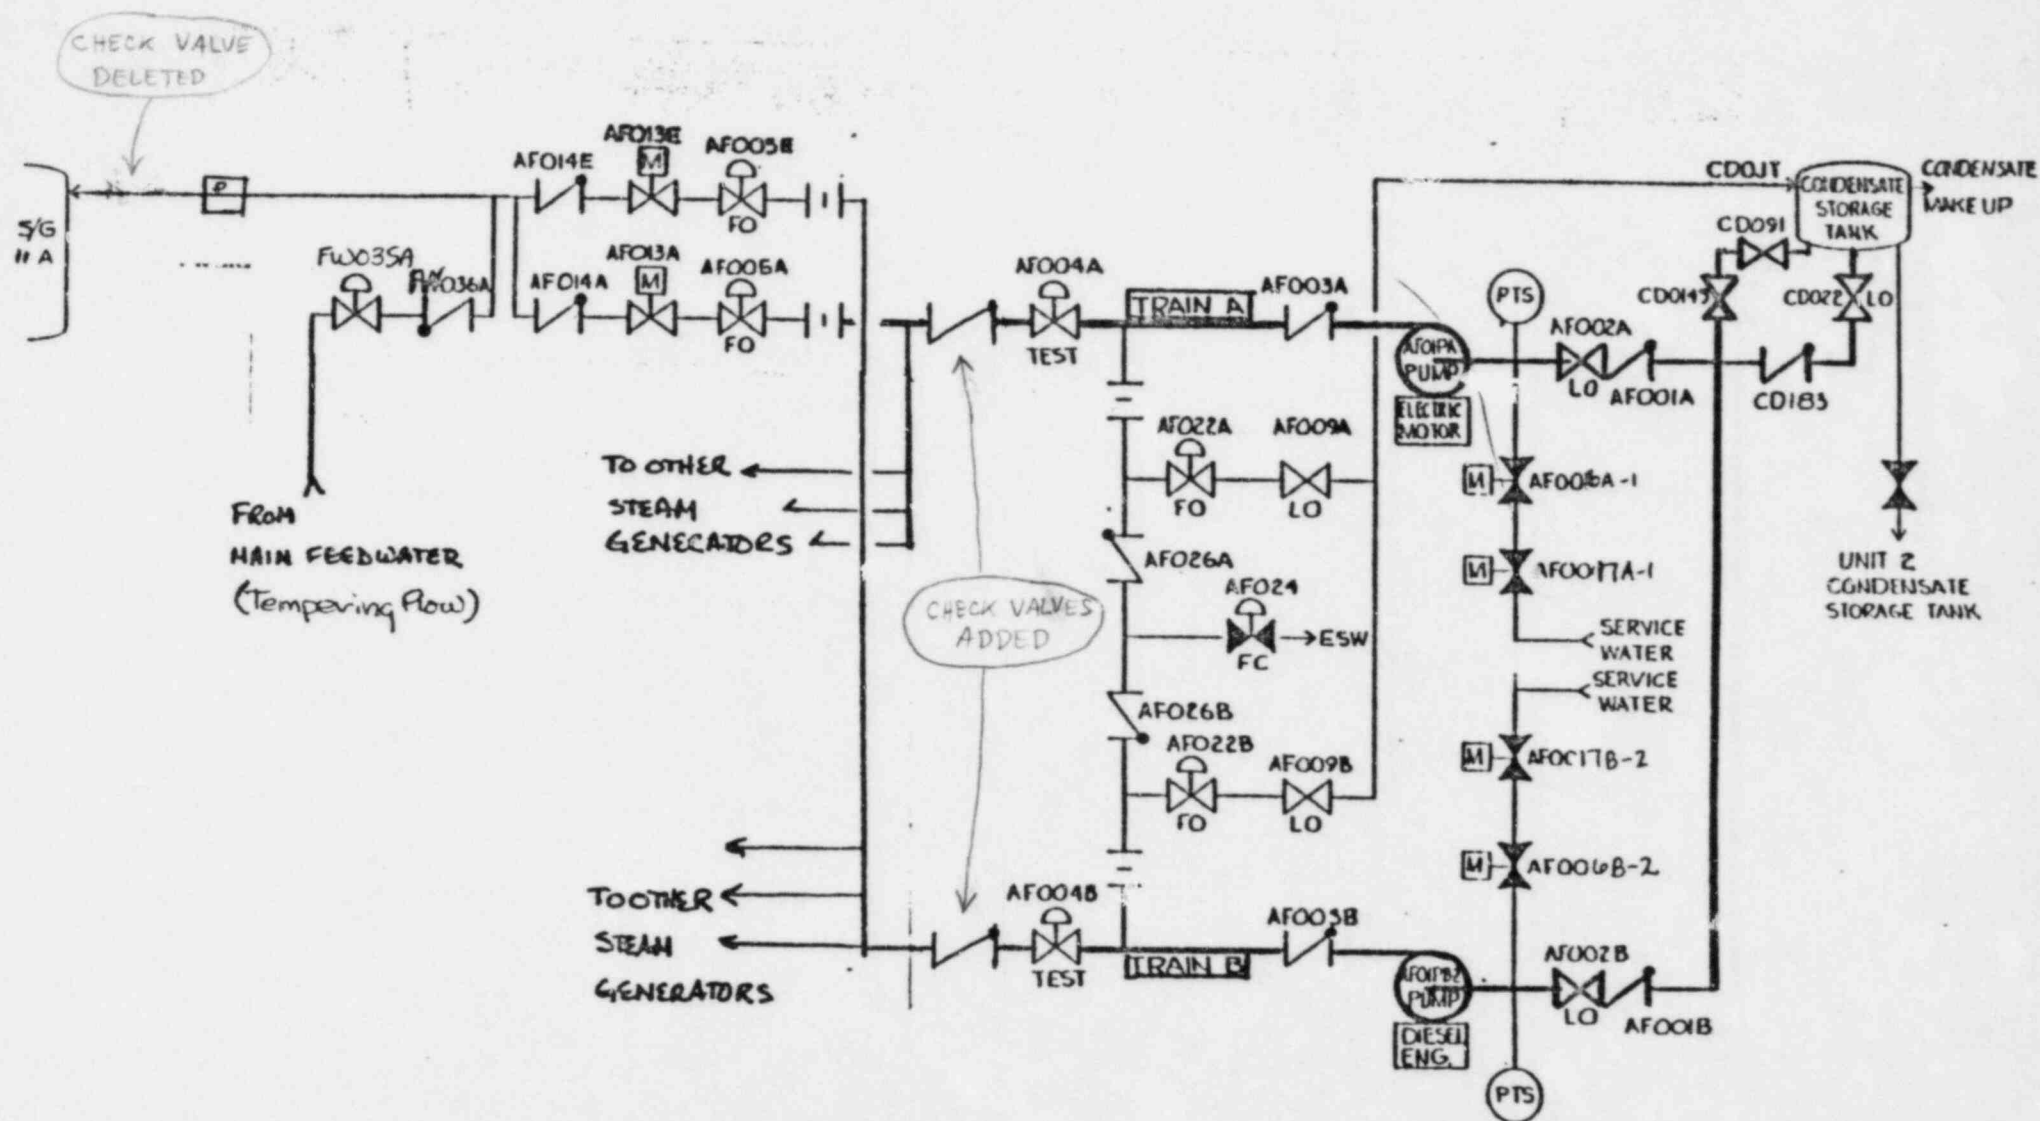
Revised
FIGURE 6
2-15-83

BYRON AFW SYSTEM

Mr. Ainger's affidavit also noted that check valves in the auxiliary nozzle piping were being removed to assure the effectiveness of controlled-closure check valves farther upstream. A typical diagram of this piping was provided in Figure 6 attached to reference (a). The check valves being removed are the ones closest to the steam generators, identified in the typical diagram (Figure 6) as valve FW037A.

Removal of these check valves necessitates the addition of other check valves to provide redundant back flow protection in certain piping. Without additional check valves in the auxiliary feedwater pump discharge piping, there is only one check valve in the piping connecting the upper steam generator nozzles and the condensate storage tank via the auxiliary feedwater pump miniflow lines. An additional check valve will therefore be installed in the discharge piping of each auxiliary feedwater pump to minimize back-leakage through this path. A revised version of Figure 6 is attached to document the location of these new valves.
