# Public Service Company of Colorado

July 28, 1983  
Fort St. Vrain  
Unit No. 1  
P-83261

SUBJECT: Fort St. Vrain Unit No. 1  
Control Room HVAC Failure Criteria

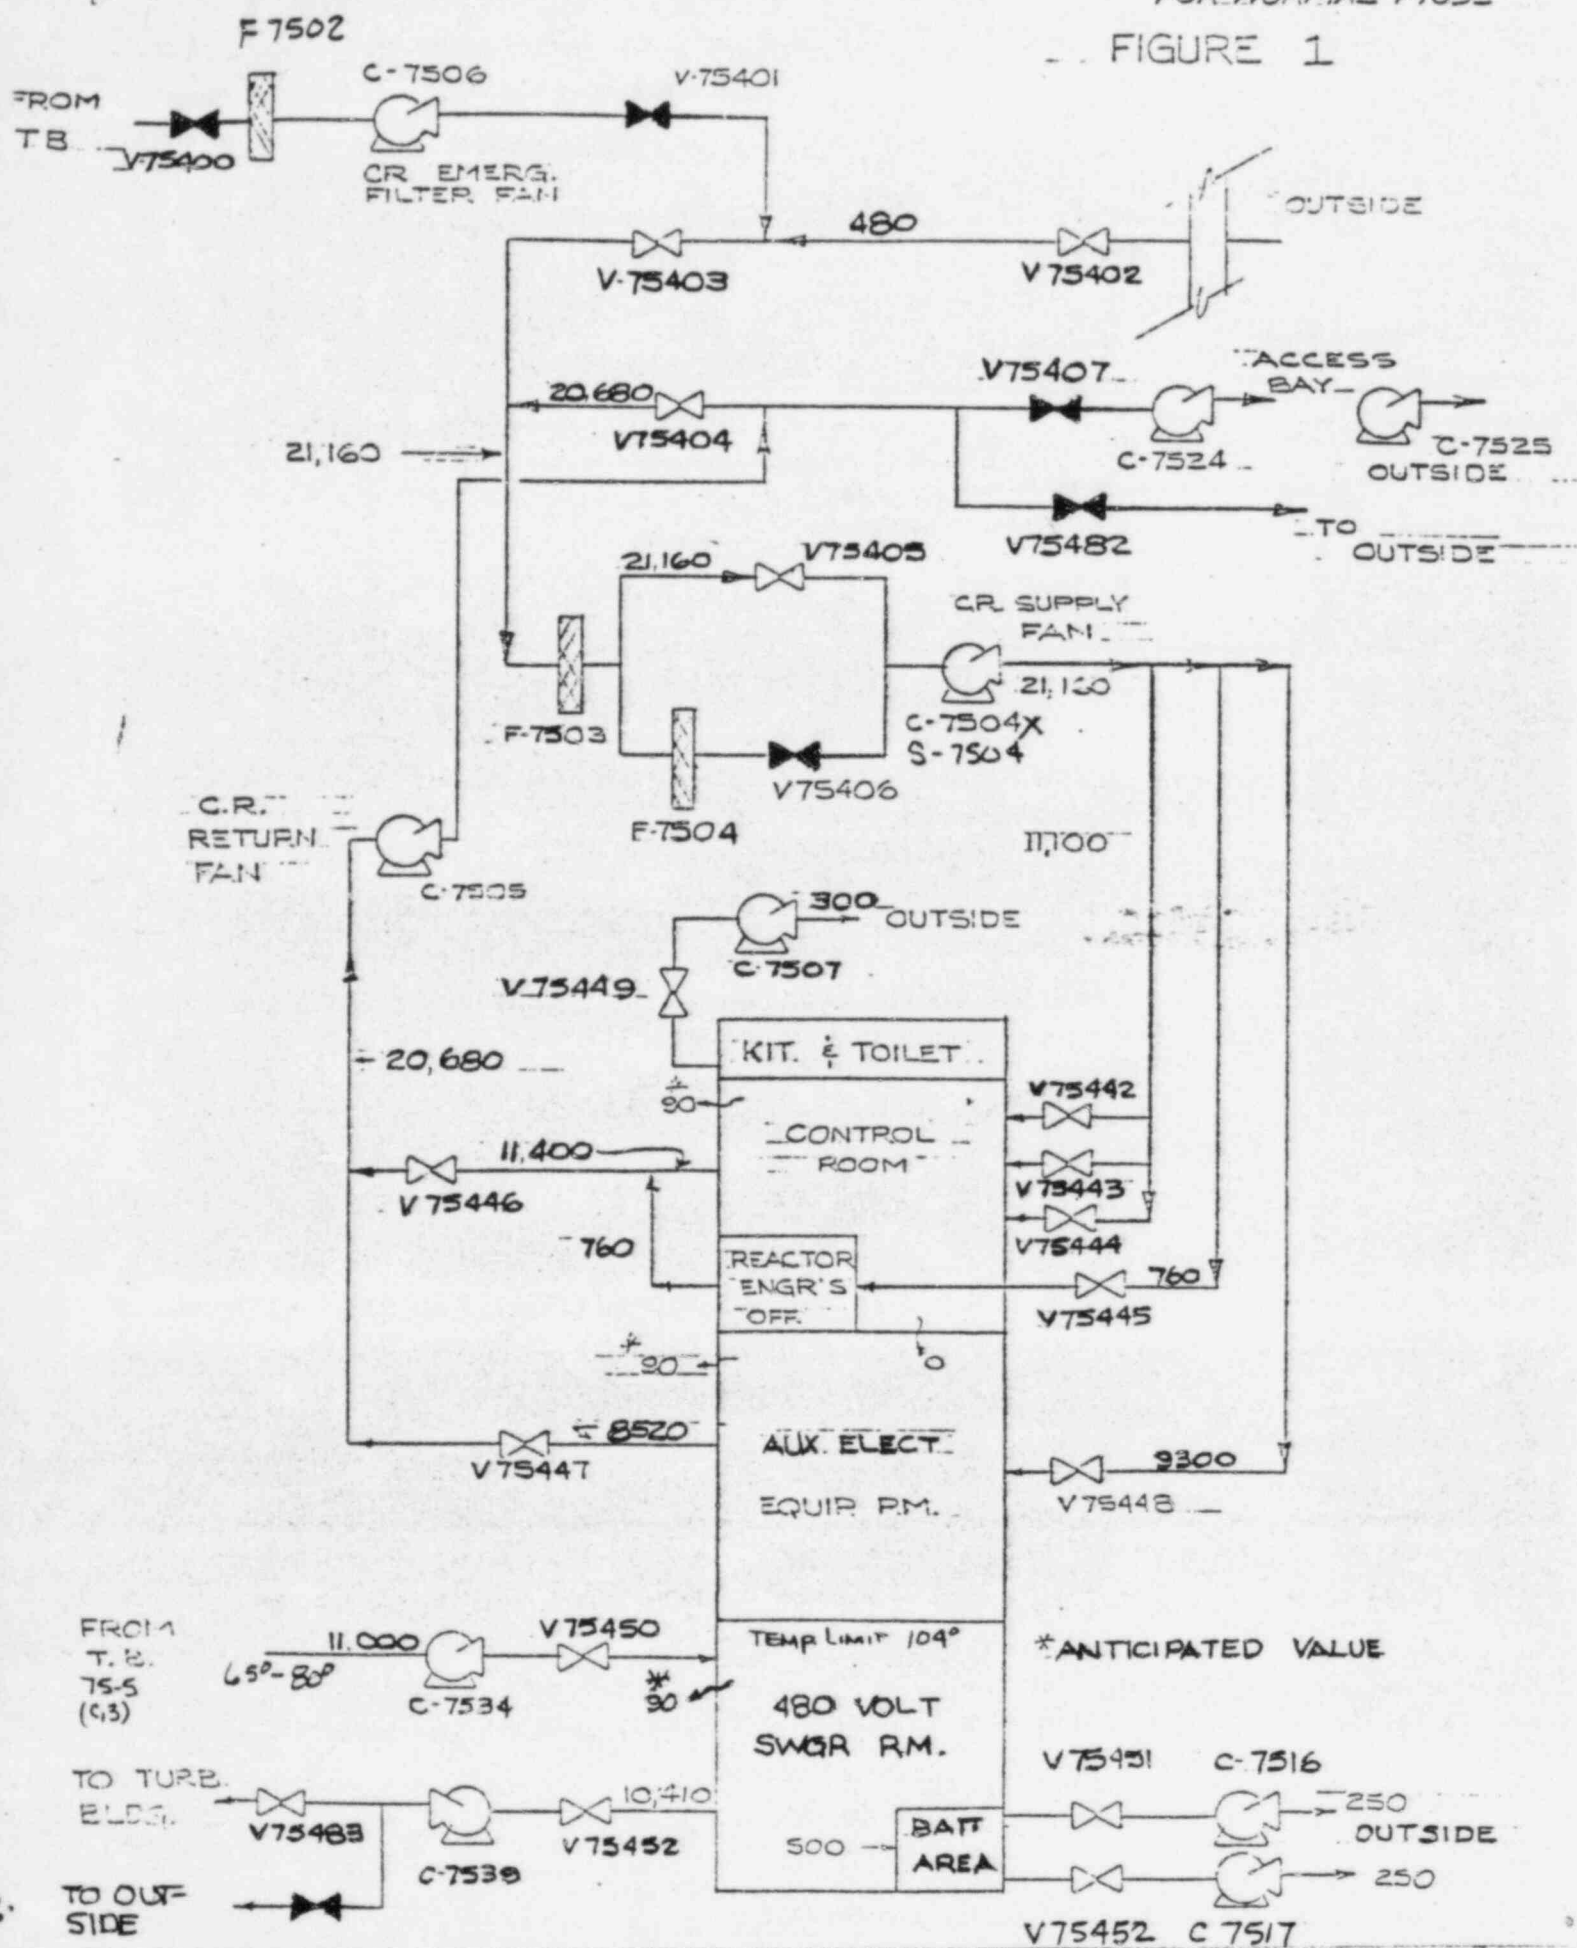
FIGURE 1

FLOW SHOWN IN CFM  
FOR NORMAL MODE

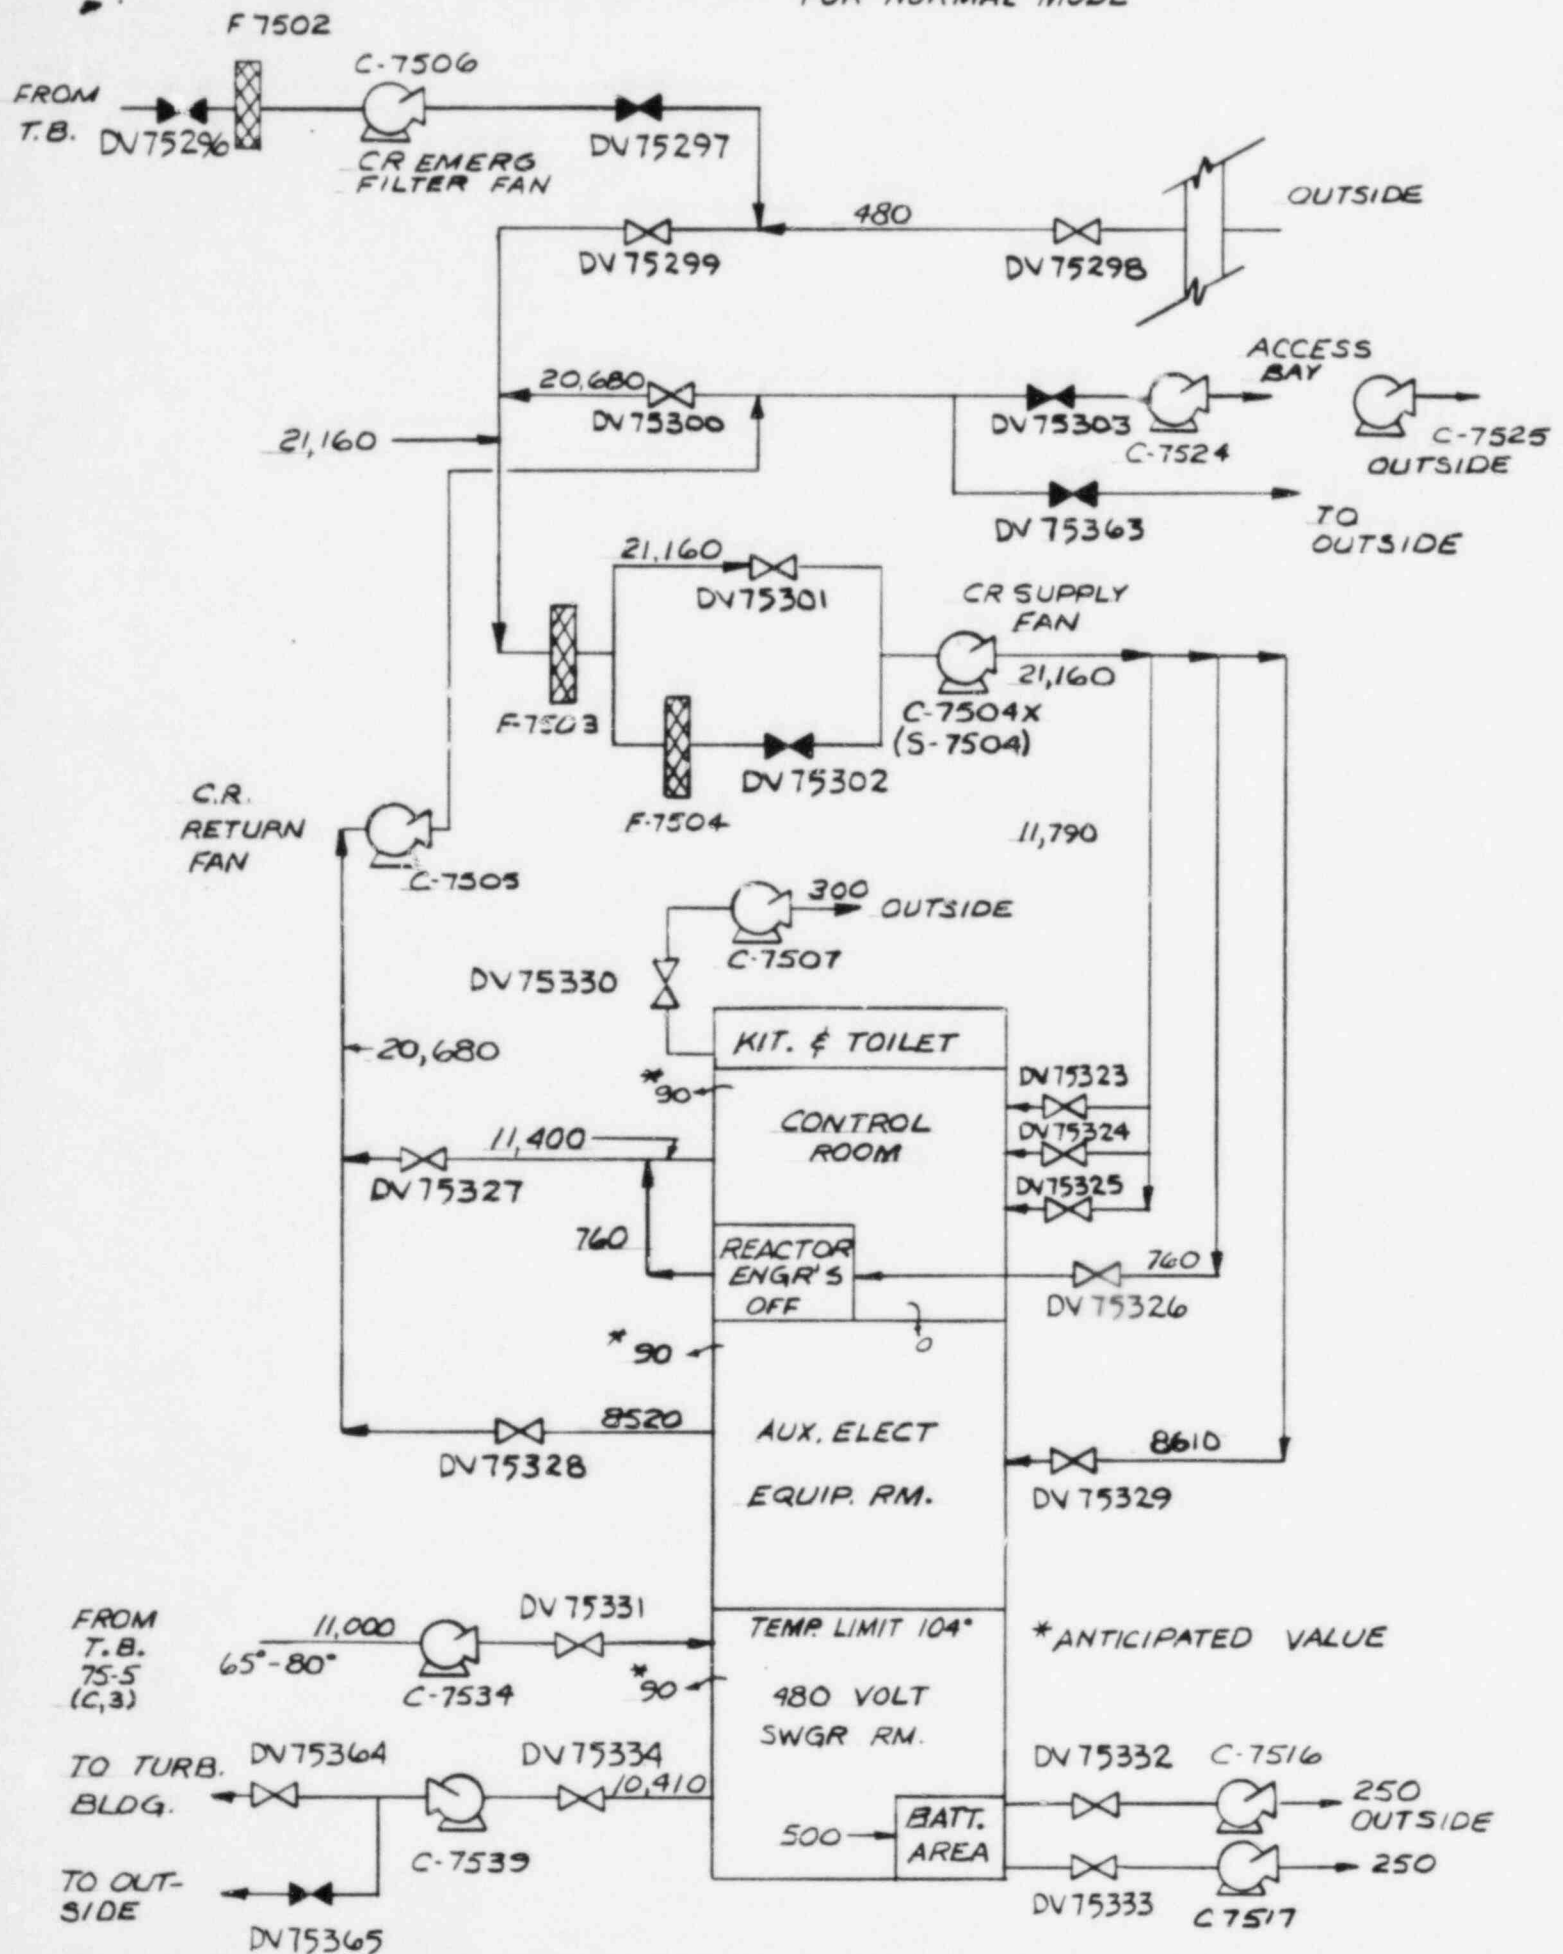
# CONTROL ROOM HVAC SYSTEM - MODIFIED DESIGN FIGURE 2

FLOW SHOWN IN CFM  
FOR NORMAL MODE

It should be noted that a modification has been implemented to identify the "V" dampers with a more conventional "DV" damper valve nomenclature. This new identification has been included for your use and information. (Figure 2)

V75402 now DV75298  
V75405 now DV75301  
V75407 now DV75303  
V75482 now DV75363  
V75449 now DV75330  
V75400 now DV75296  
V75401 now DV75297  
V75406 now DV75302
