Subject: Grand Gulf Nuclear Station
Docket No. 50-416
License No. NPF-29
Proposed Amendment to the Operating License Concerning
Closure and Deletion of License Condition 2.C.(26),
Turbine Disc Integrity (PCOL-94/01)

CLOSURE AND DELETION OF LICENSE CONDITION 2.C.(26)

1. PCOL-94/01: Closure and Deletion of Operating License Condition 2.C.(26), Turbine Disc Integrity
2. Affected Operating License Page: 10

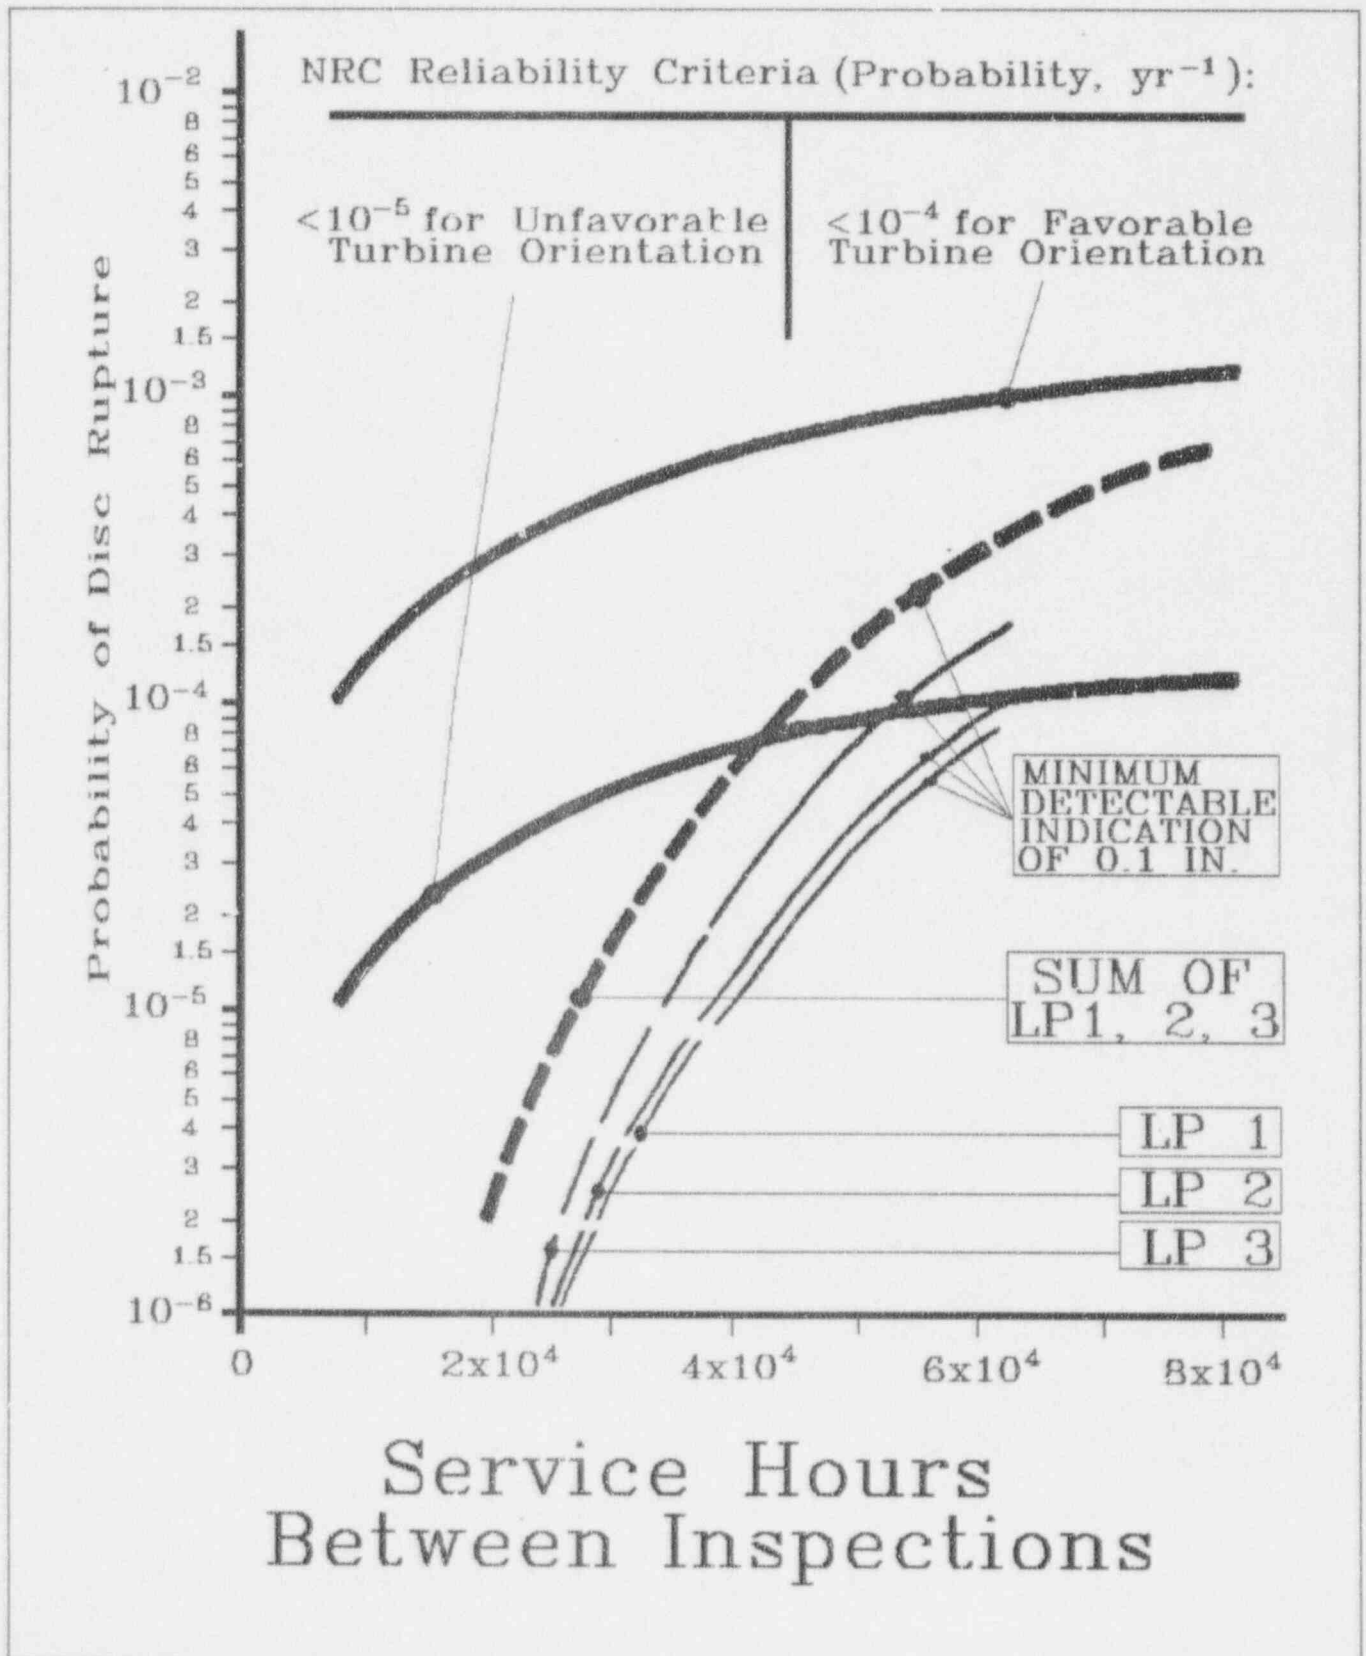
FIGURE 2

BOLD Hours at time of LP rotor disc inspections

It is also necessary to determine failure probability curves for each currently installed rotor. Using the original probabilities for disc cracking for each rotor from ER-8503 (and shown below for convenience), curves for each LP rotor were created, assuming that each rotor had a minimum detectable indication of 0.1 inch. The sum of the three new curves equals the original curve. These three new curves were then graphed on the original Figure 1E85.093 curve. This new graph is attached Figure 2.

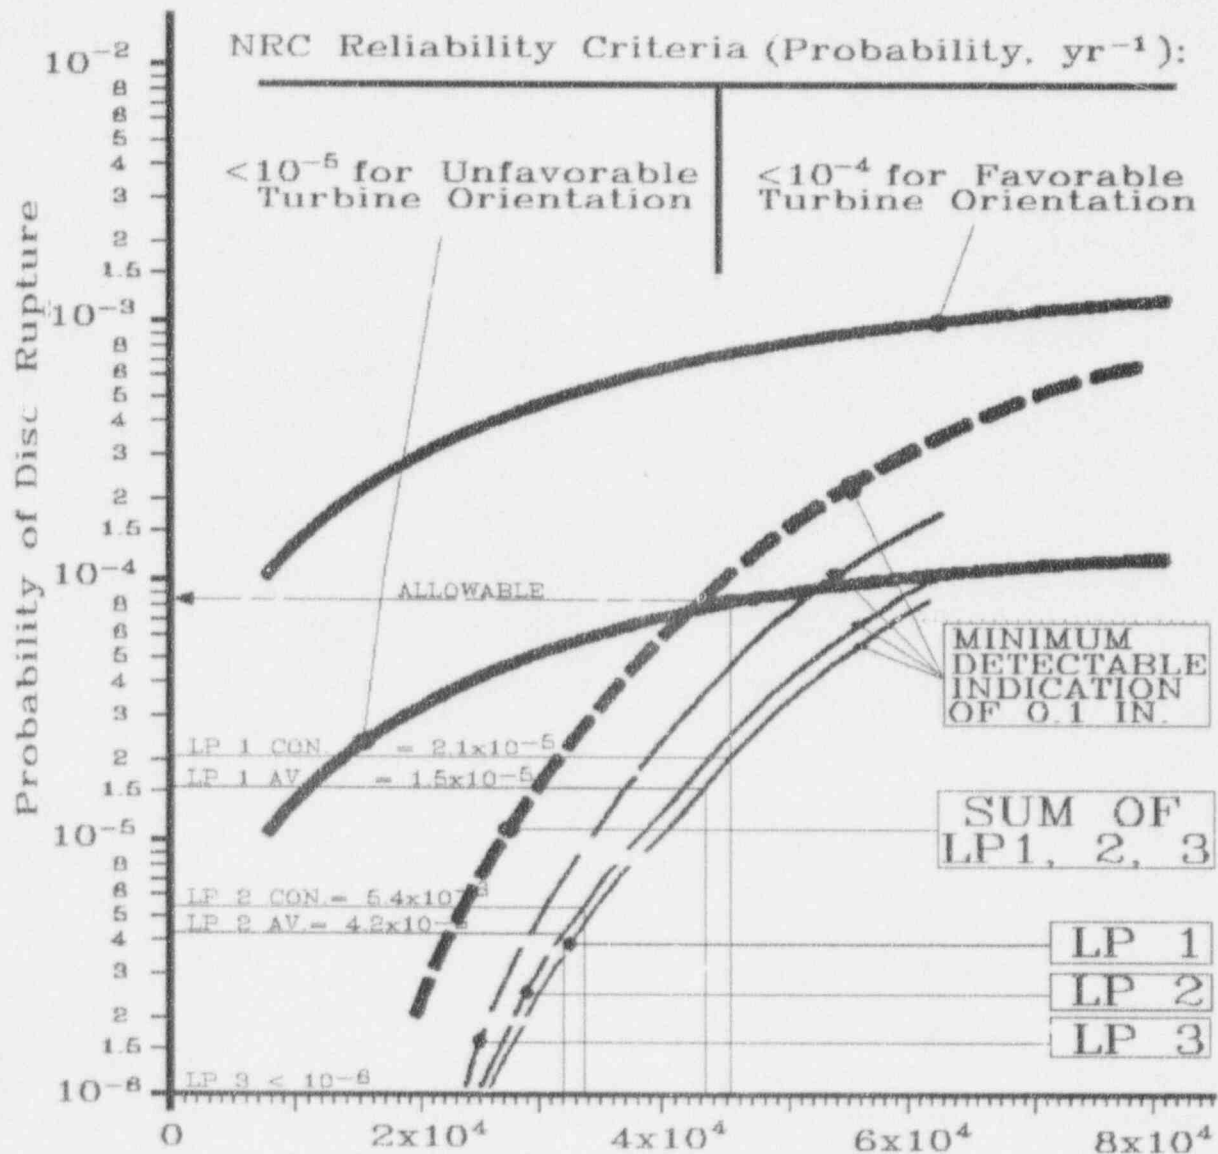
FIGURE 3
Example RF07

LP No. 1 = 43,376 AV, 45,146 CON. Hrs
LP No. 2 = 32,083 AV, 33,853 CON. Hrs
LP No. 3 = 10,233 AV, 12,003 CON. Hrs

PROBABILITY AT RF07 = 1.9 TO 2.64×10^{-5}
NRC LIMITS NOT APPROACHED, SEE RF08

Figures 3 through 6 show that the probability of disc rupture is less than the inspection criteria without UT disc inspection of the LP-1 and LP-2 rotors before planned replacement. Results were:

From Figure 3 for RFO7, the sum of the probabilities is 1.9 to 2.64×10^{-5} . This is well within the NRC limit.

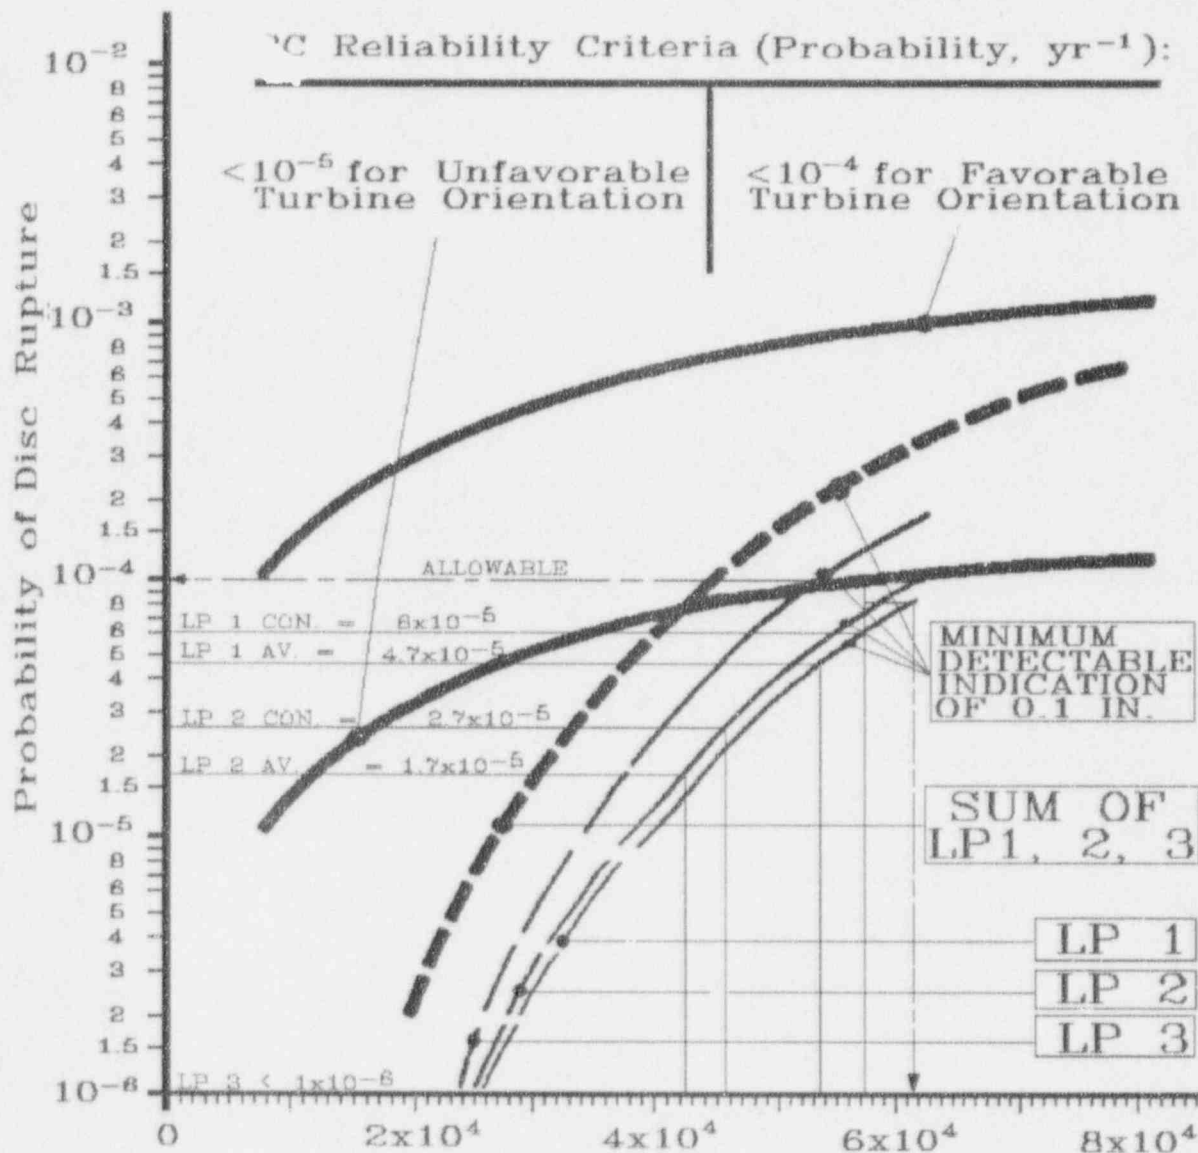
FIGURE 4

Example RF08

LP No. 1 = 53,609 AV, 57,146 CON. Hrs
LP No. 2 = 42,316 AV, 45,853 CON. Hrs
LP No. 3 = 20,466 AV, 24,003 CON. Hrs

PROBABILITY AT RFO 8 = 6.4 TO 8.7×10^{-5}
NRC LIMIT AT LP 1 = 61,500 HRS (15% MARGIN)

From Figure 4 for RFO8, the sum of the probabilities is 6.4 to 8.7×10^{-5} . The NRC limit is approached; therefore, a limit must be placed on the number of operating hours allowed before inspection of LP-1 (which is the limiting rotor at this time) is required. This limit is discussed below. During RFO8, the LP-1 will be replaced. Below is the operating hour information for LP-1 for RFO7 and RFO8, extracted from Figure 1 for convenience.

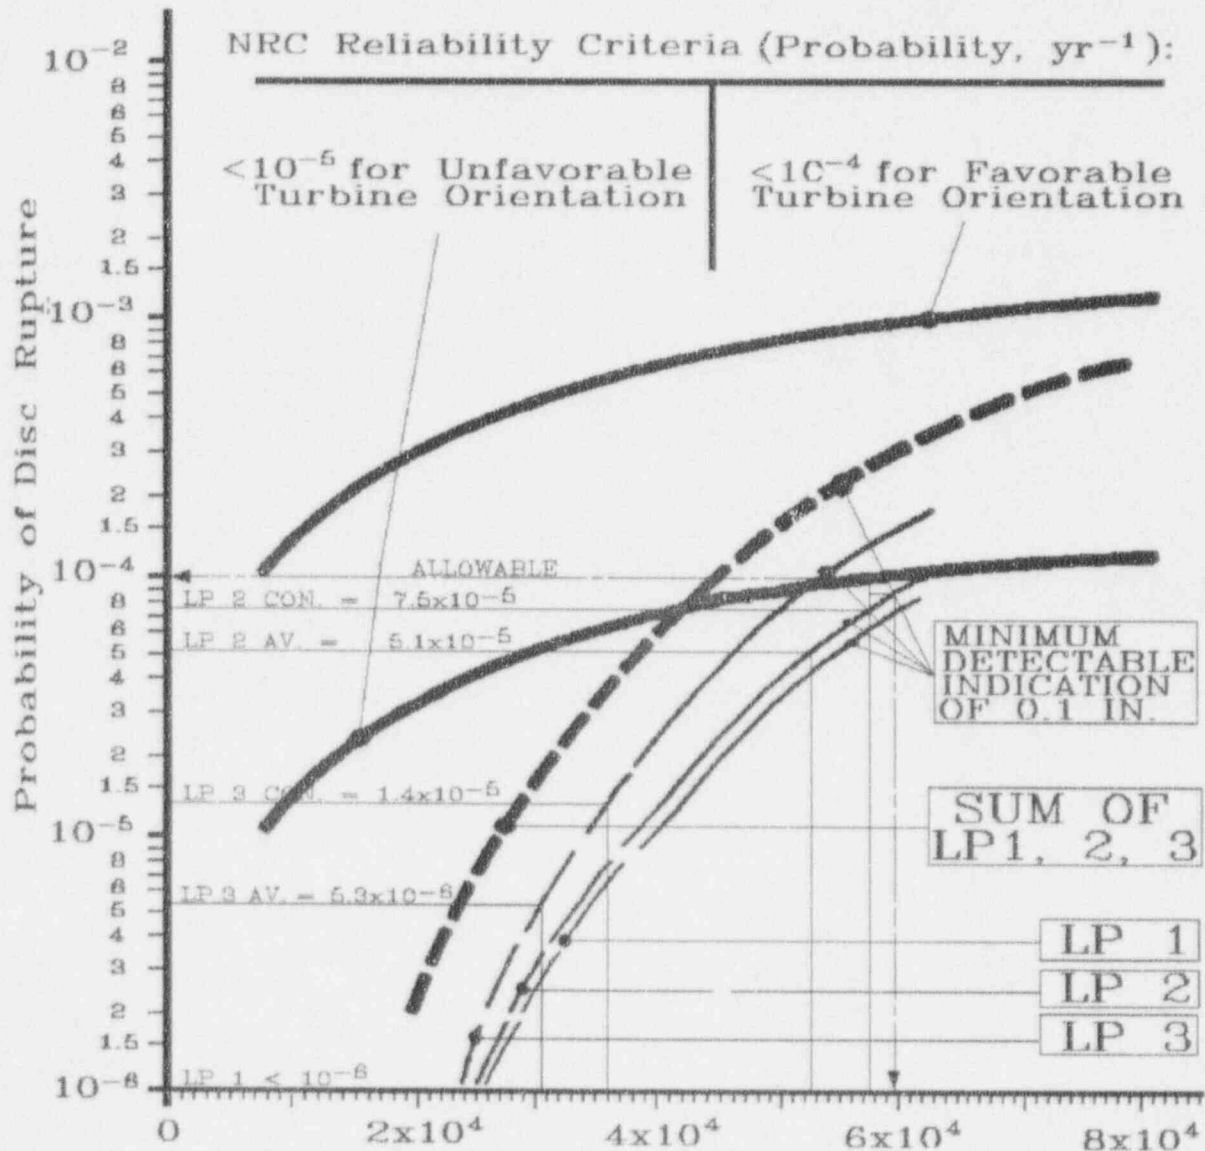
FIGURE 5

Example RF09

LP No. 1 = 10,233 AV, 12,000 CON.Hrs
 LP No. 2 = 52,549 AV, 57,853 CON.Hrs
 LP No. 3 = 30,699 AV, 36,003 CON.Hrs

PROBABILITY AT RFO 9 = 5.6 TO 8.9×10^{-5}

NRC LIMIT AT LP 2 = 59,900 HRS (14% MARGIN)

From Figure 5 for RFO9, the sum of the probabilities is 5.6 to 8.9×10^{-5} . The NRC limit is approached; therefore, a limit must be placed on the number of operating hours allowed before inspection for the LP-2 (which is the limiting rotor at this time) is required. This limit is discussed below. During RFO9, the LP-2 rotor will be replaced. Below is the operating hour information for LP-2 for RFO8 and RFO9, extracted from Figure 1 for convenience.

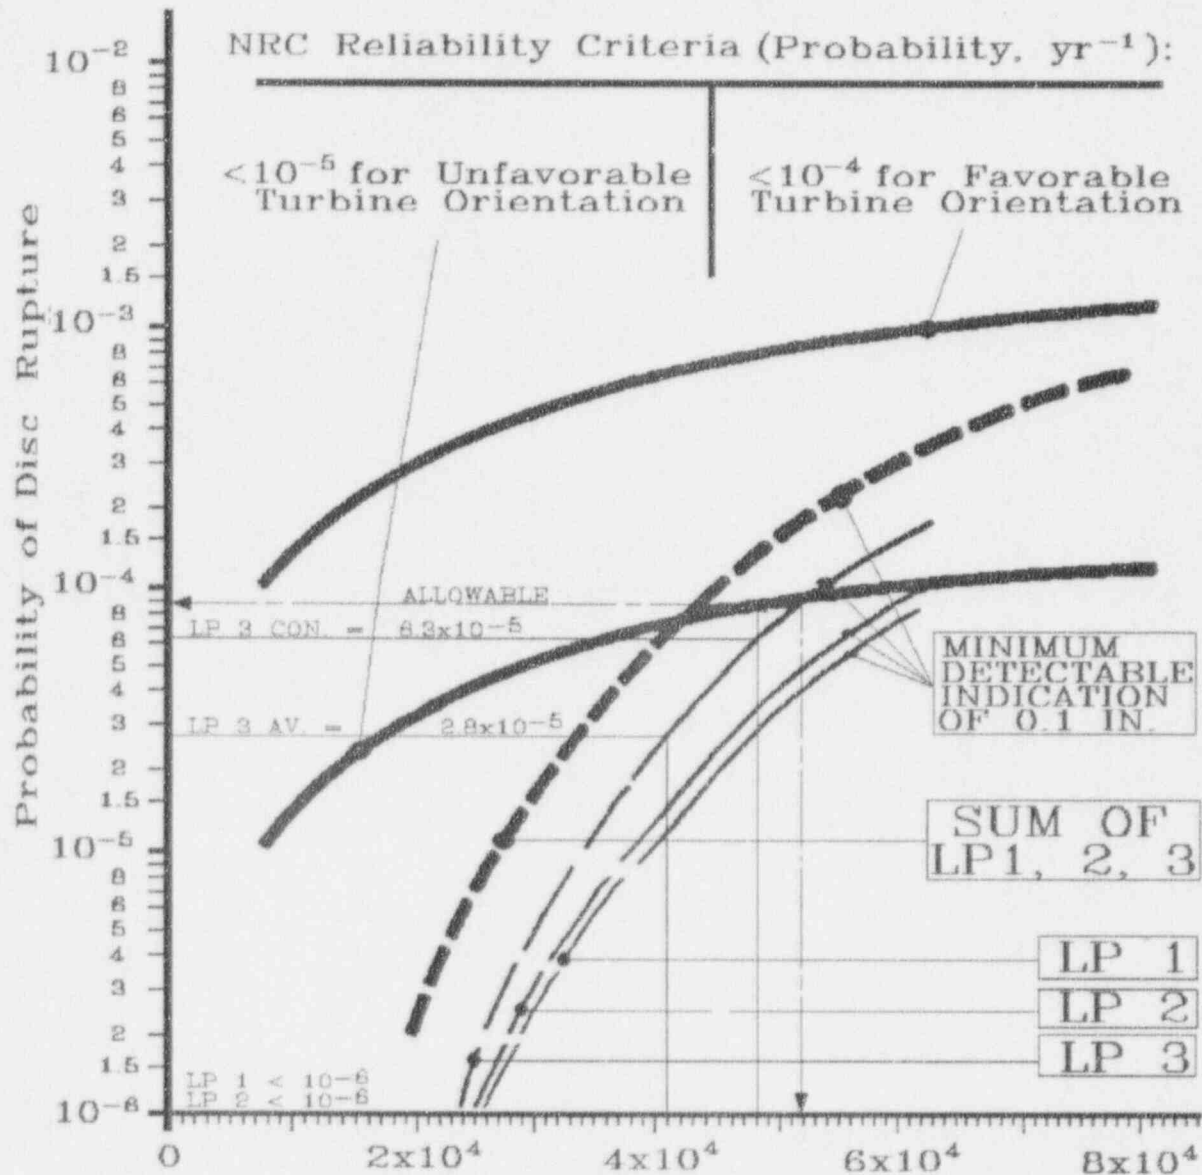
Example RFO10

LP No. 1 = 20,466 AV, 24,000 CON. Hrs
LP No. 2 = 10,233 AV, 12,000 CON. Hrs
LP No. 3 = 40,932 AV, 48,003 CON. Hrs

PROBABILITY AT RFO 10 = 2.8 TO 6.3×10^{-5}
NRC LIMIT AT LP 3 = 51,900 HRS (25% MARGIN)

The probability of disc rupture up to the time of RFO7, RFO8, RFO9 and RFO10 is represented graphically on attached Figures 3 through 6,

As shown in ER-8503 Figures 1E85.090, 1E85.091 and 1E85.092, LP-1 and LP-2 have a slower crack growth rate than LP-3 due to better material properties. Evaluation of actual material properties yields the attached Figures 3 through 6 for RFO7, RFO8, RFO9 and RFO10. In summary, the risk of a rotor disc failure is as follows if the LP-1 and LP-2 UT disc inspections are delayed for one cycle until replaced:
