SOUTH CAROLINA ELECTRIC & GAS COMPANY

Subject: Virgil C. Summer Nuclear Station  
Docket No. 50/395  
Operating License No. NPF-12  
Dropped Rod Methodology  
License Condition 2.C.22

Westinghouse has performed a plant specific analysis for the Virgil C. Summer Nuclear Station, Cycle 1, utilizing the NRC approved methodology. The results of the analysis indicate that the DNE design basis is met. Based on this evaluation, South Carolina Electric and Gas Company (SCE&G) has concluded that the interim restrictions for rod control are no longer required for Cycle 1. Attached are marked-up FSAR pages reflecting the new analysis.

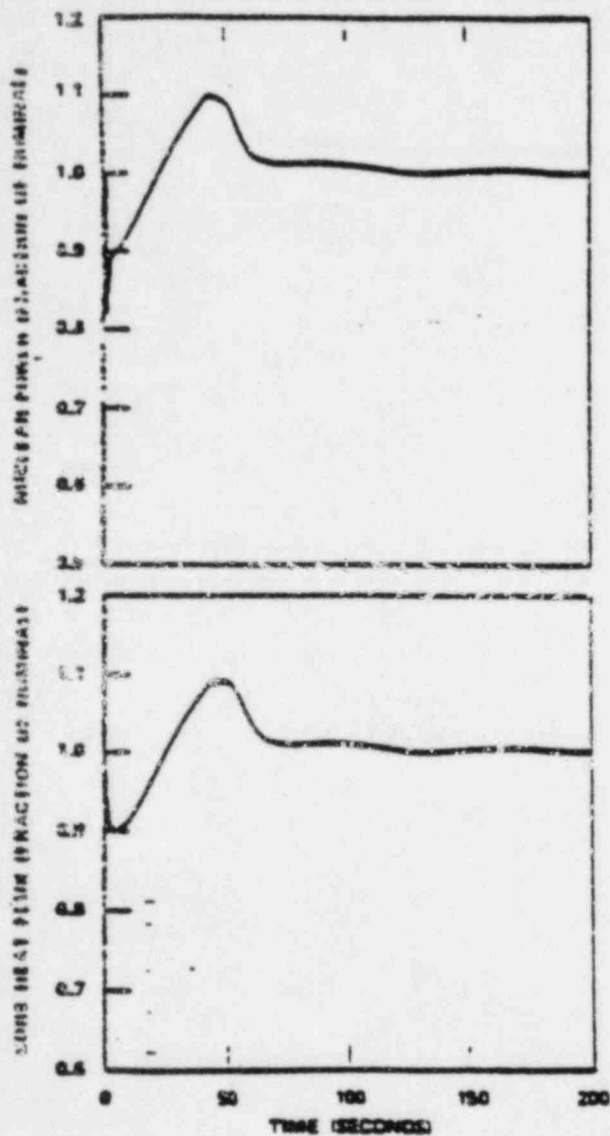
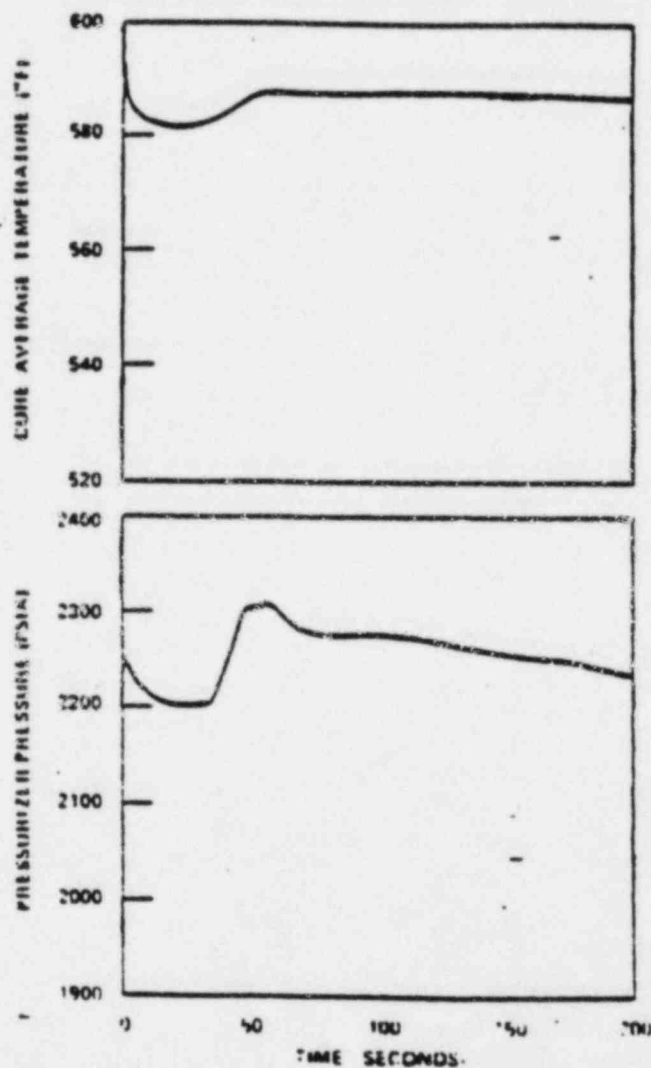
Transient Response to Dropped  
Rod Cluster Control Assembly

Figure 15.2-11 illustrates the transient for the following limiting conditions:
