AFFIDAVIT OF GARY R. LEIDICH

NUCLEAR REGULATORY COMMISSION

In the Matter of)	
)	
THE CLEVELAND ELECTRIC)	Docket Nos. 50-440
ILLUMINATING COMPANY, <u>et al.</u>)	50-441
)	
(Perry Nuclear Power Plant,)	
Units 1 and 2))

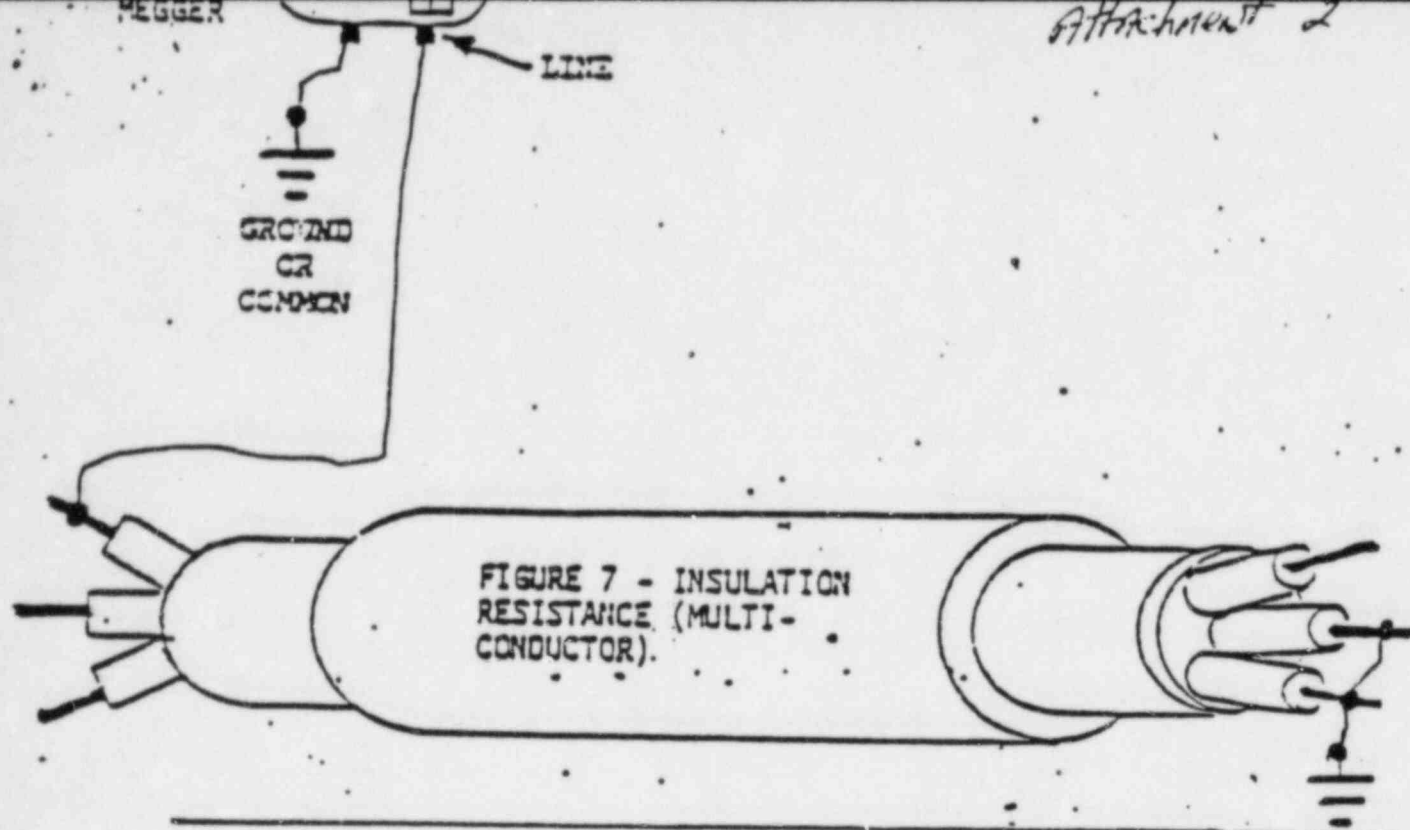
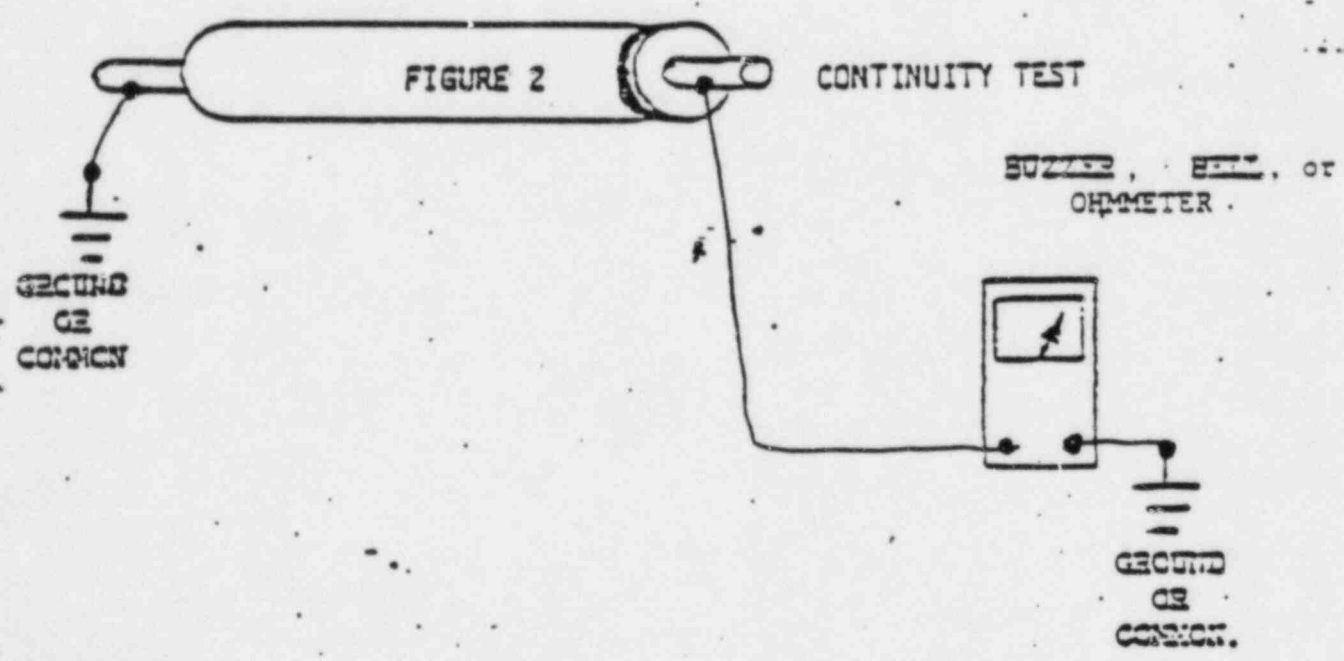
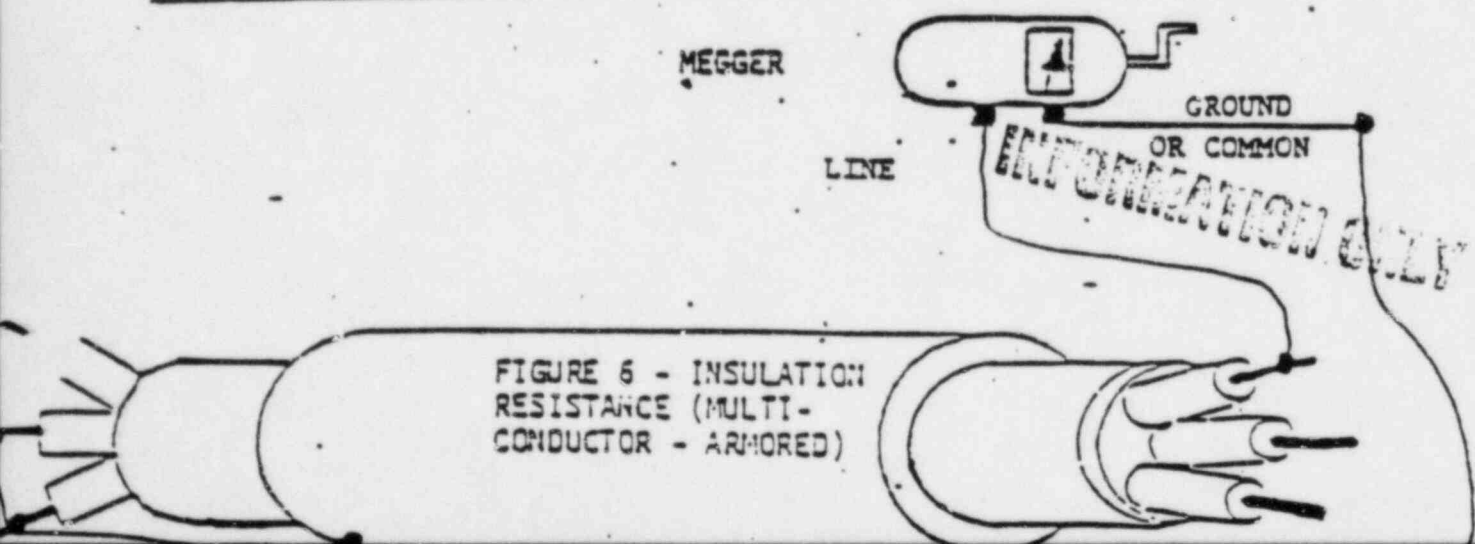
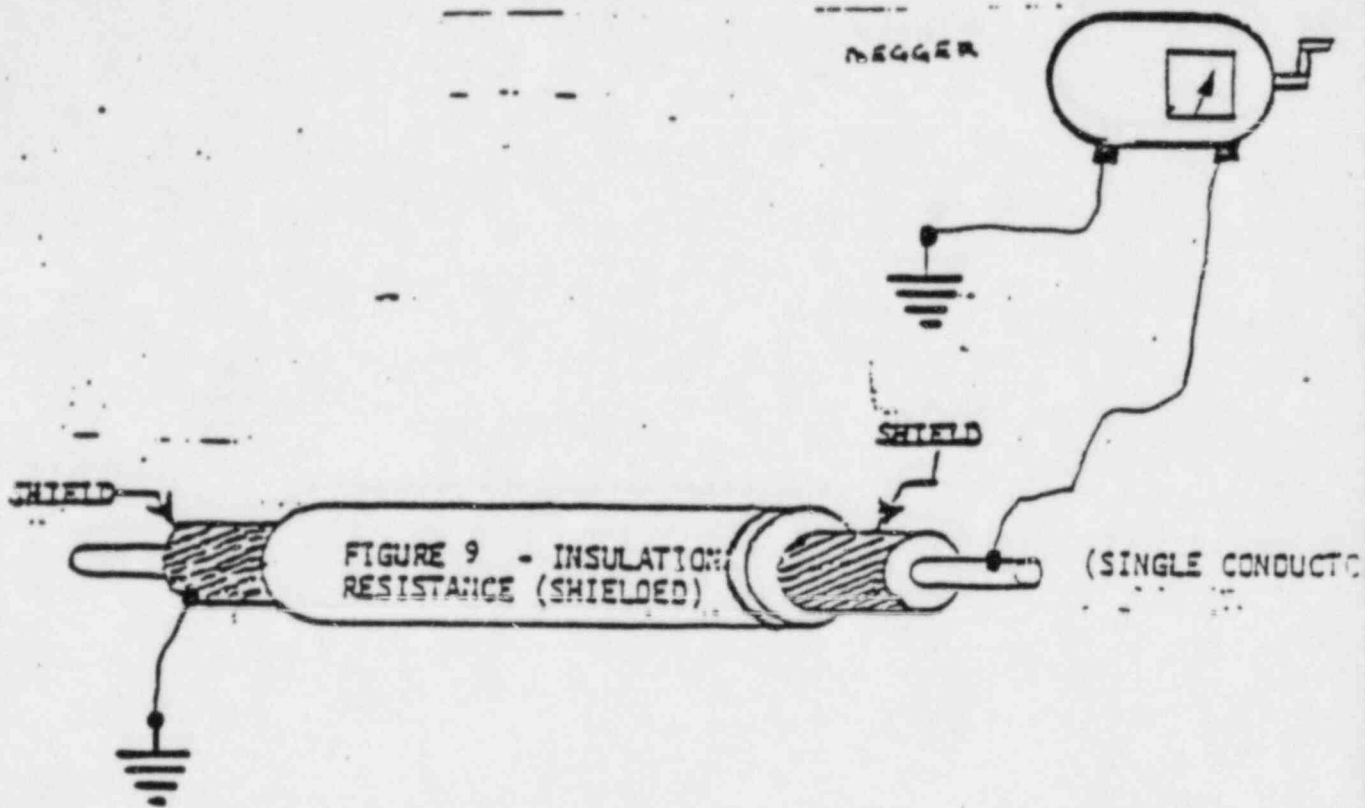
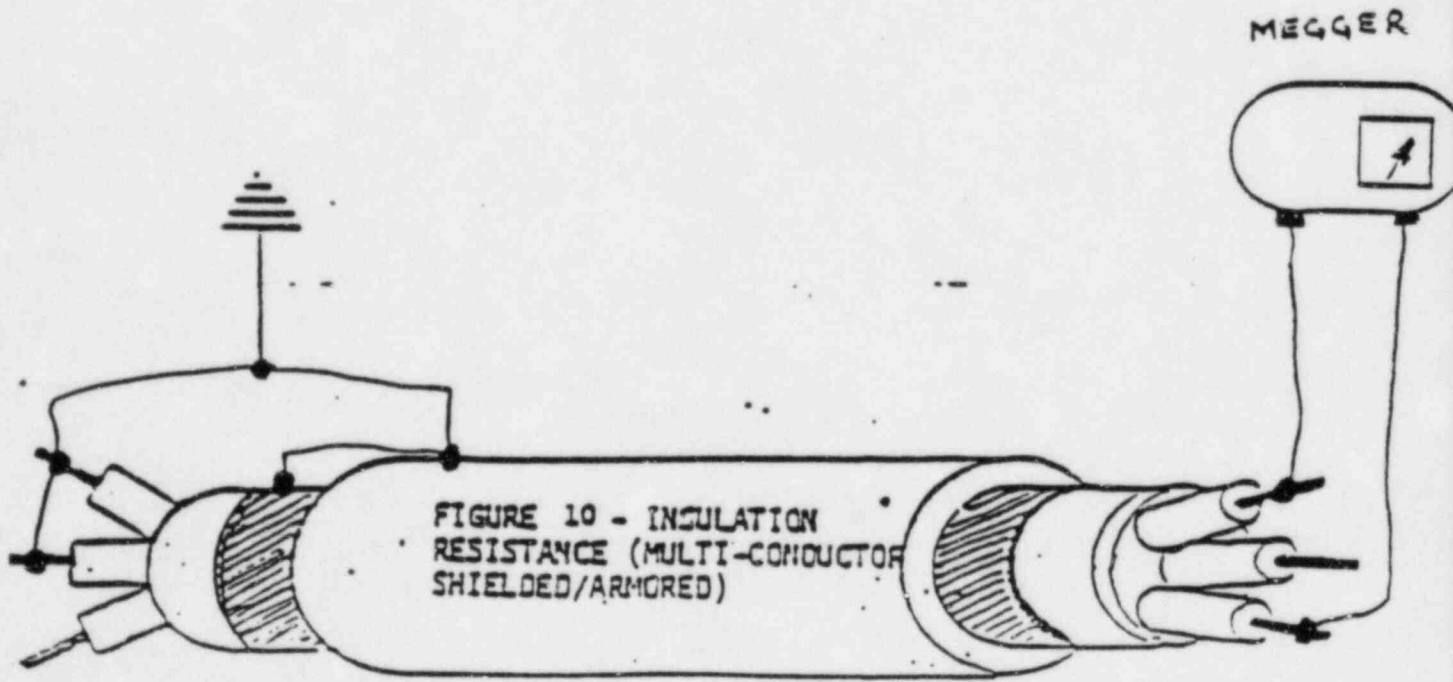
Connect the points shown on attached pages to show a correct megger or continuity test.
