APPLICATION OF TEXAS UTILITIES
GENERATING COMPANY, ET AL. FOR
AN OPERATING LICENSE FOR
COMANCHE PEAK STEAM ELECTRIC
STATION UNITS #1 AND #2
(CPSES)

TESTIMONY OF CASE WITNESS
MARK A. WALSH

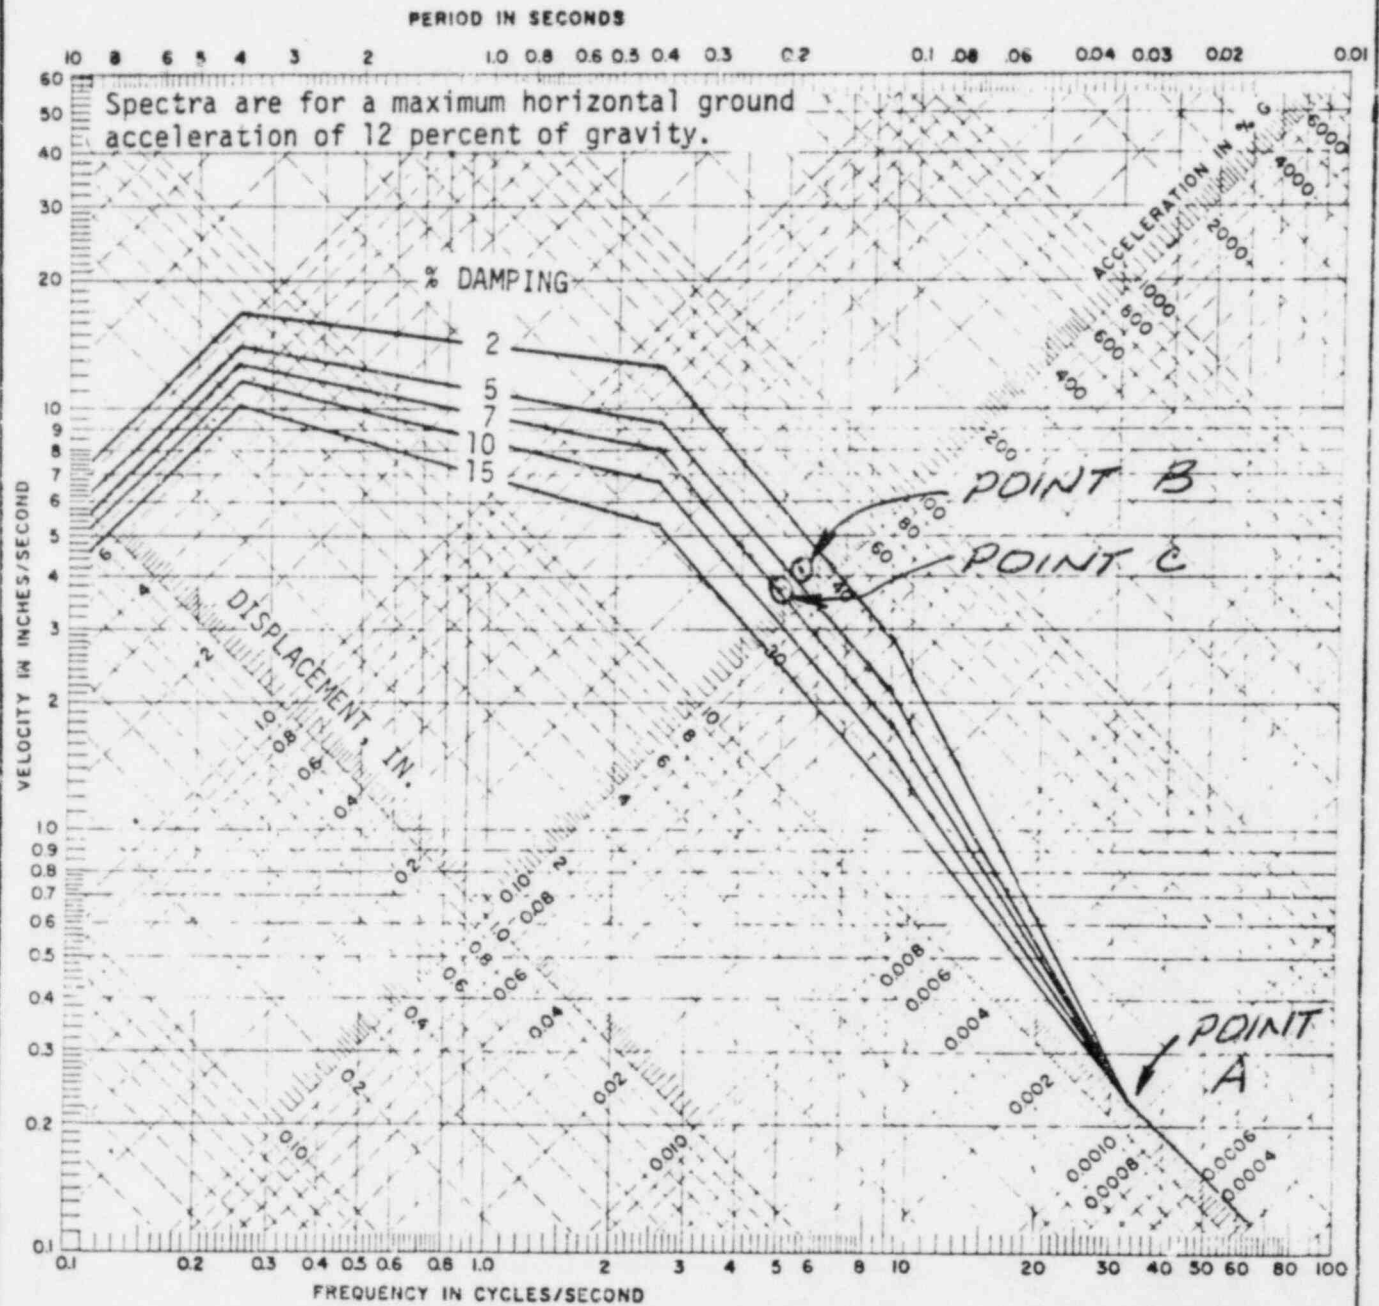
COMANCHE PEAK S.E.S.
FINAL SAFETY ANALYSIS REPORT
UNITS 1 and 2

DESIGN RESPONSE SPECTRA
FOR HORIZONTAL SAFE
SHUTDOWN EARTHQUAKE

2 The load which causes the displacement is from the weight of the support
3 and the tray with its contents. The weight is in the horizontal direction
4 and is actually the mass times the acceleration due to gravity that is contri-
5 buting to the horizontal displacement. When a support is rigid, the seismic
6 acceleration it will experience is .12 g's at ground level, and this is in-
7 dependent of damping.

8 Now consider a support that displaces 1/8 of an inch (.125 inches) using
9 4% damping its horizontal acceleration at ground level is 35% of gravity, as
10 indicated on Attachment A as point B. With 7% damping, its horizontal accelera-
11 tion would be 28% of gravity. It is apparent that the higher damping will
12 produce smaller seismic loads. But equally apparent is the acceleration
13 from a rigid condition equalling 12% of gravity goes to 28% of gravity with 7%
14 damping, in essence the seismic load will double.
