Nebraska Public Power District

Subject: Response to Confirmatory Action Letter
Cooper Nuclear Station
NRC Docket No. 50-298

STARTUP AND POWER ASCENSION PLAN

(SHUTDOWN 94-03)

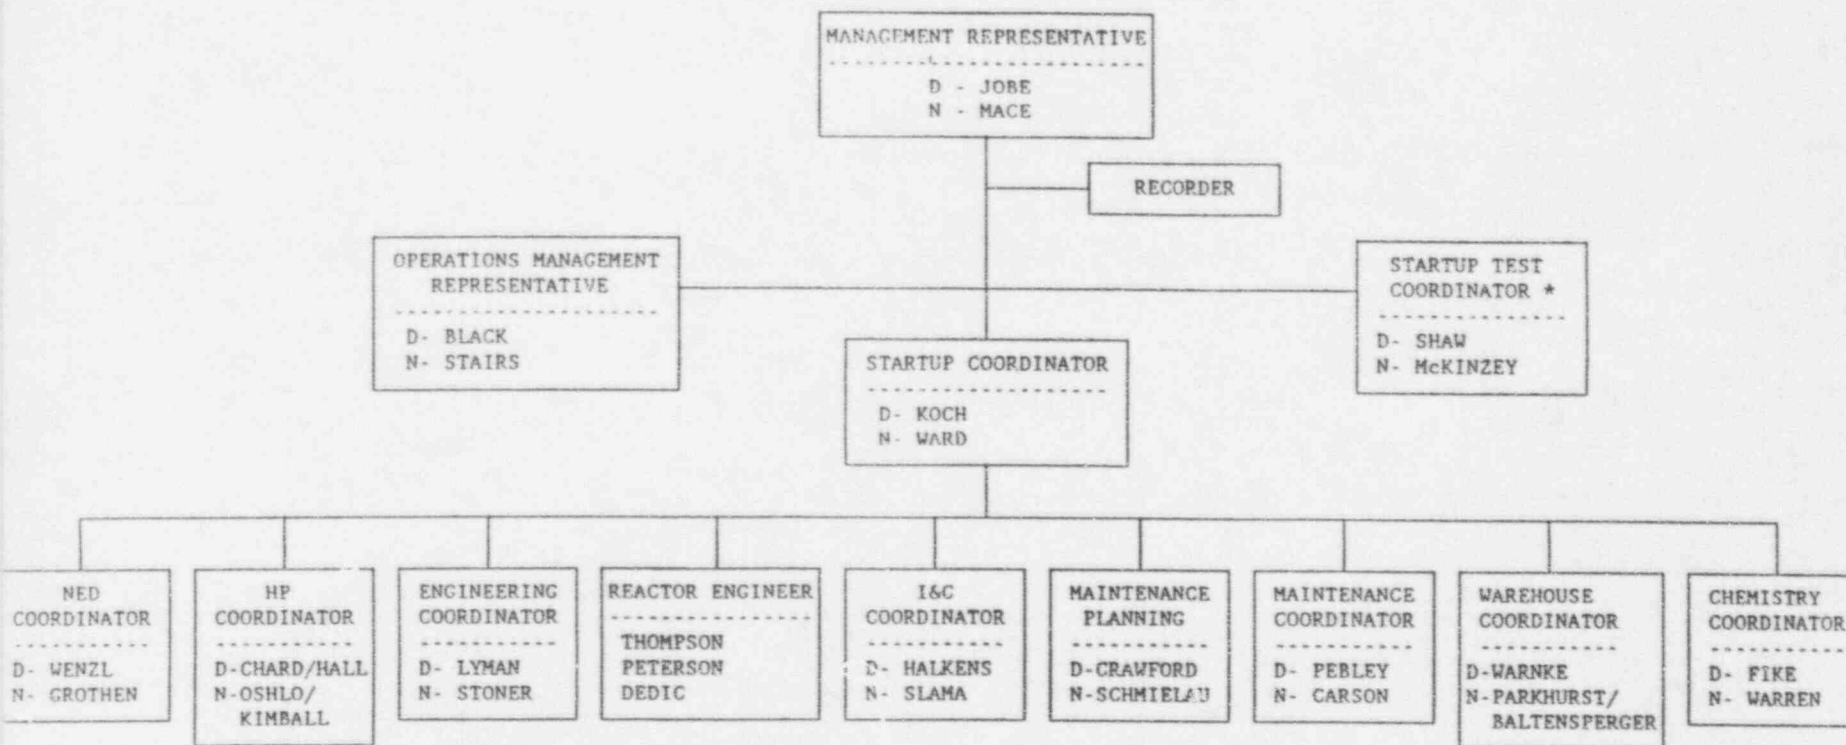
* - SRO LICENSE OR SRO CERTIFICATION
D - DAY SHIFT
N - NIGHT SHIFT

NOTE: 1) THE STARTUP AND POWER ASCENSION ORGANIZATION IS ESTABLISHED WHEN MODE SWITCH IS PLACED IN STARTUP AND SHALL REMAIN IN EFFECT UNTIL THE SECOND REACTOR FEED PUMP DISCHARGE VALVE IS FULLY OPEN.
