NRC DOCKET 50-366
OPERATING LICENSE, NPF-5
EDWIN I. HATCH NUCLEAR PLANT UNIT 2
VENT HEADER CRACK

Work Plan

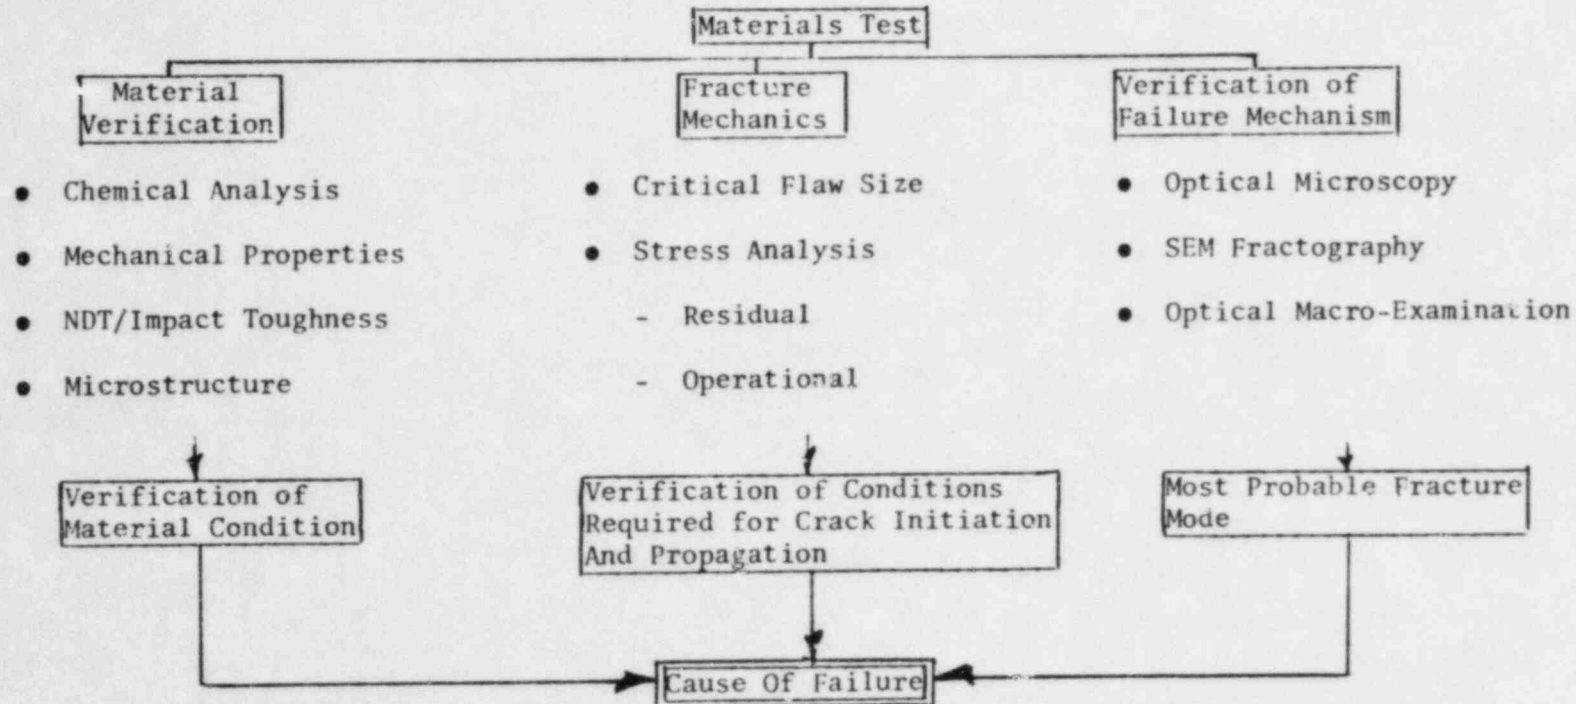
FIGURE 1 - WORK PLAN

The work plan that GE is following is outlined in **Figure 1**. The plan consists of three tasks; materials verification testing, fracture mechanics evaluation, and failure analyses. The goal of the test program is the identification of the cause of failure.
