PACIFIC AIR PRODUCTS CO.

Regarding: Final Report and Conclusions -
Pacific Air Products Co. Linear Converters
Investigation

Field lubrication of the linear converter unit should be performed:

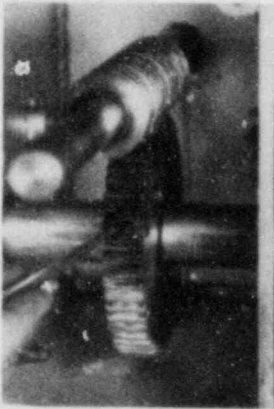
5. Apply a generous amount of grease between the gear and rack to all exposed areas of the gear and rack with a short bristled brush.
