**Commonwealth Edison**

Subject: Byron Station Units 1 and 2  
Braidwood Station Units 1 and 2  
Safety-Related D.C. System  
Additional Information  
NRC Docket Nos. 50-454/455 and 50-456/457

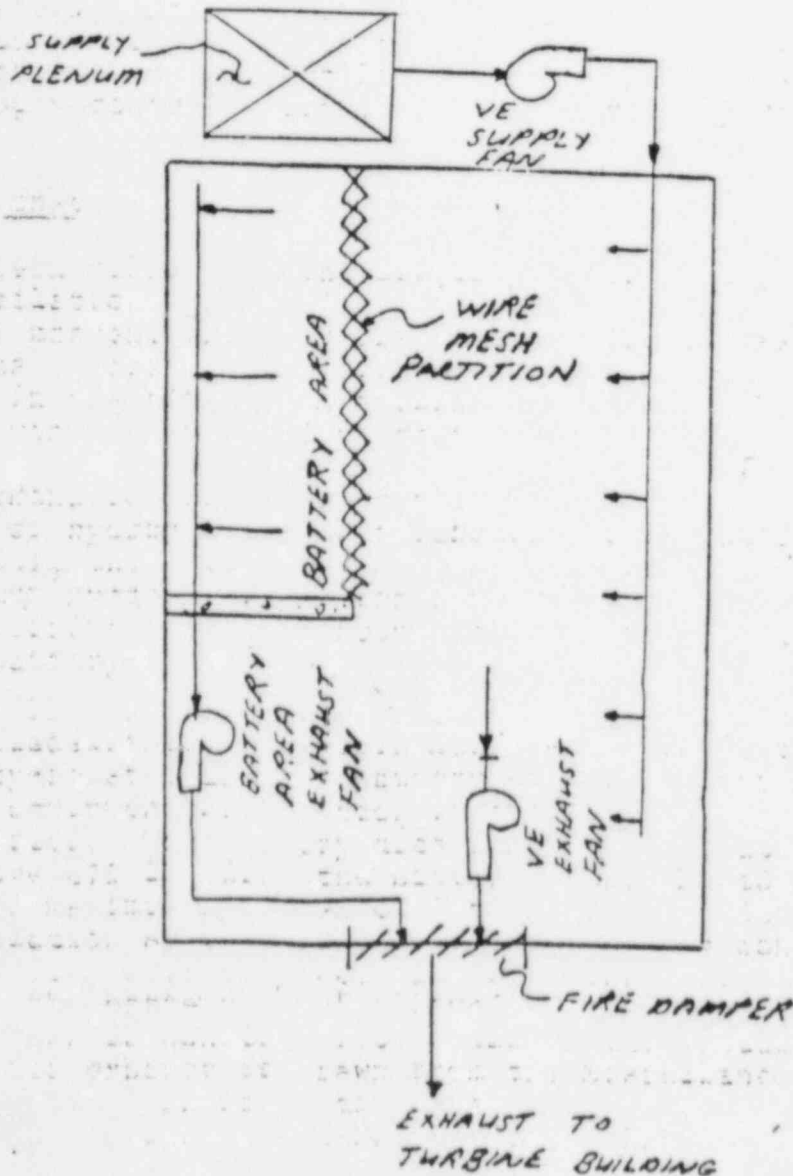
Miscellaneous Electric Equipment Room  
(and Battery Area) Ventilation System (Typical)

Figure 1 illustrates the equipment arrangement and air flow for the Miscellaneous Electric Equipment Room ventilation system. The safety-related 125V DC Battery Area is a part of the Miscellaneous Electric Equipment Room, which is enclosed by a three-hour fire-rated barrier. The battery area exhaust ventilation system will remove 475 CFM from the battery area.

All of the makeup air for the battery area exhaust is drawn from the Miscellaneous Electric Equipment Room. In order to purge (i.e., sweep) the total volume of the battery area, the exhaust duct is located adjacent to the wall opposite the wire mesh partition. The exhaust ductwork is located at the highest practical point in the room (i.e., immediately under the intermediate roof structural steel) and extends over the entire length of the rear battery rack.
