## **PILGRIM NUCLEAR GENERATING STATION**

INVESSEL VISUAL INSPECTION  
EIGHTH REFUEL OUTAGE

PILGRIM NUCLEAR POWER STATION  
BOSTON EDISON COMPANY  
IVI REACTOR INTERNAL COMPONENTS  
RFO 8 - AUGUST 1991

FINAL REPORT FOR  
INVESSEL INSPECTIONS  
OF REACTOR INTERNAL COMPONENTS  
PERFORMED AT  
PILGRIM NUCLEAR GENERATING STATION  
BOSTON EDISON ELECTRIC COMPANY

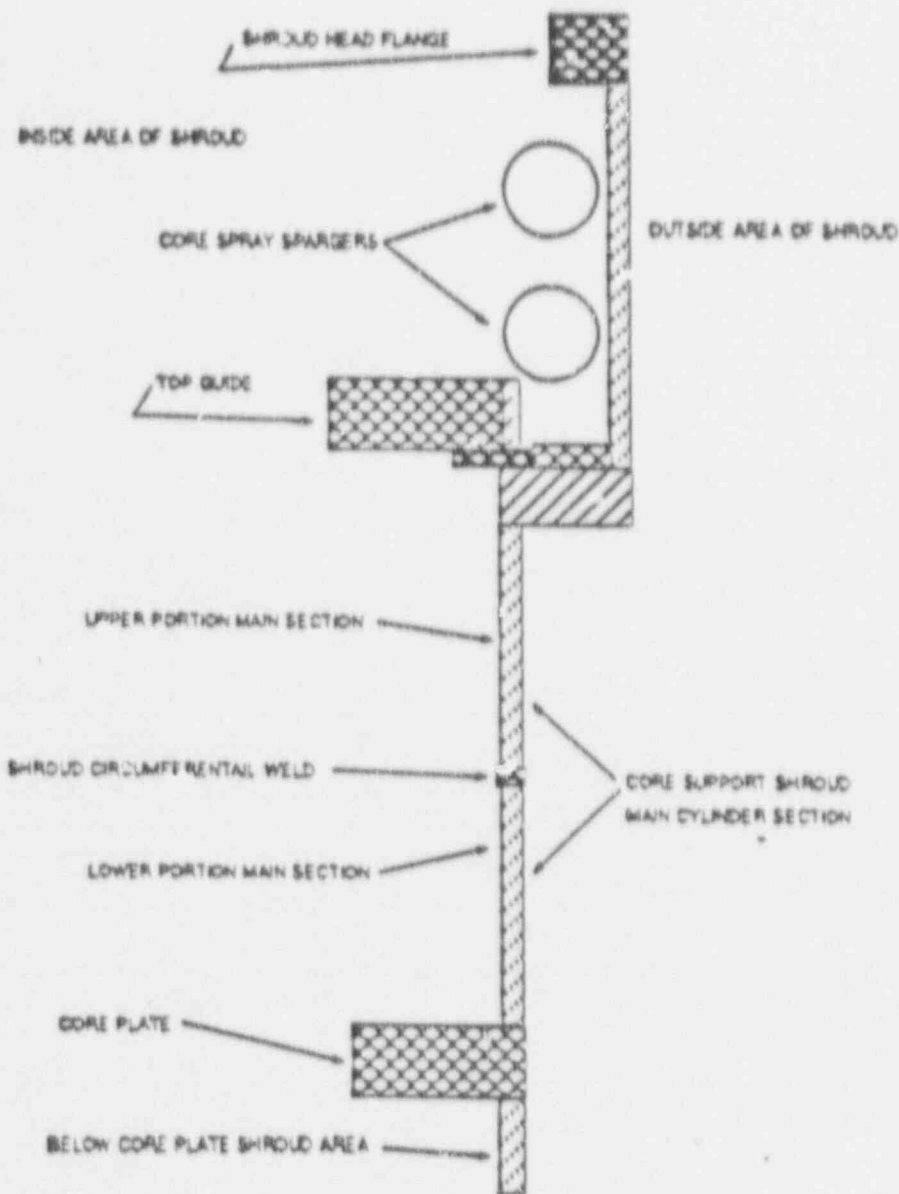
FIGURE 1

NO. GE-VT-284 REV. 0 PAGE 24 OF 24  
TITLE: IN-VESEL VISUAL INSPECTION (IVVI)  
PROCEDURE FOR BWR 3 RPV INTERNALS

- 6.21.3 Condition of the inside surface accessible portion of the circumferential weld in the main cylinder section of the shroud. This weld is located between the core plate and the top guide (see Figure 1).

- 6.21.5 Record the section of the shroud circumferential weld examined.
- 6.21.6 Condition of the inside surface accessible portion of the two vertical welds in the main cylinder section, upper portion of the shroud (see Figure 1).

- 6.21.7 Condition of the inside surface accessible portion of the two vertical welds in the main cylinder section, lower portion of the shroud (see Figure 1).
