UNITED STATES OF AMERICA
NUCLEAR REGULATORY COMMISSION

In The Matter of)
COMMONWEALTH EDISON)
COMPANY)
(Byron Nuclear Power)
Station, Units 1 & 2))

SUMMARY OF DIRECT TESTIMONY OF
RICHARD P. TUETKEN

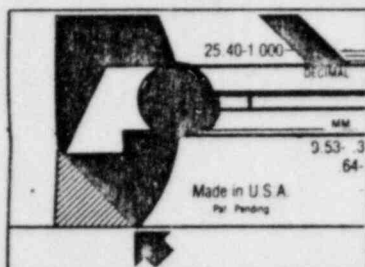
To measure fillet welds place irregular curve edge flush to horizontal toe of weld so the straight edge is in line with the horizontal member.

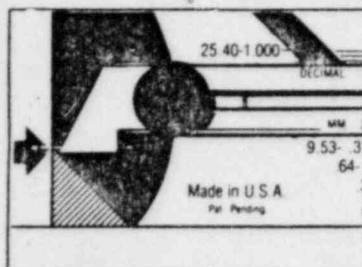
Adjust the offset arm up or down along the diagonal slots until the tip of the arm touches the top of the weld.

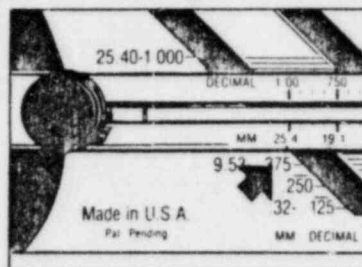
Read the weld size indicated. The increments are in $\frac{1}{32}$ " and $\frac{1}{16}$ " markings up to 1". All numerals are etched into the surface and filled for easier reading.

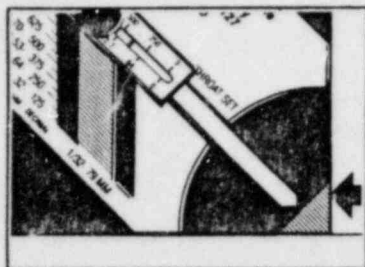
To measure weld throat thickness place the 45° angle end flush to the horizontal and vertical members. Loosen the thumb screw and slide the pointer until it touches the face of the weld.

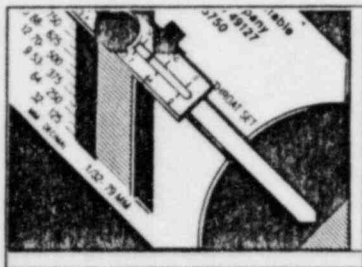
Tighten the thumb screw and read the measurement from the $\frac{1}{32}$ " calibrations along the pointer. A quick, sure way to find convex or concave welds and to correct them with additional filler material to meet standards.
