NORTHEAST UTILITIES

October 5, 1984

Millstone Nuclear Power Station, Unit No. 3
Probabilistic Safety Study (PSS)

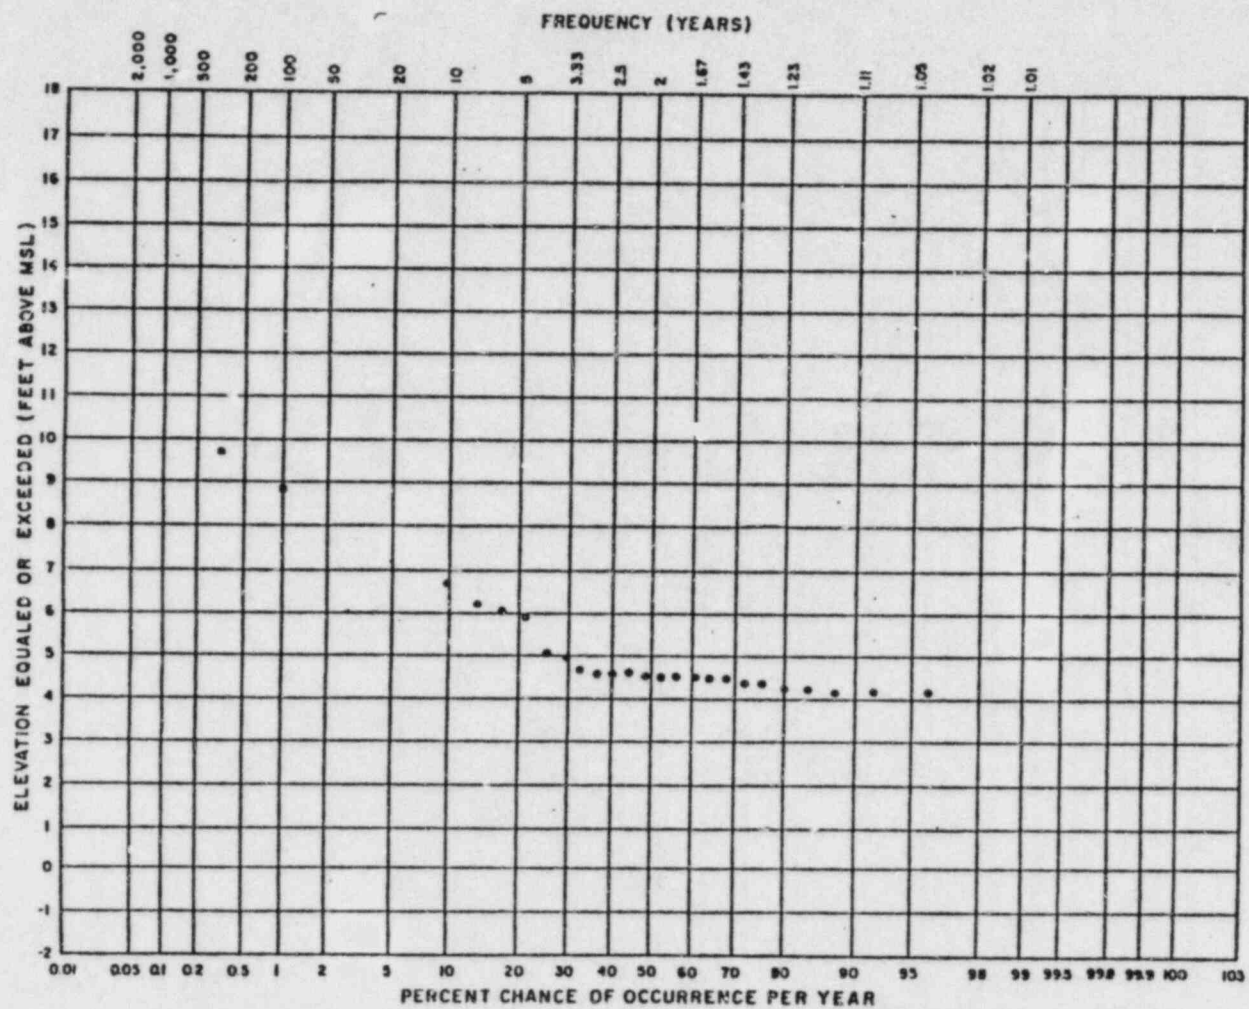
FIGURE 2.4-6
 FREQUENCY OF TIDAL FLOODING
 AT NEW LONDON, CONNECTICUT
 MILLSTONE NUCLEAR POWER STATION
 UNIT 3
 FINAL SAFETY ANALYSIS REPORT

- (a) The elevation of the threshold to the water-tight doors is 14.75 feet. Attached is Figure 2.4-6 from the FSAR entitled "Frequency of Tidal Flooding at New London, Connecticut." This figure is based upon historical data in the vicinity of Millstone and includes the occurrence of the 1938 Hurricane. Extrapolation of this data indicates that the recurrence interval for tidal flooding above elevation 14.75 is greater than 2000 years. This would equate to best estimate frequency of occurrence of $5 \times 10^{-4}/\text{yr}$.
