PACIFIC GAS AND ELECTRIC COMPANY

May 29, 1984

PGandE Letter No.: DCL-84-195

Re: Docket No. 50-275, OL-DPR-76
Docket No. 50-323
Diablo Canyon Units 1 and 2
Response to 146 Allegations

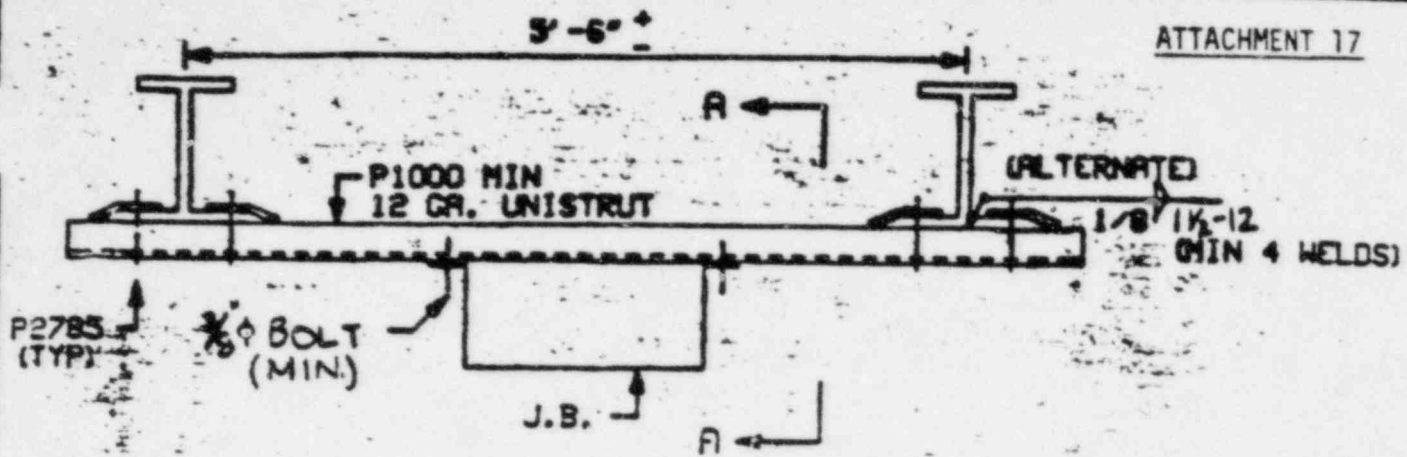
TYPICAL ARRANGEMENT OF ELECTRICAL BOX
SUPPORT FROM STEEL BEAMS

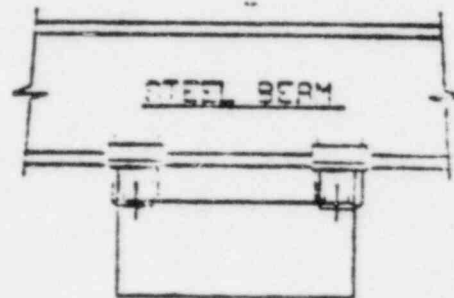
SECTION A-A

1. ALL CONNECTIONS WITH 1/2" Ø UNISTRUT NUTS AND BOLTS EXCEPT AS NOTED
2. MAX. LOADING 10" X 6" X 10" 12 GA. ELECTRICAL BOX

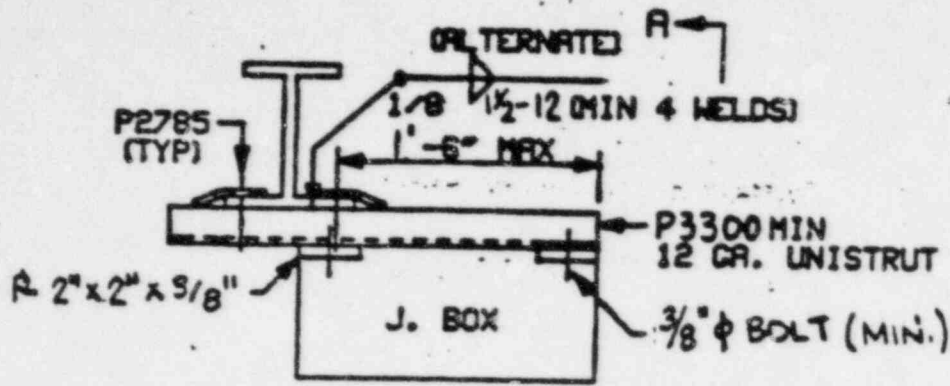
1. ALL CONNECTIONS WITH 1/2" Ø UNISTRUT NUTS AND BOLTS EXCEPT AS NOTED
2. MAX. LOADING 24" x 24" x 12" 12 GA. ELECTRICAL BOX
