Subject: Waterford 3 SES
Docket No. 50-382
Construction Appraisal Team Findings 6.2 and 6.3 -
Masonry Wall Deficiencies

BY A. LEON DATE 11/28/84SHEET 1 OF 2CHKD. BY G.W. DATE 11/29/84OFS NO. _____ DEPT. NO. 653CLIENT LP & LPROJECT WATERFORD SES IIISUBJECT CLARIFICATION OF STRESSES ORIGINATED FOR 6" PIPE THRU WALL S1

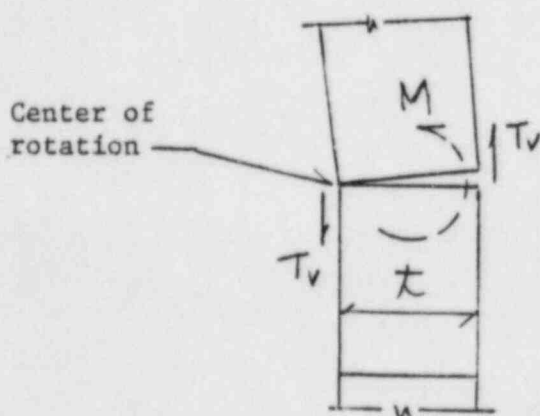
Condition 1.

Due to the nature of the block wall, the geometry at failure under condition 1 is as follows:

$$T_v = \frac{M}{t} \approx \frac{M}{6}$$

Where M: the induced moment
t: thickness of one wythe

This condition has been analyzed on Sh. 42.4 & Sh. 42.5.

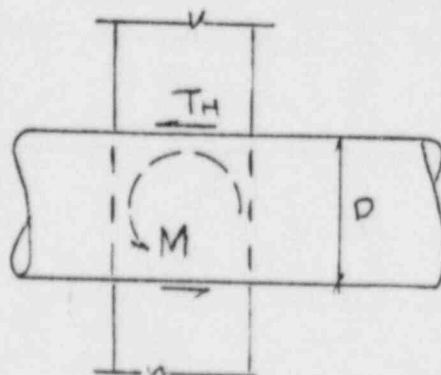
Condition 2

By the same analogy, assume the force T_H acting in a horizontal direction tends to push the block off the wall. This condition has been analyzed on Sh. 42.4

$$T_H = \frac{M}{D} \approx \frac{M}{6}$$

The analysis for this 6" ϕ drainage pipe represents the worst case of pipe that penetrates through the block wall.
