SHOREHAM NUCLEAR POWER STATION

SNRC-1141

Fire Protection
Shoreham Nuclear Power Station - Unit 1
Docket No. 50-322

Response to Deviations

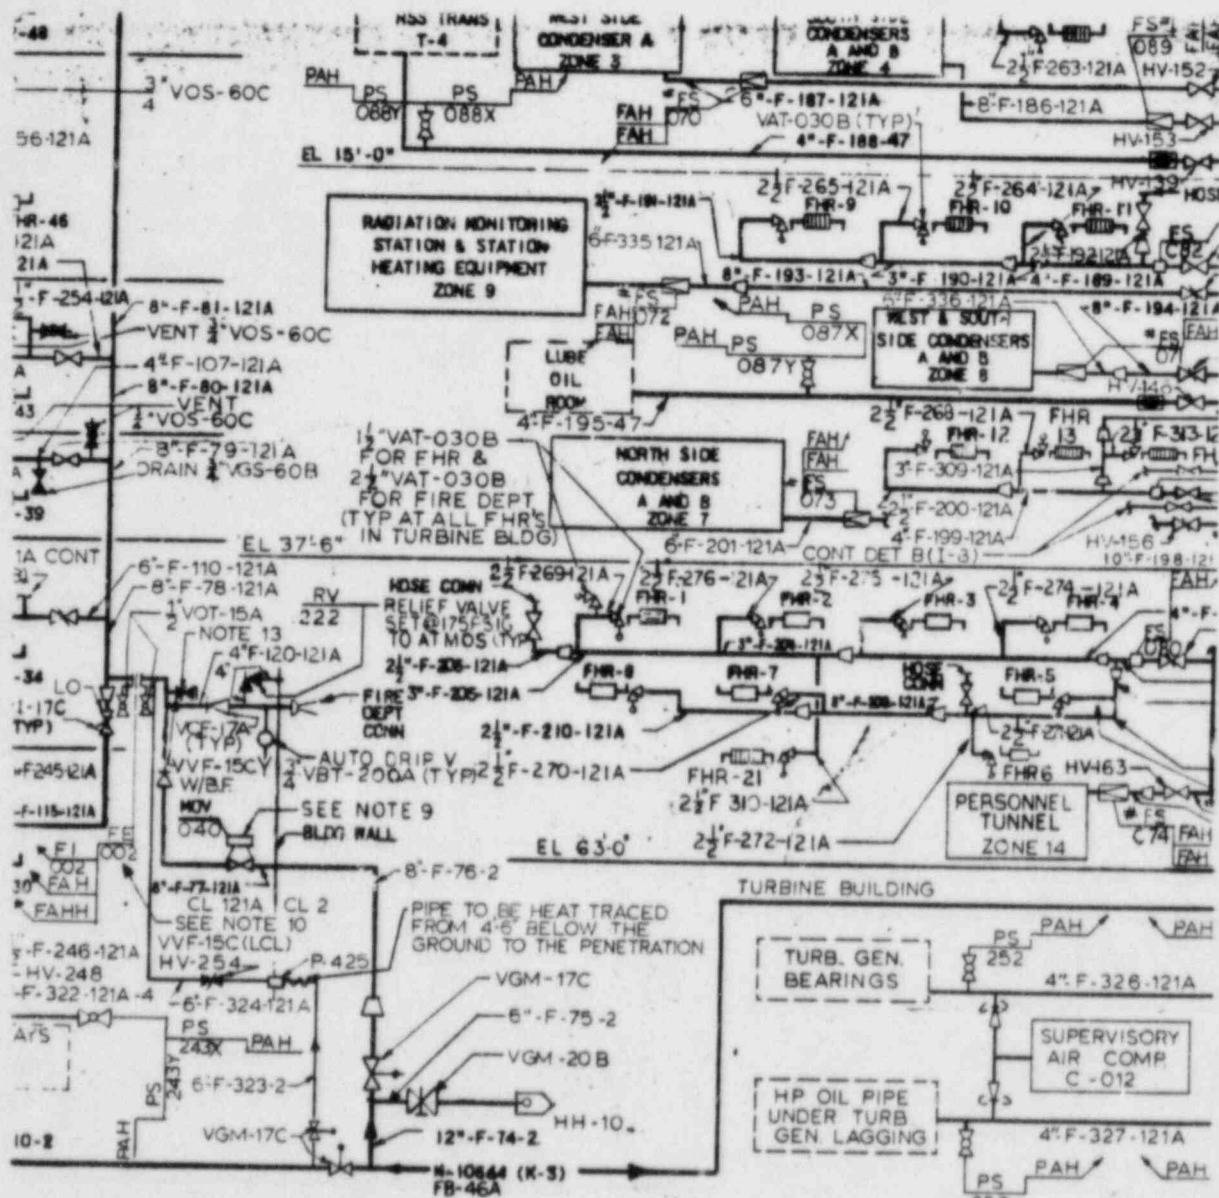
DESCRIPTION	REV	DATE	ISSUE	DESCRIPTION	CHKD	CORR	APPR	DATE	ISSUE	DESCRIPTION
SEE RECORD OF DRAWING CHANGES - ISSUE 2 DIAGRAM REARRANGED - ADDED LINE NO. 10664 (K-3) FIRE DEPT. HOSE CONN.										ORIGINAL ISSUE
