Subject: CHANGE ROOM PROCEDURE

ATTACHMENT 1
Page 1 of 2

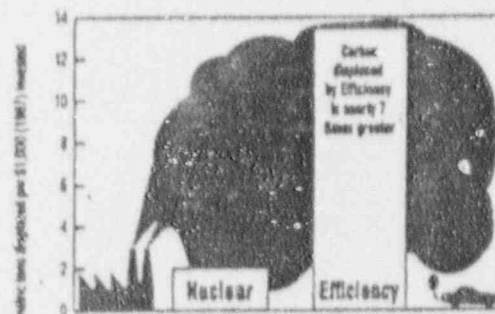
Carbon Dioxide Displacement Potential

In the U.S., improved electrical efficiency can be up to seven times more cost-effective than new nuclear power in reducing carbon dioxide emissions from coal-fired power. Every \$1,000 invested in nuclear power displaces two metric tons of CO₂ emissions. Every \$1,000 invested in efficiency displaces nearly 14 tons of CO₂.

Source: Hill Keppin and Gregory Kats, "Comparative Analysis of Nuclear and Efficiency Abatement Strategies," Energy Policy, Dec. 1988
