NUREG/CR-5923
BNL-NUREG-52338

High Pressure Coolant Injection System Risk-Based Inspection Guide for Hope Creek

Prepared by
M. Villaran, W. Shier

Brookhaven National Laboratory

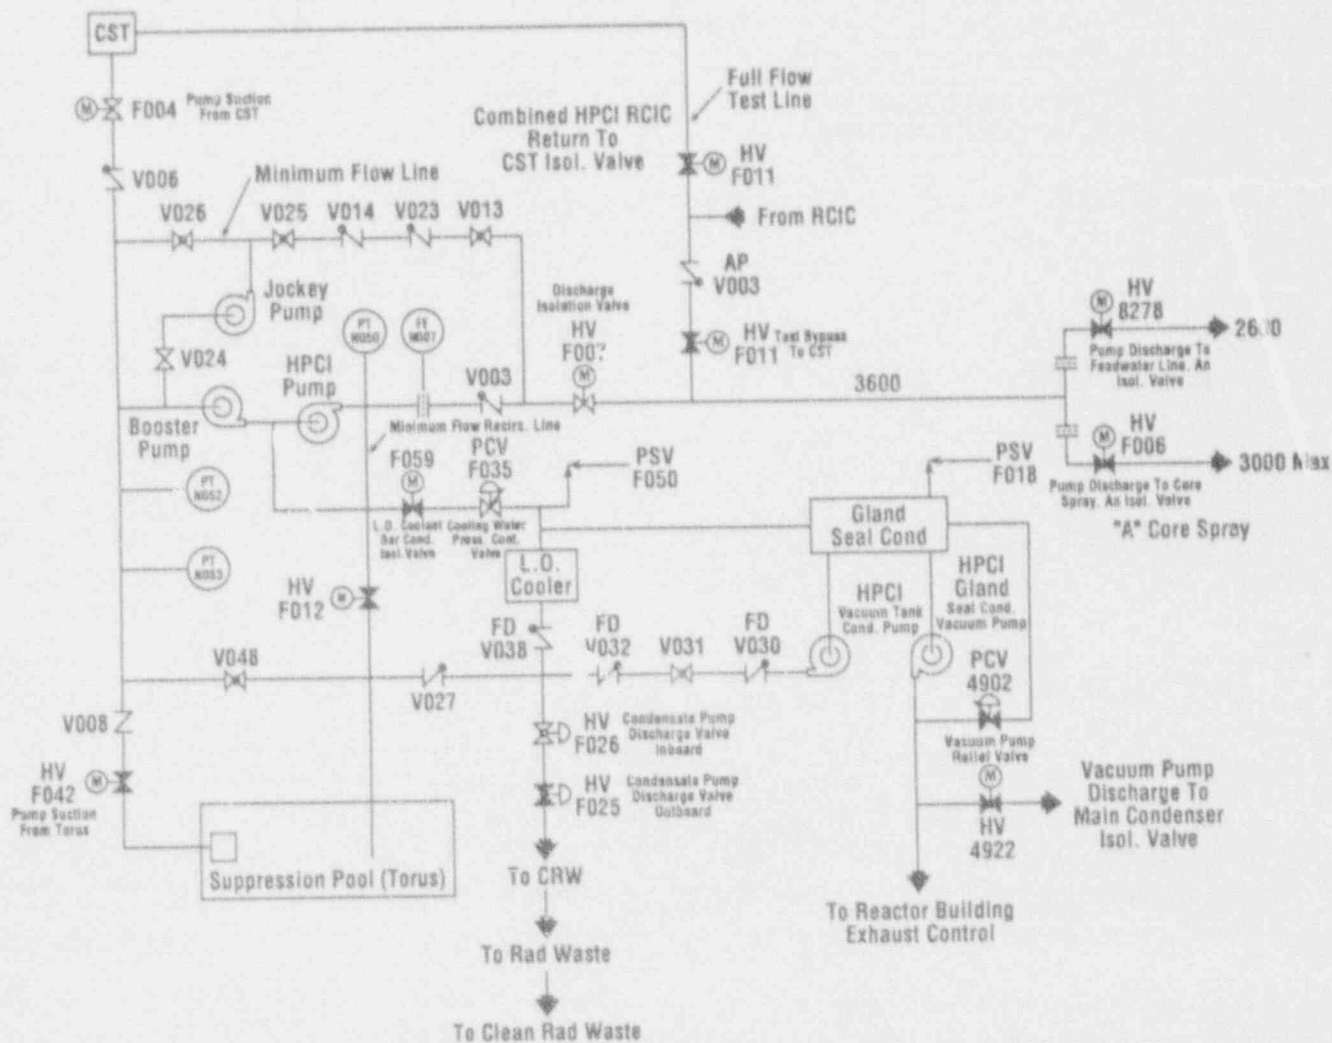
Figure 2a HPCI Water System

The HPCI system is automatically actuated on low reactor water level (level 2) or high drywell pressure. If automatic actuation fails, the system can be manually initiated from the control room.

<u>Page</u>
FIGURES	
2a HPCI Water System	2-2
2b HPCI Steam System	2-3

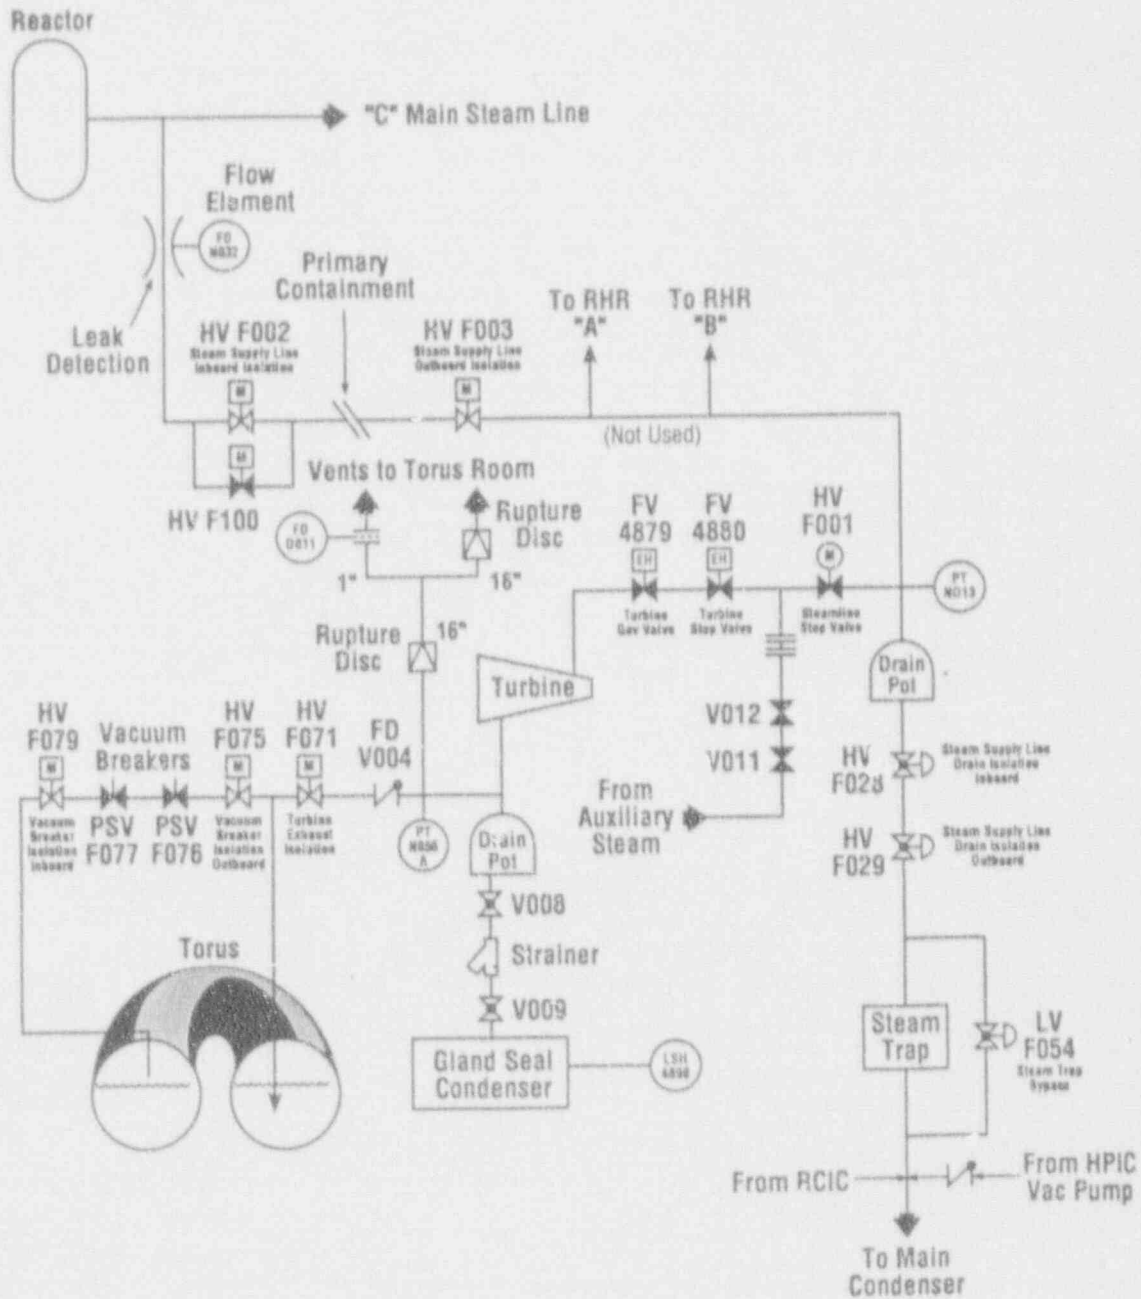
Figure 2b HPCI Steam System

Steam is admitted to the HPCI turbine through valve F001, turbine stop valve, and turbine control valve. These valves are normally closed and are opened by an HPCI initiation signal. Exhaust steam from the turbine is discharged to the suppression pool, while condensed steam from the steam lines and leakage from the turbine gland seals are routed to a barometric condenser, which drains to the radwaste system when HPCI is in standby and back to the booster pump when HPCI is operational.
