Millstone Nuclear Power Station, Unit No. 2
Reply to Notice of Violation
Inspection Report 50-336/92-22

Millstone Nuclear Power Station Unit No. 2
Reply to a Notice of Violation
Inspection Report 50-336/92-22

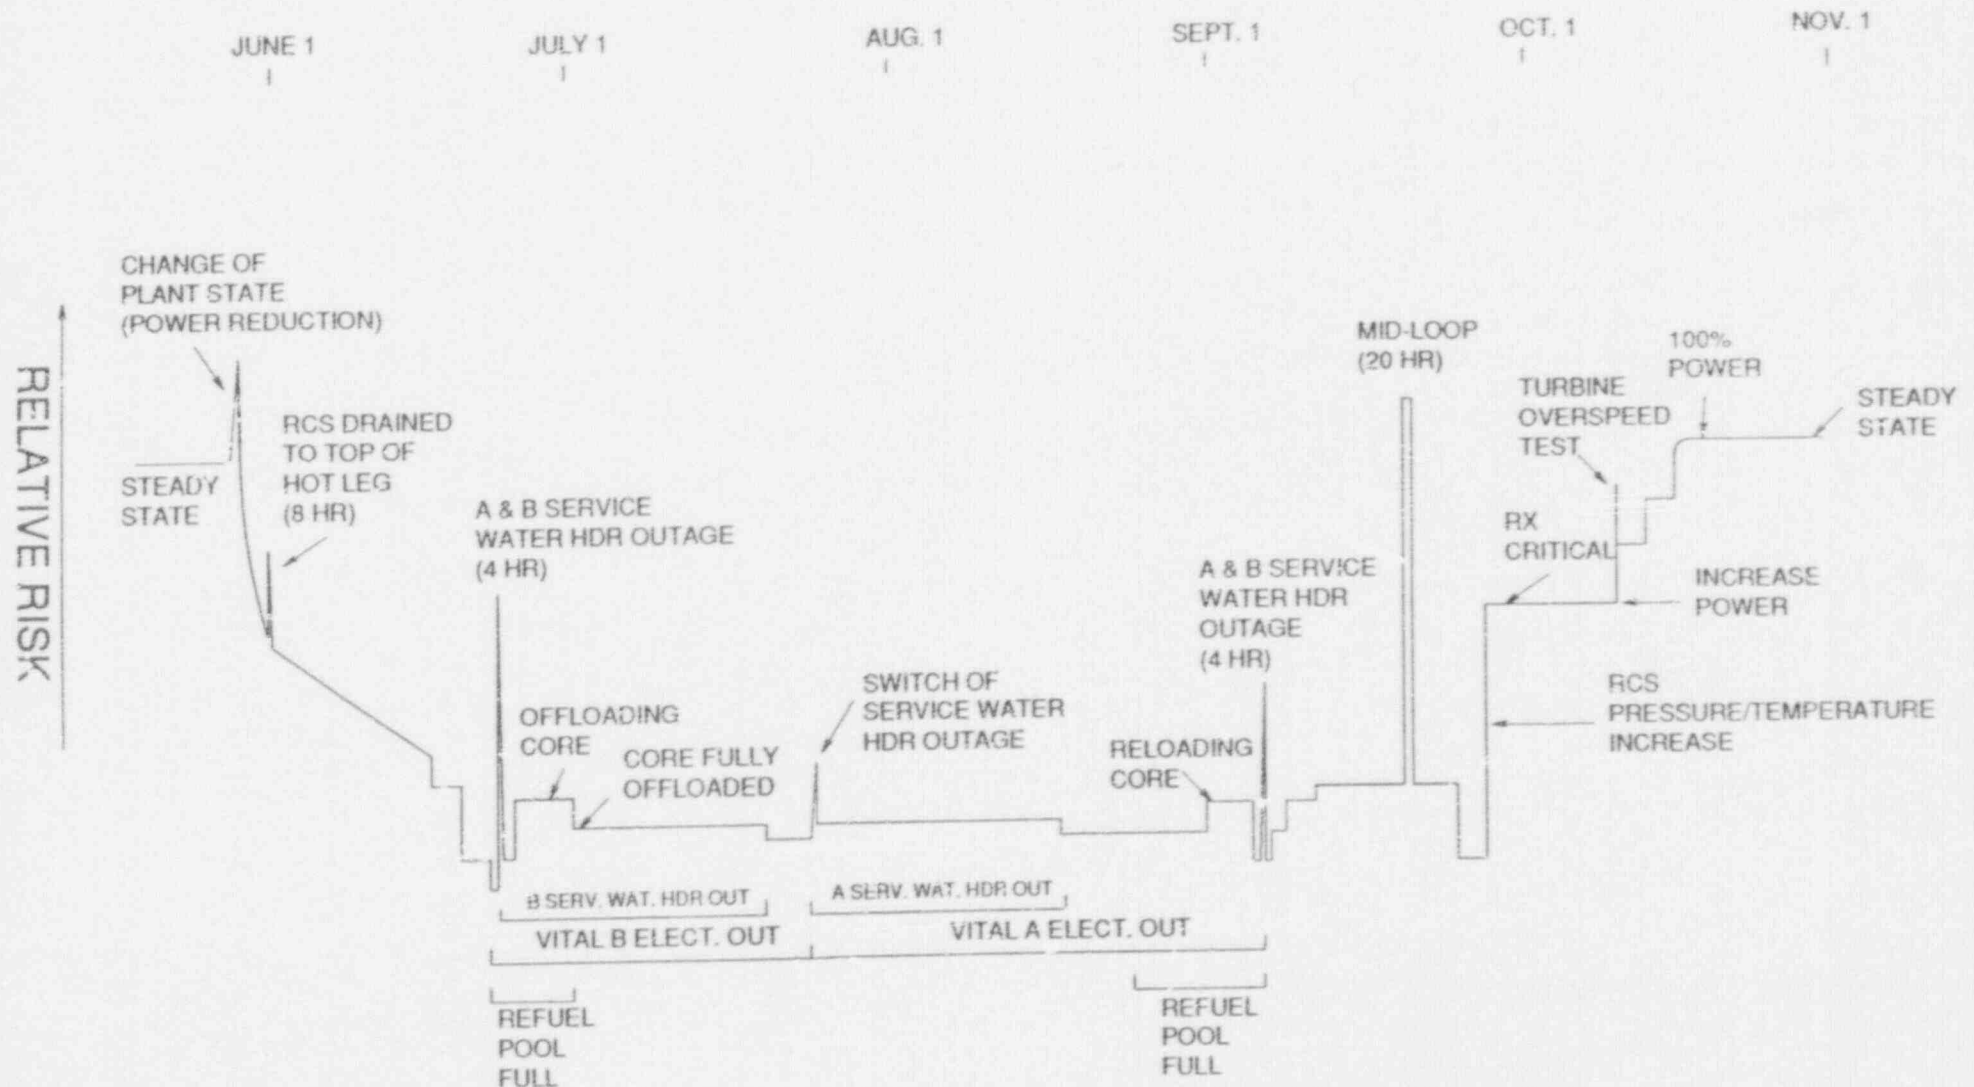
MILLSTONE UNIT 2
CYCLE 11 REFUELING (SGRP)
1992
OUTAGE RISK PROFILE

DAD
6/16/92
REV. 1
