Department of Energy

SUBJECT: 1996 Inspection of the Spook, Wyoming, Title I Site

1996 Annual Inspection of the Spook, Wyoming, UMTRCA Title I Disposal Site

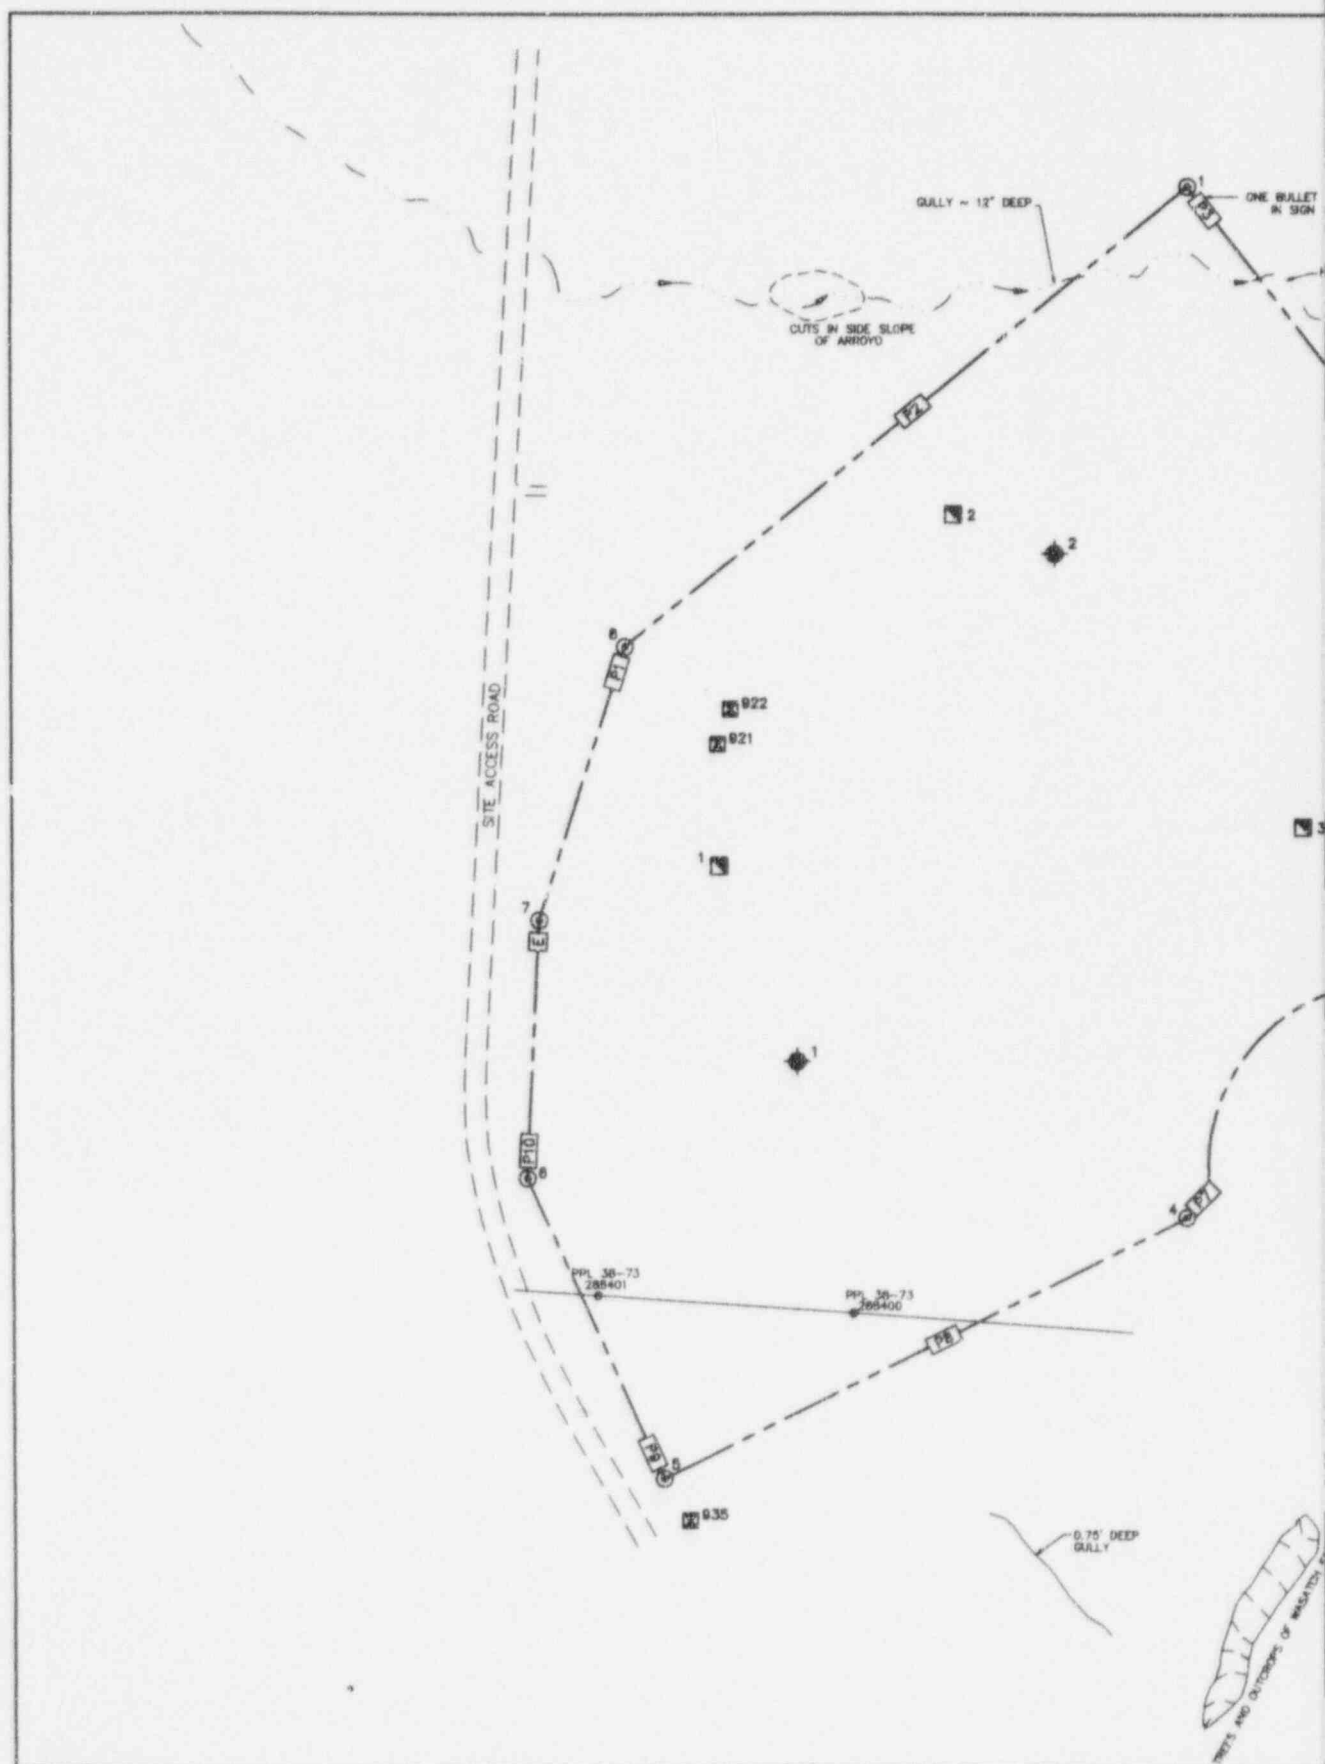
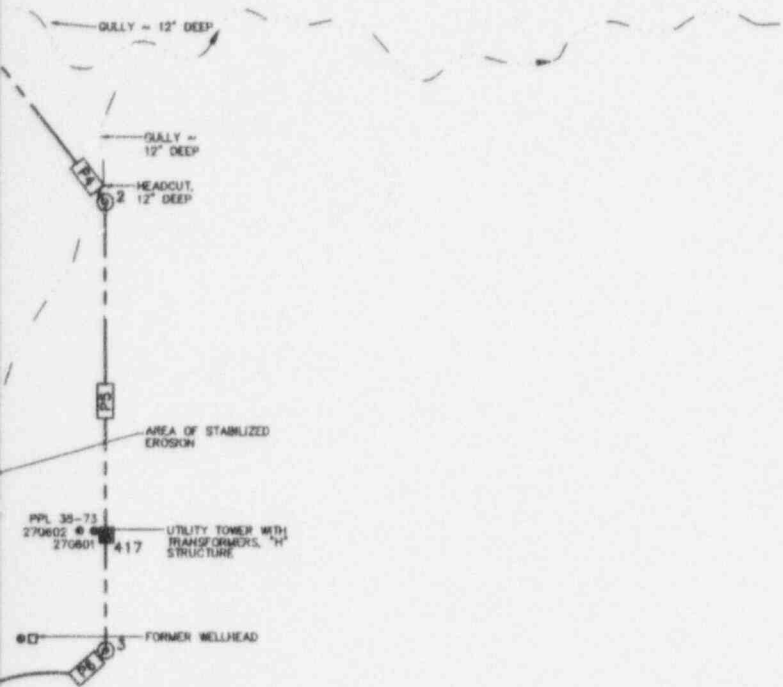
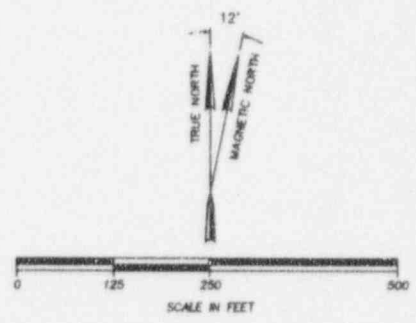
EXPLANATION

- [E] ENTRANCE SIGN
- [P10] PERIMETER SIGN AND NUMBER
- ◆ 1 SITE MARKER AND NUMBER
- ⊙ 1 BOUNDARY MONUMENT AND NUMBER
- ⊞ 1 COMBINED SURVEY MONUMENT/
BOUNDARY MONUMENT AND NUMBER
- ⊞ 827 MONITOR WELL AND NUMBER
- FORMER WELLHEAD
- ⌒ DEPRESSION
- PACIFIC POWER AND LIGHT
POWER POLES AND LINE
- PROPERTY BOUNDARY
- >— SURFACE DRAINAGE WITH FLOW DIRECTION
- ⊙ POWER POLE

One entrance sign and 10 perimeter signs are at this site. All were in place and undamaged except for P3, which has a bullet hole. The missing cap, or finial, on the post for P3 was replaced during this inspection.

The 2 site markers, 8 boundary monuments, and 3 survey monuments were in excellent condition. Concrete bases around several of the boundary monuments rise an inch or so above the surface of the surrounding soil, but this appears to be an artifact of installation and is not a concern. There is no evidence of erosion around the boundary monuments, although minor sheet wash or deflation may have occurred before vegetation became established.

The most noticeable erosion on site is confined to two areas, both part of the same drainage system. One branch of this drainage system flows across the northern tip of the site from west to east; the other branch starts near the transformer platform (see below) and drains the east side of the site, flowing northward to join the first branch. Each branch contains one noticeable knickpoint, as noted during the 1995 inspection. Little has changed over the past year: neither knickpoint has increased in height or migrated upstream from its 1995 position.
