SUBJECT: MEETING SUMMARY: INSPECTION REPORT 96-10 FINDINGS  
FARLEY NUCLEAR PLANT - DOCKET NOS. 50-348, 50-364

This refers to the management meeting on November 4, 1996, conducted at the NRC Region II Office. The purpose of the meeting was to discuss findings documented in Inspection Report (IR) 50-348, 50-364/96-10. It is our opinion, that this meeting was beneficial.

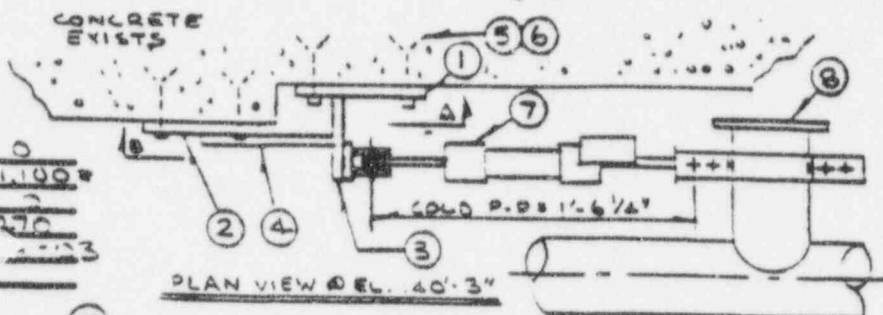
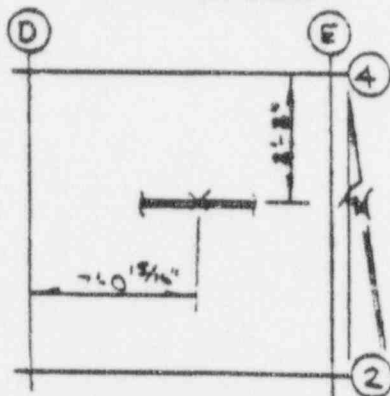
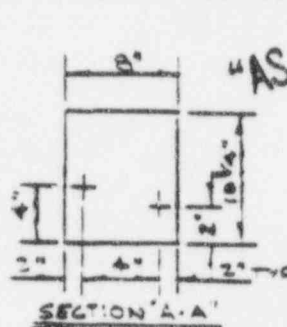
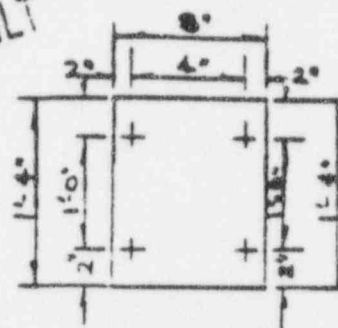
AS BUILT

X = -.302

Y = .003

Z = .021

Y Design Load = 0

X Design Load = 1100#

Z Design Load = 370

ITEM NO	MATERIALS AND OPERATIONS	QUAN	SNIP
	SEISMIC SHOCK & SWAY SUPPRESSOR CONSISTING OF ALL MATERIAL EXISTS IN FIELD	ONE	
1	1/2"x8" Carbon Steel Plate 0'-10 3/4" Long	1	
2	1/2"x8" Carbon Steel Plate 1'-6" Long	1	
3	1/2"x5 1/2" Carbon Steel Plate 0'-6" Long	1	
4	1/2"x6" Carbon Steel Plate 0'-9" Long	1	
5	3/4" Rod Nuts	6	
6	3/4" Tap Bolts 1 1/2" Long	6	
7	1 1/2" cylinder 5" Stroke, Fig. 200 Option #3, 2 3/8" O.D. Pipe, Hydraulic Shock & Sway Suppressor, Load = 1100#, Cold Piston Setting = " Hot Piston Setting = 3 11/16"/24-74	1	
8	Special U.S. 63, Carbon Steel Type "A" 2" Stanchion 6" Pipe 2'-0'-9 1/8", E=7 1/8", G=3/8"x6"x6"	1	
	SEISMIC ASSEMBLY SKETCH & ENGINEERING BUNDLE & TAG	1	
	MARK# AEW-267	1
