SUBJECT: REQUEST FOR ADDITIONAL INFORMATION (RAI) REGARDING PREVENTIVE
MAINTENANCE PROGRAM FOR REACTOR TRIP BREAKERS/MAINTENANCE AND
TRENDING - BEAVER VALLEY, UNIT 2

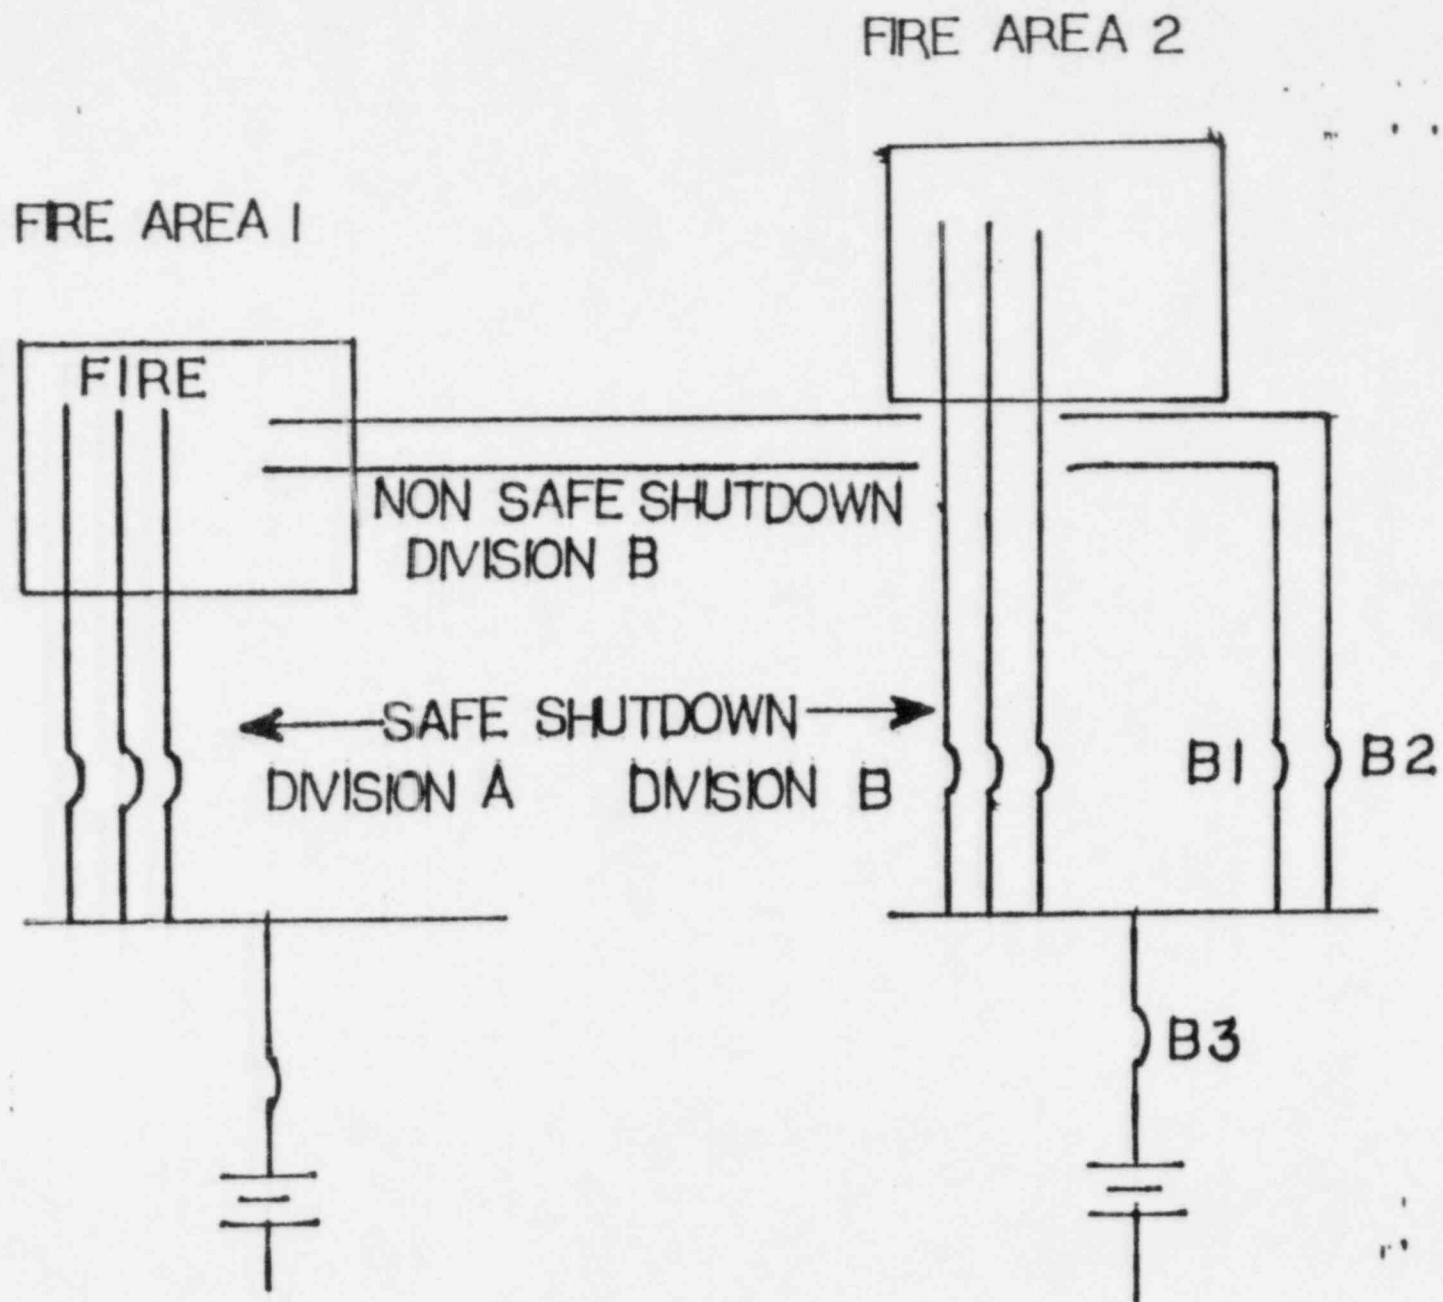
FIGURE 1 - Revision 1

2. We have a concern regarding the potential for multi-high impedance faults in AC power circuits which could result in the loss of power to safe shutdown equipment. Figure 1 contains a sketch of circuit designs which could result in the loss of needed power to safe shutdown equipment. As can be seen in Figure 1, redundant divisions of safe shutdown cables are properly separated in accordance with Appendix R criteria. However, a fire in fire area A would result in loss of Division A safe shutdown equipment and cause damage to nonsafe shutdown cables associated with the Division A bus. Further, the individual fault current resulting from the fire damage in the nonsafe shutdown cables may not be enough to trip the individual breakers

(B_1 and B_2), but the sum of the faults may be sufficient to trip the main breaker, B_3). If this were to occur, the Division B bus and the corresponding redundant Division B safe shutdown would be lost. You must show that multi-high impedance faults in AC power circuits resulting from a single fire cannot result in the loss of function of any safety-related system as outlined above.
