RADIOLOGIC AND ENGINEERING ASSESSMENT

DOE ID NO.: GJ-05609-RS
ADDRESS: 207 COUNTRY CLUB PARK

URANIUM MILL TAILINGS REMEDIAL ACTION PROJECT OFFICE

BENDIX FIELD ENGINEERING CORPORATION
P.O. Box 1569
Grand Junction, Colorado 81502

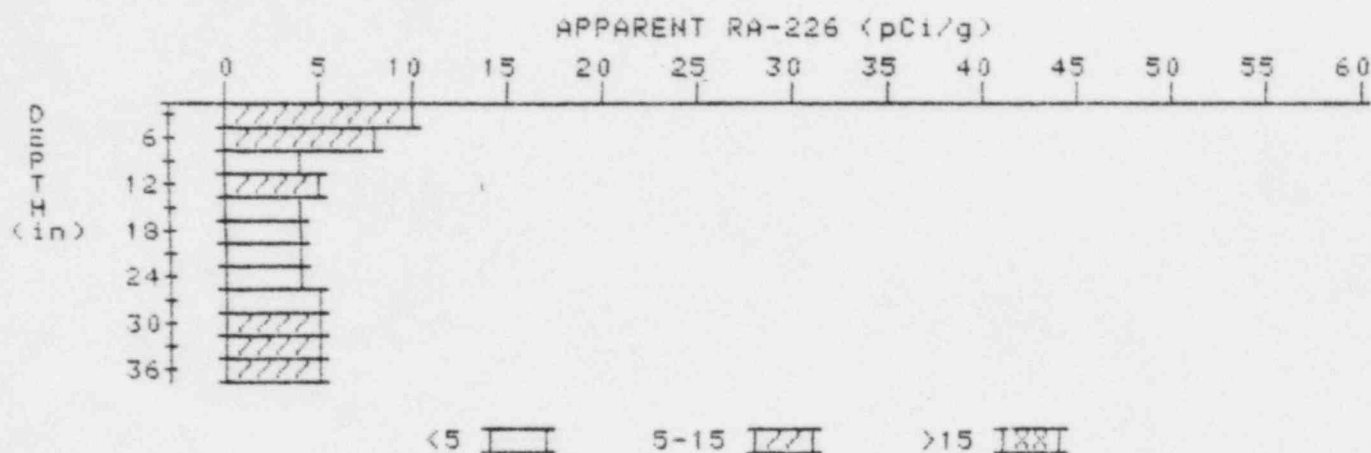
APPARENT RADIUM-226 CONCENTRATION DECONVOLUTION GRAPH

PROPERTY NUMBER: GJ-05609-RS

HOLE NUMBER: 9

LOCATION: 160214

Depth (in)	Apparent Radium-226 (pCi/g) Undeconvolved	Apparent Radium-226 (pCi/g) Deconvolved
3	9.6	9.6
6	7.8	7.6
9	6.1	4.3
12	5.4	5.4
15	4.7	3.8
18	4.5	4.1
21	4.5	4.3
24	4.6	4.4
27	4.8	4.8
30	5.0	5.4
33	5.0	5.0
36	5.0	5.0

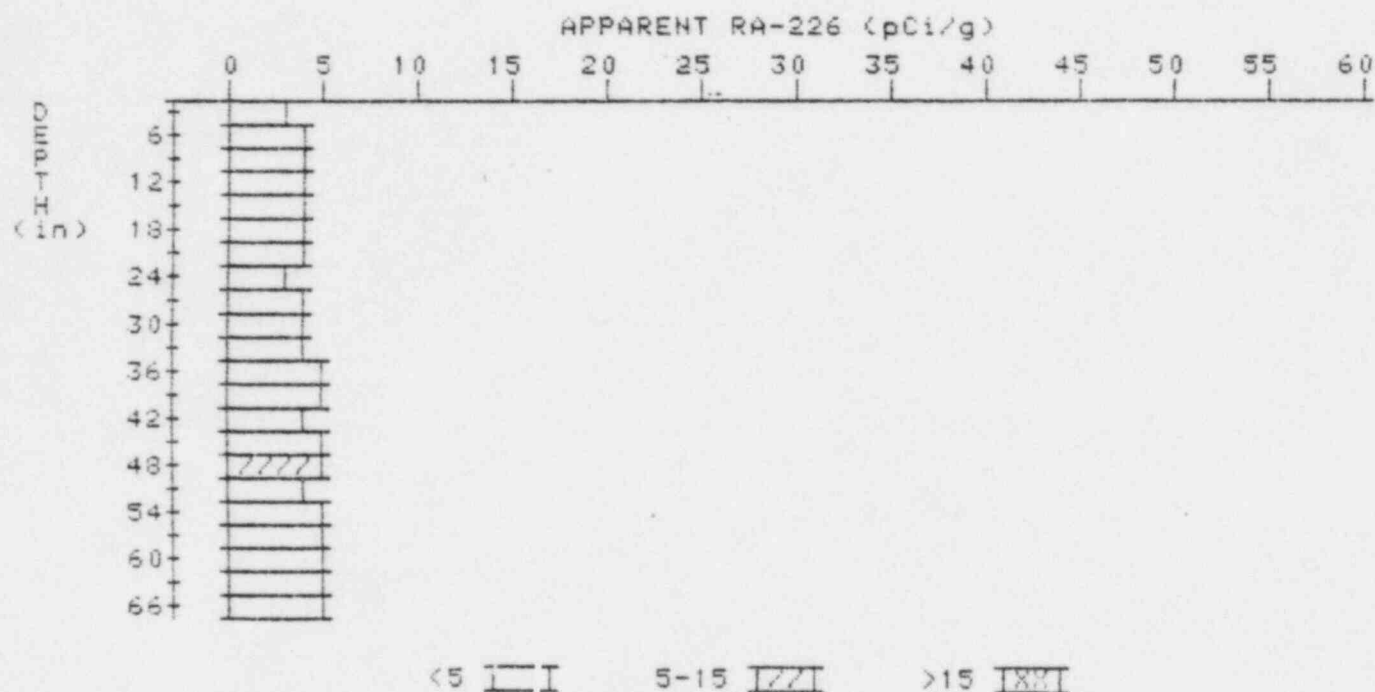
APPARENT RADIUM-226 CONCENTRATION 12 DECONVOLUTION GRAPH

PROPERTY NUMBER: GJ-05609-RS
HOLE NUMBER: 12
LOCATION: 211255

Depth (in)	Apparent Radium-226 (pCi/g) Undeconvolved	Apparent Radium-226 (pCi/g) Deconvolved
3	3.3	3.3
6	3.6	3.8
9	3.8	4.0
12	3.9	3.9
15	4.0	4.2
18	4.0	4.2
21	3.9	3.9
24	3.8	3.3
27	4.0	4.4
30	4.0	3.6
33	4.2	4.2
36	4.4	4.6
39	4.5	4.7
42	4.5	4.3
45	4.6	4.6
48	4.7	5.1

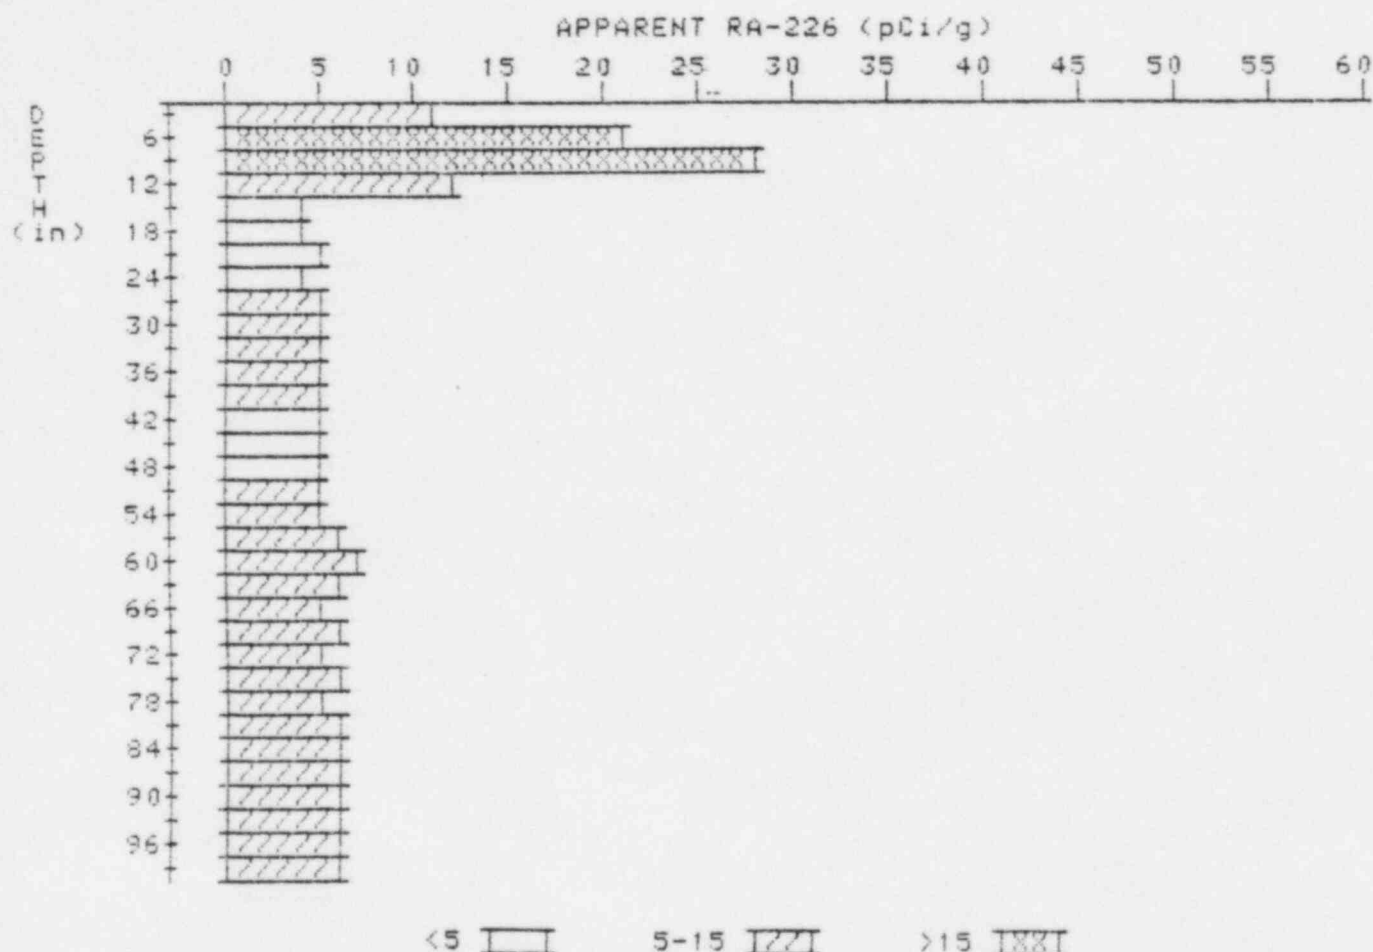
APPARENT RADIUM-226 CONCENTRATION 13 DECONVOLUTION GRAPH

PROPERTY NUMBER: GJ-05609-RS

HOLE NUMBER: 13

LOCATION: 218245

Depth (in)	Apparent Radium-226 (pCi/g) Undeconvolved	Apparent Radium-226 (pCi/g) Deconvolved
3	10.6	10.6
6	15.4	20.9
9	17.1	28.3
12	12.5	11.8
15	8.3	4.4
18	6.3	4.3
21	5.4	4.5
24	5.0	4.3

27	5.0	5.0
30	5.0	5.0
33	5.0	5.0
36	5.0	5.0
39	5.0	5.2
42	4.9	4.7
45	4.9	4.7
48	5.0	4.6
51	5.3	5.5
54	5.5	5.1
57	5.9	6.3
60	6.1	6.6
63	6.0	6.4
66	5.7	5.3
69	5.6	5.6
72	5.5	5.1
75	5.6	5.6
78	5.6	5.2
81	5.8	6.2
84	5.8	5.6
87	5.9	5.7
90	6.1	6.5
93	6.1	5.9
96	6.2	6.4
99	6.2	6.2

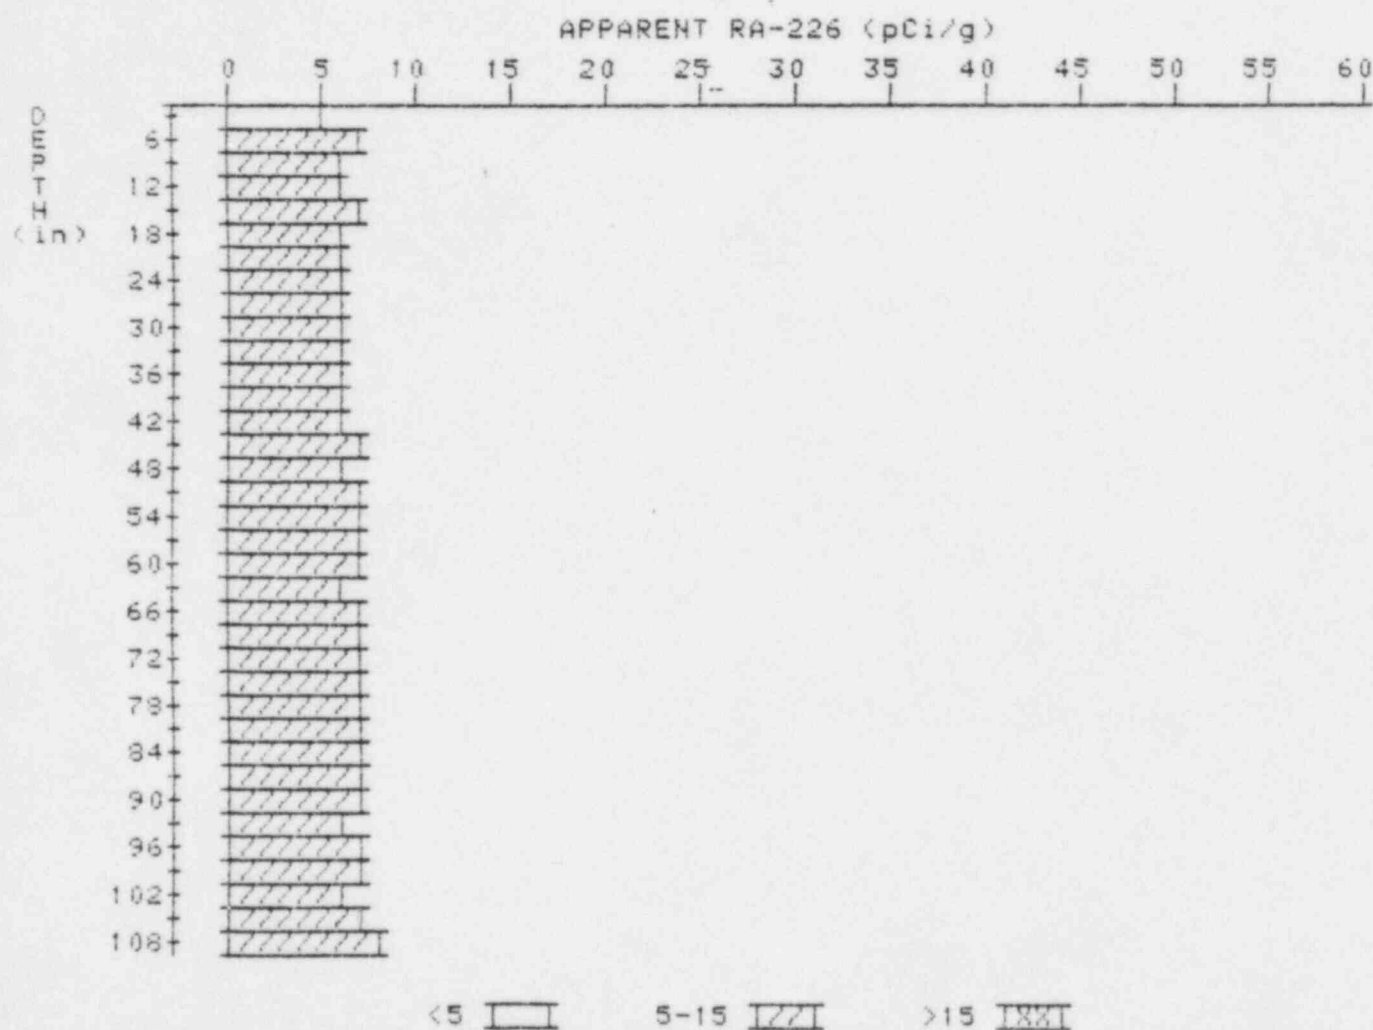
APPARENT RADIUM-226 CONCENTRATION 14 DECONVOLUTION GRAPH

PROPERTY NUMBER: GJ-05609-R3

HOLE NUMBER: 14

LOCATION: 219228

Depth (in)	Apparent Radium-226 (pCi/g) Undeconvolved	Apparent Radium-226 (pCi/g) Deconvolved
3	4.6	4.6
6	5.5	6.7
9	5.7	5.7
12	5.9	5.9
15	6.1	6.6
18	6.0	6.2

21	5.8	5.6
24	5.7	5.5
27	5.7	5.7
30	5.7	5.5
33	5.8	5.8
36	5.9	5.7
39	6.1	6.3
42	6.2	6.0
45	6.4	6.8
48	6.4	6.2
51	6.5	6.5
54	6.6	6.8
57	6.6	6.6
60	6.6	6.6
63	6.6	6.4
66	6.7	6.7
69	6.8	6.6
72	7.0	7.2
75	7.1	7.5
78	7.0	7.0
81	6.9	7.1
84	6.7	6.5
87	6.6	6.6
90	6.5	6.5
93	6.4	5.9
96	6.6	6.8
99	6.7	6.7
102	6.8	5.9
105	7.4	7.2
108	8.1	8.1

Because of unusually high readings continuously down the boreholes, a revisit was made to check the data. A 105-inch deep hole was drilled a foot from 219228. Readings similar to 219228 were taken from that location.

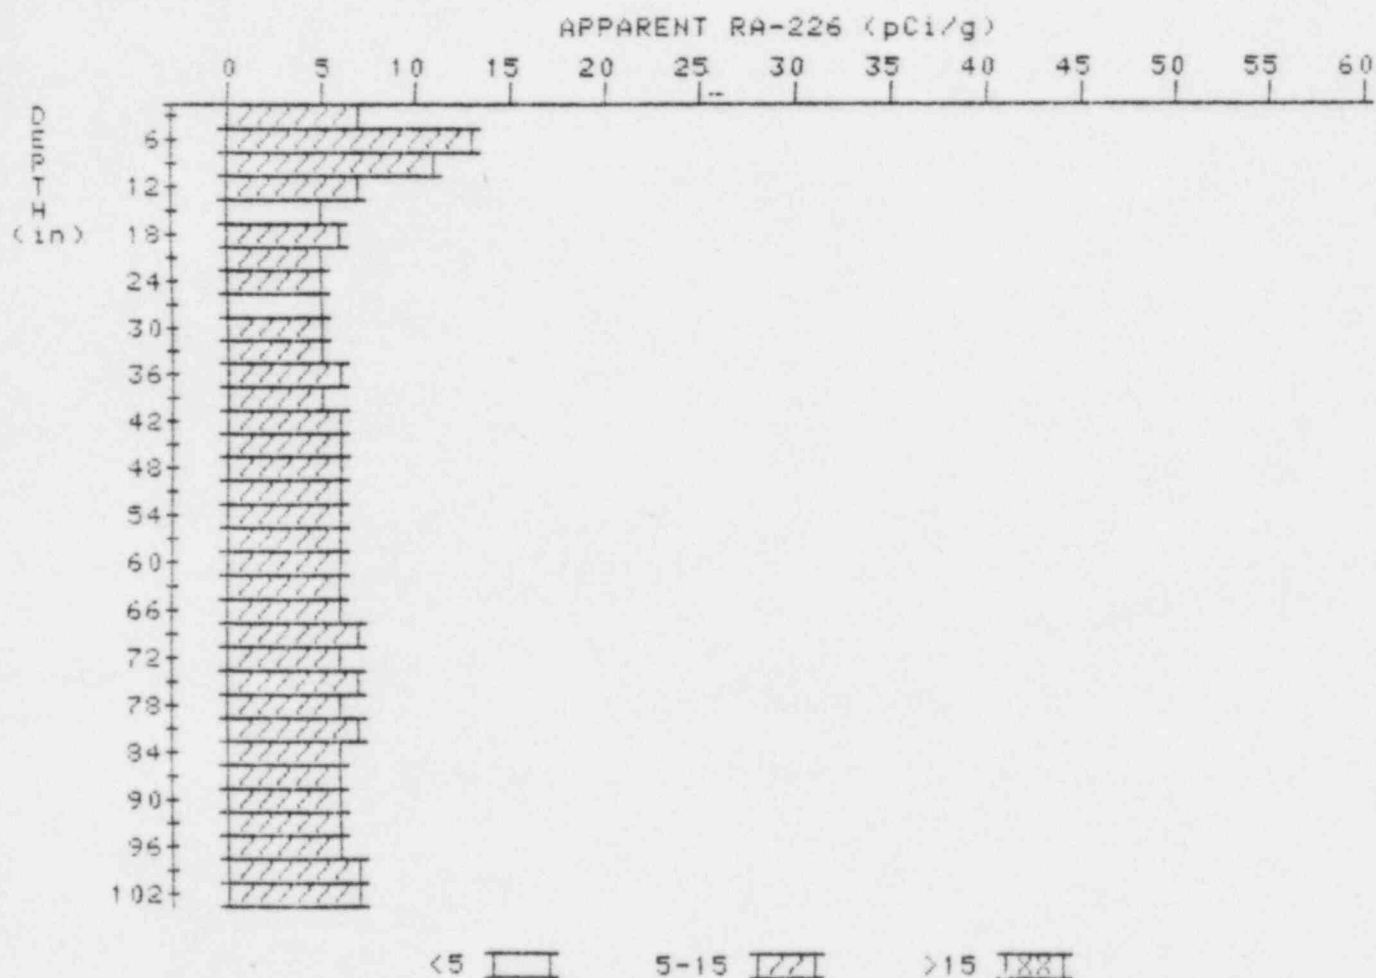
APPARENT RADIUM-226 CONCENTRATION 15 DECONVOLUTION GRAPH

PROPERTY NUMBER: GJ-05609-RS
HOLE NUMBER: 15
LOCATION: 219229

Depth (in)	Apparent Radium-226 (pCi/g) Undeconvolved	Apparent Radium-226 (pCi/g) Deconvolved
3	6.5	6.5
6	8.9	13.3
9	8.8	11.3
12	7.3	6.6
15	6.2	5.0
18	5.8	5.8
21	5.4	5.0

24	5.2	5.0
27	5.1	4.6
30	5.3	5.5
33	5.4	5.0
36	5.7	6.2
39	5.7	5.3
42	5.9	6.3
45	5.9	5.7
48	6.0	6.2
51	6.0	6.0
54	6.0	6.0
57	6.0	6.0
60	6.0	6.0
63	6.0	5.8
66	6.1	5.9
69	6.3	6.7
72	6.3	5.8
75	6.6	7.3
78	6.5	6.3
81	6.5	6.7
84	6.4	6.4
87	6.3	6.3
90	6.2	5.8
93	6.3	6.3
96	6.4	6.0
99	6.7	7.4
102	6.6	6.6

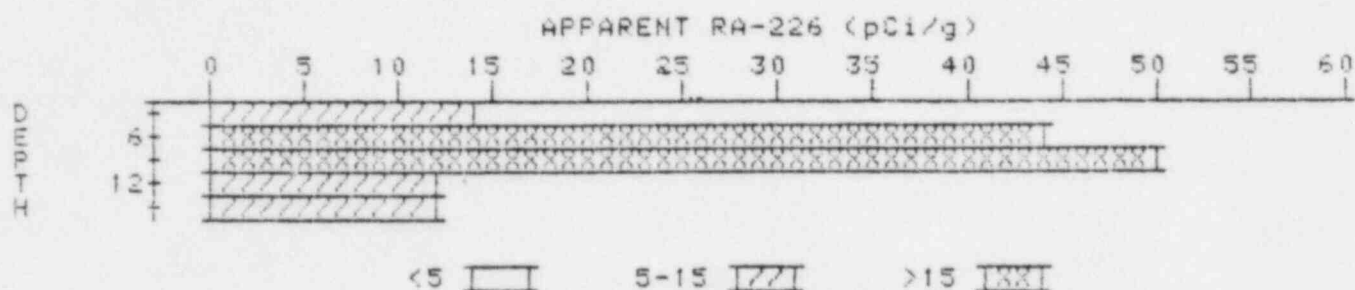
APPARENT RADIUM-226 CONCENTRATION 17 DECONVOLUTION GRAPH

PROPERTY NUMBER: GJ-05609-RS
HOLE NUMBER: 17
LOCATION: 230245

Depth (in)	Apparent Radium-226 (pCi/g) Undeconvolved	Apparent Radium-226 (pCi/g) Deconvolved
3	14.0	14.0
6	26.3	44.4
9	28.4	49.6
12	18.6	12.2
15	12.4	12.4

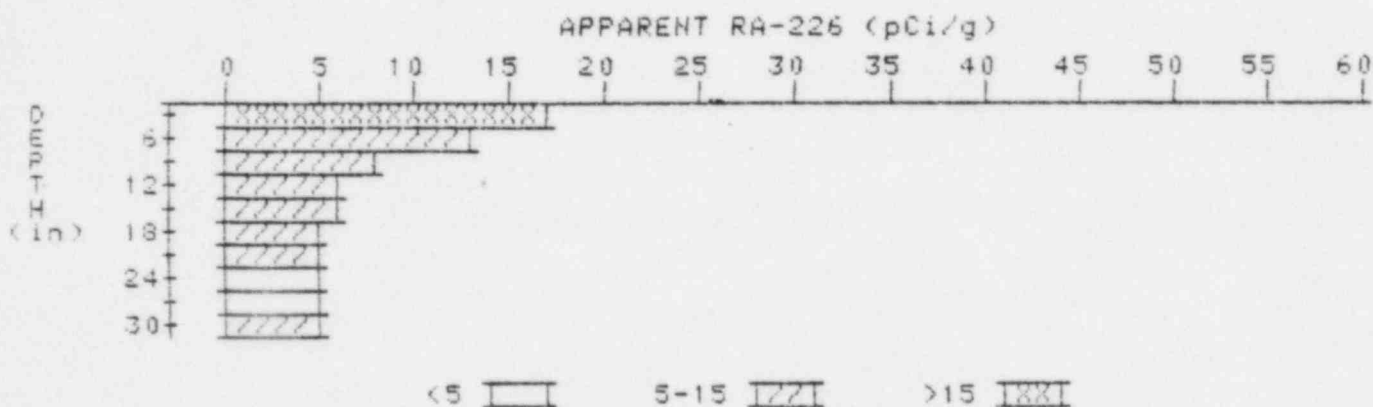
APPARENT RADIUM-226 CONCENTRATION 20 DECONVOLUTION GRAPH

PROPERTY NUMBER: GJ-05609-RS
HOLE NUMBER: 20
LOCATION: 243244

Depth (in)	Apparent Radium-226 (pCi/g) Undeconvolved	Apparent Radium-226 (pCi/g) Deconvolved
3	17.1	17.1
6	13.4	12.7
9	10.1	8.0
12	8.0	6.4
15	6.8	6.1
18	6.0	5.5
21	5.5	5.1
24	5.2	4.7
27	5.2	4.8
30	5.4	5.4

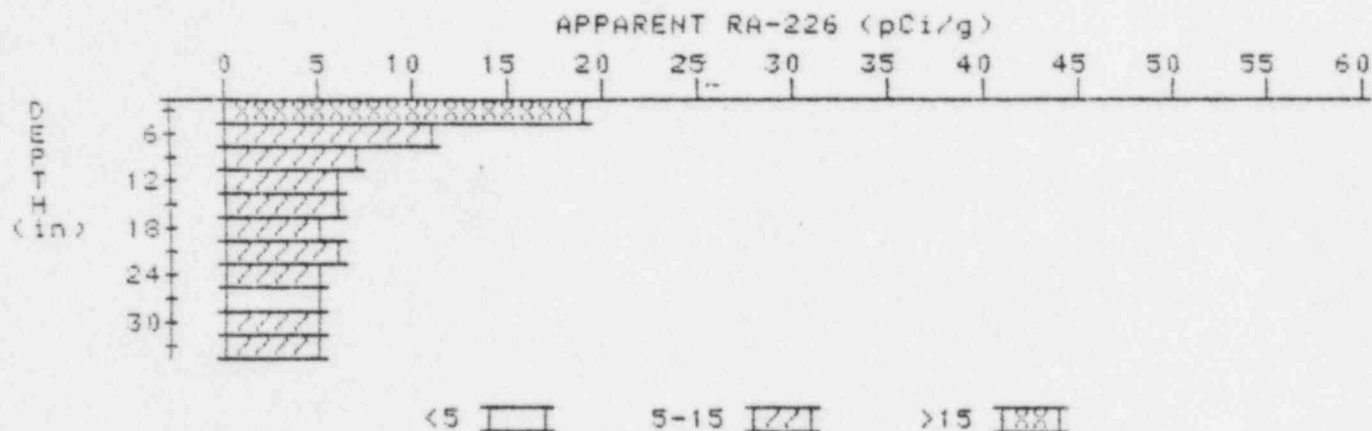
APPARENT RADIUM-226 CONCENTRATION 23 DECONVOLUTION GRAPH

PROPERTY NUMBER: GJ-05609-RS

HOLE NUMBER: 23

LOCATION: 246247

Depth (in)	Apparent Radium-226 (pCi/g) Undeconvolved	Apparent Radium-226 (pCi/g) Deconvolved
3	19.4	19.4
6	13.9	10.9
9	10.1	7.3
12	7.9	5.8
15	6.9	6.4
18	6.2	5.5
21	5.0	6.1
24	5.5	5.1
27	5.3	4.9
30	5.3	5.3
33	5.3	5.3

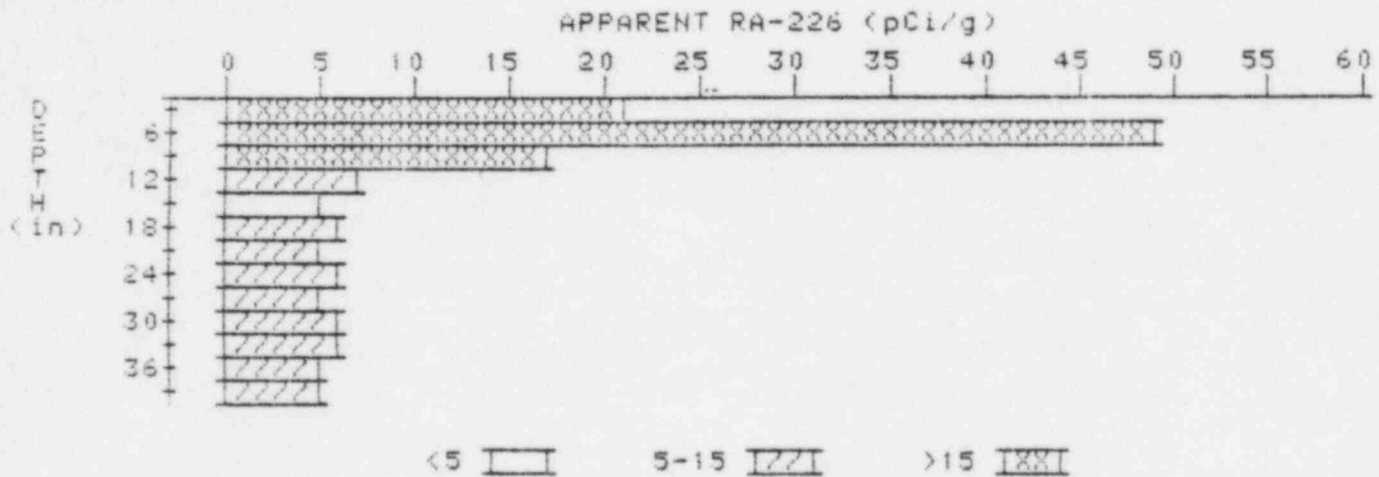
APPARENT RADIUM-226 CONCENTRATION 26 DECONVOLUTION GRAPH

PROPERTY NUMBER: GJ-05609-RS
HOLE NUMBER: 26
LOCATION: 260215

Depth (in)	Apparent Radium-226 (pCi/g) Undeconvolved	Apparent Radium-226 (pCi/g) Deconvolved
3	20.8	20.8
6	26.1	48.7
9	18.7	16.9
12	12.3	7.5
15	8.6	4.9
18	7.0	5.6
21	6.2	5.1
24	6.0	6.2
27	5.7	5.3
30	5.6	5.6
33	5.5	5.5
36	5.4	5.4
39	5.3	5.3

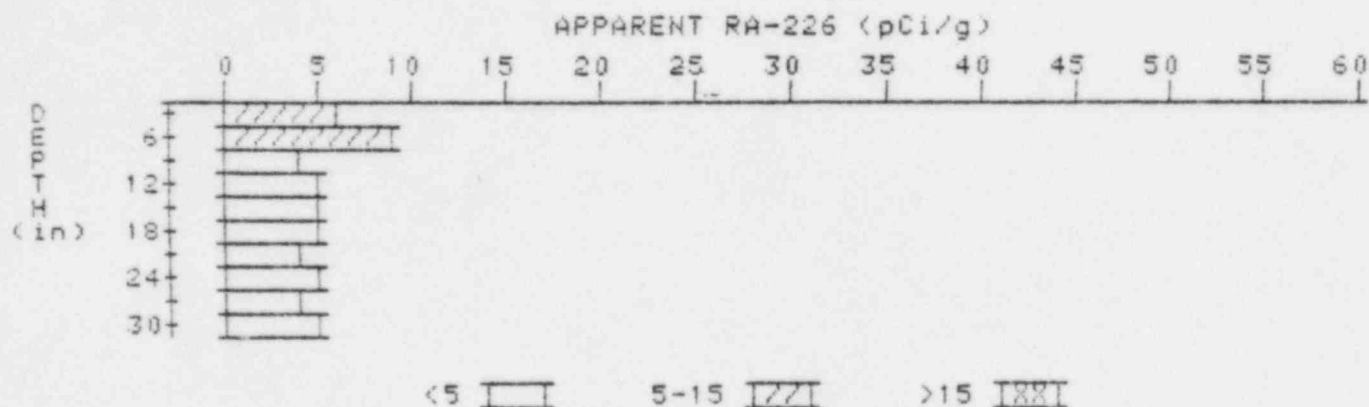
APPARENT RADIUM-226 CONCENTRATION 27 DECONVOLUTION GRAPH

PROPERTY NUMBER: GJ-05609-R3
HOLE NUMBER: 27
LOCATION: 260256

Depth (in)	Apparent Radium-226 (pCi/g) Undeconvolved	Apparent Radium-226 (pCi/g) Deconvolved
3	5.9	5.9
6	6.3	6.3
9	5.3	4.2
12	4.9	4.5
15	4.7	4.5
18	4.6	4.6
21	4.5	4.5
24	4.5	4.7
27	4.4	4.0
30	4.5	4.5

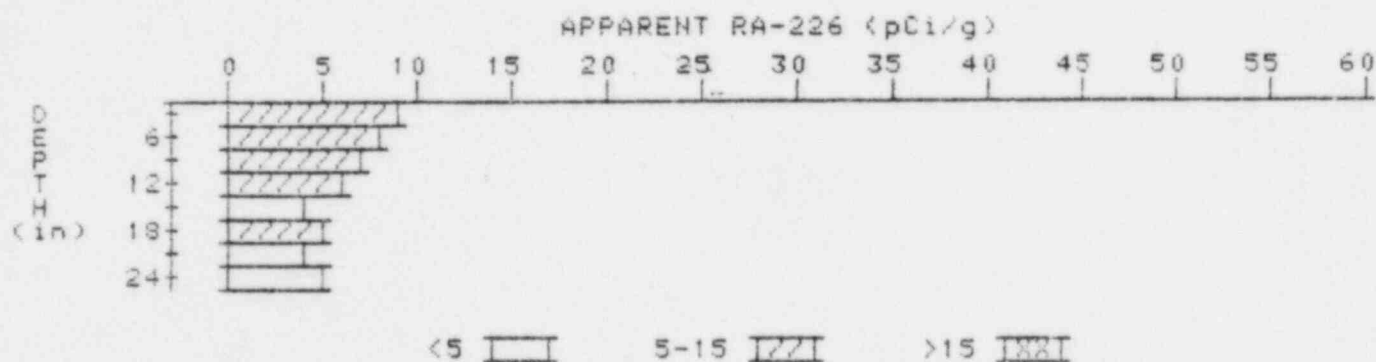
APPARENT RADIUM-226 CONCENTRATION 29 DECONVOLUTION GRAPH

PROPERTY NUMBER: GJ-05609-RS
HOLE NUMBER: 29
LOCATION: 270256

Depth (in)	Apparent Radium-226 (pCi/g) Undeconvolved	Apparent Radium-226 (pCi/g) Deconvolved
3	8.5	8.5
6	7.9	8.4
9	7.0	7.4
12	5.9	5.5
15	5.0	3.8
18	4.8	5.2
21	4.4	3.5
24	4.5	4.5

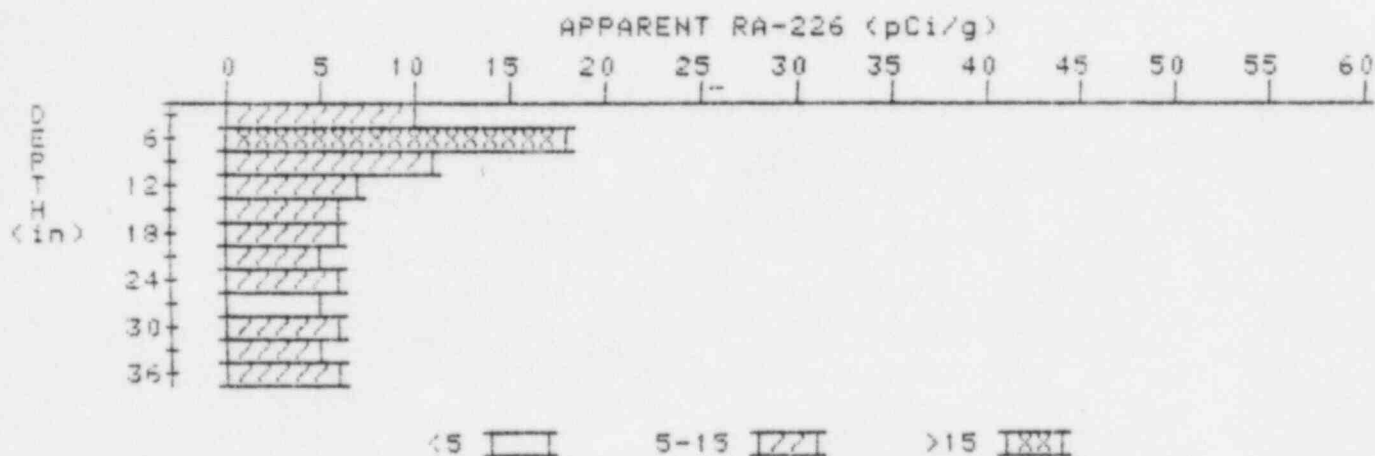
APPARENT RADIUM-226 CONCENTRATION 30 DECONVOLUTION GRAPH

PROPERTY NUMBER: GJ-05609-RS
HOLE NUMBER: 30
LOCATION: 281216

Depth (in)	Apparent Radium-226 (pCi/g) Undeconvolved	Apparent Radium-226 (pCi/g) Deconvolved
3	9.9	9.9
6	11.8	17.8
9	10.3	11.2
12	8.3	7.1
15	7.0	5.9
18	6.3	5.9
21	5.8	5.1
24	5.7	5.9
27	5.5	5.0
30	5.6	5.6
33	5.7	5.3
36	6.0	6.0

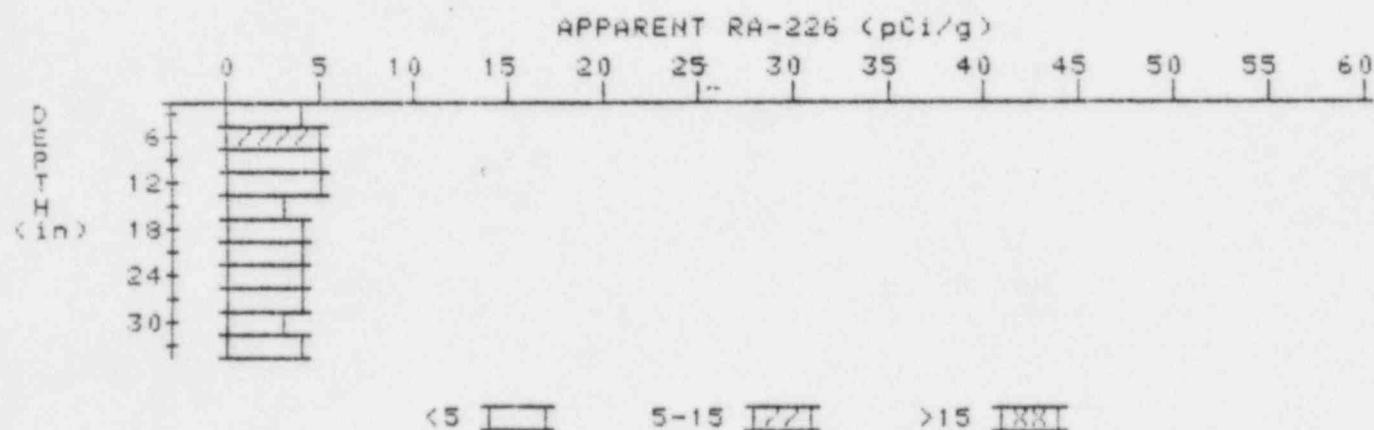
APPARENT RADIUM-226 CONCENTRATION 32 DECONVOLUTION GRAPH

PROPERTY NUMBER: GJ-05609-RS
HOLE NUMBER: 32
LOCATION: 290256

Depth (in)	Apparent Radium-226 (pCi/g) Undeconvolved	Apparent Radium-226 (pCi/g) Deconvolved
3	4.0	4.0
6	4.4	5.1
9	4.4	4.6
12	4.3	4.3
15	3.9	3.4
18	3.8	3.3
21	3.7	3.5
24	3.7	3.7
27	3.7	3.7
30	3.7	3.2
33	4.0	4.0

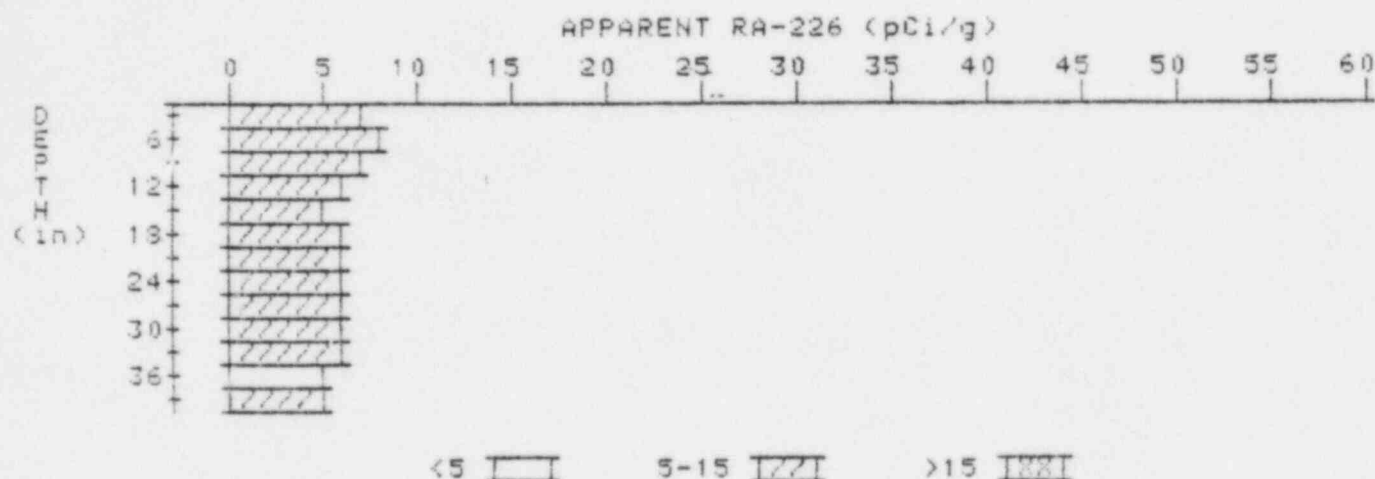
APPARENT RADIUM-226 CONCENTRATION 42 DECONVOLUTION GRAPH

PROPERTY NUMBER: GJ-05609-RS
HOLE NUMBER: 42
LOCATION: 135226

Depth (in)	Apparent Radium-226 (pCi/g) Undeconvolved	Apparent Radium-226 (pCi/g) Deconvolved
3	7.2	7.2
6	7.1	7.8
9	6.6	6.6
12	6.1	5.7
15	5.8	5.1
18	5.9	6.3
21	5.8	5.6
24	5.8	5.6
27	5.9	6.3
30	5.9	6.0
33	5.6	5.8
36	5.3	4.9
39	5.2	5.2

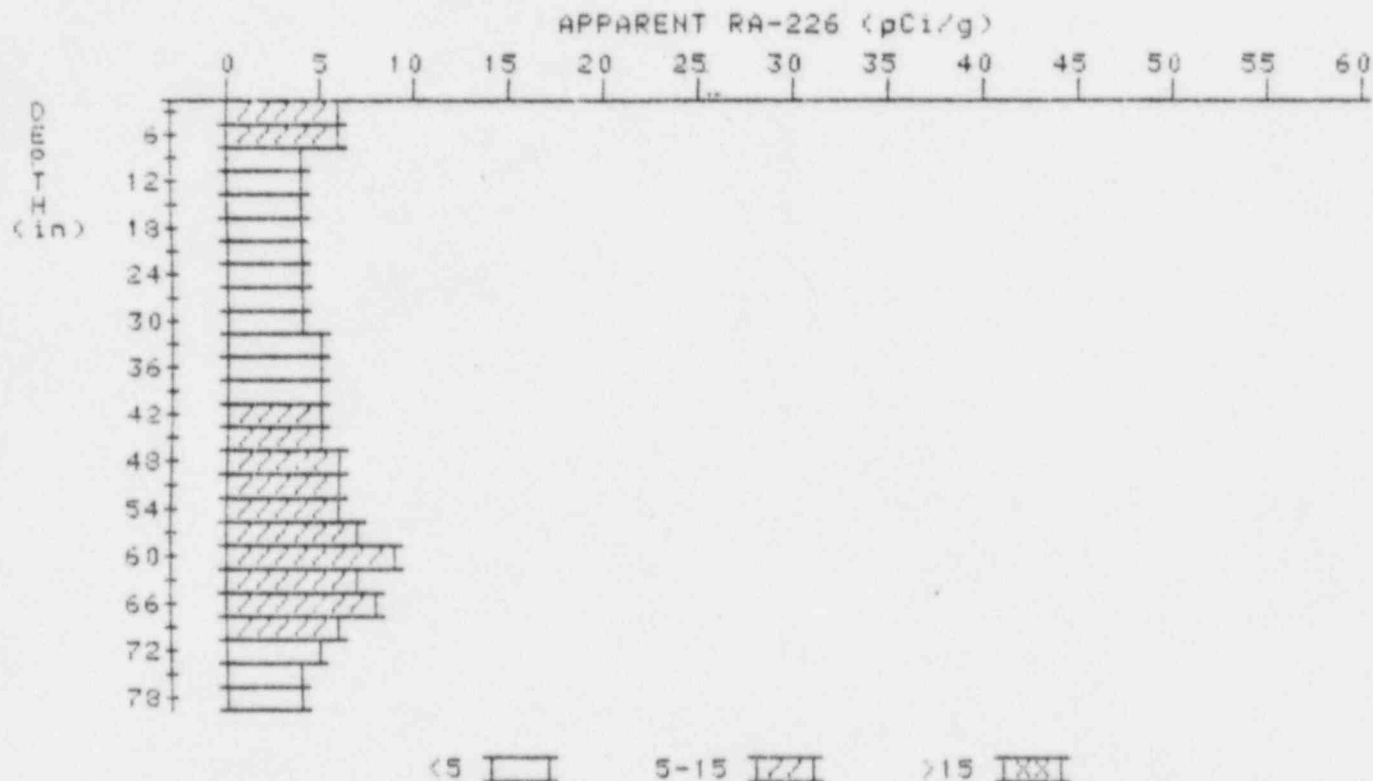
APPARENT RADIUM-226 CONCENTRATION 43 DECONVOLUTION GRAPH

PROPERTY NUMBER: GJ-05609-RS
HOLE NUMBER: 43
LOCATION: 137237

Depth (in)	Apparent Radium-226 (pCi/g) Undeconvolved	Apparent Radium-226 (pCi/g) Deconvolved
=====	=====	=====
3	5.7	5.7
6	5.4	5.9
9	4.9	4.3
12	4.5	4.3
15	4.3	4.3
18	4.1	3.9
21	4.0	3.6
24	4.1	4.1
27	4.2	4.2
30	4.3	4.1
33	4.5	4.5
36	4.7	4.9
39	4.8	4.6

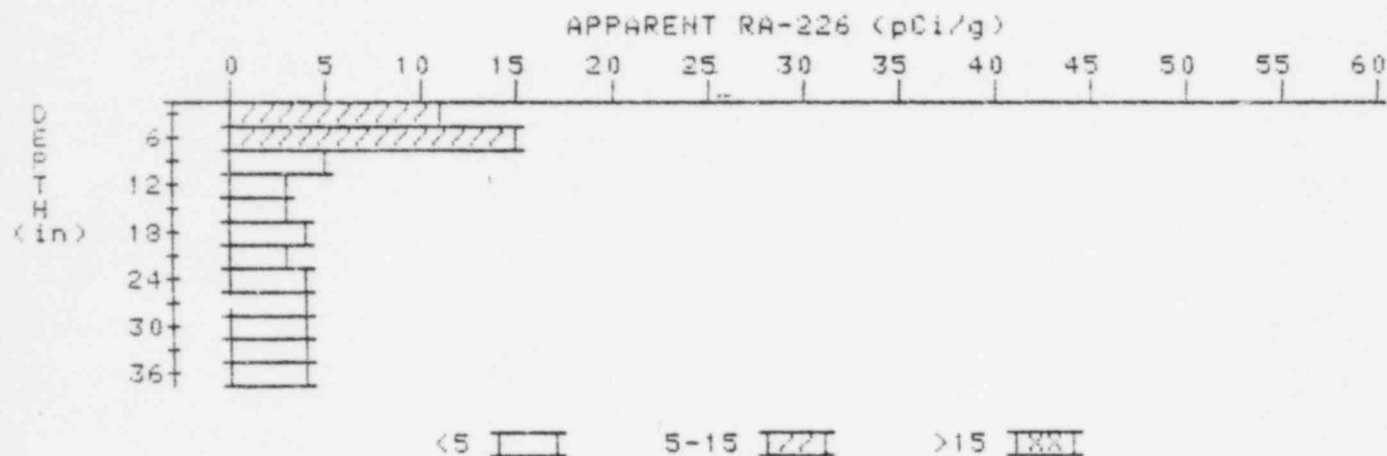
APPARENT RADIUM-226 CONCENTRATION 45 DECONVOLUTION GRAPH

PROPERTY NUMBER: GJ-05609-RS
HOLE NUMBER: 45
LOCATION: 150252

Depth (in)	Apparent Radium-226 (pCi/g) Undeconvolved	Apparent Radium-226 (pCi/g) Deconvolved
3	10.9	10.9
6	10.3	14.9
9	7.1	5.0
12	5.1	3.3
15	4.1	2.9
18	3.8	3.6
21	3.6	2.9
24	3.8	4.2
27	3.3	3.6
30	3.9	3.5
33	4.2	4.4
36	4.4	4.4

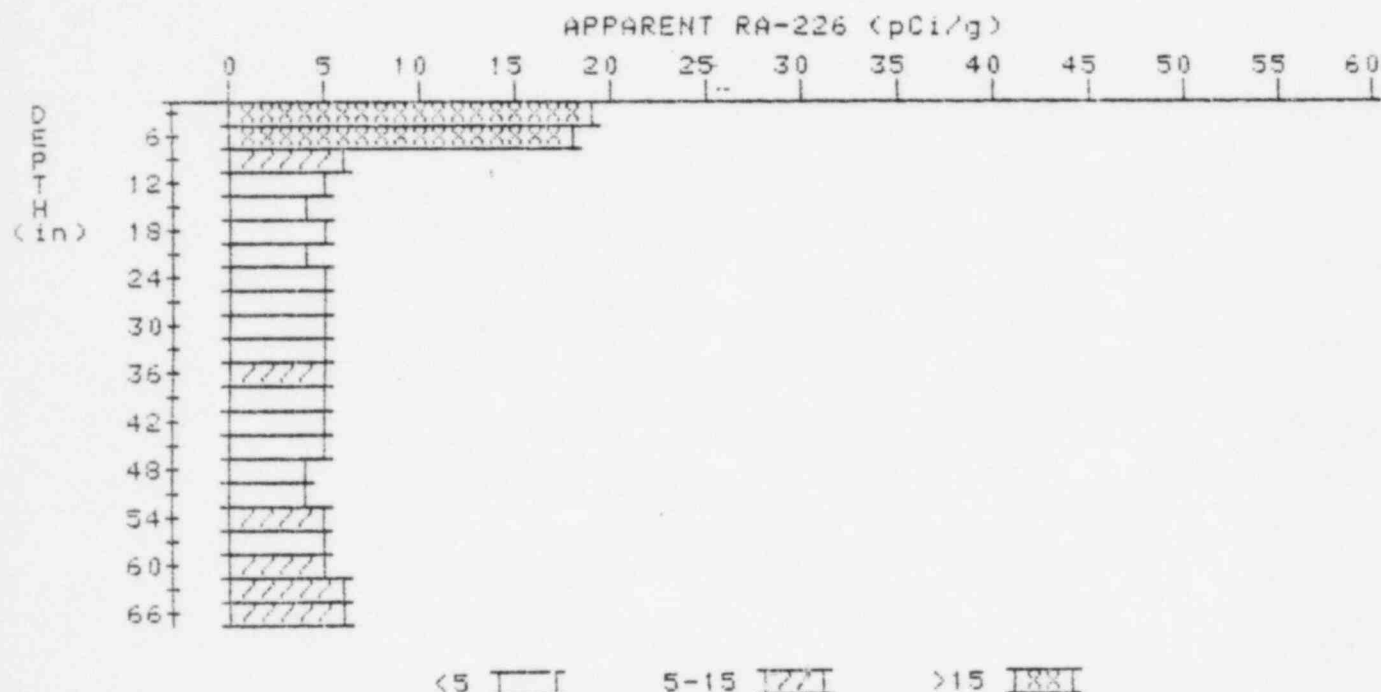
APPARENT RADIUM-226 CONCENTRATION 47 DECONVOLUTION GRAPH

PROPERTY NUMBER: GJ-05609-RS
HOLE NUMBER: 47
LOCATION: 153245

Depth (in)	Apparent Radium-226 (pCi/g) Undeconvolved	Apparent Radium-226 (pCi/g) Deconvolved
3	19.2	19.2
6	15.4	17.9
9	10.2	6.1
12	7.3	4.8
15	5.8	4.4
18	5.1	4.6
21	4.7	4.0
24	4.7	4.5
27	4.8	5.0
30	4.8	4.8
33	4.8	4.6
36	4.9	5.3
39	4.8	4.8
42	4.7	4.7
45	4.6	4.6
48	4.8	4.6

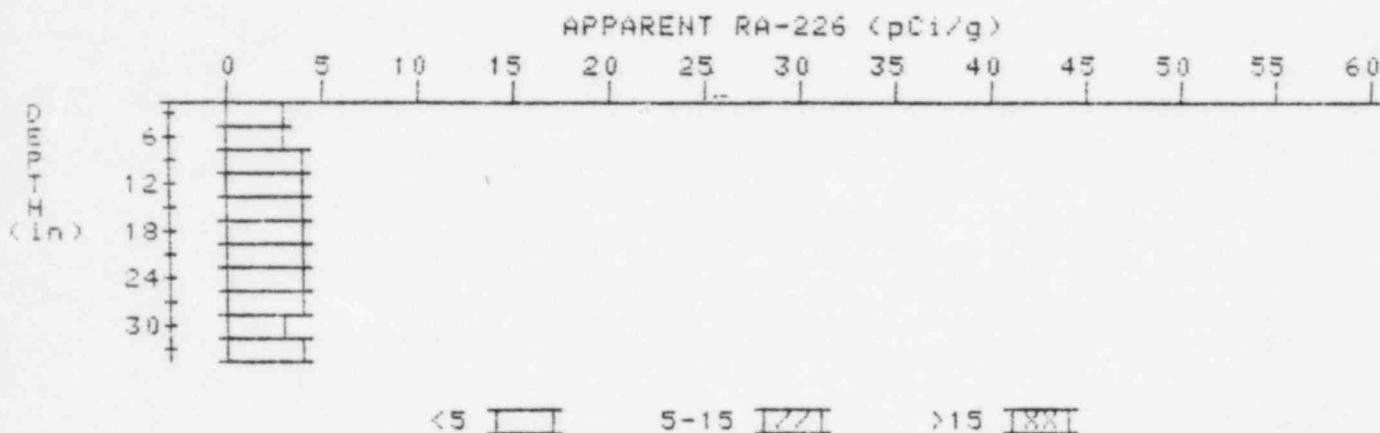
APPARENT RADIUM-226 CONCENTRATION 48 DECONVOLUTION GRAPH

PROPERTY NUMBER: GJ-05609-RS
HOLE NUMBER: 48
LOCATION: 154273

Depth (in)	Apparent Radium-226 (pCi/g) Undeconvolved	Apparent Radium-226 (pCi/g) Deconvolved
3	3.2	3.2
6	3.4	3.4
9	3.6	3.6
12	3.8	4.2
15	3.8	3.6
18	3.9	4.1
21	3.9	3.9
24	3.9	4.1
27	3.8	4.0
30	3.6	3.4
33	3.5	3.5

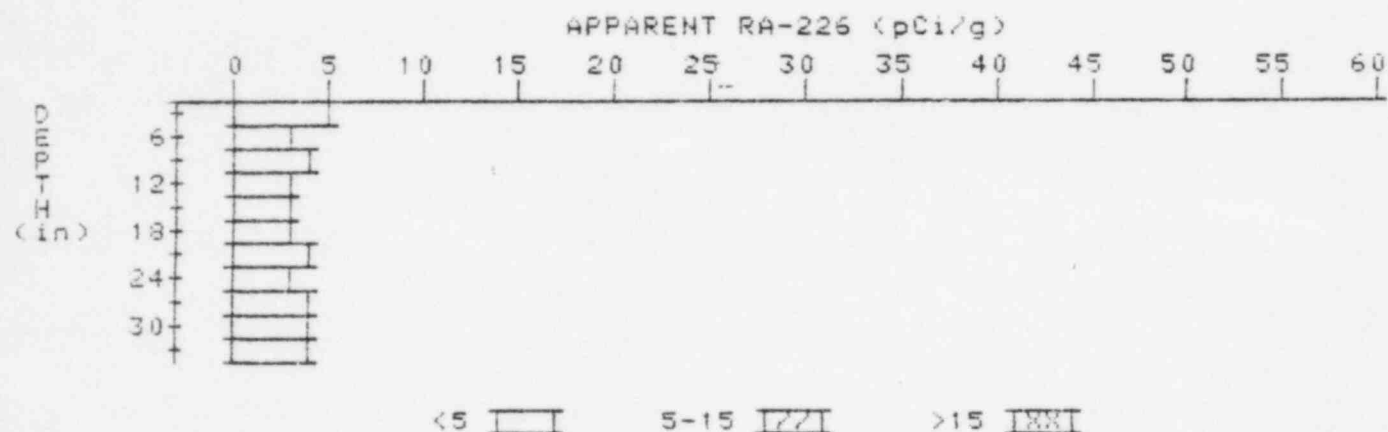
APPARENT RADIUM-226 CONCENTRATION 49 DECONVOLUTION GRAPH

PROPERTY NUMBER: GJ-05609-RS
HOLE NUMBER: 49
LOCATION: 160250

Depth (in)	Apparent Radium-226 (pCi/g) Undeconvolved	Apparent Radium-226 (pCi/g) Deconvolved
3	4.5	4.5
6	3.8	2.9
9	3.6	3.8
12	3.3	2.8
15	3.3	3.1
18	3.4	3.4
21	3.5	3.5
24	3.6	3.4
27	3.8	4.0
30	3.9	3.9
33	4.0	4.0

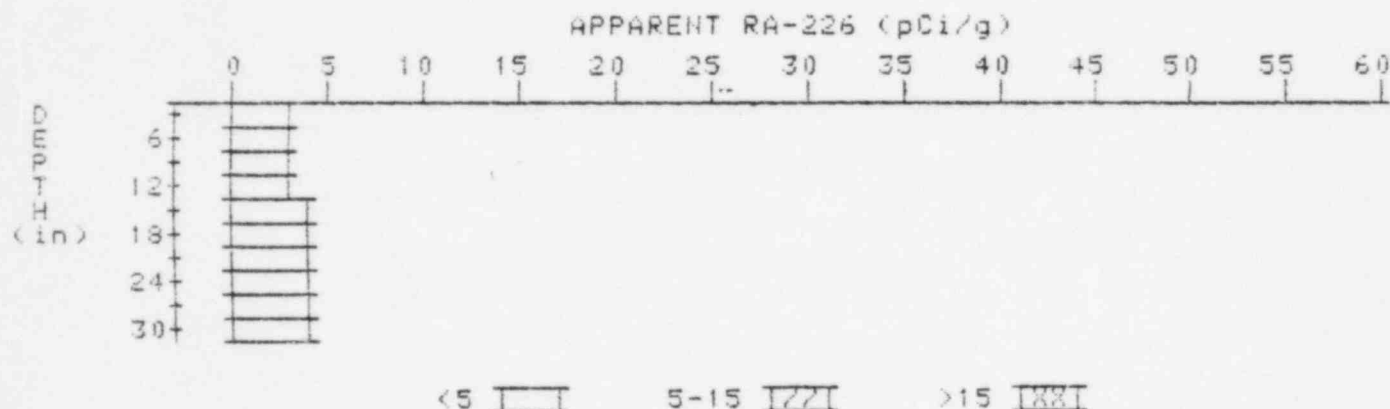
APPARENT RADIUM-226 CONCENTRATION 50 DECONVOLUTION GRAPH

PROPERTY NUMBER: GJ-05609-RS
HOLE NUMBER: 50
LOCATION: 161232

Depth (in)	Apparent Radium-226 (pCi/g) Undeconvolved	Apparent Radium-226 (pCi/g) Deconvolved
3	3.1	3.1
6	3.3	3.5
9	3.4	3.4
12	3.5	3.3
15	3.7	3.7
18	3.9	4.1
21	4.0	3.8
24	4.2	4.4
27	4.3	4.3
30	4.4	4.4

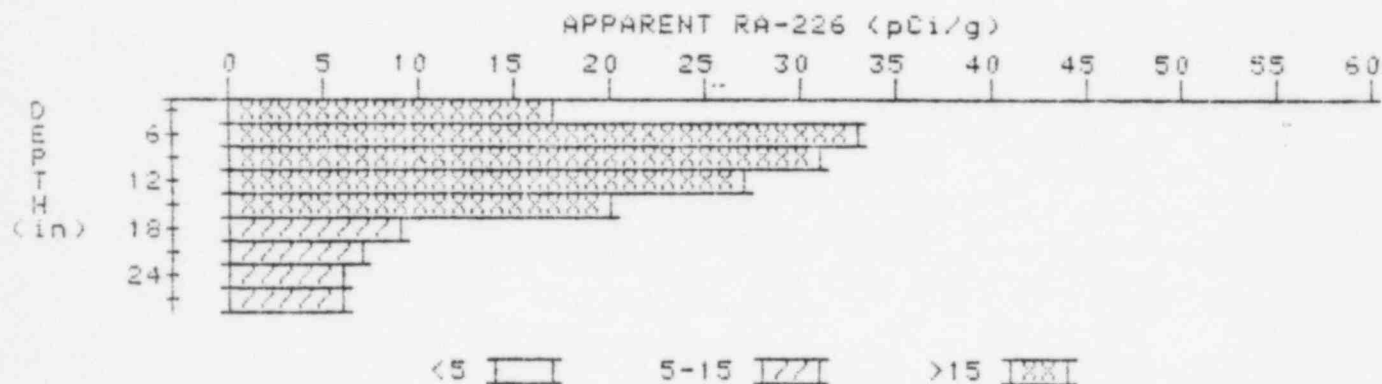
APPARENT RADIUM-226 CONCENTRATION 53 DECONVOLUTION GRAPH

PROPERTY NUMBER: GJ-05609-RS
HOLE NUMBER: 53
LOCATION: 169265

Depth (in)	Apparent Radium-226 (pCi/g) Undeconvolved	Apparent Radium-226 (pCi/g) Deconvolved
3	17.1	17.1
6	23.6	32.8
9	24.9	30.9
12	22.8	27.2
15	18.2	20.0
18	12.6	8.7
21	9.2	7.1
24	7.0	5.8
27	5.5	5.5

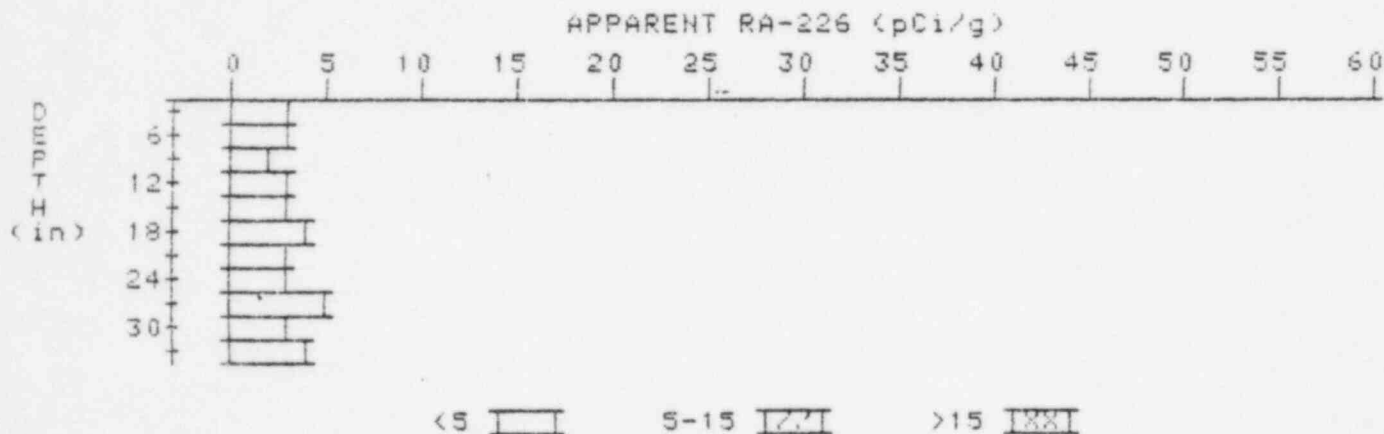
APPARENT RADIUM-226 CONCENTRATION 55 DECONVOLUTION GRAPH

PROPERTY NUMBER: GJ-05609-R3
HOLE NUMBER: 55
LOCATION: 172258

Depth (in)	Apparent Radium-226 (pCi/g) Undeconvolved	Apparent Radium-226 (pCi/g) Deconvolved
3	2.7	2.7
6	2.9	3.2
9	2.7	2.2
12	2.9	2.9
15	3.1	2.9
18	3.4	3.9
21	3.4	3.2
24	3.5	3.3
27	3.7	4.6
30	3.4	2.7
33	3.5	3.5

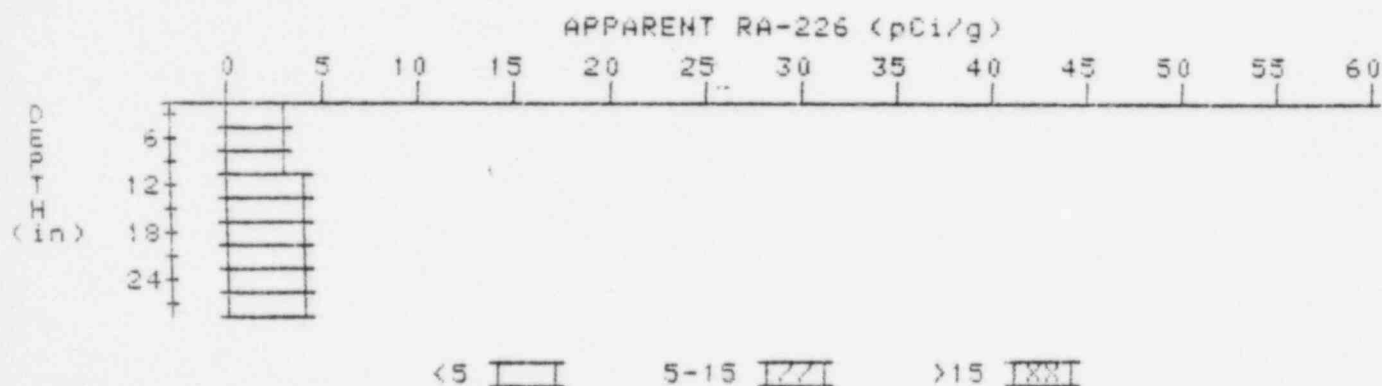
APPARENT RADIUM-226 CONCENTRATION 56 DECONVOLUTION GRAPH

PROPERTY NUMBER: GJ-05609-RS
HOLE NUMBER: 56
LOCATION: 180220

Depth (in)	Apparent Radium-226 (pCi/g) Undeconvolved	Apparent Radium-226 (pCi/g) Deconvolved
3	2.7	2.7
6	3.0	3.0
9	3.3	3.3
12	3.6	4.0
15	3.7	3.7
18	3.8	3.6
21	4.0	4.2
24	4.1	3.7
27	4.4	4.4
