COMPLIANCE INSPECTION REPORT

1. Name and address of licensee Mallinckrodt Chemical Works Mallinckrodt/Nuclear Box 6172, Lambert Field St. Louis, Missouri 63145	2. Date of inspection 9-13 & 14-67 and 10-17-67
	3. Type of inspection Reinspection
	4. 10 CFR Part(s) applicable 20 and 30

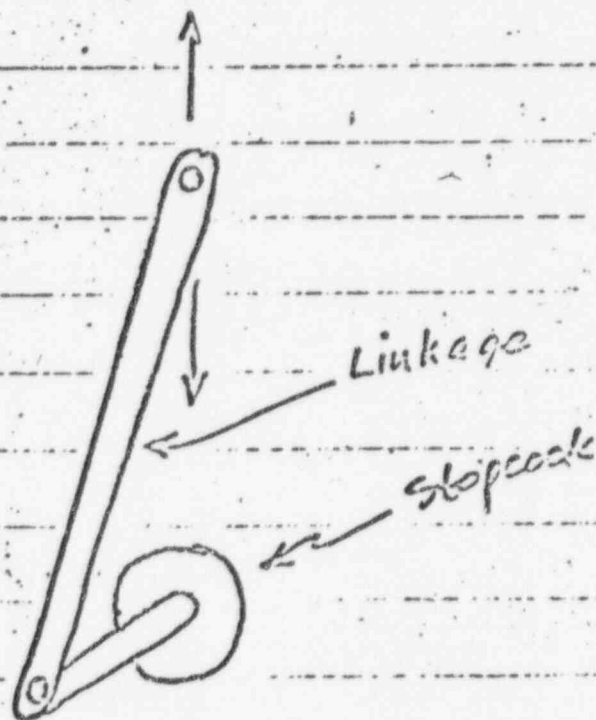
Adjustable stops for
limiting upstroke

INLET

Dispensing
piston

Linkage

stopcock

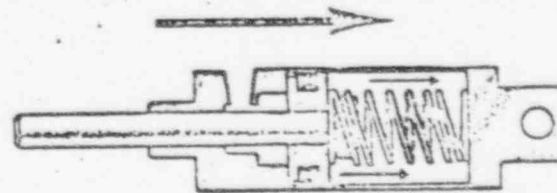
SINGLE ACTING - PULL TYPE (REVERSE ACTION)

In a "pull" type cylinder, air or fluid entering the front of the cylinder pushes the piston rod back into the cylinder creating a pulling action. An enclosed spring returns rod to its normal position when air or fluid pressure is exhausted.
