**Re: Second Freedom of Information Act Request Regarding the Salem
Generating Station, Docket Nos. 50-272 and 50-311**

Peer Group: Older Westinghouse 4-Loop
92-3 to 95-2 Trends and Deviations

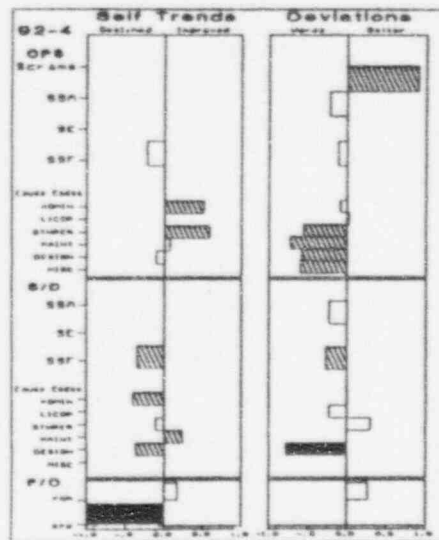
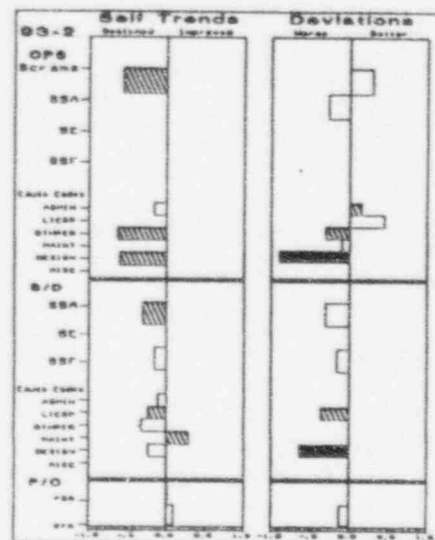
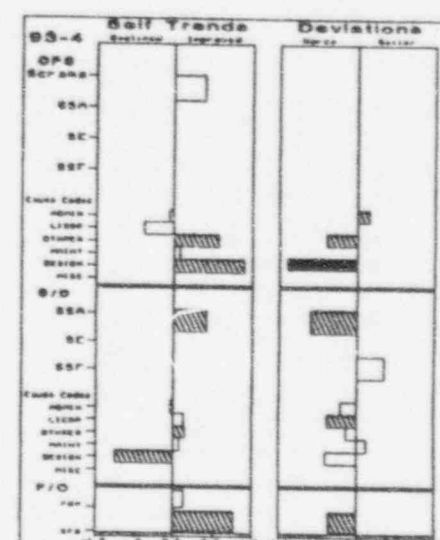
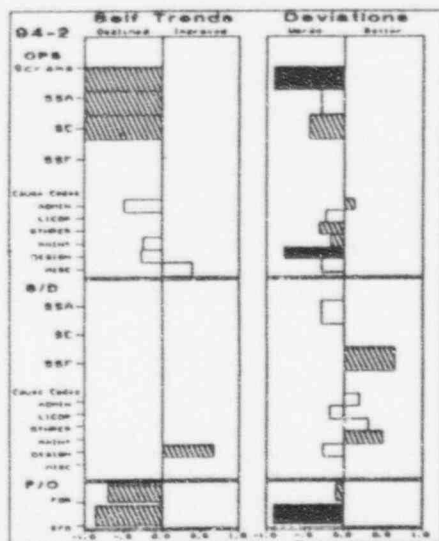
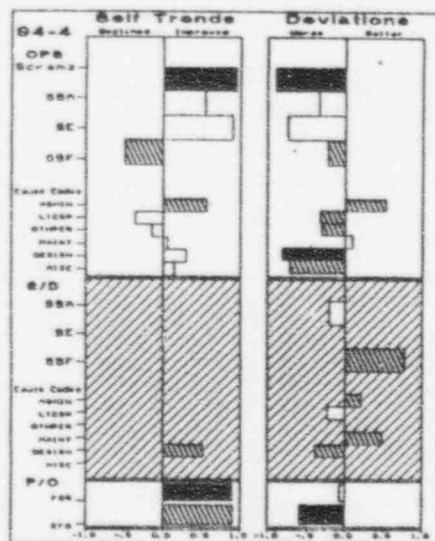
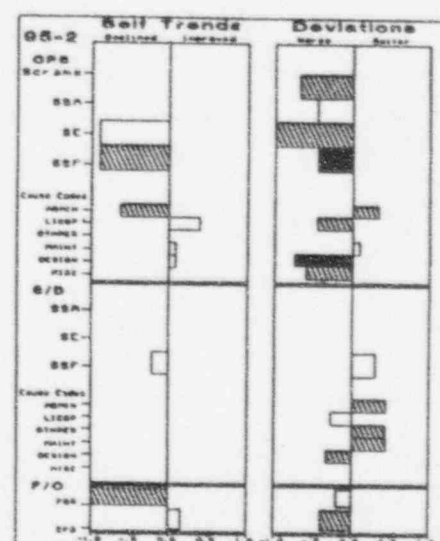
Trends & Deviations

Shaded Regions: Inadequate phase time in last 2 quarters to update calculations

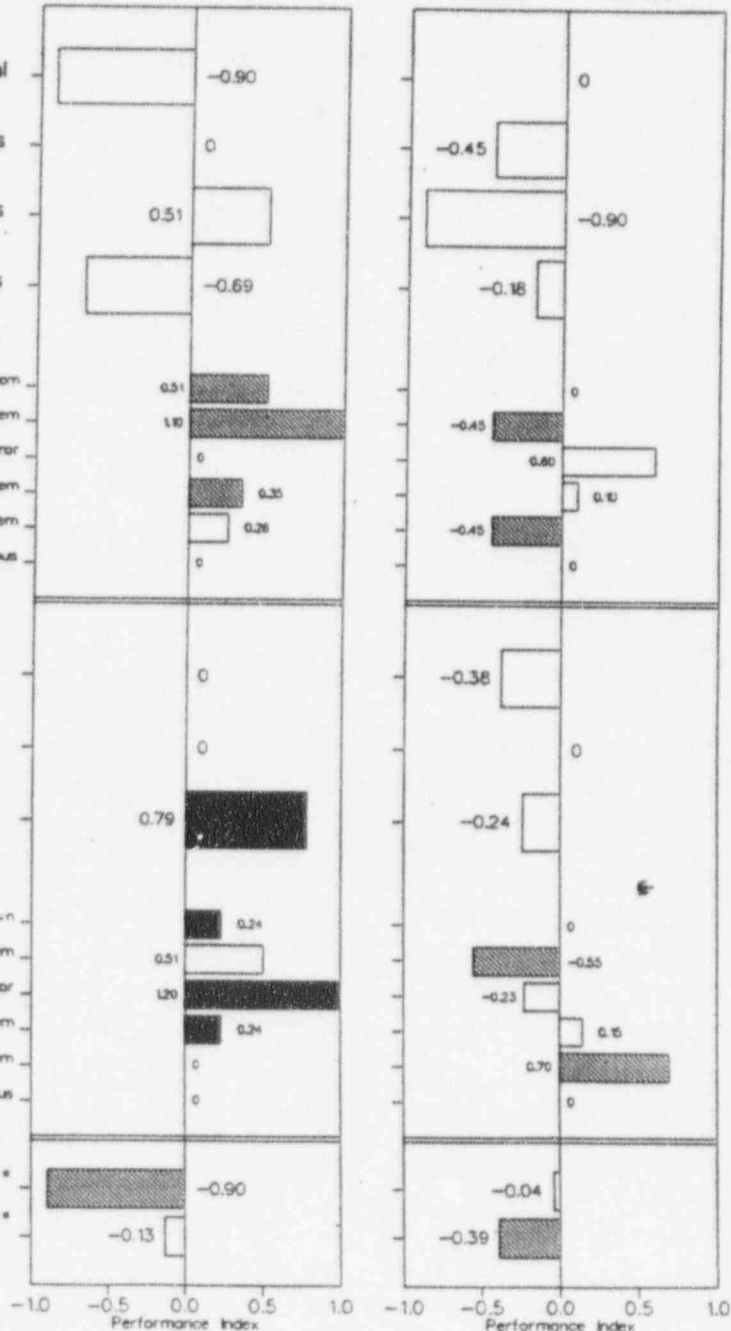
Plant
Self-Trend
Short Term
Declined Improved

Deviations From
Peer Group
Median
Long Term
Worse Better

* Not Calculated for Operational Cycle

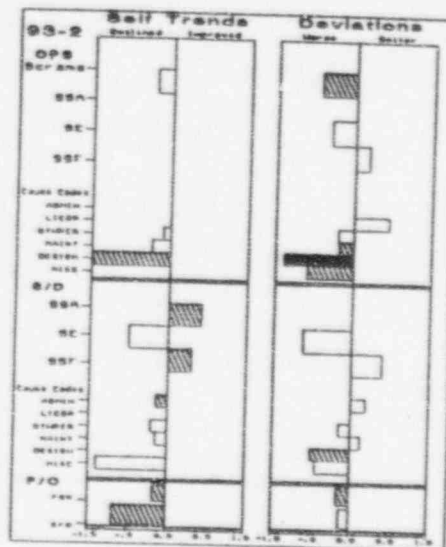
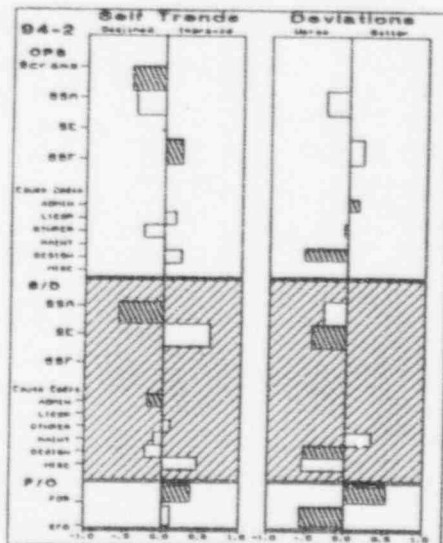
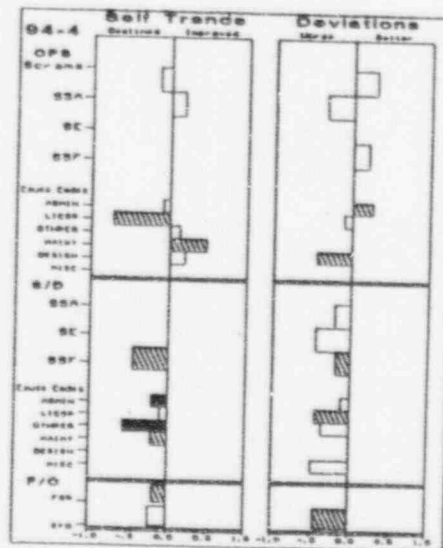
Trends & Deviations

Shaded Regions: Inadequate phase time in last 2 quarters to update calculations
