SUBJECT: OPEN ISSUE ON SLOPE STABILITY

Open issue 7 of the Draft Technical Evaluation Report (DTER) for Atlas Corporation's (Atlas') proposed reclamation plan for uranium mill tailings at its Moab, Utah site, is the capability of the slopes of the disposal cell to endure geologic processes including settlement. In response to that issue, Atlas has provided additional information to the Nuclear Regulatory Commission including a report prepared by your consultant, Woodward-Clyde, "Evaluation of Potential Surface Deformation Related to Salt-Dissolution Subsidence at the Atlas Tailings Site, Moab, Utah" dated July 8, 1996. In that report, a procedure developed by Bray et al is used to evaluate potential deformation of the tailings pile surface.

Re: Evaluation of Potential Surface Deformation Related to Salt-Dissolution Subsidence  
at the Atlas Tailings Site, Moab, UT, 8 Jul 96, Woodward-Clyde Federal Services.

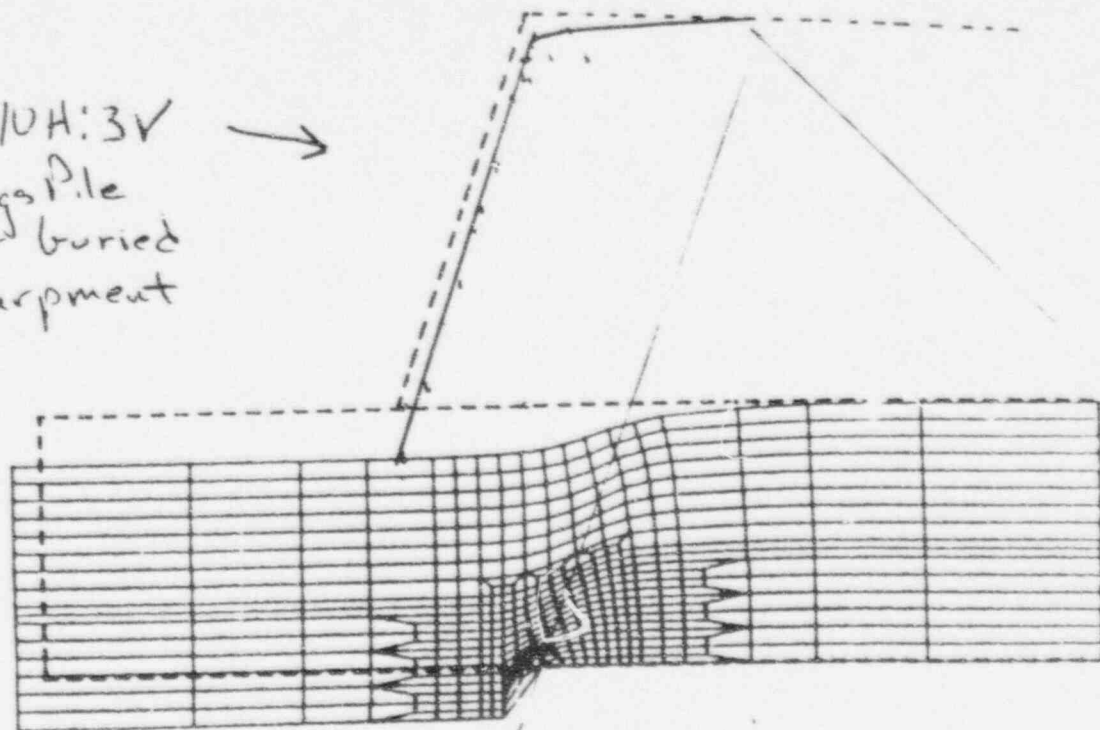
Figure A.

— shear failure over time

10H:3V  
Tailings Pile  
over buried  
escarpment

representative for the Atlas site because of the unconstrained free face of the the tailings pile with minimal lateral confining forces. (see attached figure A) The Bray model would be more applicable to subgrade disposal.

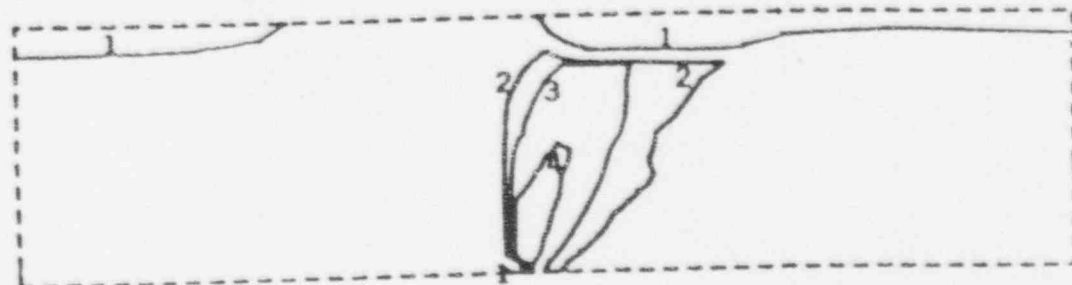
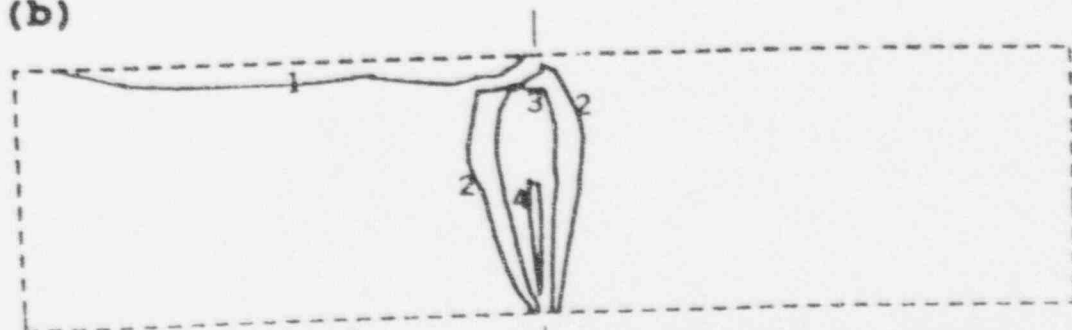
(a)

(b)

- 1 Tension Failure
- 2 Stress Level = 75%
- 3 Stress Level = 85%
- 4 Shear Failure

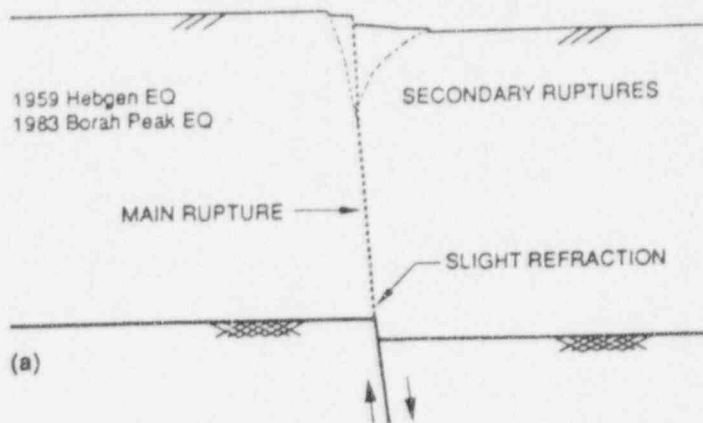
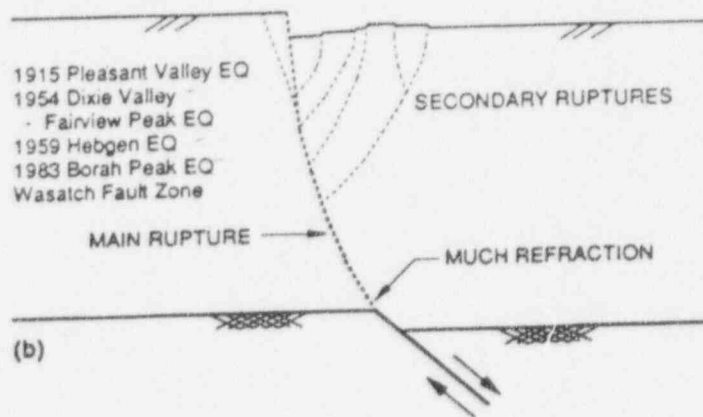
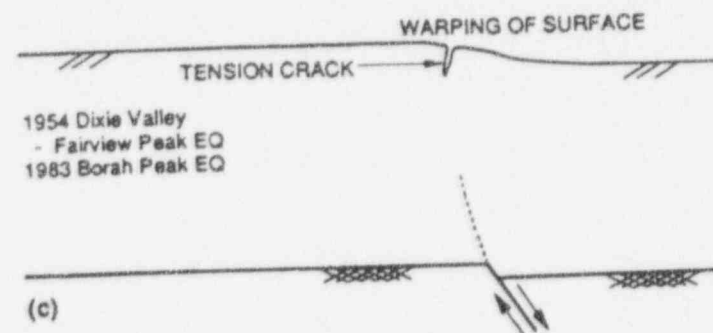
FIG. 7. Path of Normal Fault Rupture through Soil: (a) Stiff Earth Materials, Steep Dip; (b) Stiff Earth Materials, Shallow Dip; (c) Ductile Earth Materials

LESS OFFSET AT GROUND SURFACE

(a)

(b)

(c)

e.) The angle of dip of the fault plane is important to the corresponding area of surface displacement. What is the angle of dip of the fault plane at the Atlas site? (see Bray fig. 7)
