Enclosed for your review and comment is a copy of the draft NUREG/CR6412, "Aging and Loss-of-Coolant Accident (LOCA) Testing of Electrical Connections," dated July 31, 1996.

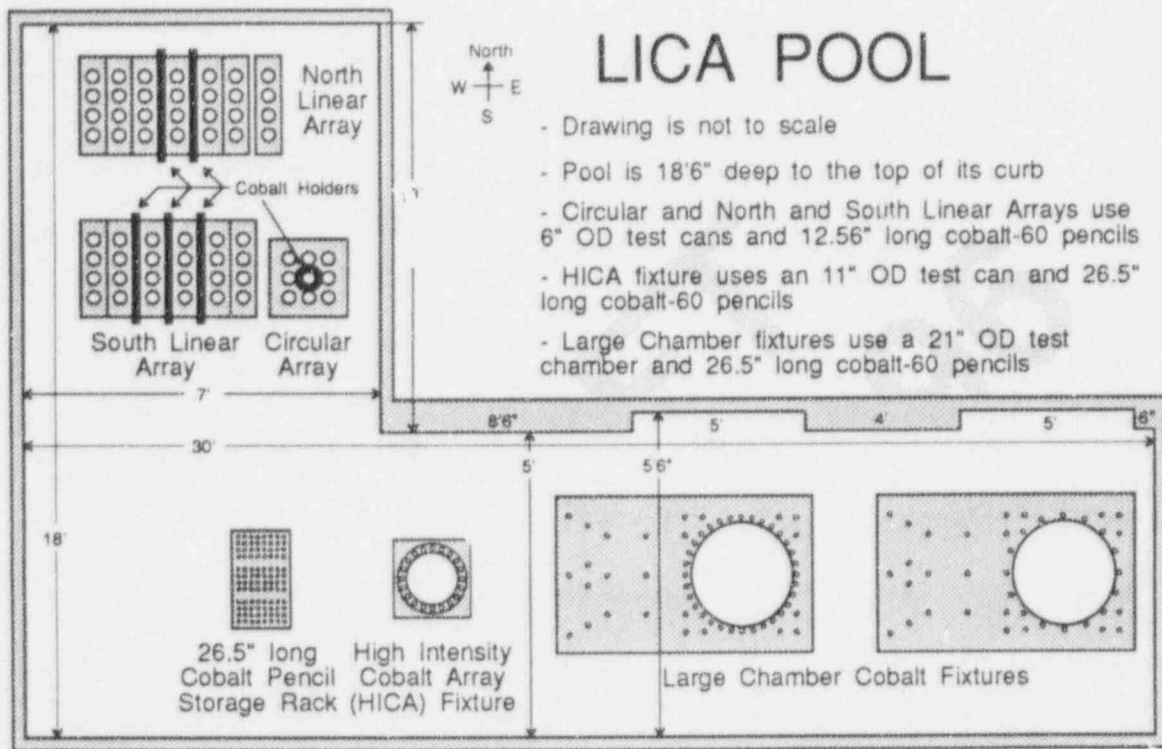
Figure 2.1: Plan view of the LICA pool and fixtures—not to scale.

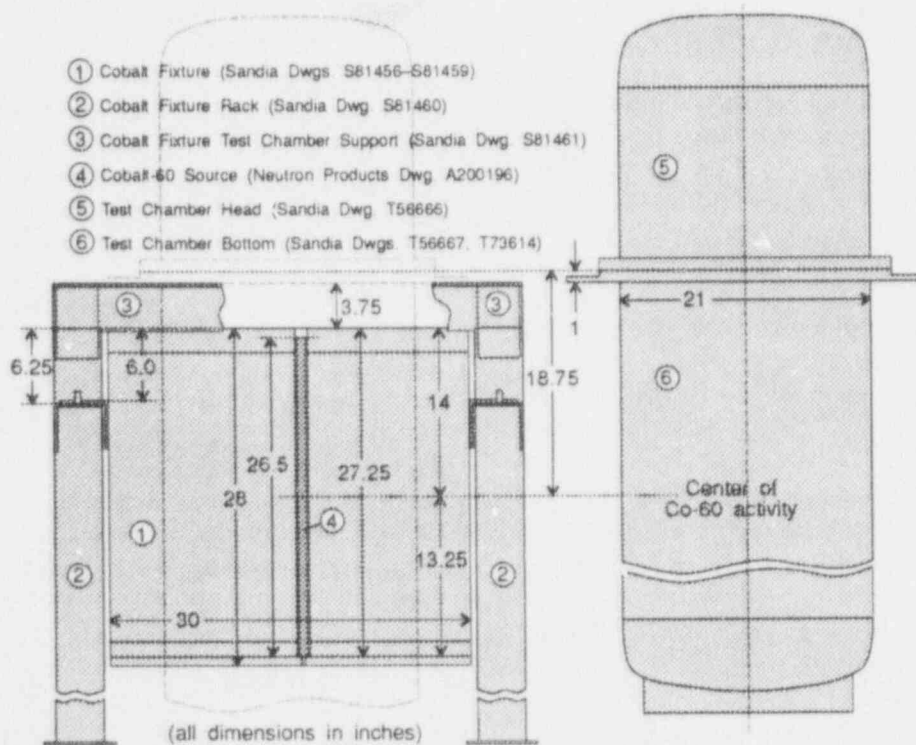
Figure 2.2: Sketch of a test chamber and large chamber cobalt fixture.

The mandrel consists of a pair of stainless steel rings attached to one another with eight stainless steel rods. The cables attached to the connections go into and then back out of the test chamber—they enter the test chamber through a penetration in the test chamber head, are attached vertically to the mandrel (parallel to the mandrel rods), and then loop back up through the center of the mandrel and finally exit the test chamber through another penetration in the test chamber head. Figure 2.5 shows a top view of the arrangement of connections in the test chamber. Two Hoffman A-806CHNF enclosures, each containing one Marathon and one States terminal block, were mounted inside the mandrel. A 0.25 inch diameter weep hole was located at the bottom of each enclosure. The cables entered and exited each enclosure through an elbow and a short section of conduit located inside the test chamber.

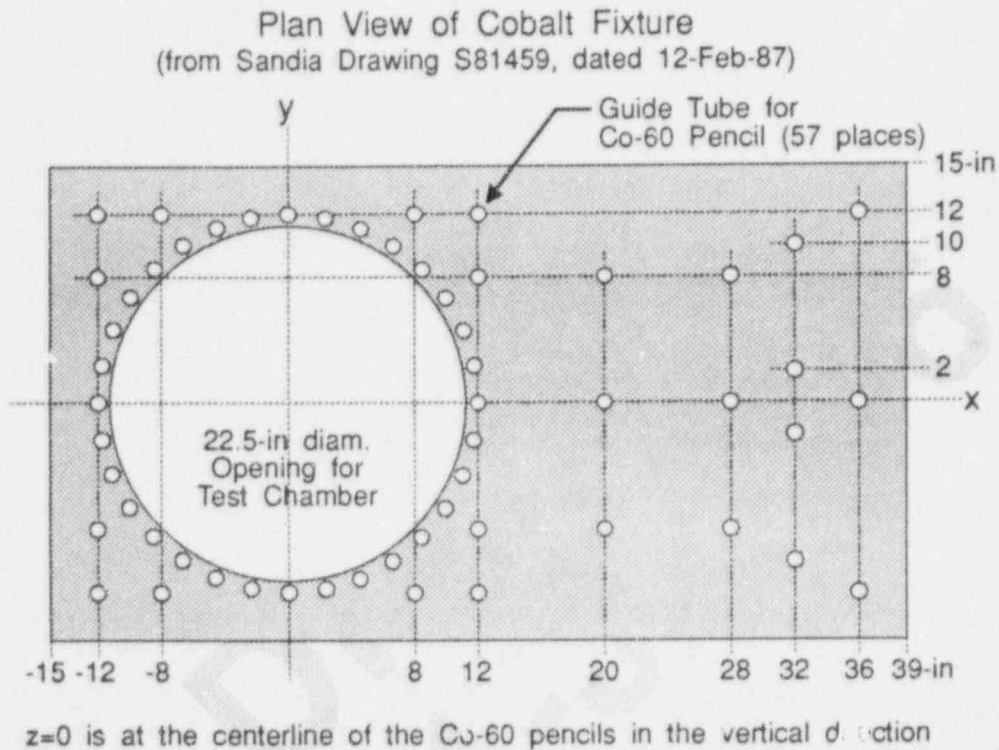
Figure 2.3: Plan view of large chamber cobalt fixture showing the fixture coordinate system and possible cobalt source locations.

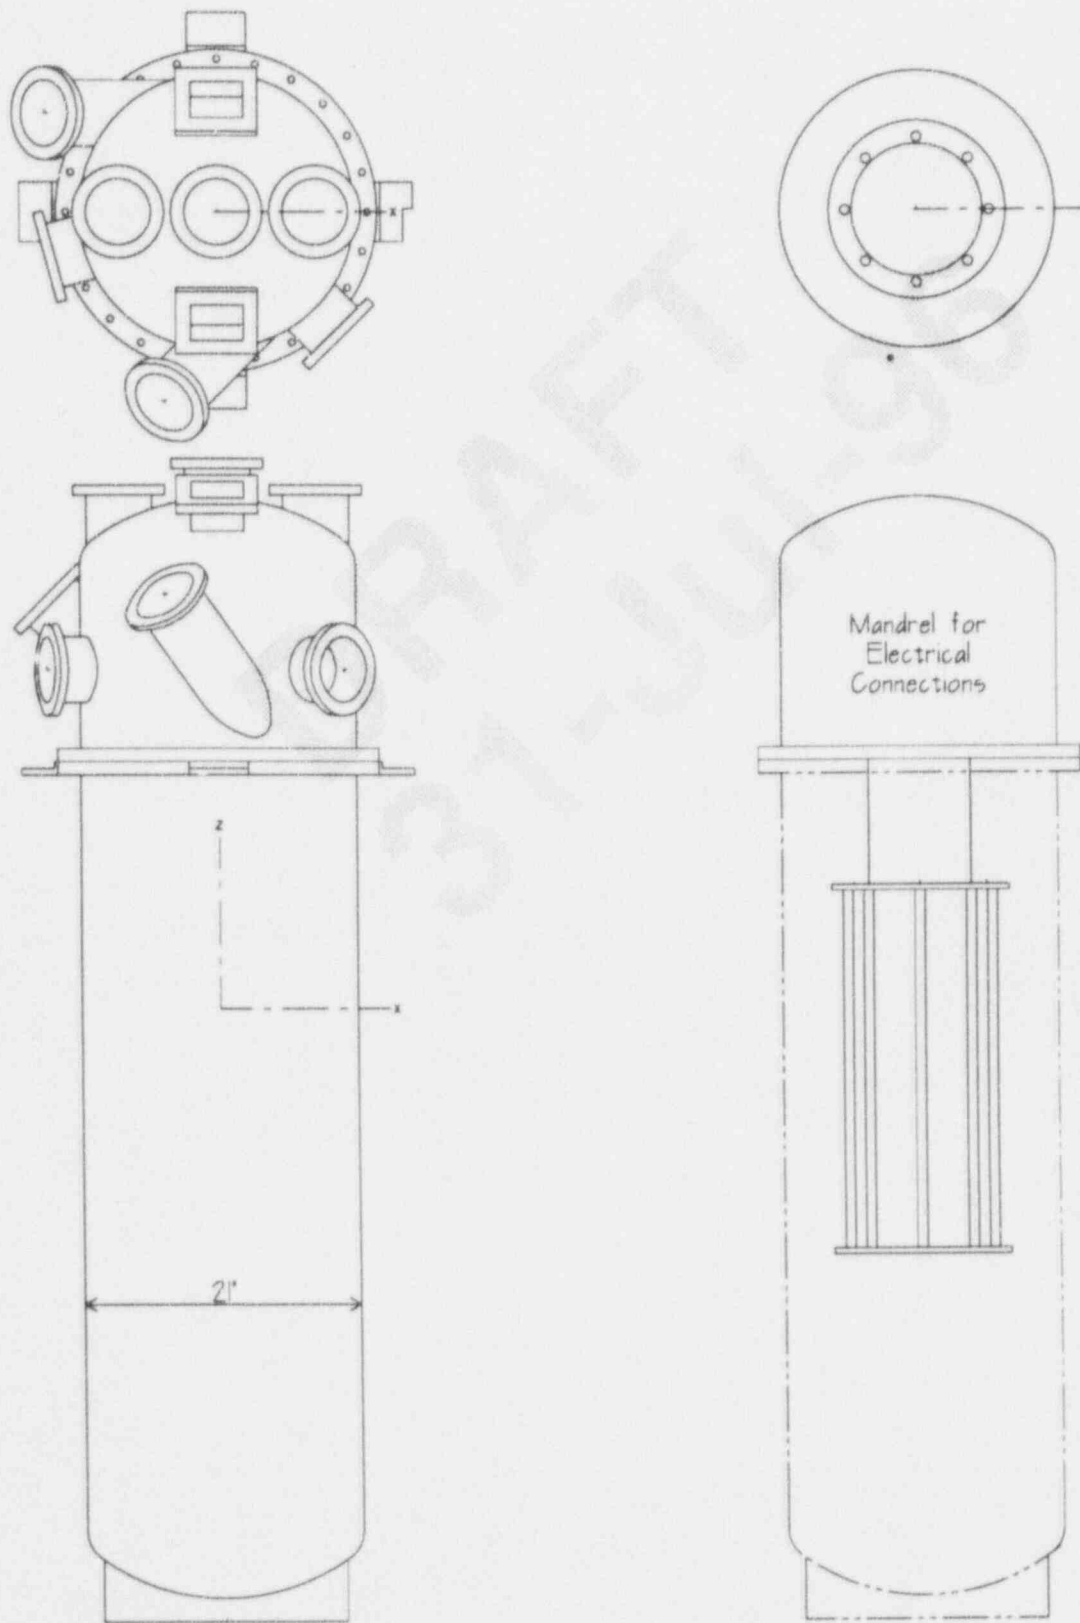
Figure 2.4: Detail of the test chamber and a sketch of the mandrel on which the electrical connections were mounted—drawn to scale.

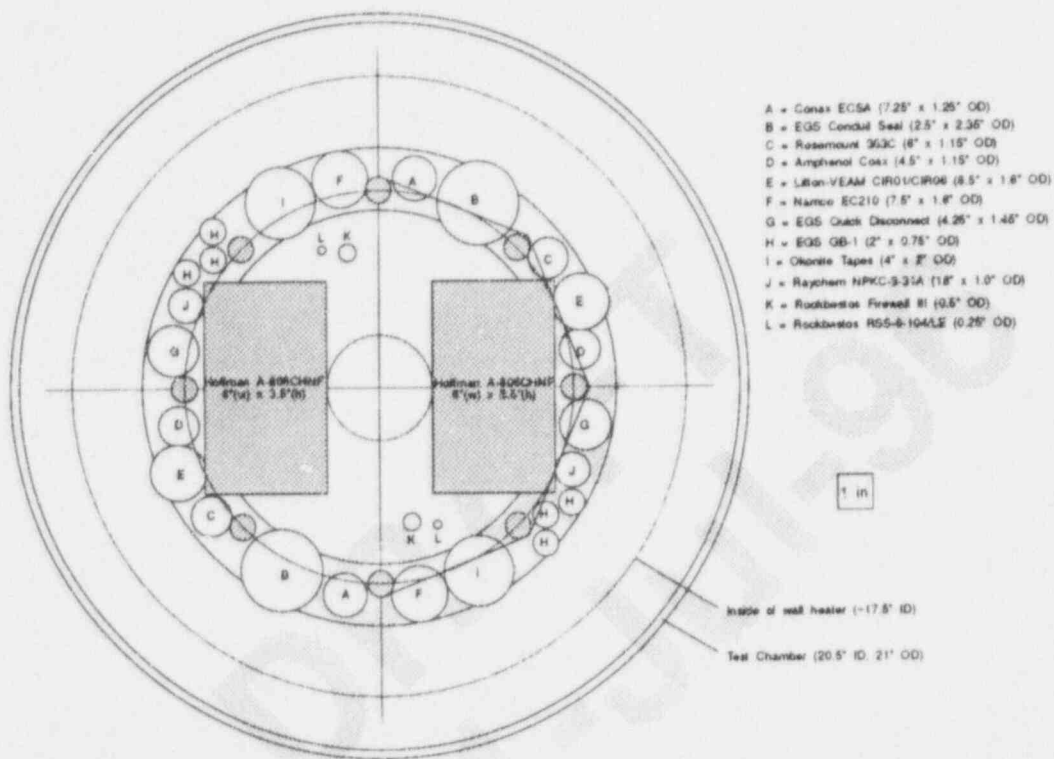
Figure 2.5: Top view of the test chamber and mandrel showing how the connections were arranged.

Figure 2.5 shows a top view of the arrangement of connections in the test chamber. Two Hoffman A-806CHNF enclosures, each containing one Marathon and one States terminal block, were mounted inside the mandrel; the top of each enclosure was located at the centerline of the cobalt-60 sources. As shown in Figure A.1, the Marathon terminal block was installed at the top of each of the two enclosures. A 0.25 inch diameter weep hole was located at the bottom of each enclosure. The cables entered and exited each enclosure through an elbow and a short section of conduit located inside the test chamber.

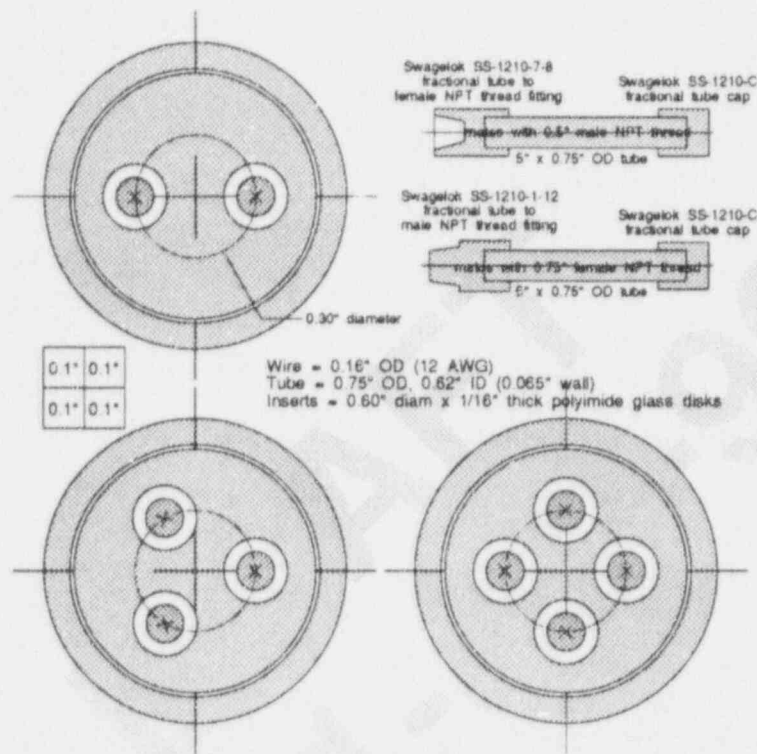
Figure 2.6: Sketch of the device enclosures used for installation of conduit seals and connectors that would normally be installed in a device.

fittings (Swagelok Co., Solon, OH) as shown in Figure 2.6. After using an Alcatel ASM 51 Helium Leak Tester to verify that all the device enclosures were "leak tight" (helium leak rate of less than 10^{-7} cc/sec), the conductors that pass through the connection were inserted into the device enclosure, using phenolic inserts to hold the ends of the conductor in known relation to one another, and the connection and device enclosure were threaded together. There was no attempt to physically check if the connections were leaking during the test. Leaking connections could be identified during the test only if the data measurements begin to show anomalies, or at the conclusion of the test if the device enclosure had moisture inside when it was opened.

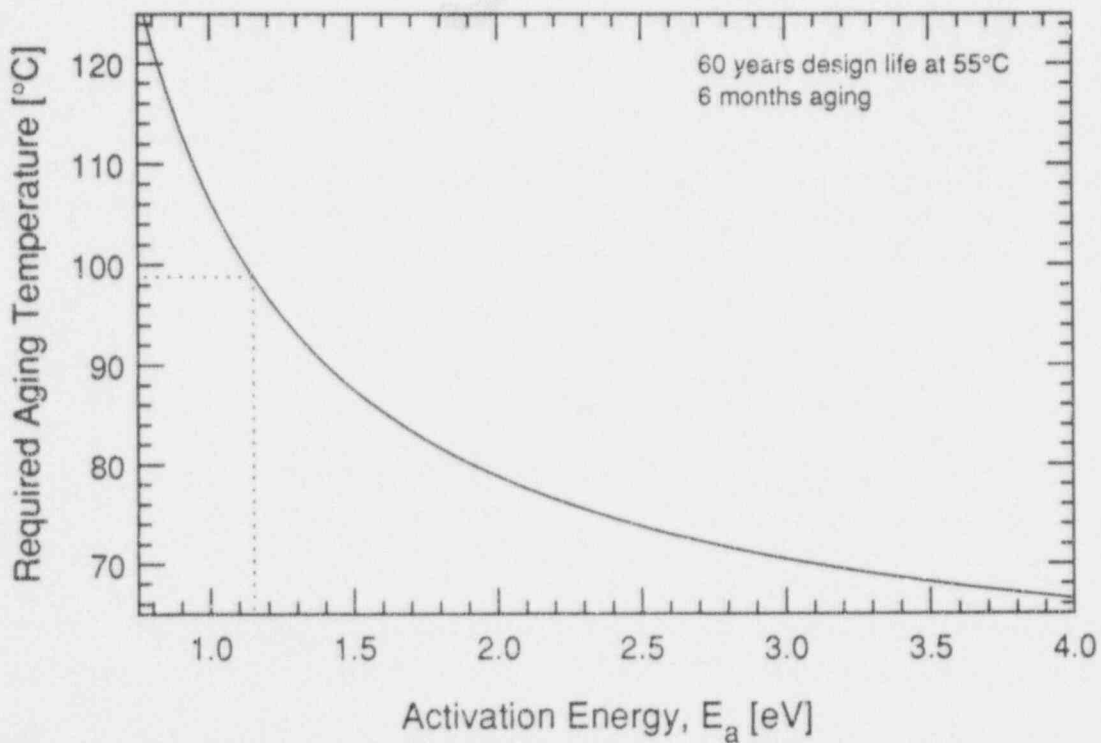
Figure 2.7: Required aging temperature as a function of activation energy, E_a .

Table 2.4 gives the activation energies of the tested connections, and a plot of the required aging temperature as a function of activation energy is shown in Figure 2.7. Using the data in Table 2.4, an activation energy of $E_a = 1.15$ eV was chosen to give conservative data for most of the connections. For the 1.15 eV activation energy, the Arrhenius relation gives a required aging temperature of 98.8°C (209.8°F).

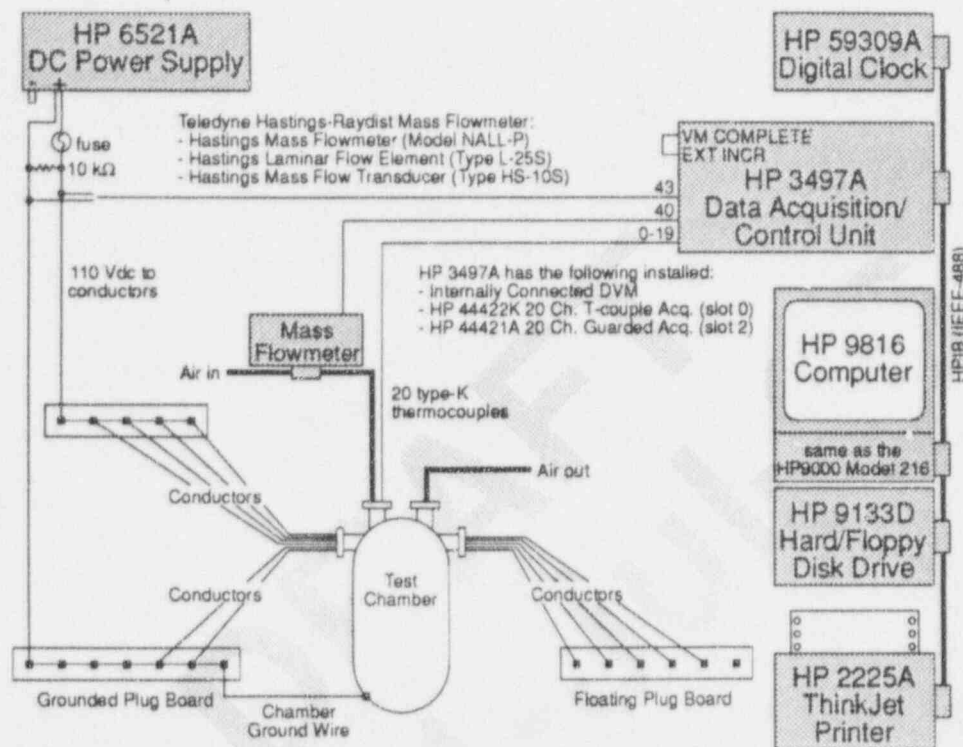
Figure 2.8: Schematic of the system used to monitor test chamber conditions during aging and accident irradiation.

insulation on the outside. The chamber temperature was set using temperature controllers and type K thermocouples (Style AC mineral insulated thermocouples with Inconel sheathing, Gordon Co., Richmond, IL) as sensors. Temperature uniformity was improved by insulating the test chamber and providing air circulation. A flow of 3.3 l/sec (7 ft³/min) or greater of outside air (approximately 30 air changes per hour) was supplied to the test chamber to maintain circulation and ambient oxygen concentration. Twenty thermocouples were used to monitor the temperature inside the test chamber. Aging conditions (temperature, airflow, and cable excitation) were monitored using the system shown schematically in Figure 2.8, the resulting data are shown in Figure 2.9.

Accident irradiation conditions (temperature, airflow, and cable excitation) were monitored using the system shown schematically in Figure 2.8, the resulting data are shown in Figure 2.10. Because of the near symmetry of the radioactive cobalt sources around the test chamber, the test chamber was not rotated during the accident irradiation.

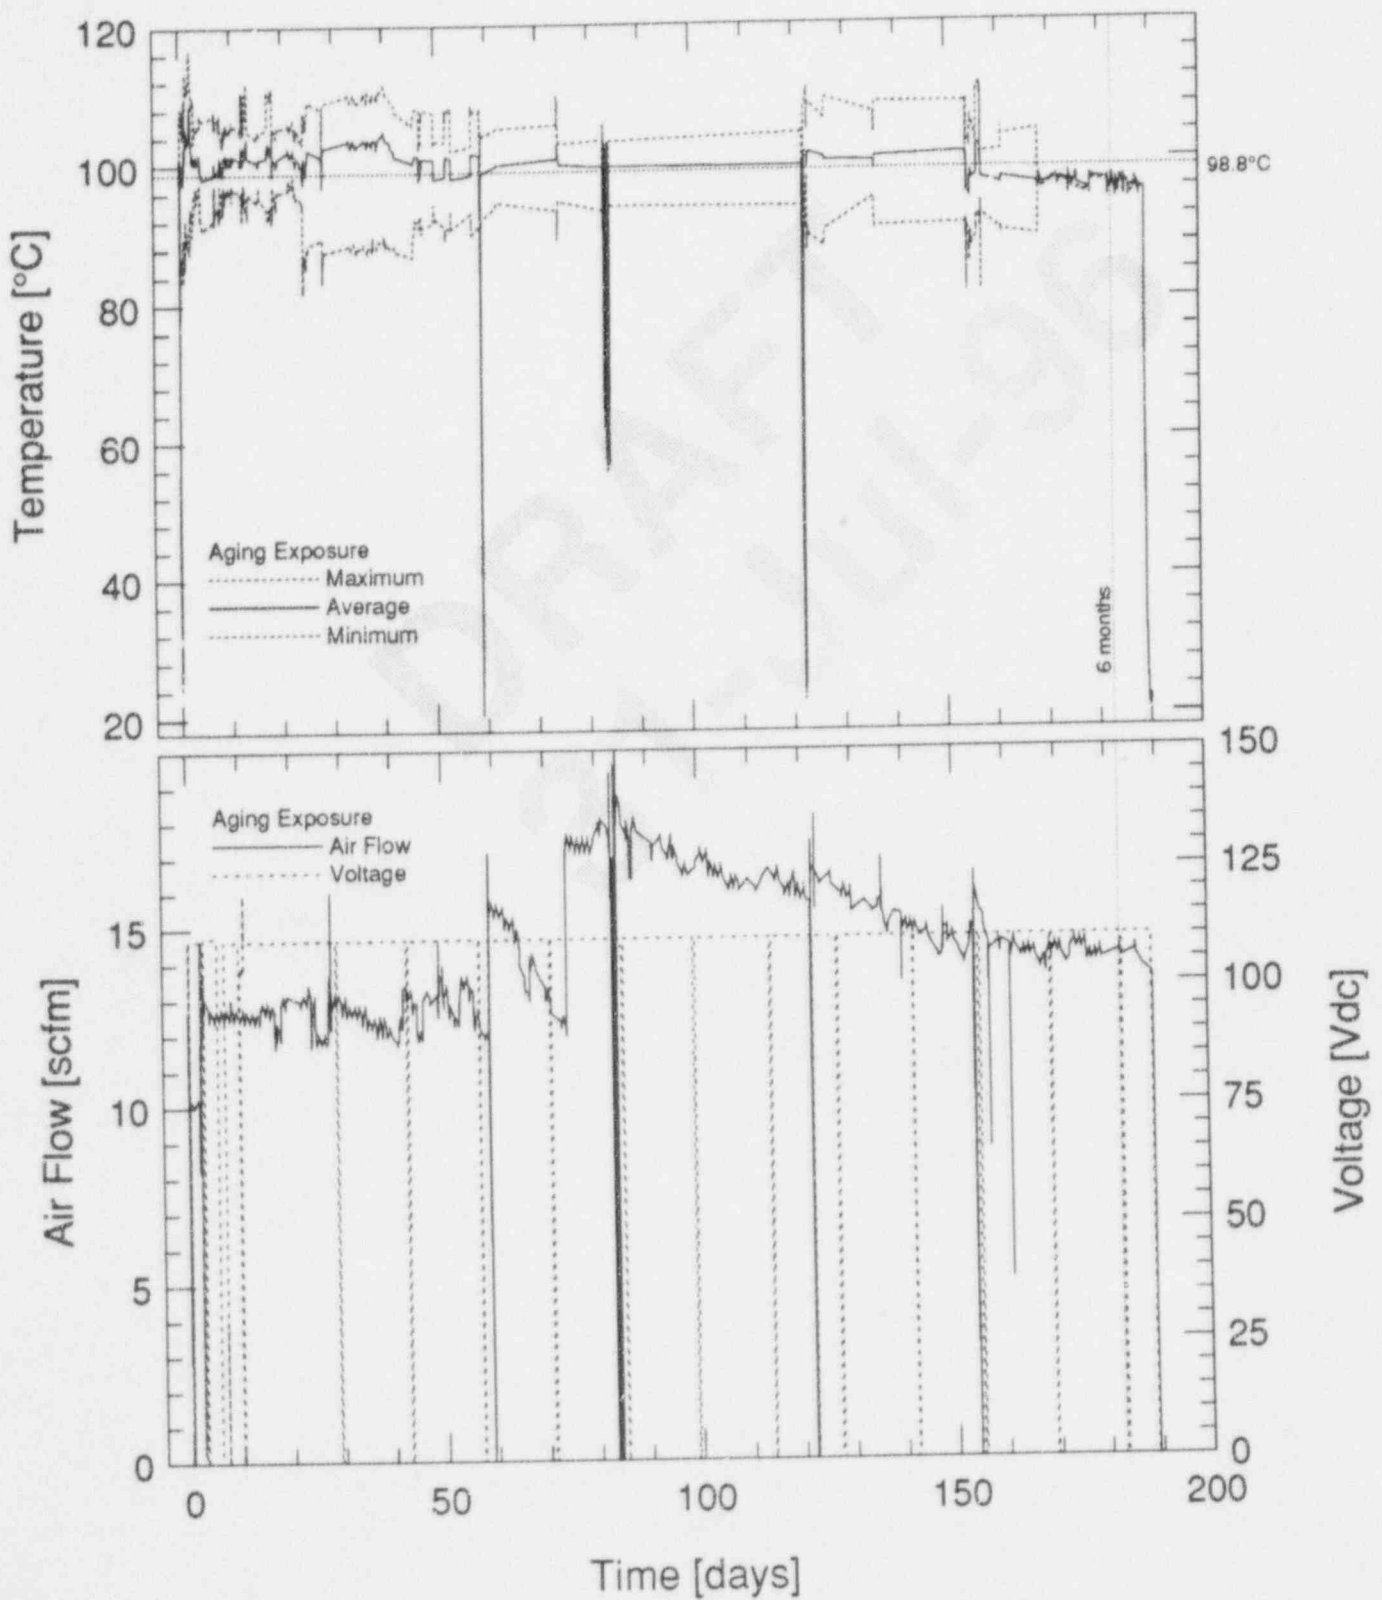
Figure 2.9: Temperature, airflow, and cable excitation during the simultaneous radiation and thermal aging exposure.

During the aging, all the conductors in each connection except for one ground conductor were energized with 110 Vdc (and no current) as indicated in Table 2.2. The test chamber was rotated three times during aging to help ensure a uniform radiation dose for all the tested connections.

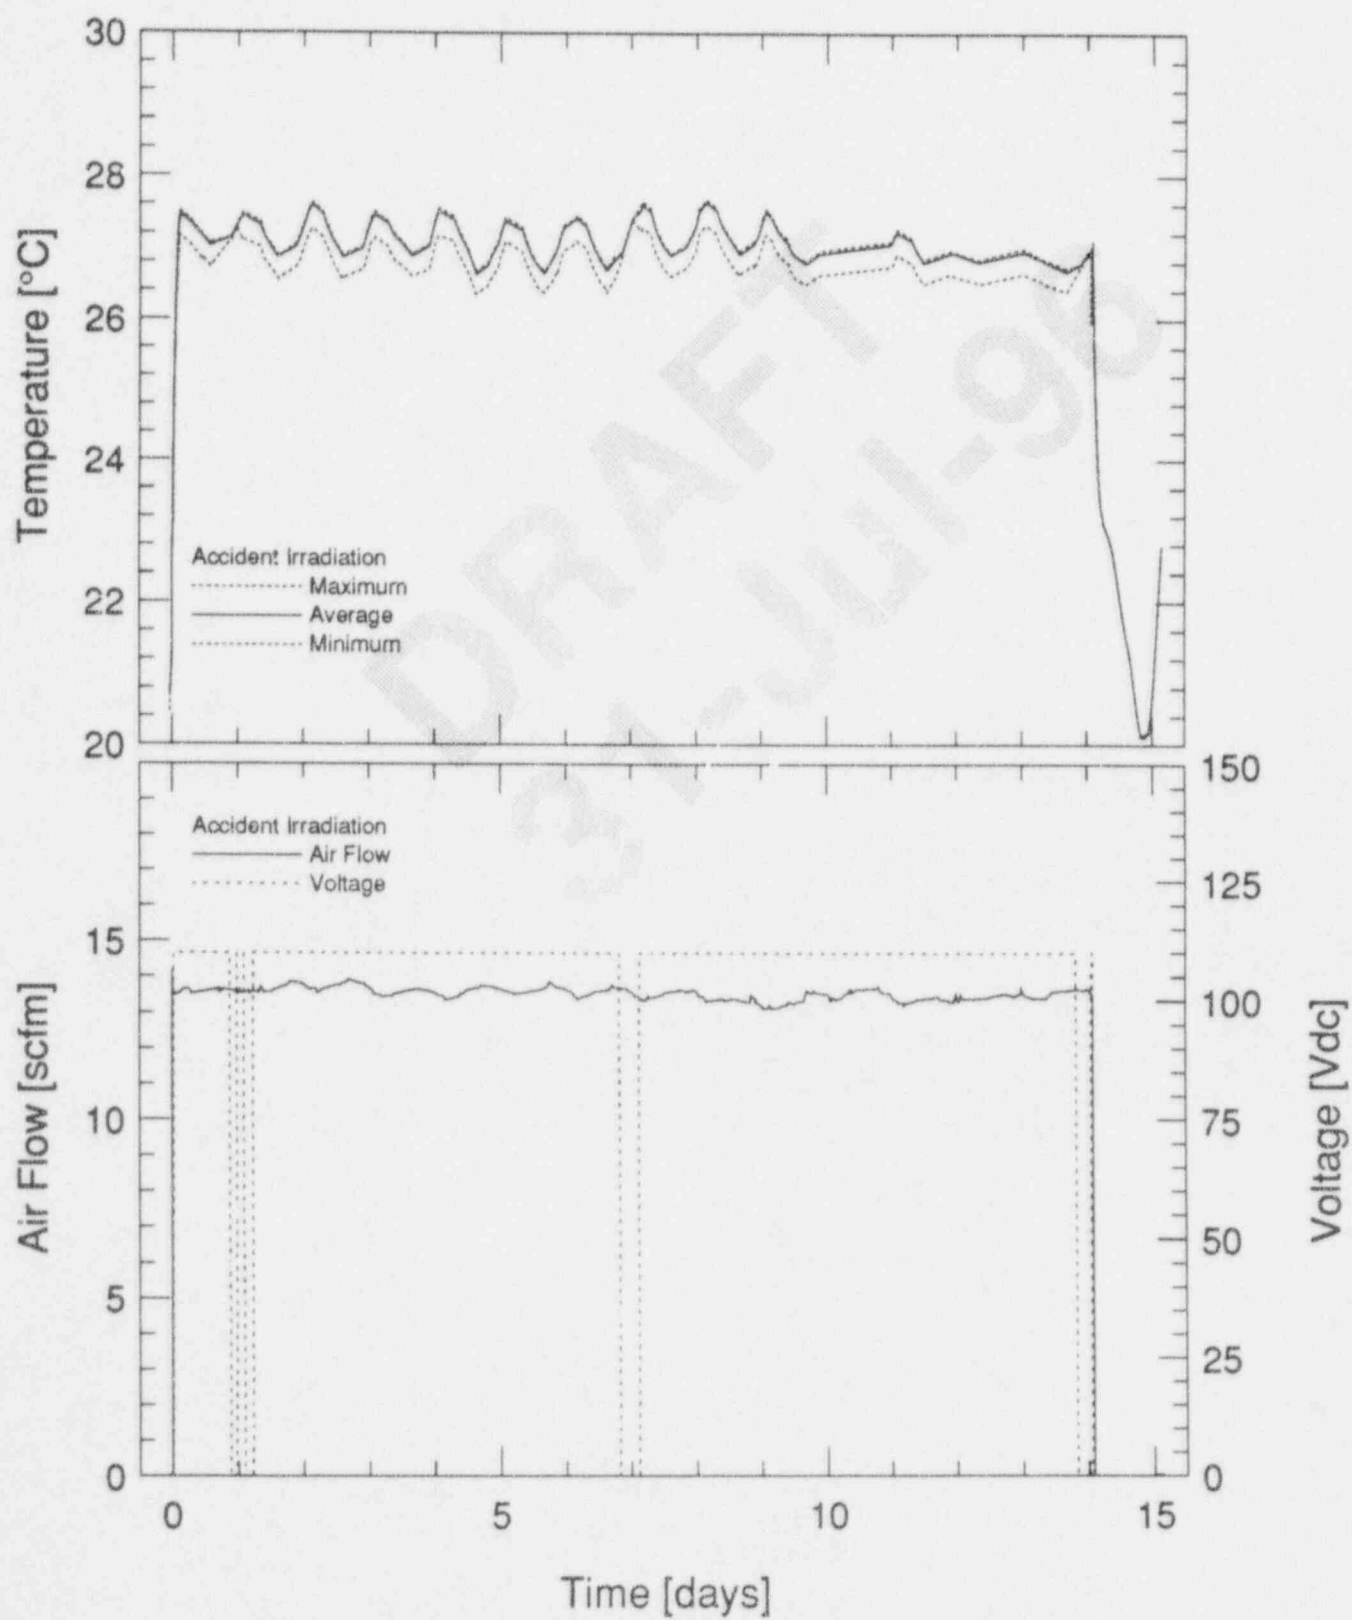
Figure 2.10: Temperature, airflow, and cable excitation during the accident radiation exposure.

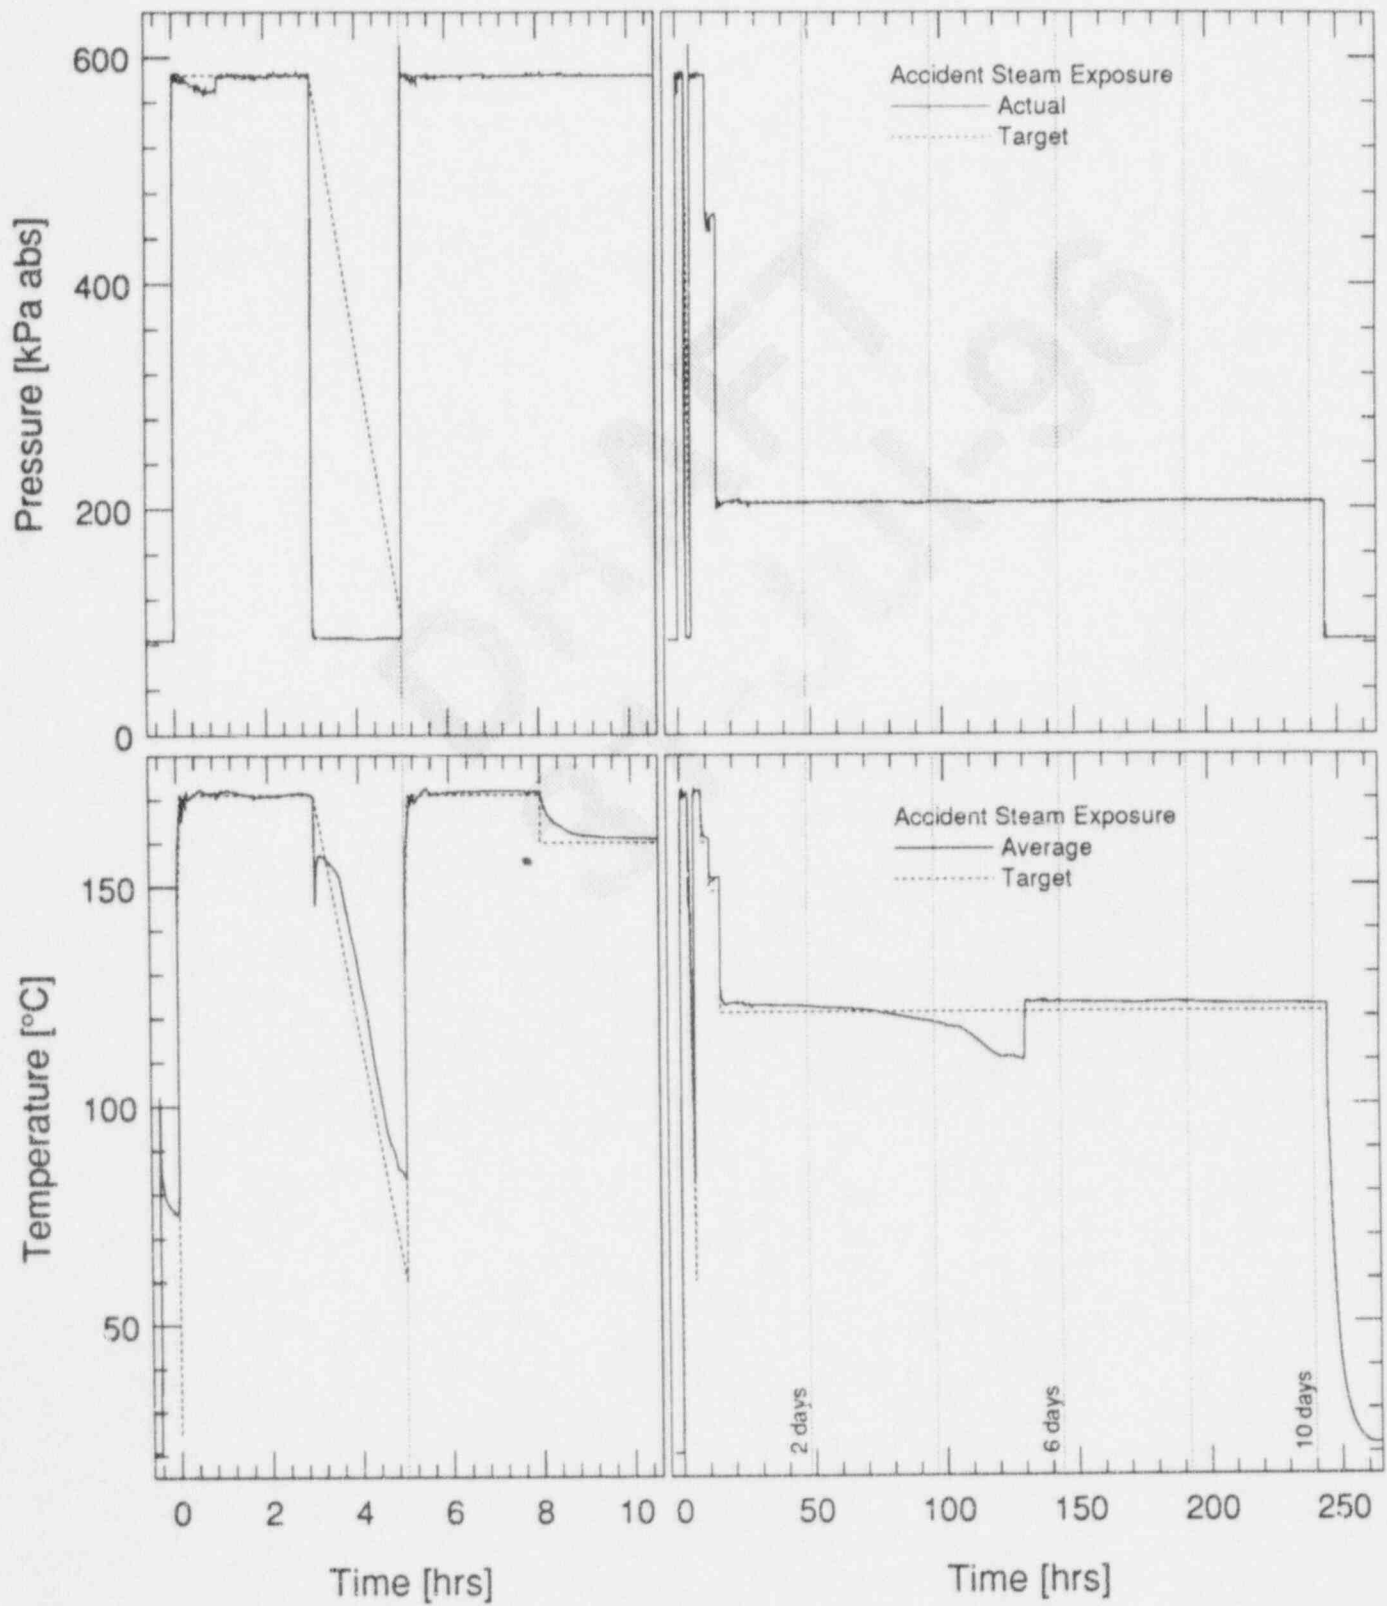
Figure 2.11: Pressure and temperature during the accident steam exposure.

The actual and target pressure and temperature during the accident steam exposure are shown in Figure 2.11. The pressure shown in Fig. 2.11 was measured using a single Heise 710B pressure transducer with a range of 0–1380 kPa gauge (0–200 psig). The temperature shown in Fig. 2.11 is the average value calculated from the 20 thermocouples in the test chamber.

when steam was introduced into the chamber. The valve controlling steam flow into the test chamber was immediately closed, the open port was then closed and the first transient was restarted approximately 24 min later. This can be seen in the Figure 2.11 temperature plot which shows that the test chamber temperature reached approximately 102°C (216°F) prior to the start of the first transient. The second problem was a slow drop in the test chamber temperature that occurred during days 4 and 5. This was due to steam condensate slowly beginning to fill the test chamber after a steam trap failed so that condensate no longer drained from the test chamber. The pressure remained on target because it was manually set by a pressure regulator, however as more and more condensate collected in the bottom of the test chamber, the steam injected into the test chamber was no longer able to keep it at the saturation temperature and thus the test chamber temperature began to cool.

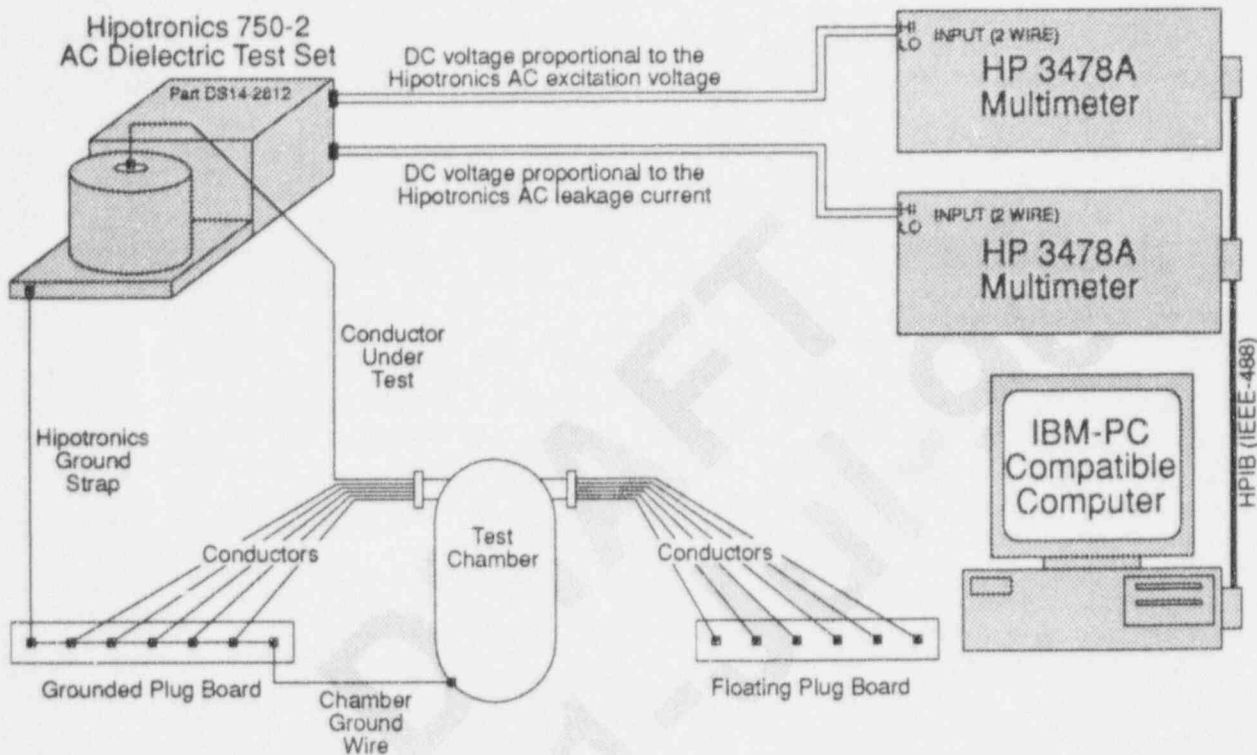
Figure 2.12: Schematic of the system used to measure ac leakage currents.

Using the system shown schematically in Figure 2.12, a Hipotronics Model 750-2 AC Dielectric Test Set (Hipotronics, Inc., Brewster, NY) was used to perform leakage current measurements on the connectors. Data were acquired for dry connections at voltages of 600 and 1000 Vac rms (60 Hz) and for submerged

The Hipotronics dielectric test set outputs dc voltages proportional to the ac excitation voltage and ac leakage current. These two dc voltage outputs were acquired using two HP 3478A Multimeters, one acquired the excitation voltage and the other the leakage current. Data acquisition utilized the following procedure:

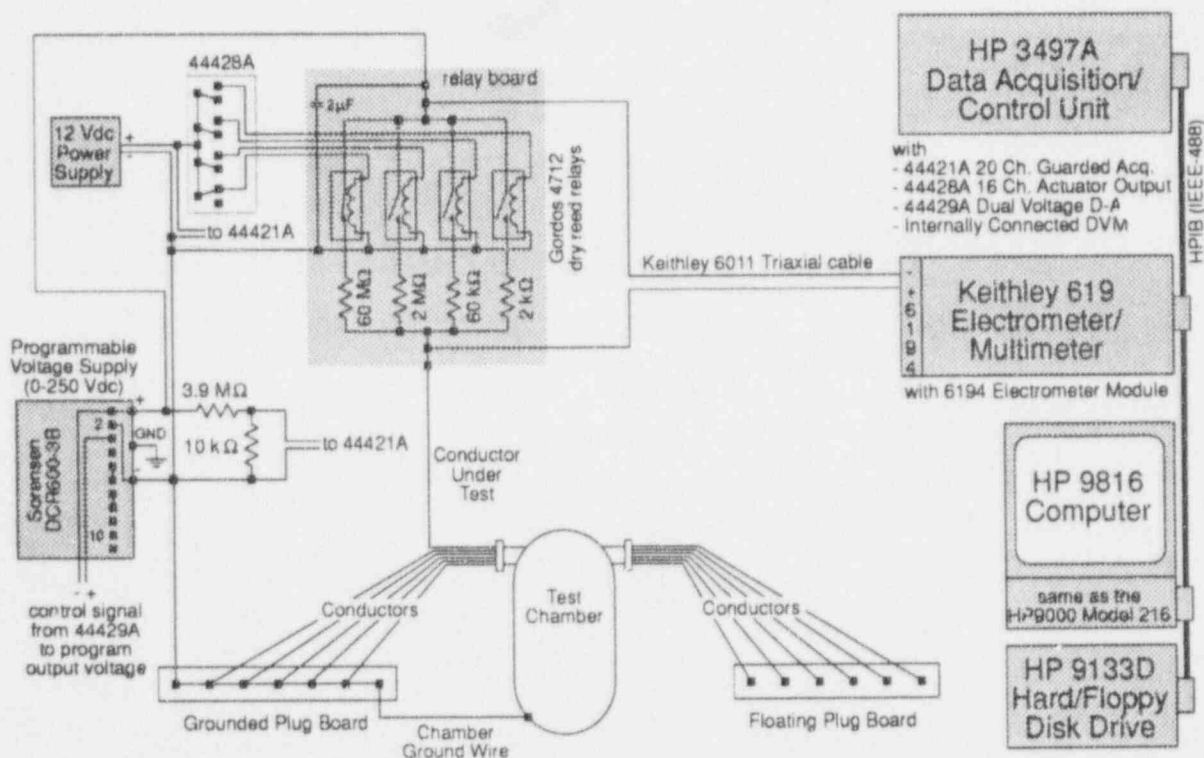
Figure 2.13: Schematic of the system used to measure insulation resistance.

The IR of the complete cable samples was measured at discrete times using the system shown schematically in Figure 2.13—a detailed discussion of this system appears in Ref. [16, Section A.2]. The conductor (or shield) under test was connected to the dc power supply through a resistor—all other conductors (and shields) were grounded before applying the dc voltage. The opposite ends of all the cables were allowed to float electrically. The majority of IR measurements were performed at 100 Vdc, however some data were also acquired at 50 and 250 Vdc. A single IR measurement consisted of acquiring 15 samples of the voltage across the resistor at times ranging from 2 seconds to 1 minute after the application of the power supply voltage. For each of the 15 samples, the conductor's IR was calculated using the measured voltage across the known resistance and the power supply voltage. To reduce the effect of measurement noise, the IR values were fit using a least-squares polynomial regression and the value from the fit, rather than the actual measured value, was used as the IR at 1 minute.

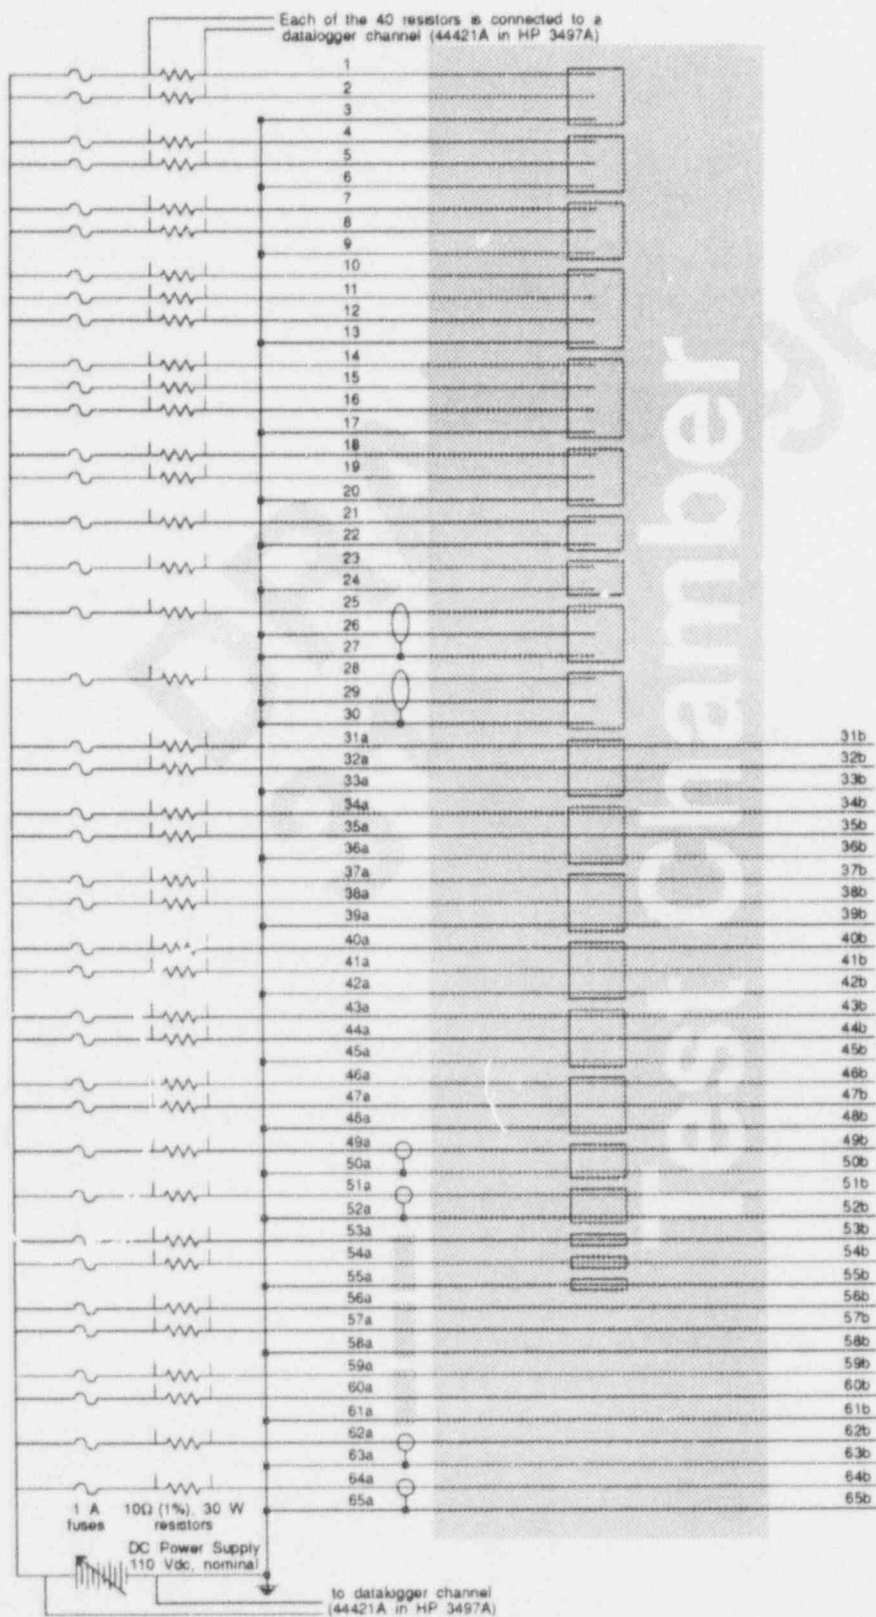
Figure 2.14: Circuitry used to measure continuous insulation resistance during the accident steam exposure.

During the accident steam exposure, IR measurements were performed using the circuit shown in Figure 2.14 in addition to the discrete IR measurements. These IRs are referred to as "continuous" IRs, even though they were not truly continuous—these measurements were performed at intervals ranging from 10–300 seconds. The conductor numbers in the figure correspond to the numbers in Table 2.2. As indicated in Fig. 2.14 and Table 2.2, one conductor or shield from each cable was connected to ground to provide a ground plane—no continuous IR measurements are available for these grounded conductors. The continuous system could measure IR values up to approximately $10^8 \Omega$ which is several orders of magnitude less than what could be measured with the discrete IR system. The continuous IR system is most useful for identifying short-term drops in IR values, such as during the initial transient of the accident steam exposure, that would otherwise be missed by the discrete IR system. A more complete discussion of the measurement limits of the continuous IR system appears in Ref. [16, Section 2.4.3].

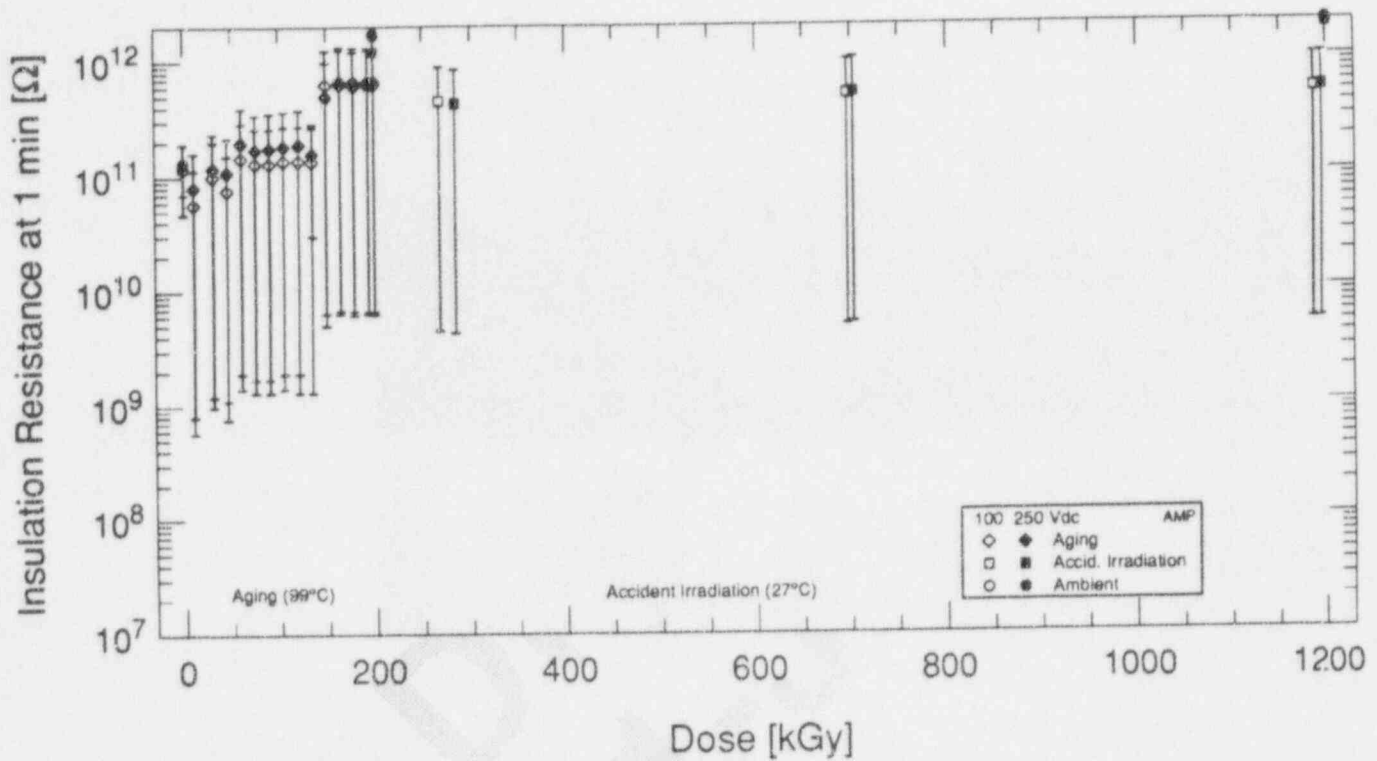
Figure 3.1: IR of Amphenol coaxial connector during aging and accident irradiation.

Only IR data were acquired during the simultaneous thermal and radiation aging exposure, these data are plotted versus radiation dose in Figures 3.1-3.12, these figures also include the accident irradiation IR data. Each plotted point is the average and the plotted bars show the sample standard deviation for the IR measurements of all the conductors for the given type of connection. The IR measurements during the aging exposure were performed with the test chamber and cable leads submerged in the LICA pool.

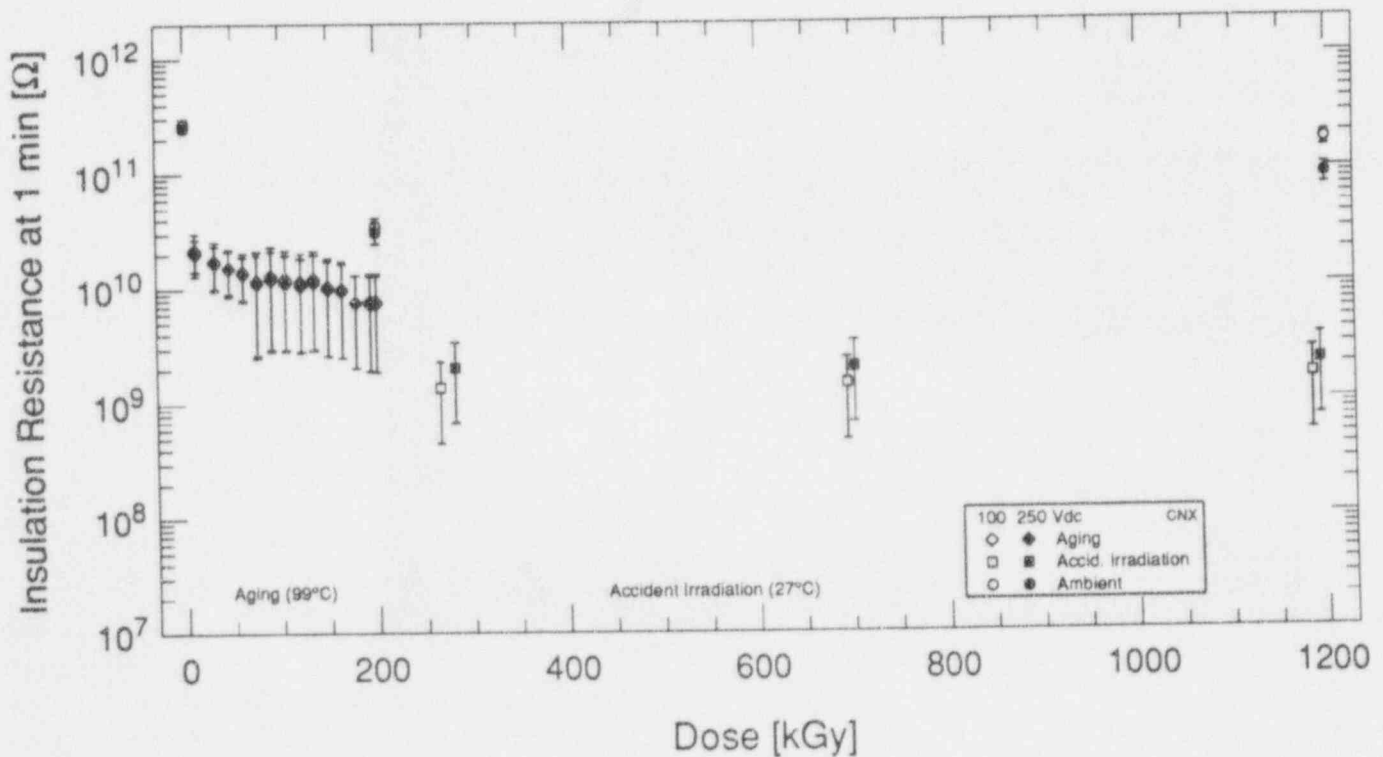
Figure 3.2: IR of Conax ECSA conduit seal during aging and accident irradiation.

- Conductor 22 from a Conax ECSA conduit seal also had reduced IR values (see Figure 3.2); the $8.3 \times 10^9 \Omega$ measurement at 60 kGy fell to $7.0 \times 10^6 \Omega$ at 75 kGy and remained at these low levels for the remainder of the aging exposure. The other 3 conductors typically had IR values near $10^{10} \Omega$.

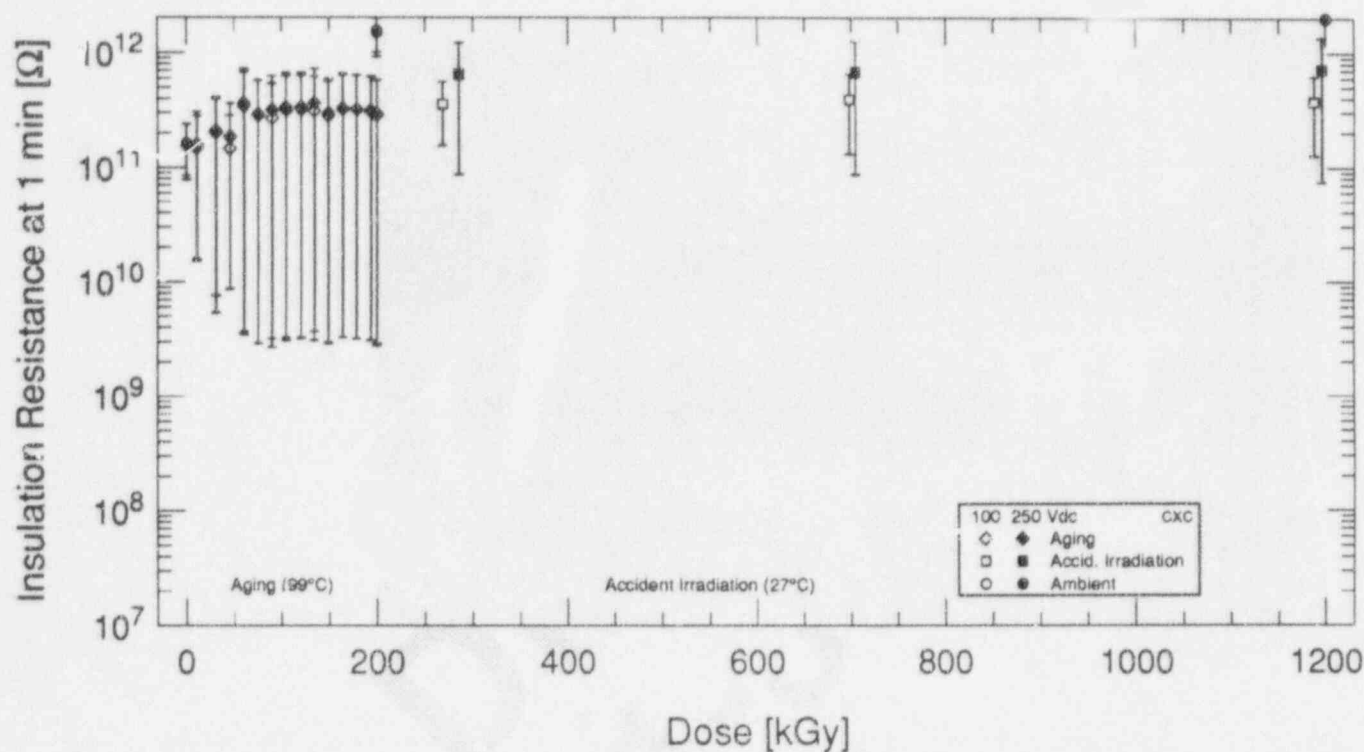
Figure 3.3: IR of Rockbestos coaxial cable during aging and accident irradiation.
